The Taylor Review Pilot

Case Study Chelsworth, All Saints (CofE)

Grade I, ca. 14th Century

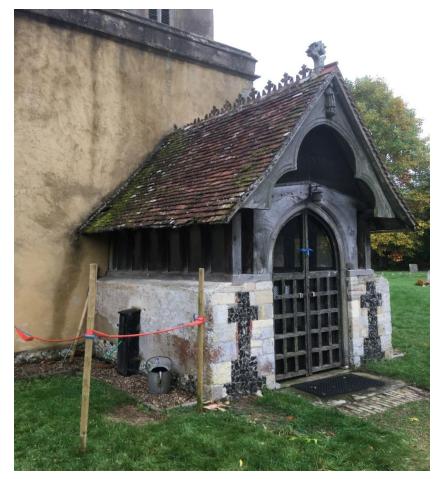
North porch entrance, pre-repair.

- North porch, main entrance to the building.
- Roof tiles are dangerously loose, missing rain water goods, rotting timber work.
- Real H&S concerns with the potential of slipping tiles.
