NORTH EAST

HERITAGE AT RISK 3 Reducing the risks 7 Publications and guidance 10 THE REGISTER 12 12 Content and assessment criteria Key to the entries 15 North East heritage assets at risk 17 County Durham (UA) 18 26 Northumberland (UA) 49 Tees Valley Tyne and Wear 54

In its fourth year, the Heritage at Risk Register now includes grade I and II* listed buildings, listed places of worship, scheduled monuments, registered parks and gardens, registered battlefields, protected wreck sites and conservation areas known to be at risk as a result of neglect, decay or inappropriate development. This year, for the first time, we have published a list of 'priority sites': important heritage at risk sites where we will focus our resources to secure their futures.

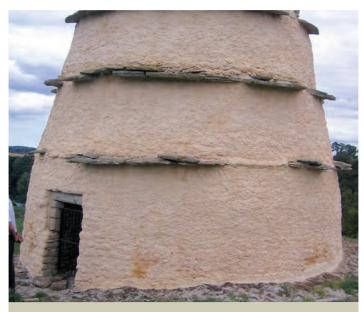
DOVECOTE AT BARFORTH HALL, COUNTY DURHAM The Art of Consolidation – the dovecote pictured after repair works were completed.

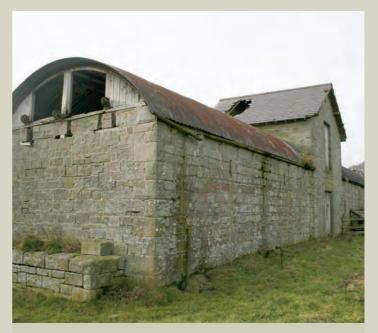
HYDRAULIC SILO, CRAGEND FARM, NORTHUMBERLAND Abandoned Experiment – this hydraulic silo is the legacy of a rare failed experiment by the great industrialist Lord Armstrong.
