## HMS B2

Archaeological Report

### HMS B2 DOVER APPROACHES

#### ARCHAEOLOGICAL REPORT

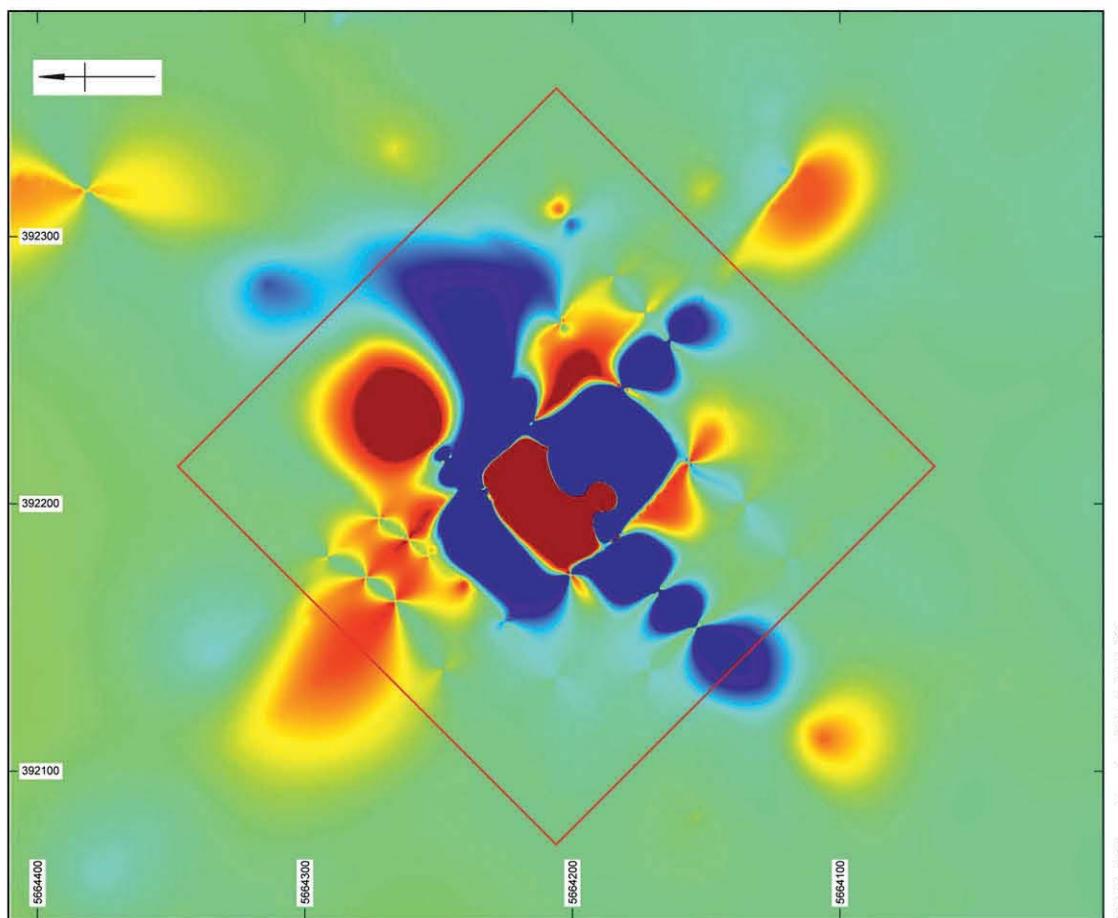
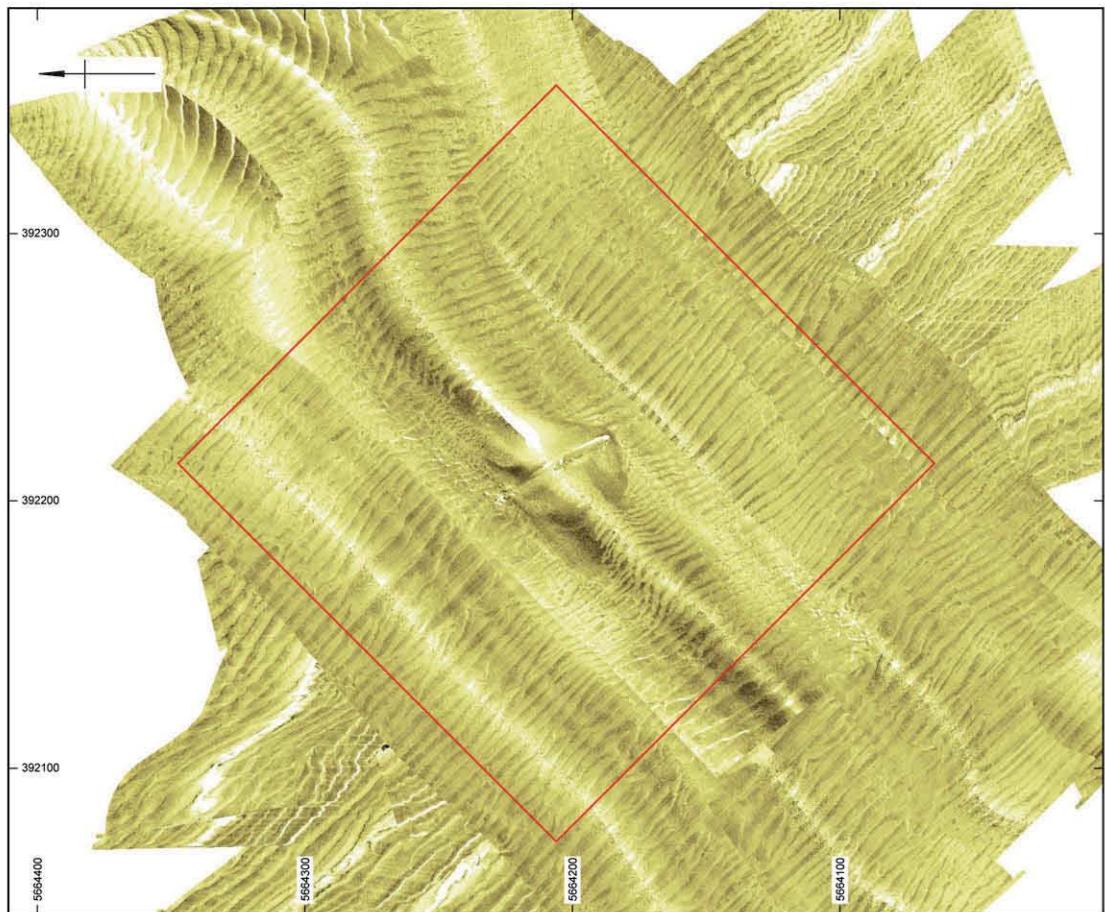
Figure 2  
Sidescan Sonar Mosaic and Gridded Magnetometer Data

- 4.2.2 The wreck of HMS B2 is located in approximately 26m depth LAT (Lowest Astronomical Tide of water and has been identified at the recorded UKHO position. The main body of the wreck (**7002**) appears relatively intact and upright, and has been found orientated approximately NNW-SSE and measuring approximately 45.9m by 5.9m by 3.4m (**Fig 1** and **Fig 2**). Subsequent diver survey has indicated that the bow is located to the SE. A large shadow in the centre suggested the conning tower is intact and in place, the location of which is used here as the position of the wreck. The section aft of the conning tower appeared partially buried, although the stern of the ship was visible suggesting the fins, hydroplanes and rudder, are still in place (**Sheet 1**). The wreck is associated with a very large (14655nT) magnetic anomaly.

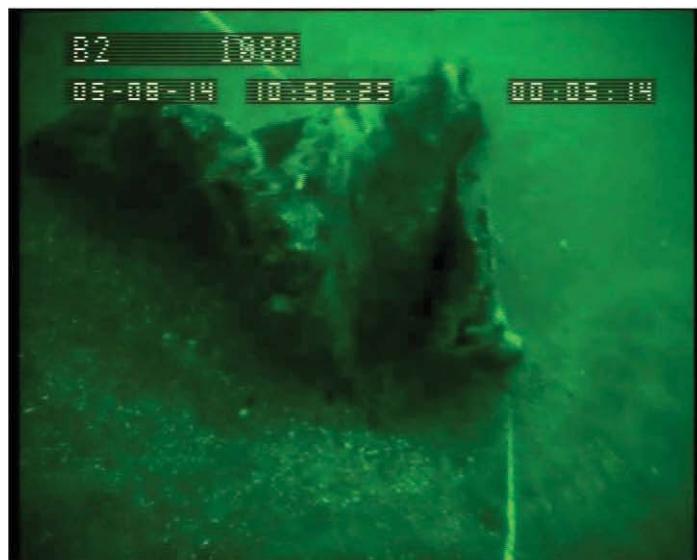
Plate 3: WA1142 – Anomaly 7003

- 4.7.17 Twisted metal debris corresponding with anomaly **7003** was found c. 3m NE of the conning tower (**Plate 3, WA1142**).
