# Plymouth Civic Centre

## Feasibility Study

Final Report June 2010

AVANTI  
ARCHITECTS

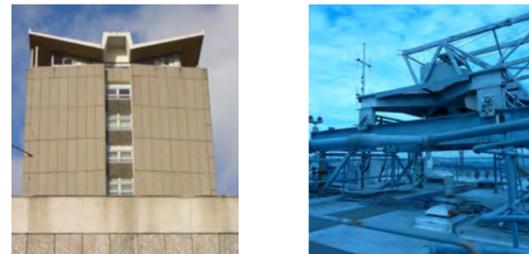
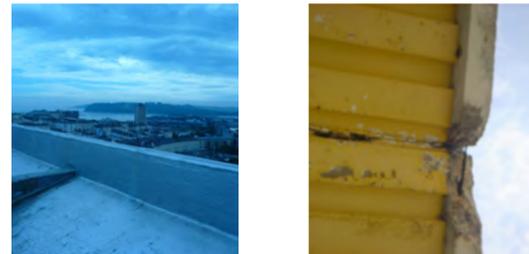
Ribbed concrete soffit to the wing roof is painted. There are some areas of concrete deterioration especially at the edges and at movement joints, also refer to Structural Survey by SW.

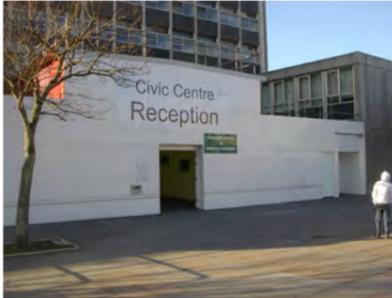
CIVIC OFFICES - 15 STOREY TOWER	
<p><b>East façade from ground to second floors (including the external soffit)</b></p>

<p>Most of the façade is currently covered with protective structure and therefore the condition remains unknown. The visible mosaic finish to the sloping soffit (Naples Yellow Glass) was visually inspected from ground level. The inspection revealed isolated patches where the mosaic tiles have fallen off and shows signs of modest movement.</p>	
<p><b>West façade from ground to second floors</b></p>

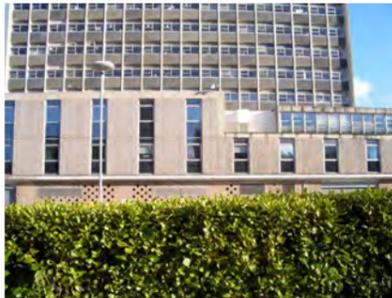
<p>Original west façade at ground level is now incorporated in the 1980s extension.</p> <p>The façade at first floor is constructed in a full height aluminium glazed system (age unknown). The glazed screen is in good visual order, although not compliant with current standards.</p> <p>The western façade of the extension is of prefabricated exposed aggregate panels and aluminium window assemblies all of which appear to be in good visual order.</p> <p>The second level (first floor) of extension steps away from the original tower enveloping a roof terrace which acts as the escape route for the northern core. This area is currently covered with protective structure. The exposed visible façades are generally in good visual order, also see structural survey report by SW.</p>

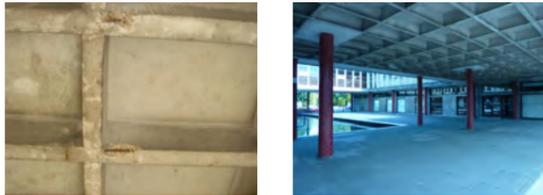
<p><b>Exposed soffit to elevated section</b></p> <p>The coffered soffit is fair faced concrete with various degrees of degradation and spalling, also see structural survey by SW.</p>

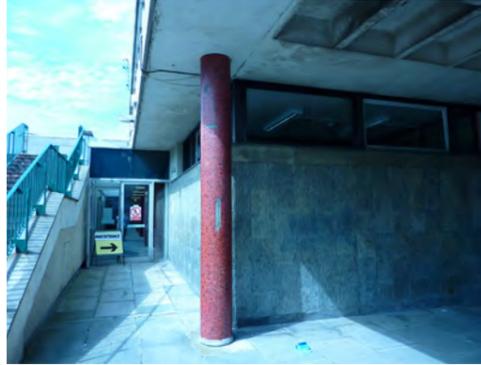
SOUTHERN ADMINISTRATIVE BLOCK, THE LINK BLOCK	
<p><b>Columns to elevated section</b></p> <p>The red mosaic covered columns are in fair condition with some local areas of missing tiles apparently due to malicious interference rather than naturally occurring deterioration. Also see structural survey by SW.</p>

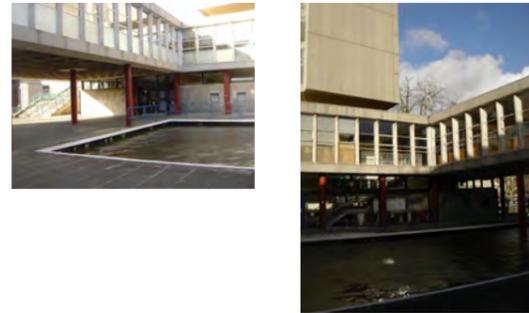
The condition of window assemblies ranges between poor to fair. The windows do not comply with current standards. The thickness of the glass below railing level is not likely to meet current safety compliance standards in respect of containment.

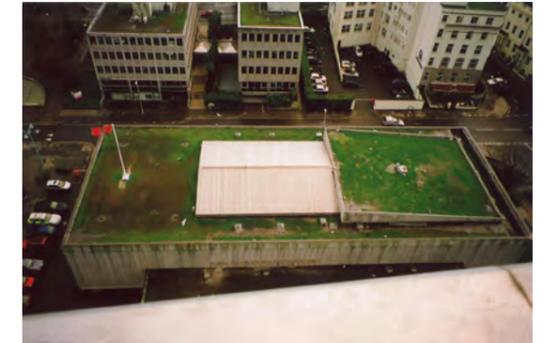
There is evidence of moss growth and some ponding. The exact condition, build up and age of the roofing membrane is unknown, but it can be assumed that replacement of the covering with enhanced insulation and drainage gradient would be included in a general refurbishment project.

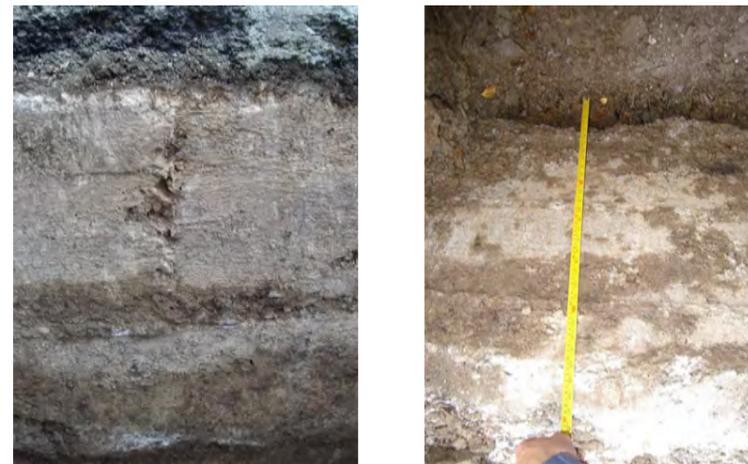
Trial pits were excavated in the public car park to inspect the condition of the reinforced concrete foundations, in particular to investigate any signs of ground related chemical attack. Two separate locations were investigated, with visual and tactile surveys indicating the foundations to be of a good and sound condition and showing no signs of deterioration or distress.

Formed face of foundations exposed in car park trial pits

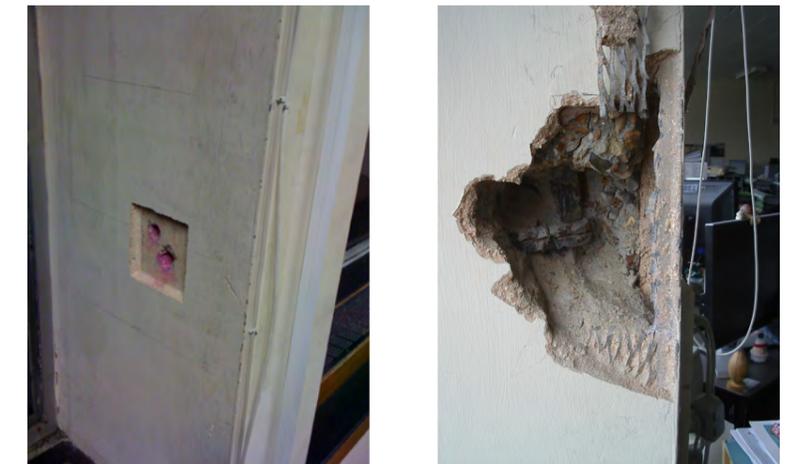
JGP identified that various elements of the internal reinforced concrete frame had carbonated, but did not measure its depth or correlate this with reinforcement cover depth, which is crucial in assessing both the current and future risk of carbonation-induced reinforcement corrosion. SW's carbonation tests at the nine test locations gave a maximum carbonation depth of 14mm, with 4mm to 6mm being typical. At the same locations the minimum concrete cover to the reinforcement was between 37mm and 48mm. On an individual basis this indicates that none of the areas sampled were at risk of carbonation-induced reinforcement corrosion. This view was also confirmed by the results of the half-cell testing data which indicated either a low or uncertain probability of corrosion.

Chloride dust sampling and carbonation testing (left). Reinforcement inspection (right).

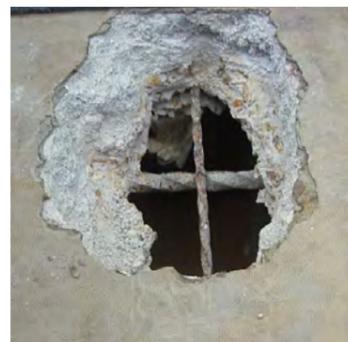
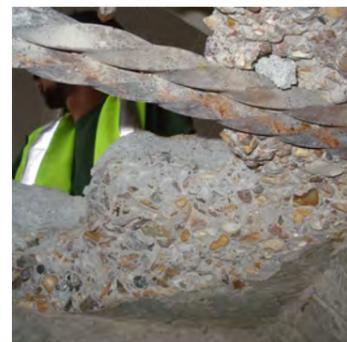
Samples of reinforcement were taken from the slab in three locations (upper, middle and lower floors) for strength testing and inspection of condition. In each case the reinforcement was found to be in good condition, with only minor surface rust. The bar size and spacing corresponded with the record reinforcement details, but with low cover to the soffit. In some cases the reinforcement cover was zero, with the bar visible in the soffit. Internal conditions are relatively mild, but the low cover does present a greater risk of carbonation and chloride related corrosion.

Reinforcement sampling and low reinforcement cover to soffit

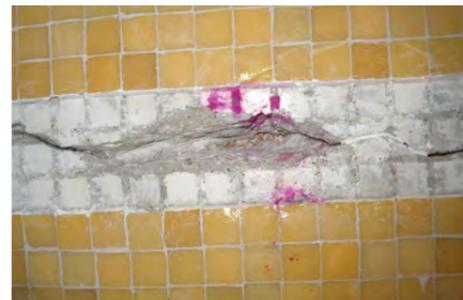
Upon removing the tiles, it was clear that the crack has been repaired in the past. Repair mortar was easily removed, as shown in the photograph below, with no signs of reinforcement or reinforcement corrosion. The crack itself was measured at up to 4mm wide, reducing in width towards the transfer beams.

Cracking in second floor soffit - area knocked out to expose extent of cracking

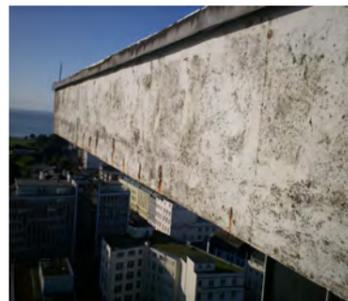
The exposed reinforced concrete soffit and edges of the gull wing roof were inspected in numerous locations using a combination of temporary scaffold and rope access techniques. Visually, the parapet appears to be in a poor condition, exhibiting many areas of reinforcement corrosion and presenting a health and safety risk to the public from falling concrete debris. In addition, the underside of the gull wing roof exhibits signs of reinforcement corrosion throughout, appearing most severe at the structural movement joints and roof edges.

Reinforcement corrosion to gull wing roof edge

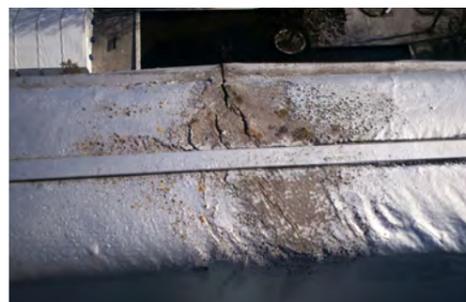
A moderate amount of cracking, and a small amount of concrete spalling was found to be present. Typically the cover was low. On the roof edge the cover was measured between 5mm and 34mm. The ribbed soffits could be seen to have very low concrete cover of between 2mm and 3mm. The reinforcement appears to have been placed on the formwork during casting in some areas.

Corrosion in parapet at movement joint. Side view (right). Top view (left).

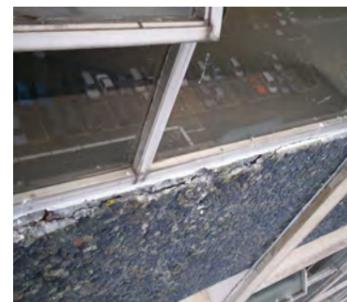
It is agreed by both parties (SW and JGP) that there are serious problems with the precast cladding units and transom cill beams to the east and west elevations of the Civic Centre, and all indications suggest that the problems are a result of reinforcement corrosion.

Dilapidated spandrel cladding panels

The poor condition of the pre-cast concrete spandrel panels and pre-cast transom cills on the east and west façades necessitates wholesale replacement, coupled with the re-fixing/refurbishment of the loose re-constituted stone pilaster panels.

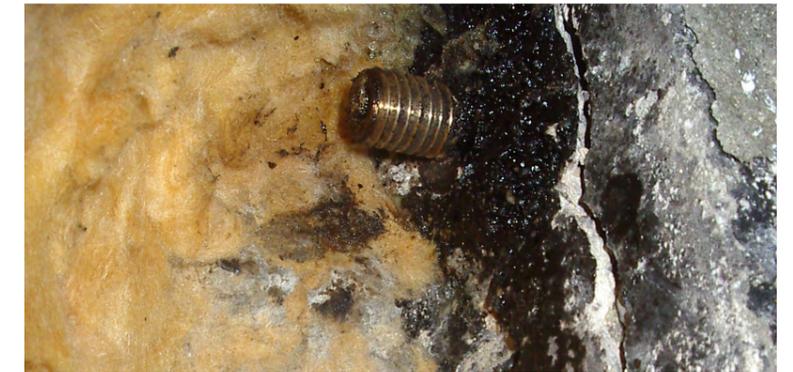
The cladding panels were not inspected during our survey work, as sufficient studies have already been carried out and their poor condition is widely accepted and clear to see. An investigation was carried out on a small selection of the cladding panel fixings, which were all found to be of non-ferrous materials, and in good condition.

Non-ferrous spandrel panel bolt fitting

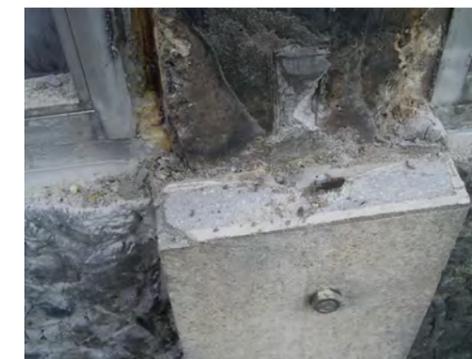
Non-ferrous metal pilaster restraint fixing

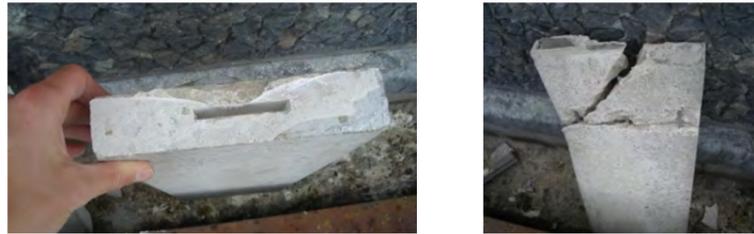
Pilaster cladding panel removed at second floor. Fixing slot visible on left.

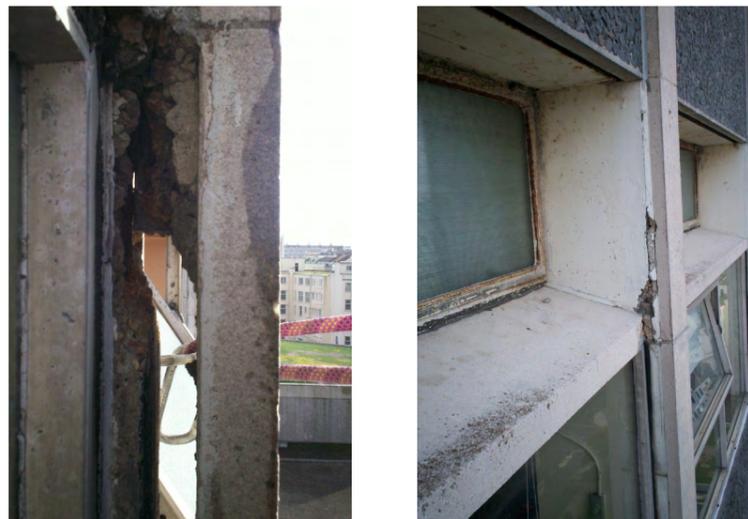
Mortar bed loss and column reinforcement corrosion
