Title INVESTIGATION AND CONSERVATION OF A MEDIEVAL DAGGER

Abstract This report describes the examination and conservation of a medieval dagger exhibited at the Tower of London.

Dagger AML 776276

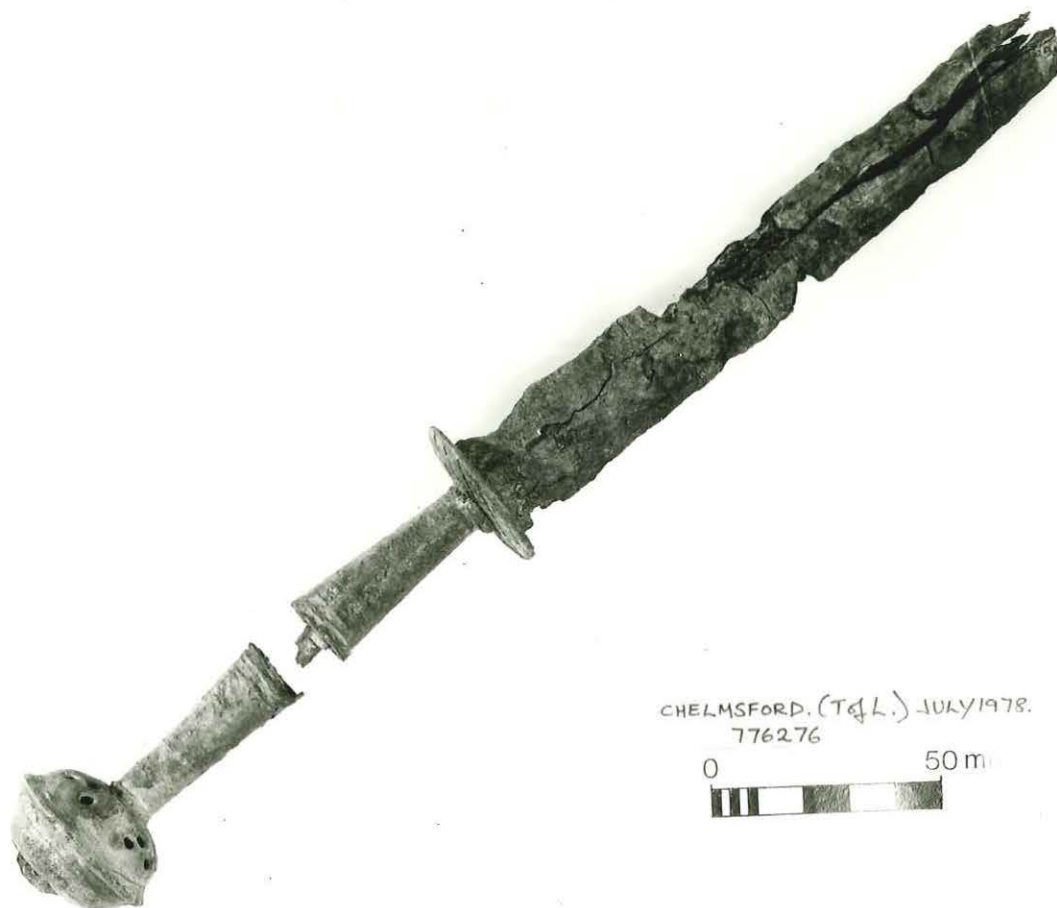
Plate 1.
Dagger before
conservation

The dagger consists of two metal components; a decorative copper alloy hilt and an iron blade. It was taken from exhibition at the Tower of London due to **accelerated** corrosion of the iron blade. Outbreaks of active salts were in evidence on the blade, causing severe lamination and deterioration of the iron structure which was reduced, at a touch, to powdery fragments.

The hilt was firstly swabbed successfully with moistened cotton wool buds dipped in a mixture of acetone and white spirit in water, with a drop of detergent added to reduce the surface tension. This treatment removed all surface dirt and revealed white metal decoration remaining in some areas. It was observed, with the aid of a binocular microscope that the incised lines of the hilt plate were filled with a brown, compacted bubbly deposit, similar in fact to a cleaner such as "Brasso" which may have at some stage been used in previous attempts to clean the object. This deposit was removed by picking with a sharpened needle held in a pin-vice and also a hand-hold vibrotool.

The hilt was passed on to a colleague Justine Bayley, for specialist examination of the white metal areas (Appendix 1). The iron blade was carefully handled to prevent further disintegration and the laminates, brushed free of surface salts with a glass bristle brush and readhered in their correct relative positions with HMG cellulose nitrate adhesive. For a stronger bond between two sections of the blade cover, Super Epoxy adhesive was used and abraded lightly to give a matt finish.
