Ancient Monuments Laboratory
Report 56/89

X-RADIOGRAPHIC AND METALLOGRAPHIC
EXAMINATION OF AN ANGLO-SAXON
PATTERN-WELDED FITTING FROM ABBOTS
WORTHY HAMPSHIRE (1983).

Vanessa Fell

Summary

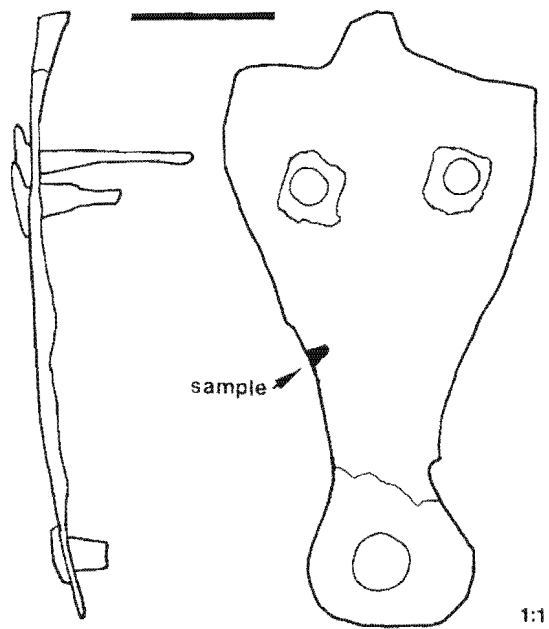
FIGURE 1. Abbots Worthy fitting SF379

Excavations at Abbots Worthy, Itchen Valley, Hampshire (SU 5044 3266), a Saxon occupation site, produced a small quantity of metalwork. One item (M3.83/W79 F.7345/7378 SF379) was an iron fitting with three iron nails in situ, possibly a hinge-plate fragment (Fig. 1). The fitting was well-preserved but incomplete. The surfaces of the fitting and the nails were covered with a substantial layer of red iron corrosion products, identified as haematite, above a layer of magnetite and the metal core. No suggestion of the structural composition was visible on the surfaces of the fitting.

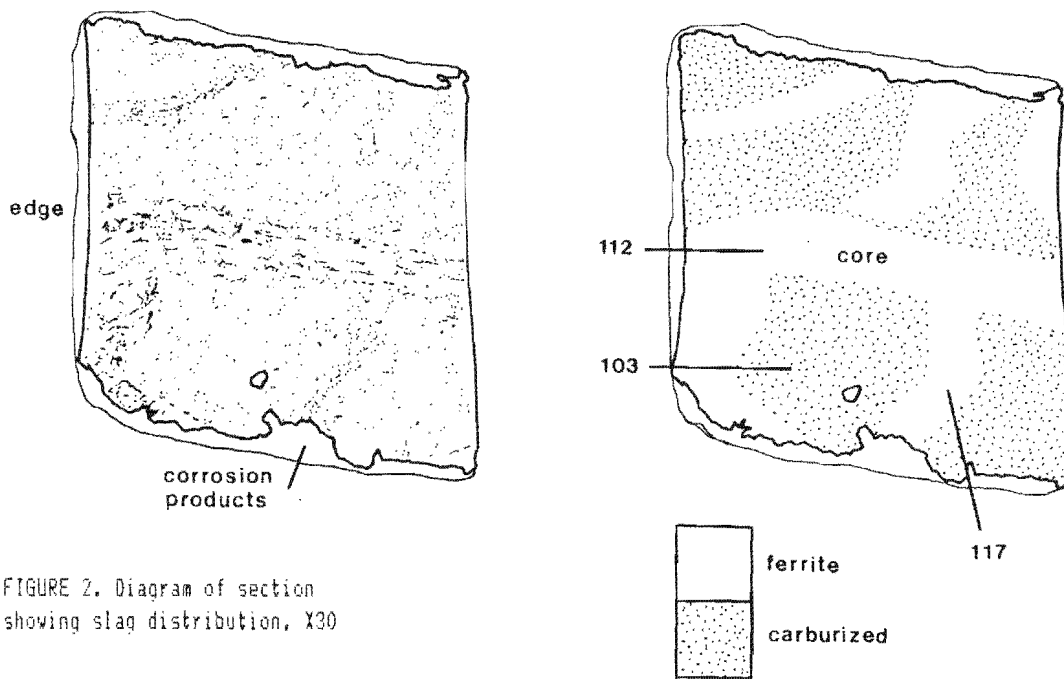
FIGURE 2. Diagram of section showing slag distribution, X30

Etching revealed a straight central ferrite core between alternate and diagonally orientated bands of ferrite and broader zones of carburized iron (Fig. 3, Plate 3). The carburized zones were of low carbon content, \approx 0.1%C, and consisted of ferrite and pearlite (Plate 4). Grains were equiaxed, slightly larger in the ferrite regions (ASTM 4) compared with the carburized regions (ASTM 5). Qualitative phosphorus estimation by scanning electron microscopy with energy-dispersive X-ray analysis detected phosphorus in the ferrite regions whereas none was detected in the carburized regions. Slag inclusions (Fig. 2) were single-phased and duplex and these were more abundant, larger and angular within the ferrite core. Stringers were well-broken and alignments corresponded with the banding visible upon etching. Hardness of the central ferrite core was 112 HV, ferrite band 117 HV, carburized zone 103 HV.

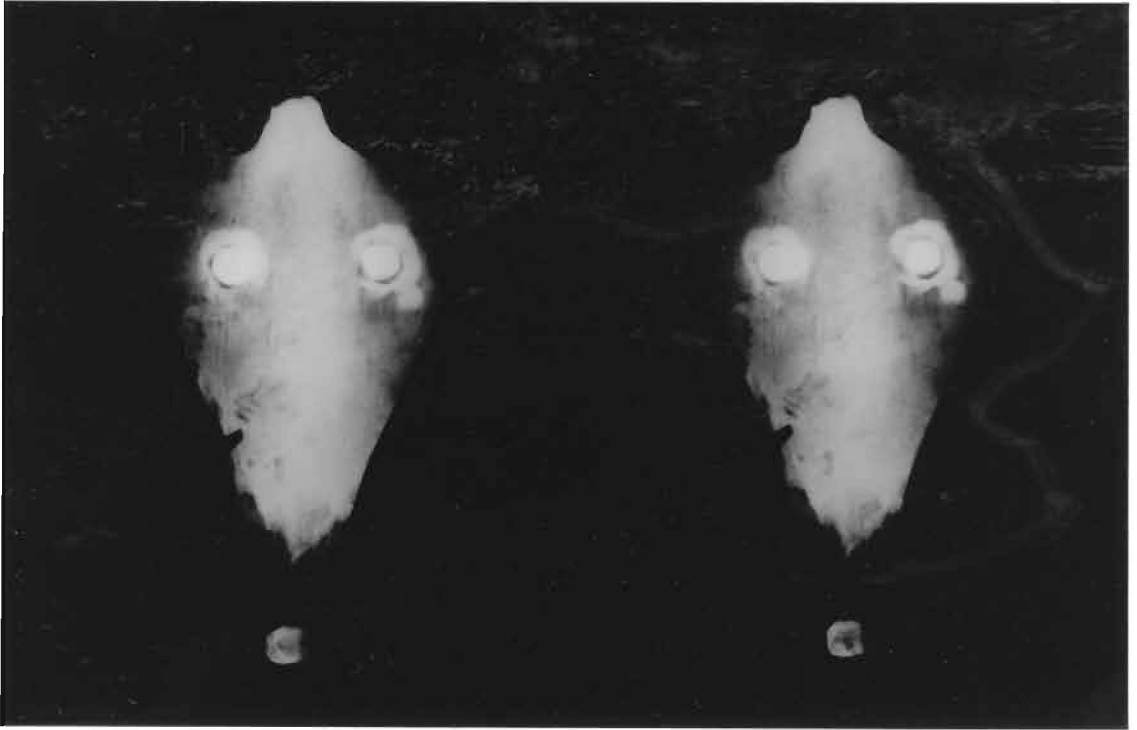
X-radiography suggested that the fitting was pattern-welded, with elements orientated longitudinally to the axis of the fitting. Stereo-X-radiography partially resolved the structure, separating the image into a double construction of composite straight rods and composite twisted rods. Lengths of both straight elements and twisted elements were traceable on both sides of the double construction, with straight elements opposite twisted elements on the second side. At least five, and possibly six, composite elements were visible along the central axis of the fitting but no structure was visible at the edges of the broadest part. The small size of the fitting and distortion by the crudely formed nail holes make the precise number of elements uncertain. Plate 2 shows one side of the double construction to consist of a central element of straight rods at the top (above the nails) between two pairs of alternately twisted elements (which form a chevron pattern on both sides of the central element). Below the nails (more visible in Plate 1), the central element is twisted and lays between straight composite rods. The pattern is reversed on the second side of the construction. The possible sixth element is just visible as an untwisted composite rod above the right nail in Plate 1.

PLATE 1. Stereo pair of X-radiographs.

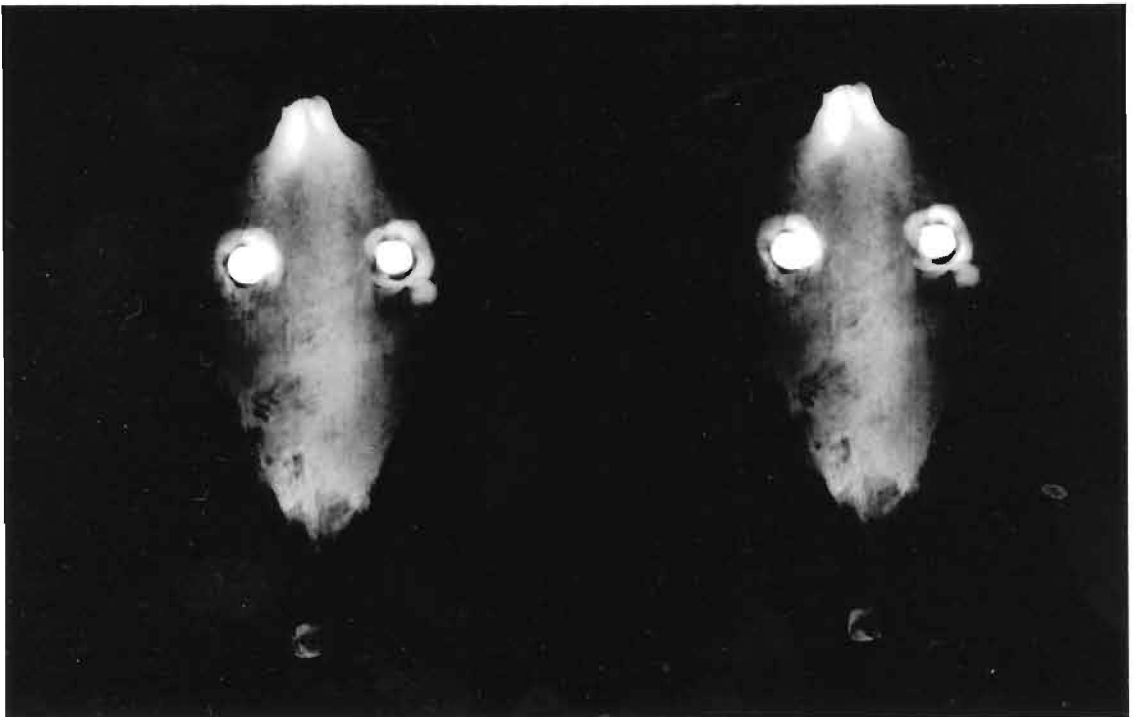
PLATE 2. Stereo pair of X-radiographs. The exposure was increased to show the pattern-welded structure in the thicker parts of the fitting.

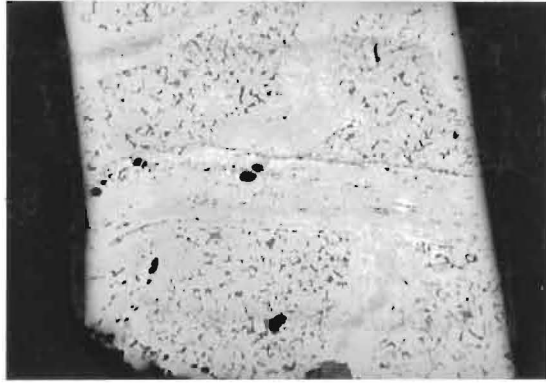
PLATE 3. Photomicrograph of section, X30

Metallographic examination confirmed the double construction suggested by the X-radiographs and also revealed a central ferrite core which had not been detected on the X-radiographs. The adjacent ferrite bands and carburized zones visible at the edges of the metallographic section (upper and lower sides of the fitting) correspond to the individual strips of the composite rods of the pattern-welding, with the central ferrite core interposed between the double pattern construction. Judging from the orientations visible on the section, the upper row of ferrite bands and carburized zones in Fig. 3 and Plate 3 probably corresponds to part of a twisted composite element of the pattern-welding whereas the lower row probably corresponds to part of a straight composite element. The presence of the haematite corrosion products on the fitting suggests that it had been heated in an oxidising atmosphere after breakage and
