Ancient Monuments Laboratory  
Report 47/93

DOVER BRONZE-AGE BOAT:  
ASSESSMENT FOR CONSERVATION

Jacqui Watson

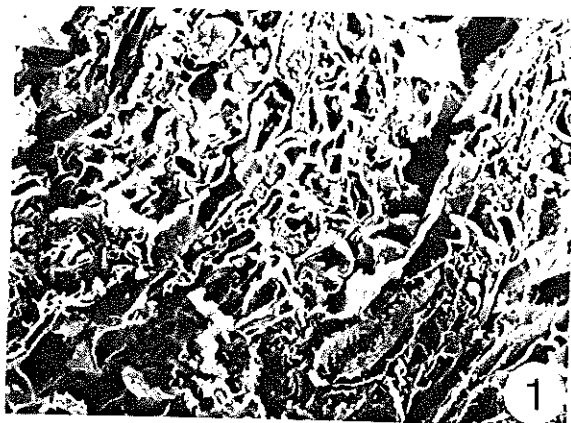
Figures 1-4. Scanning electron micrographs of transverse section of oak sample 1, part of keelboard.

1. Section taken 1mm below the surface, showing extensive cell wall degradation causing the cells of this region to collapse. Best preserved cell wall layer is the middle lamella (highly lignified). x800

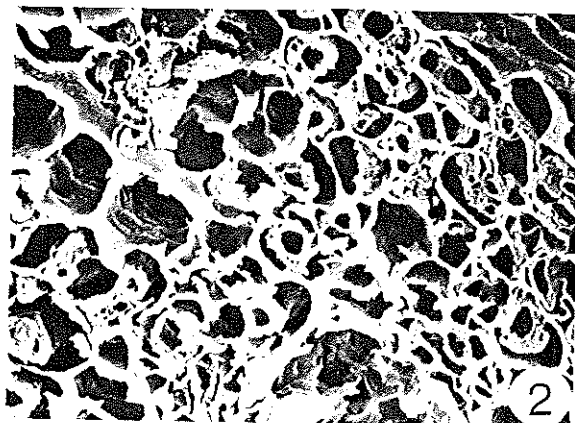
2. Section taken 2mm below the surface, showing fibre cell walls. The secondary wall layers of some cells are completely degraded, whereas others exhibit a highly porous and detached secondary wall layer. x1200

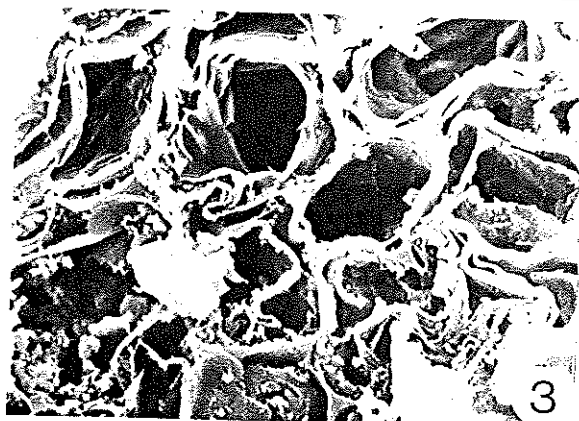
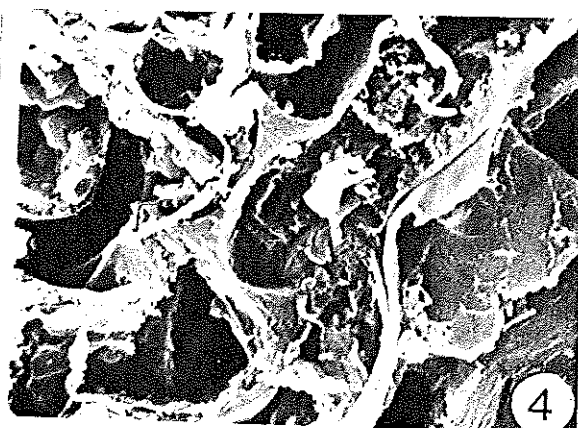
3, 4. Sections taken 1mm below surface showing extensive cell wall degradation and collapse. x2400 and x5600

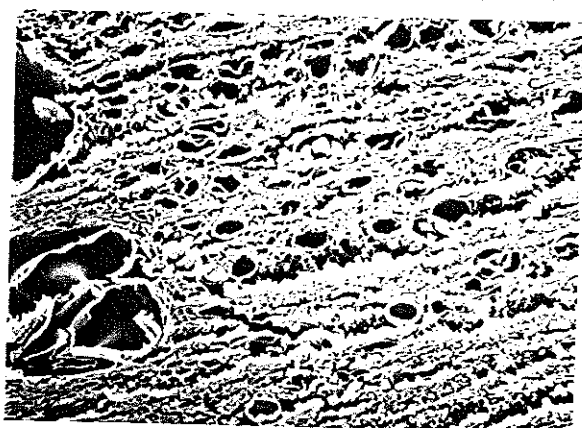
5. Section taken 2mm below surface, showing highly degraded fibres and vessels. Tyloses in vessels showing selective degradation. x160

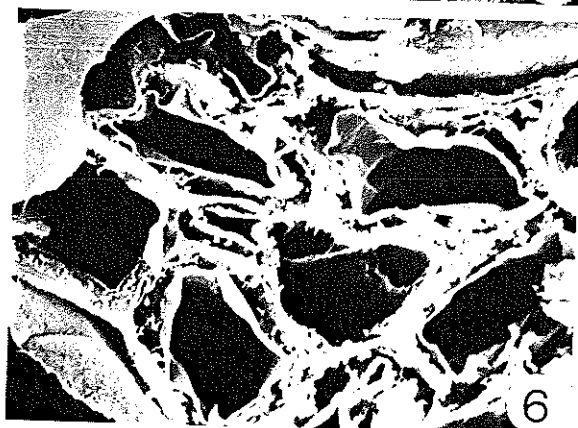
6. Porous appearance of the S2 layer of the fibre cell wall is decay due to a combination of bacteria and fungi. x3200

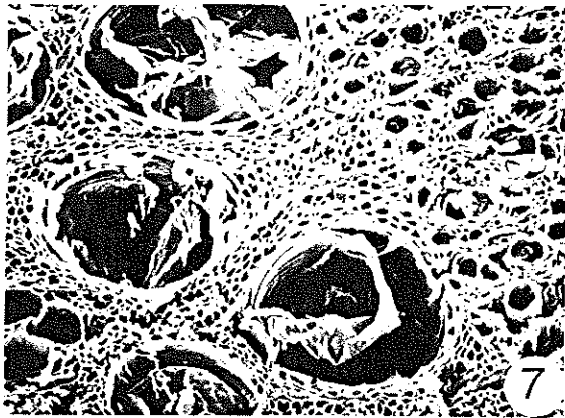
Figures 7-10. Scanning electron micrographs of transverse sections of oak sample 49, sidetrake.

7. Decayed region (outer surface) of sample showing advanced stage of decay. Tyloses in vessels showing selective degradation. x160

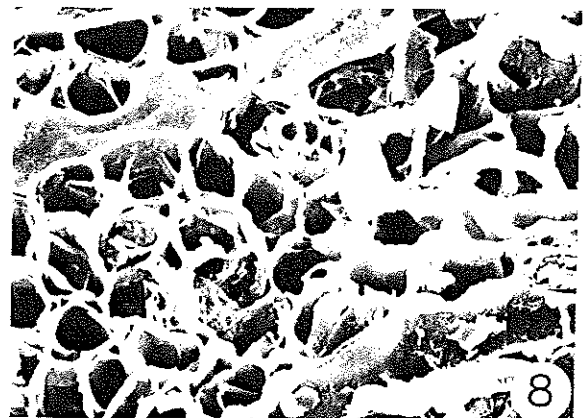
8. Condition of cells in the highly degraded outer surface layers - the secondary wall layers of most fibre cells are completely degraded, with only the middle lamella remaining. x1200

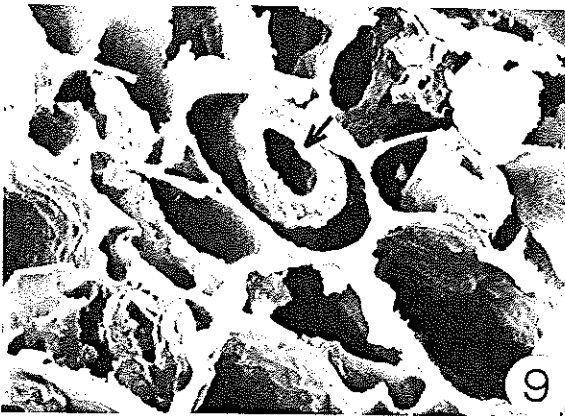
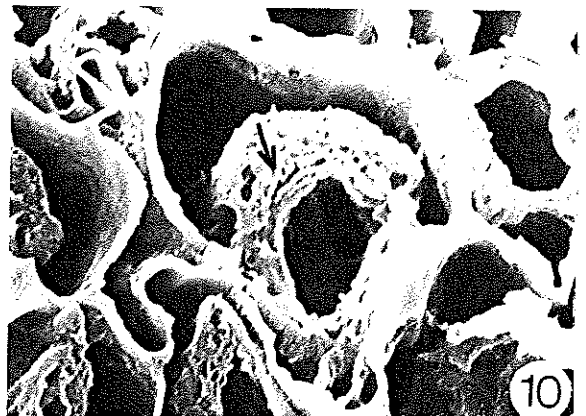
9, 10. Porous appearance of S2 layer (arrowed) of the fibre cell wall. Adjoining cells have lost their secondary wall layer leaving only the middle lamella intact. x3200 and x5600

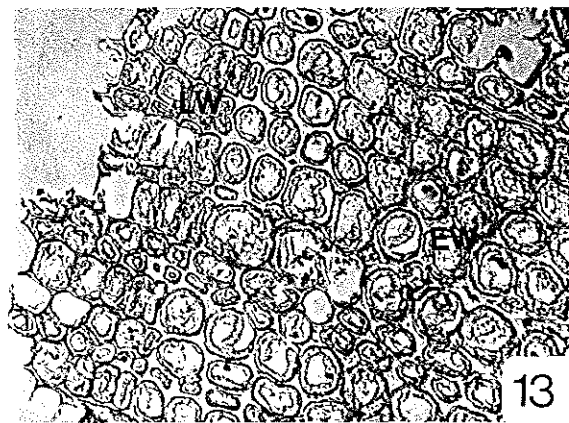
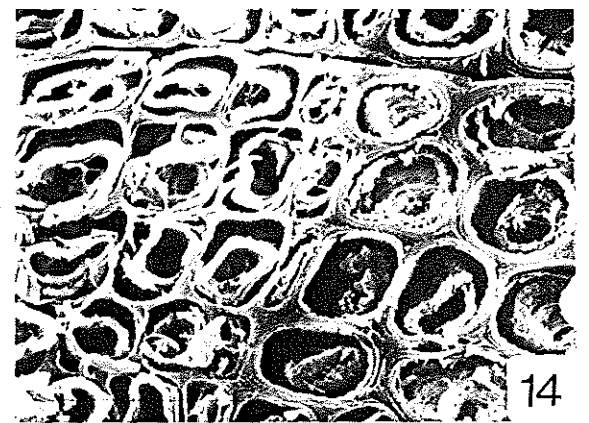
13, 14. Morphology of early (EW) and latewood (LW) of the outer decayed surface layers. Decay due to a combination of biological and chemical agents. x117 and x1600

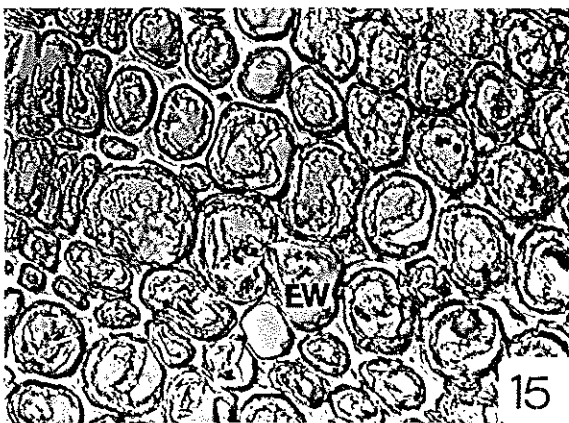
15. Early and latewood tracheids showing heavy microbial attack, especially of the S2 layer in the latewood. x188

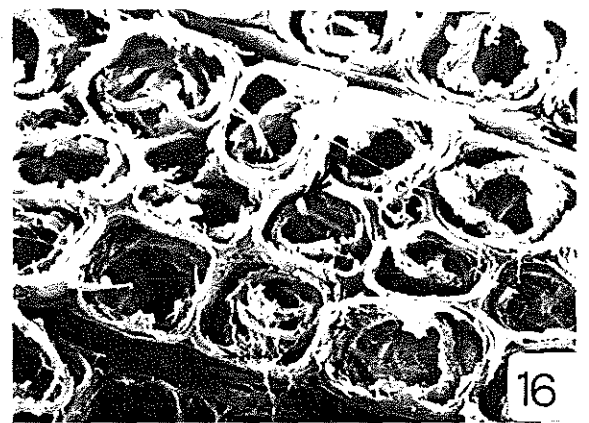
16. SEM showing extensive cell wall degradation and the presence of fungal hyphae (arrowed). x1600

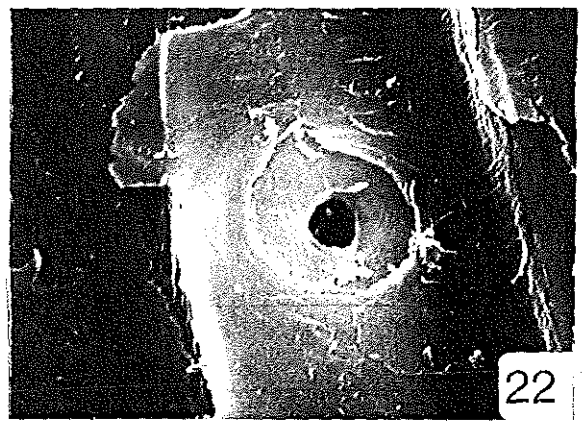
22. Longitudinal section showing a degraded pit. The tori has disappeared. x5600
