Ancient Monuments Laboratory  
Report 35/95

METALLOGRAPHIC EXAMINATION OF  
MISCELLANEOUS IRON OBJECTS  
1994

D Starley

This report provides details of a number of (unassociated) ferrous objects examined at the Ancient Monuments Laboratory during 1994. These comprised an unusual, internally oxidised cast iron fragment from Windsor Castle, Berkshire, a casting spill of cast iron from Tilbury Fort, Essex and parts of a wrought iron gate and railings from Garrison Church, Portsmouth.

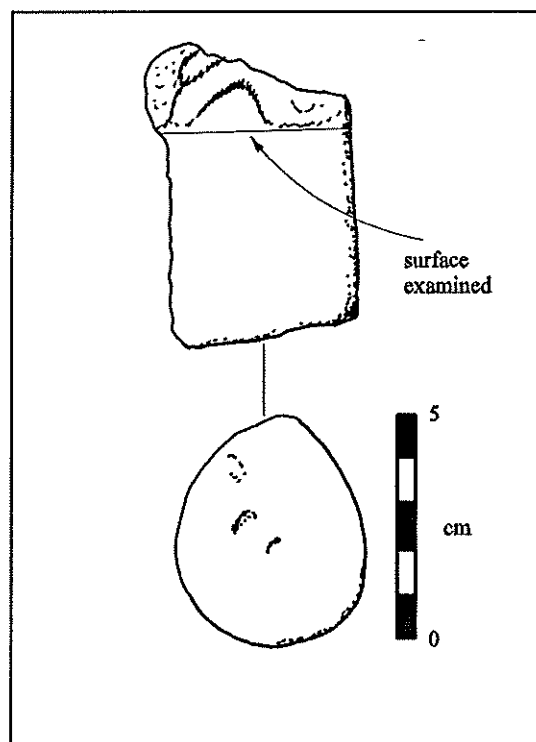
Figure1 Windsor Castle cast iron object

Find No. 13018, was an iron object (Fig. 1) of approximately cylindrical shape with a length of 50mm, diameter of 40mm and weight of 283g. The artefact was recovered from context 7101 during the excavation of the Round Tower. Although originally classed as iron, the object showed unusual corrosion products; a hard, dense layer with a distinctly purple/maroon tinge. Qualitative X-ray fluorescence (XRF) analysis of the surface identified only iron and manganese, ruling out the possible presence of unusual alloying elements or surface treatments. Streak testing of the surface on a porcelain tile gave a red-brown colour, suggestive of hematite ( $\text{Fe}_2\text{O}_3$ ), but the response to the magnet showed that at least some iron, or possibly magnetite ( $\text{Fe}_3\text{O}_4$ ), lay beneath the surface. Repeated density measurements (5.4, 5.05 & 5.05) gave a mean value of  $5.16 \text{ g cm}^{-3}$ , which is much closer to the density of magnetite and hematite (both  $5.2 \text{ g cm}^{-3}$ ) rather than pure metallic iron ( $7.9 \text{ g cm}^{-3}$ ) or cast iron ( $6.8$  to  $7.8 \text{ g cm}^{-3}$  depending on structure). However, the remarkably regular shape of the object was not consistent with it being of natural mineralogical origins and the artefact was therefore sectioned for metallographic examination.

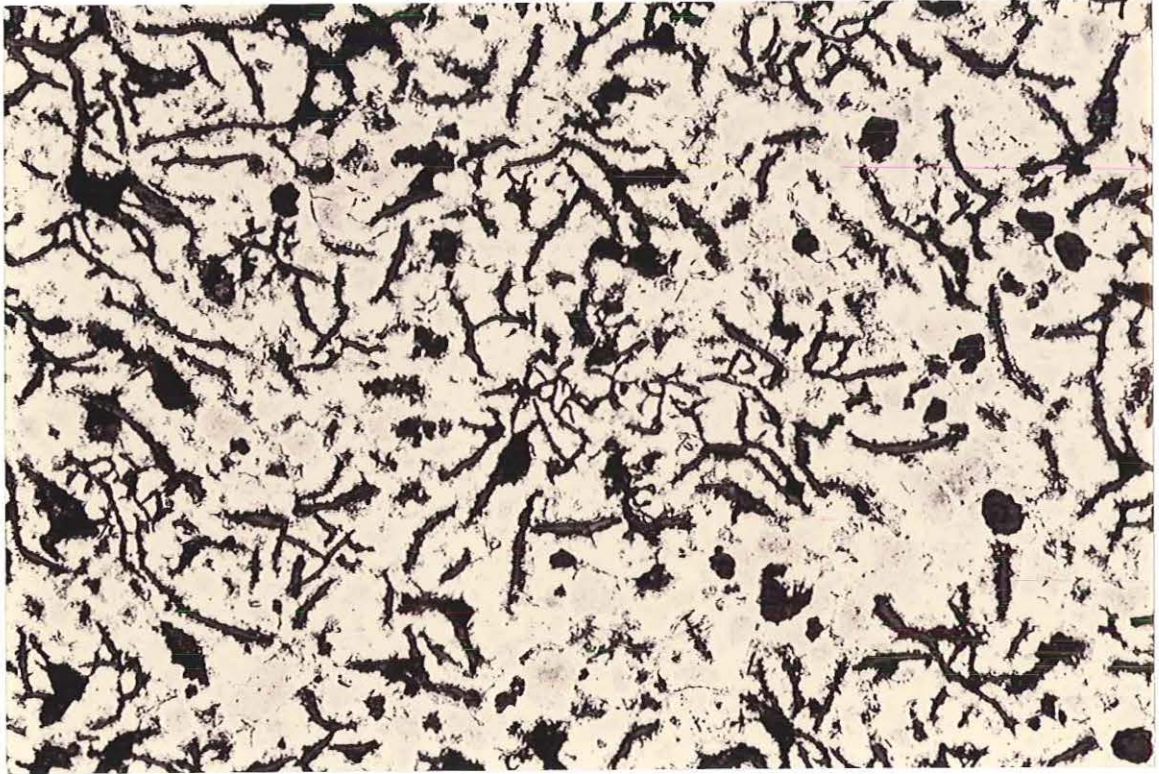
Viewed at low magnification in the **unetched** condition (Plate 1) frequent gas pores (5% by area) were observed in the structure together with what appeared to be very coarse graphite flakes (10%). However, at higher magnifications the "graphite flakes" were shown to have very ragged edges and to contain corrosion products.

The metallographic structure is that of a grey cast iron which has been transformed at high temperature. Spheroidisation of pearlite indicates that this heating would have been prolonged, perhaps of the order of hundreds of hours at 650°C. Cyclical heating is also indicated by the corrosion within the metal where hot gasses have entered the artefact through the graphite cavities. The resultant volume increase would have set up stresses within the object which may have resulted in its failure. The function of the artefact is unclear, fracture surfaces at both ends suggest that this was only a fragment of a larger cast iron object. The severely overheated structure must derive from the use of the object, rather than its manufacture, and it may well have formed part of a furnace, domestic stove or fireplace furniture.

Plate1 Windsor Castle cast iron object Micrograph: unetched x100  
Corrosion in voids left by graphite flakes

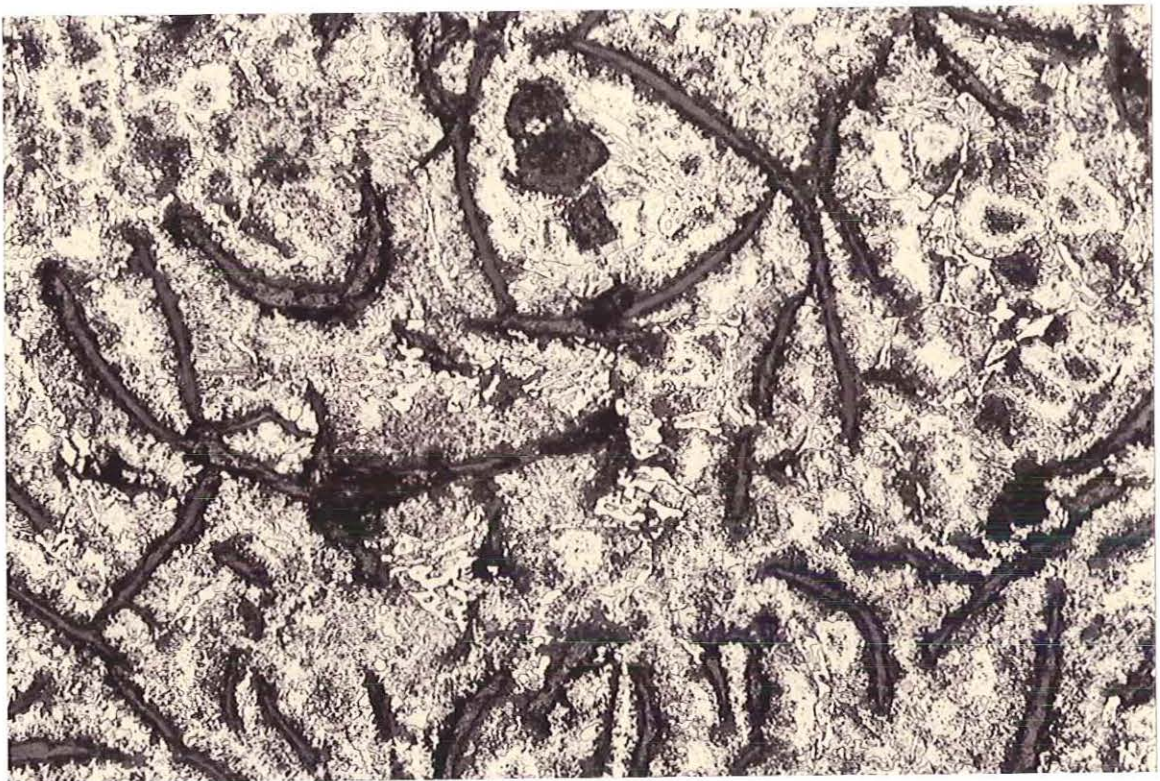
**Etching** in 2% nital (Plate2) revealed the grain structure of the metallic phases between the flakes/corrosion to be predominantly ferrite (75%) of grain size ASTM 6. The ferrite grains contained some spheroidised iron carbide and further irregularly shaped carbide (10%) was present at the ferrite grain boundaries.

Plate2 Windsor Castle cast iron object Micrograph: etched in 2% nital x200  
Ferrite with spheroidal and grain boundary iron carbide

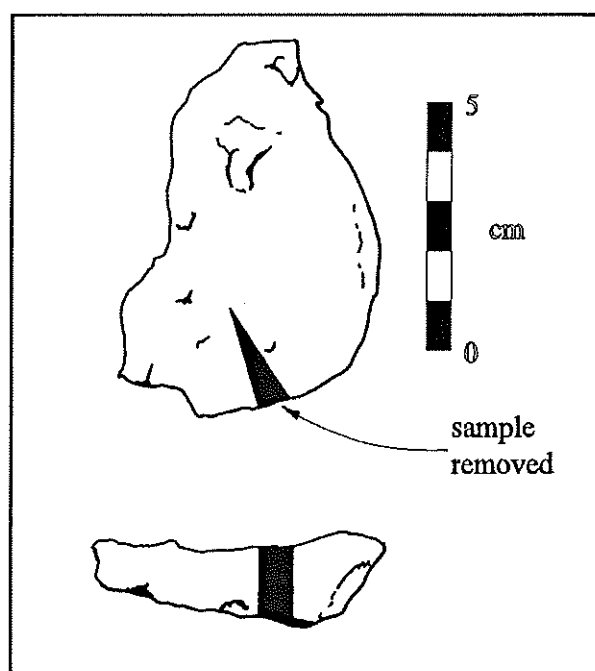
Figure2 Tilbury casting spill

An iron object (small find 443), from context 4200 at Tilbury Fort, originally thought to be part of a bloom, was received by the AM Lab. for identification. The object, (Fig. 2) was of approximately plano-convex shape had a maximum length of 80mm, width (at 90° to max. length) of 45mm, thickness of 13mm and weight of 135g. The upper surface was reasonably smooth whilst the lower was uneven, with lumps corresponding with the discrete light patches on the X-radiograph.

Metallographic examination shows the metal to be common grey cast iron containing a small amount of phosphorus. The latter element is present in the form of phosphide eutectic, a laminated constituent comprising of ferritic iron, cementite ( $\text{Fe}_3\text{C}$ ) and iron phosphide ( $\text{Fe}_3\text{P}$ ). The presence of phosphorus is not unusual, the element is co-smelted with the iron from the ore, and its concentration would have been insufficient to cause significantly increased brittleness. There is no evidence of any further heat treatment to the metal. The morphology of the cast iron indicates that the find is not a deliberately manufactured object, but a waste product, probably a spill from the casting of iron.

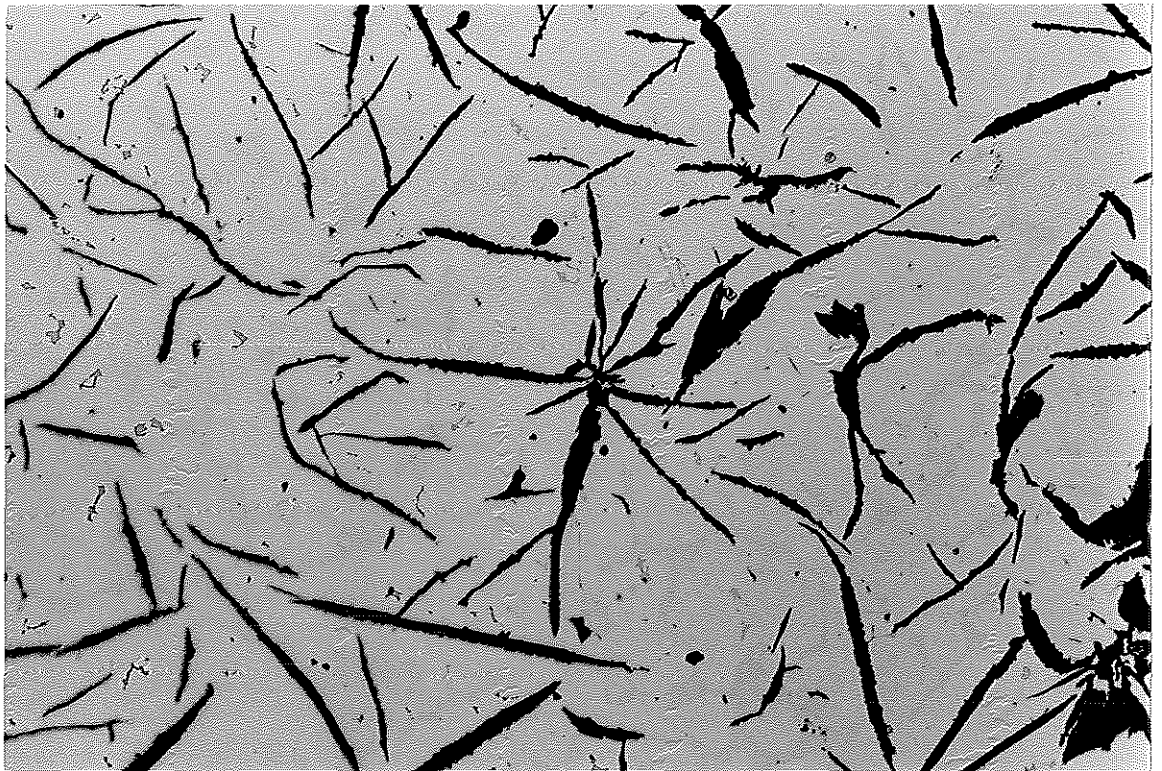
Plate3 Tilbury Fort iron casting spill. Micrograph: unetched x100  
Coarse graphite flakes

Viewing in the **unetched** condition (Plate 3) revealed coarse graphite flakes (10%). **Etching** in 2% nital (Plate 4) showed the graphite flakes to be surrounded by ferrite (40%) in the areas between these, very fine pearlite is present in dendritic form (40%) and between the dendrites can be seen the laminated structure of phosphorus eutectic.

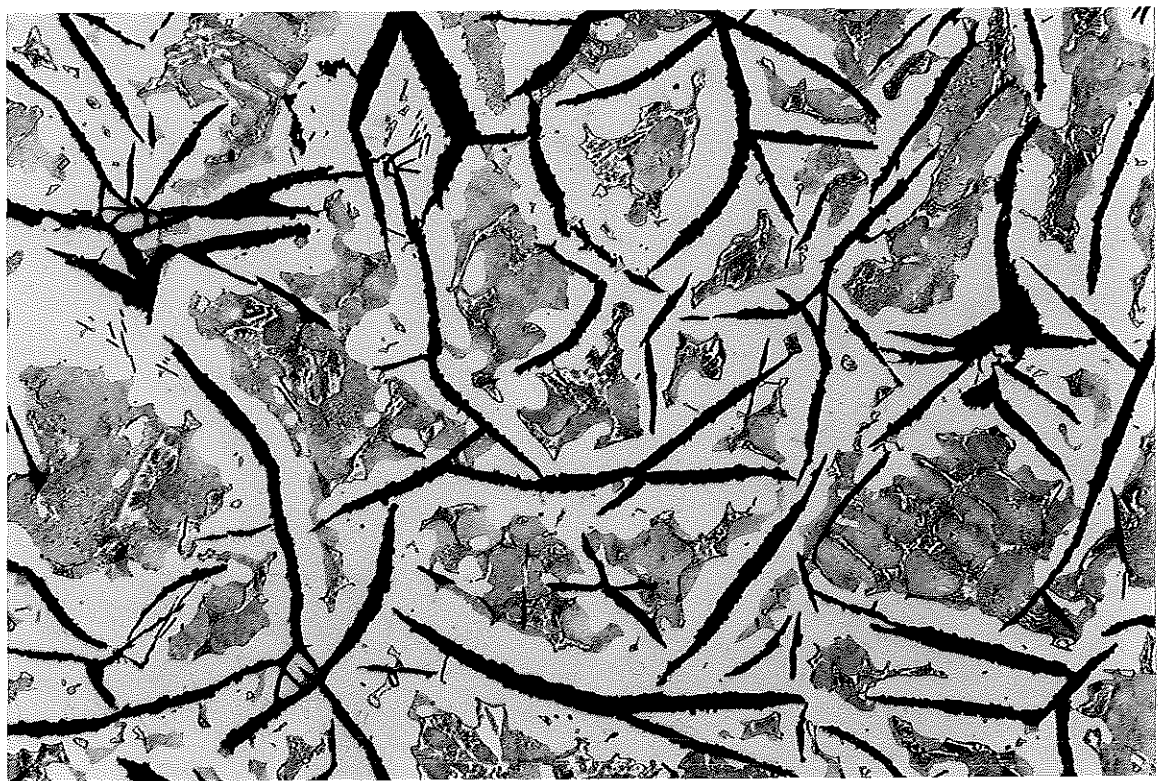
Plate4 Tilbury Fort iron casting spill. Micrograph: etched in 2% nital x100  
Ferrite surrounds the graphite, phosphorus eutectic between the pearlite dendrites

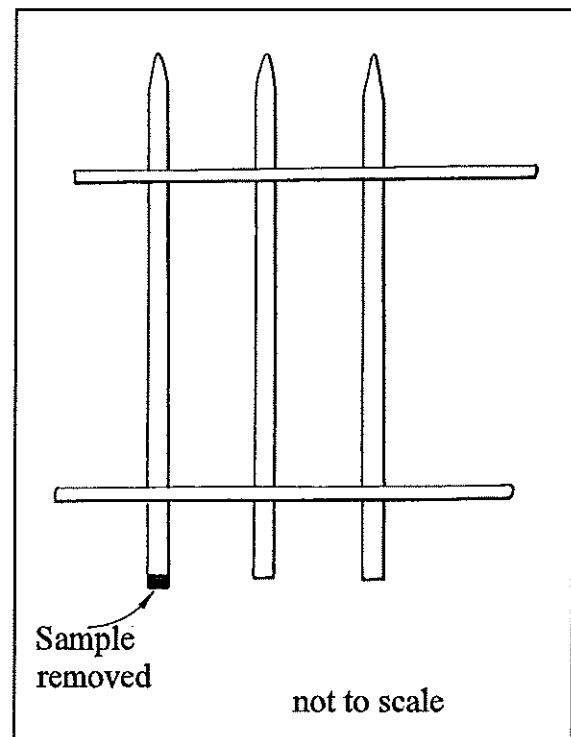
Figure 3 Garrison church railing

Figure 3 shows a length of the square sectioned railings from the Church. Many of the uprights were highly corroded; the pattern of corrosion revealing the laminated structure of the metal. The more ornate gate is illustrated in Figure 4. Corrosion on this also showed, though to a lesser extent, the lamellar nature of the iron. In addition raised areas of weld metal were observed, joining the different components of the gate, the poor "as welded" finish of these was in contrast to the otherwise well-built gate, suggesting that they date from a later repair. It was also thought that two small triangular strengthening fillets, below the joint of the hinged upright and the top and bottom horizontal rails, were likely to be later additions.

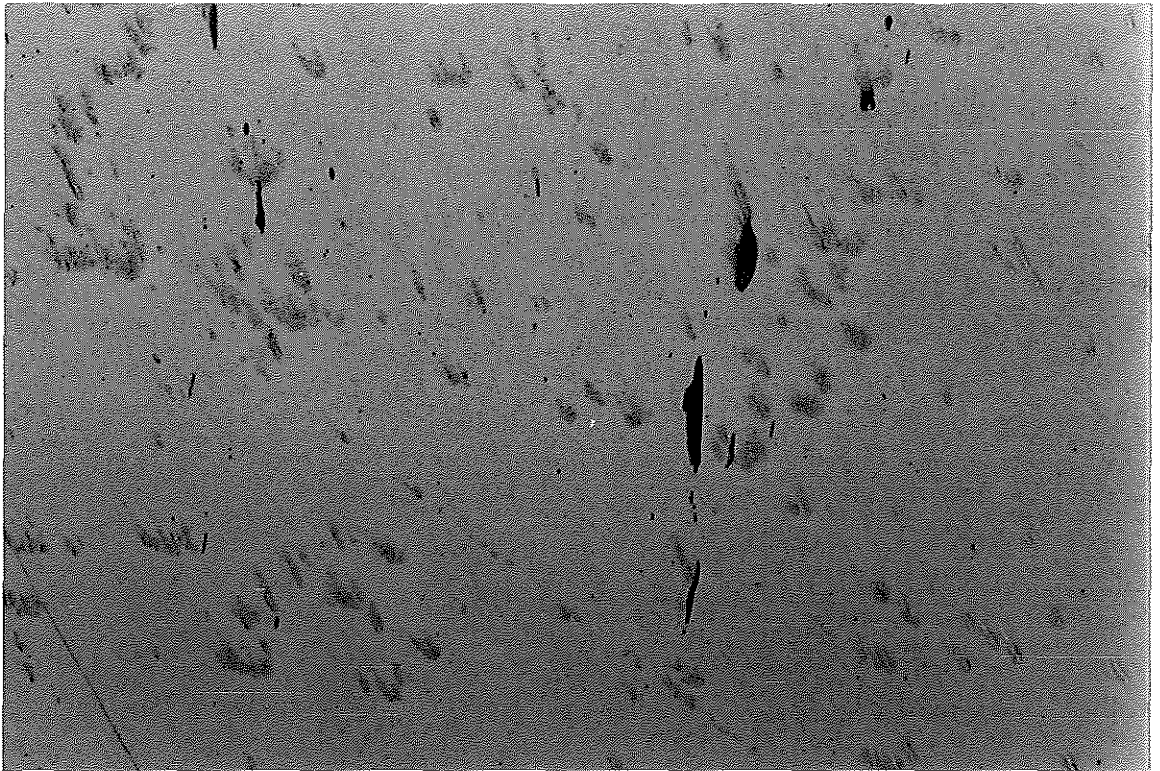
Plate 5 Garrison Church railing. Micrograph: unetched x400  
Slag inclusion elongated along length of bar

Viewing in the **unetched** condition (Plate 5) single phase slag inclusions, occupying less than 1% of the surface of the sample, were seen to be elongated along the length of the bar. **Etching** in 2% nital (Plate 6) revealed a relatively high carbon content with slight banding of ferritic iron and pearlite. Overall the elongated grains of ferrite, of size ASTM 6 comprised 75% of the structure, with the remaining 24% being fine pearlite.

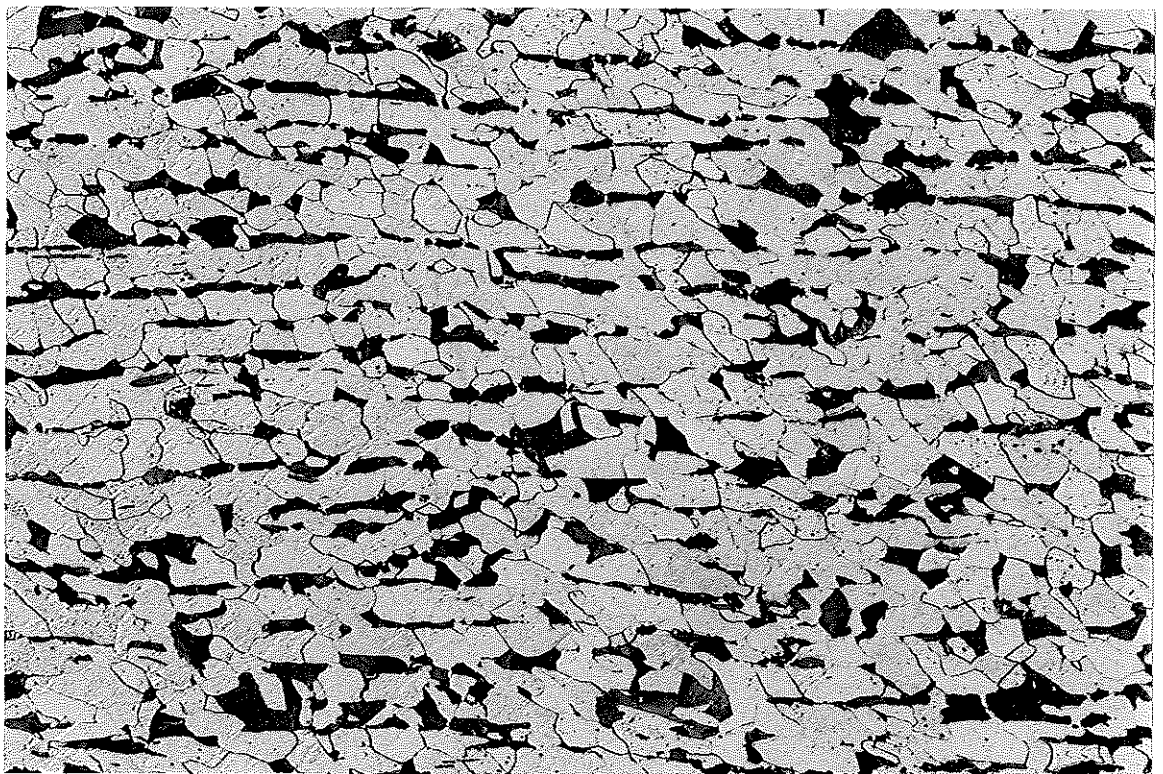
Plate 6 Garrison Church railing. Micrograph: etched in 2% nital x200  
Banded ferrite (75%) and pearlite 25%

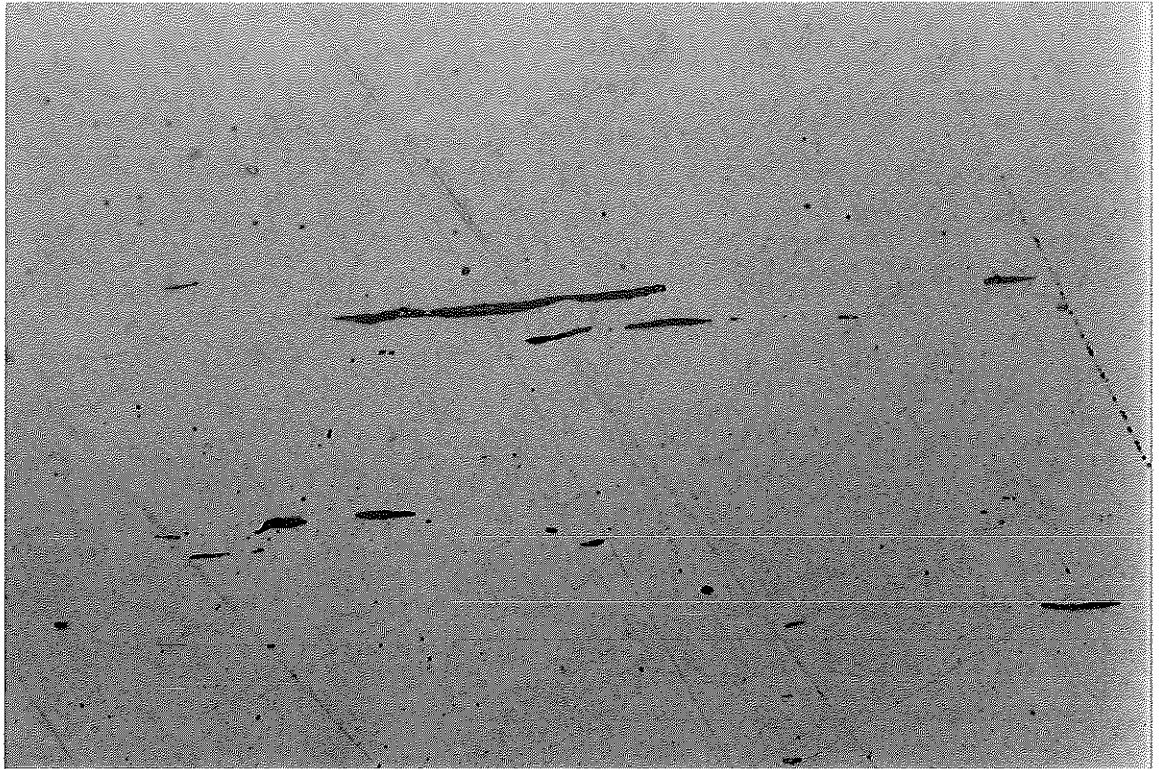
At the location of the sample it could be seen that the weld metal was not physically joined to the gate upright, a film of slag separated the two. **Unetched** (Plate 7) the upright was found to contain about 1% slag stringers, elongated along the bar, and sometimes containing two discernable phases. The fillet contained similar, if slightly fewer slag inclusions, whereas those in the weld metal were of spheroidal morphology. **Etching** in 2% Nital showed that, away from the weld zone, both the fillet and the upright were of very similar structure to the rail (Plate 8), although the grain size was slightly larger (ASTM 5 and 6 respectively), perhaps resulting from slightly higher rolling temperatures. The weld metal had a columnar, Widmanstätten structure radiating from the interface with the fillet (Plate 9). Ferrite was present as grain boundary allotriomorphs, widmanstätten side plates and intragranular plates. The remaining structure being of upper bainite. In the proximity of the weld the metallic structure of the fillet had been altered to form three distinct bands (Plate 10). Closest to the weld, the grain coarsened heat affected zone was of Widmanstätten form (ASTM 4) with ferrite at the grain boundaries and martensite/bainite within. Further from the weld the grain refined heat affected zone contained Widmanstätten of ASTM 7 with grain boundary ferrite and pearlite in the centre. Beyond this zone the grain size was unaltered, but the pearlite had spheroidised.

Plate 7 Garrison Church gate. Micrograph: unetched x400  
Slag stringers elongated along length of bar

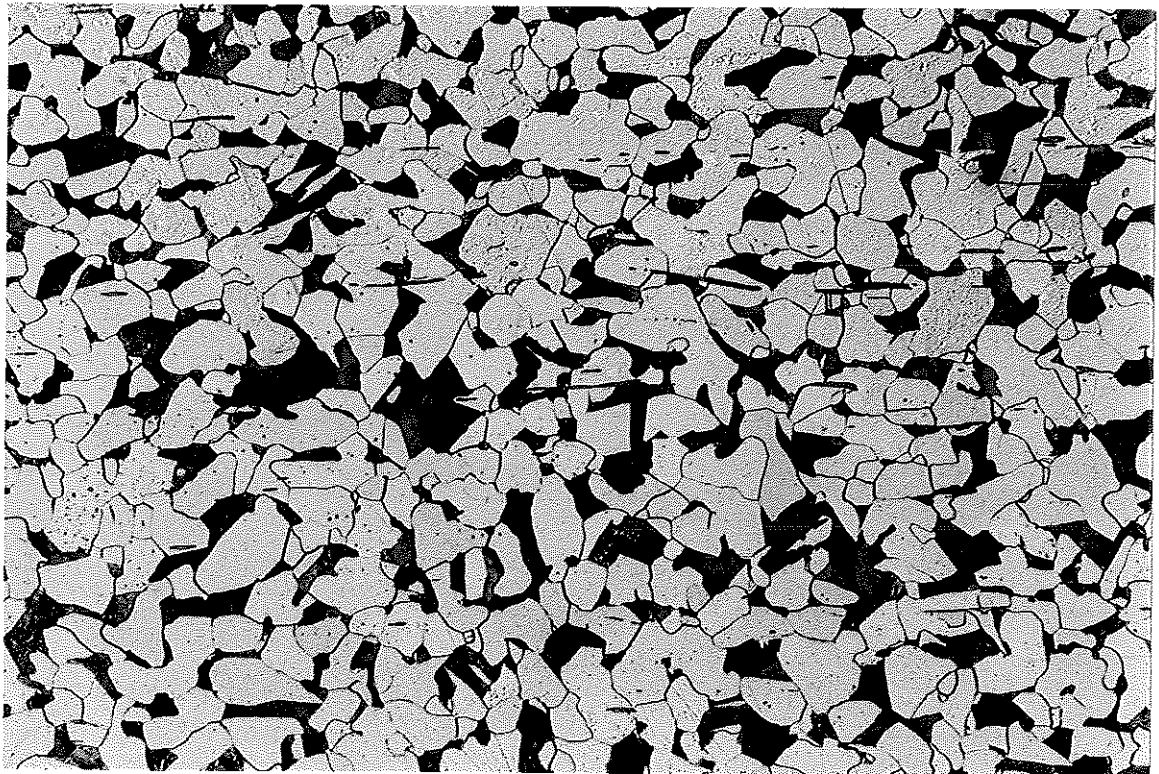
Plate 8 Garrison Church gate. Micrograph: etched in 2% nital x200  
Ferrite and pearlite

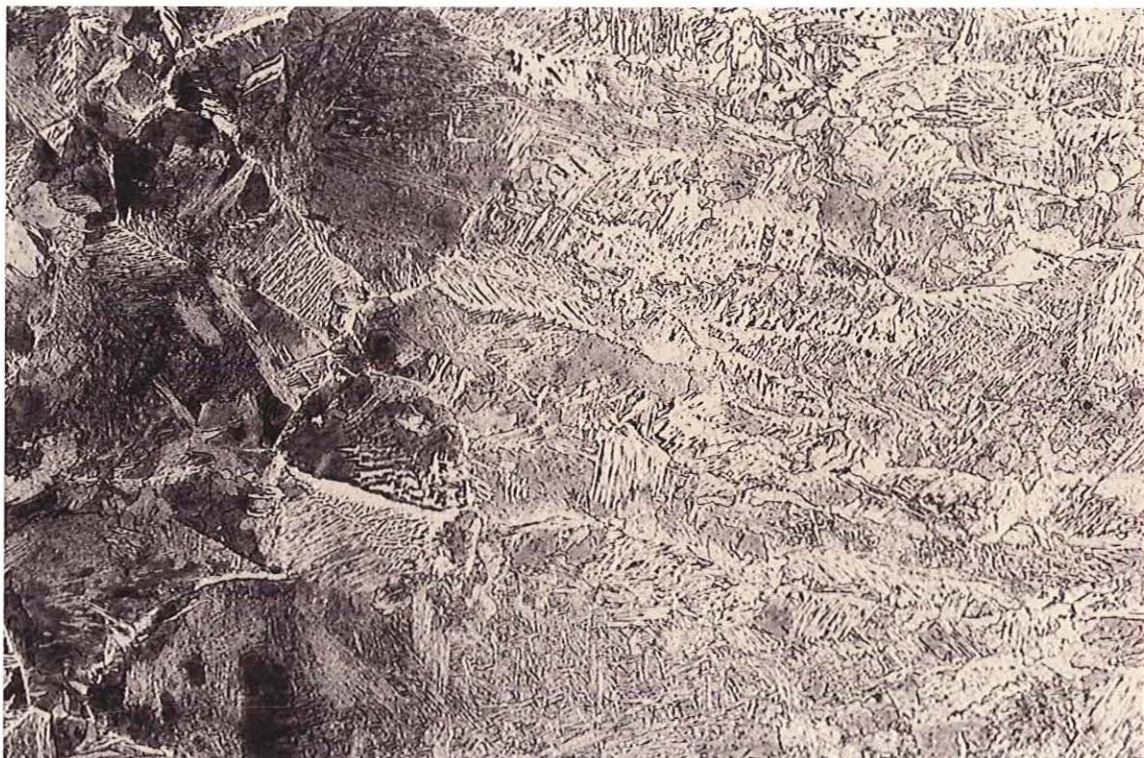
Plate 9 Garrison Church gate. Micrograph etched x200  
 Left: heat affected zone to left, Right: weld metal with widmanstätten structure

Metallographic examination of the weld metal and its relatively narrow heat affected zone indicates that this results from arc welding rather than oxy-acetylene. Early patents for arc welding date from 1849, but the technique only became widely practicable with the introduction of consumable bare steel rods in 1888. As mentioned above, the lack of any attempt to clean up the welded area, suggests a somewhat makeshift later attempt to repair the gate rather than its original manufacture. It is, therefore not possible to state whether the gate, and railings were constructed before, during or after the 1868 restoration of the church. It is, however clear that the repairs to the gate post date the restoration by at least 20 years.

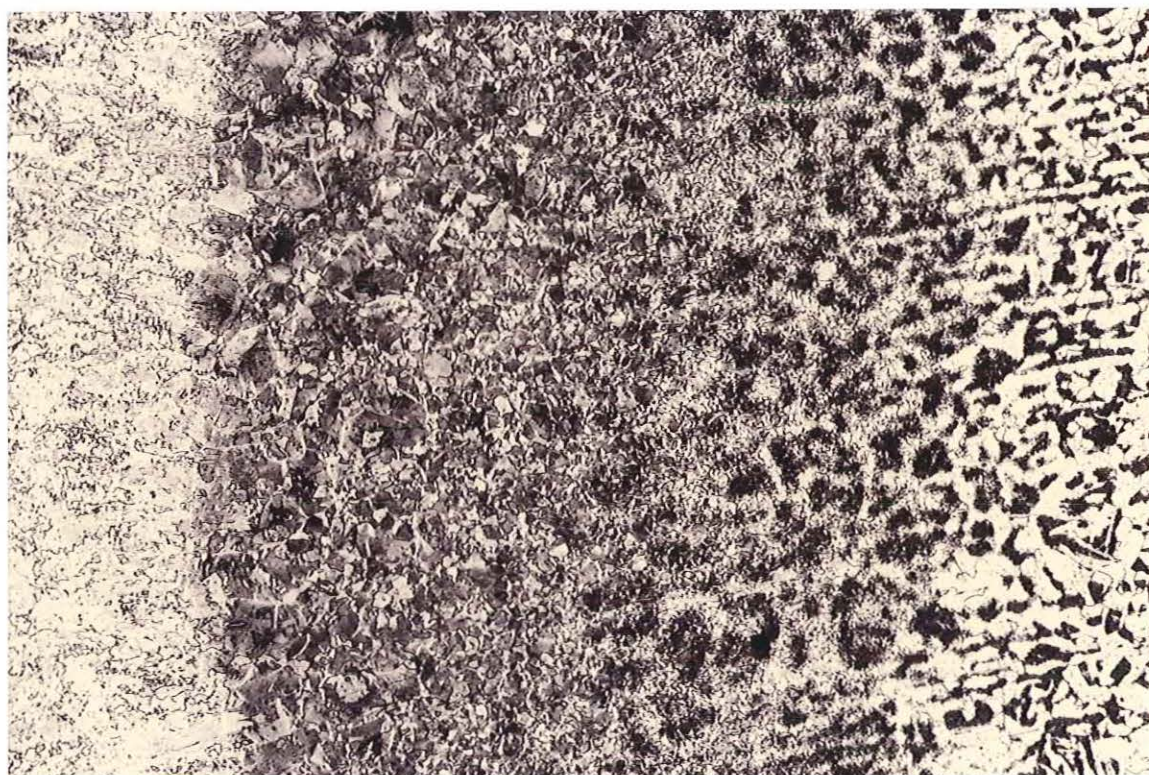
Plate 10 Garrison Church gate. Micrograph: etched in 2% nital x200  
 Left: weld metal, right: fillet
