Ancient Monuments Laboratory
Report 19/97

WALL PAINTING CONDITION AUDIT,
CASTLE ACRE PRIORY, PRIOR'S
LODGINGS, NORFOLK

J Davies

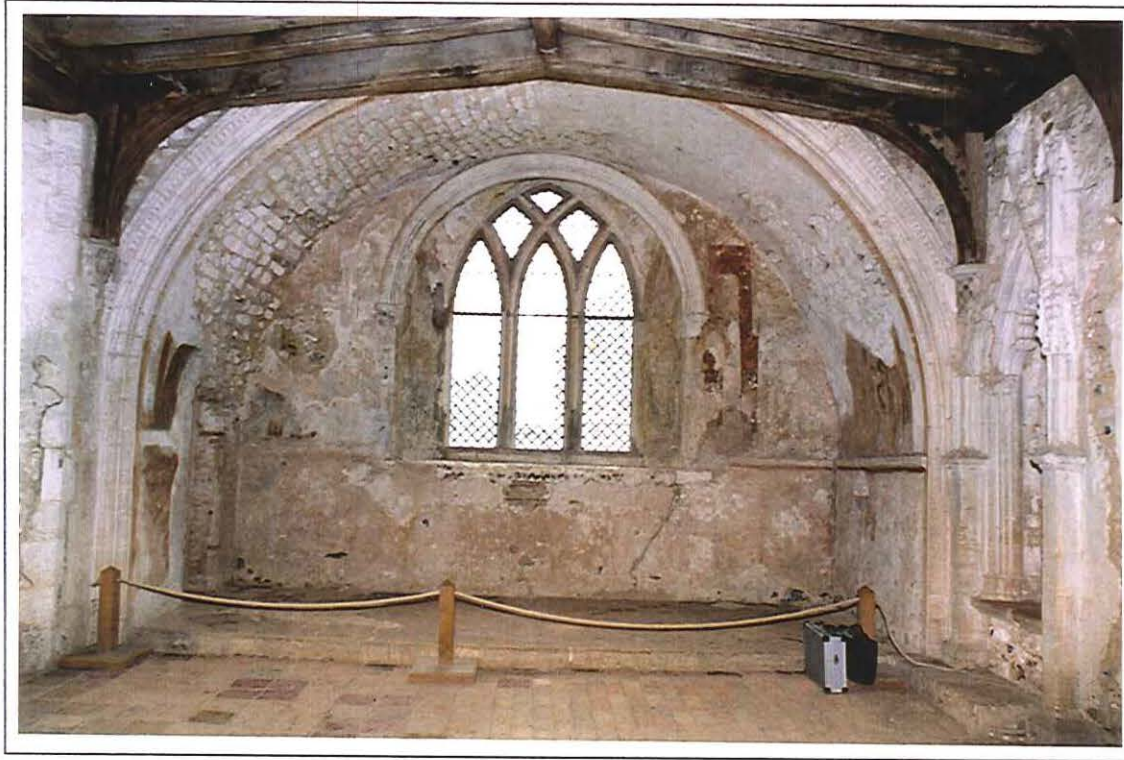
The paintings have been heavily waxed, and flaking, with consequent losses, has occurred. The white appearance of areas exposed by paint loss suggest that they are relatively recent and therefore a cause of concern.

Prior's Chapel, general view to east

Emergency flake fixing, minor repairs and recording of existing decoration should be carried out, preferably within the next year. A programme of treatment should also include testing to assess the feasibility, desirability of reducing any remaining wax coating. [Timescale: 2 conservators, 1 month, within 2-3 years].

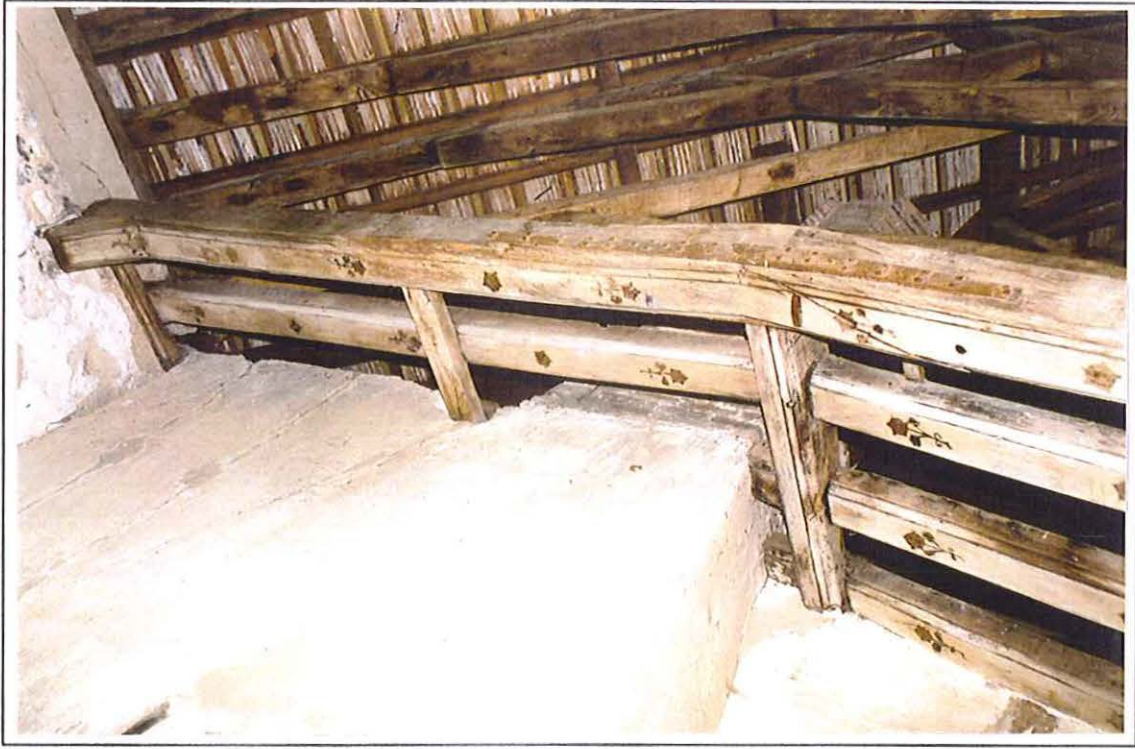
Full access to the ceiling beams was not possible during the present audit, but the painted decoration appeared to be stable.

Prior's Lodgings, ceiling

No conservation treatment appears to be necessary at present. However, the painting should be fully recorded and documented, and the condition of the ceiling should be monitored periodically.
