Ancient Monuments Laboratory
Report 18/97

WALL PAINTING CONDITION AUDIT,
BUSHMEAD PRIORY, BEDFORDSHIRE

J Davies
T Manning

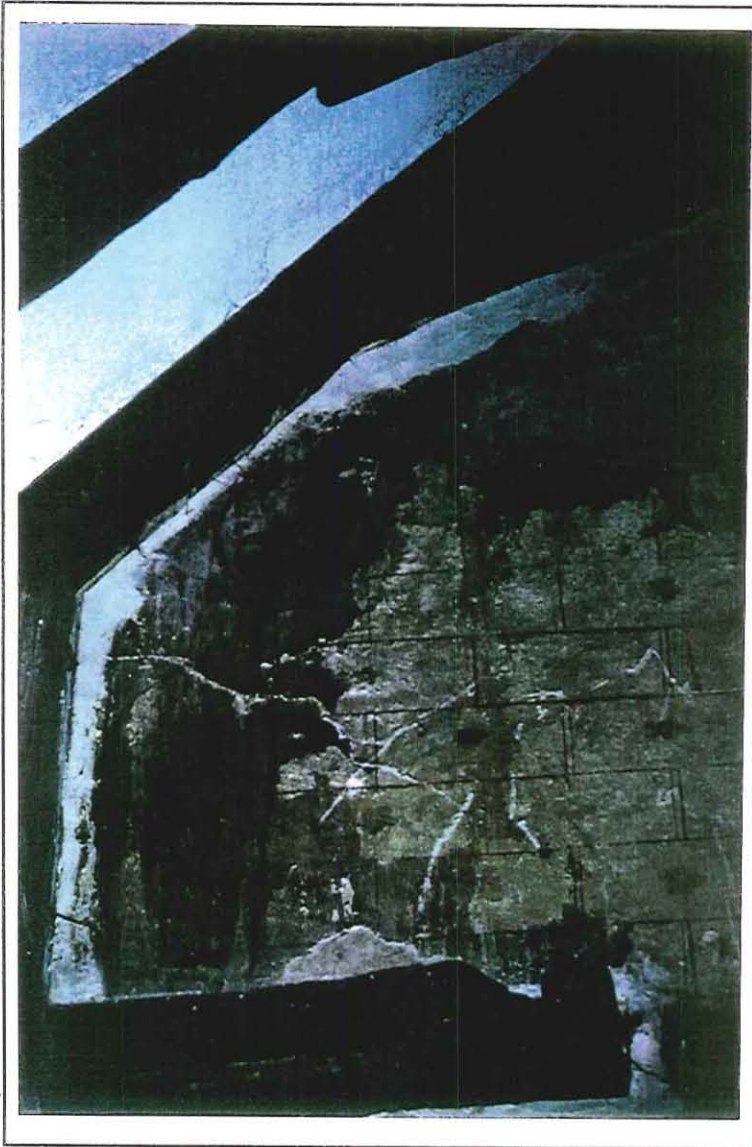
West wall, south side, detail painting under south gable

Type losses (paint layer)
Location West wall
Comments Decorative frieze, south side, upper level (above crane). This appears to be recent damage caused by flaking (in the last ten years). This loss does not appear on the photographs taken in 1983.

WEST WALL: It appears that flaking and loss of painting have occurred to the south side of the decorative frieze since the paintings were photographed in 1983. Therefore flake fixing is urgently required.

Comments WEST WALL: Urgent treatment required of flaking on south side within decorative frieze. Proper access is needed to assess the extent of the damage and method of treatment.

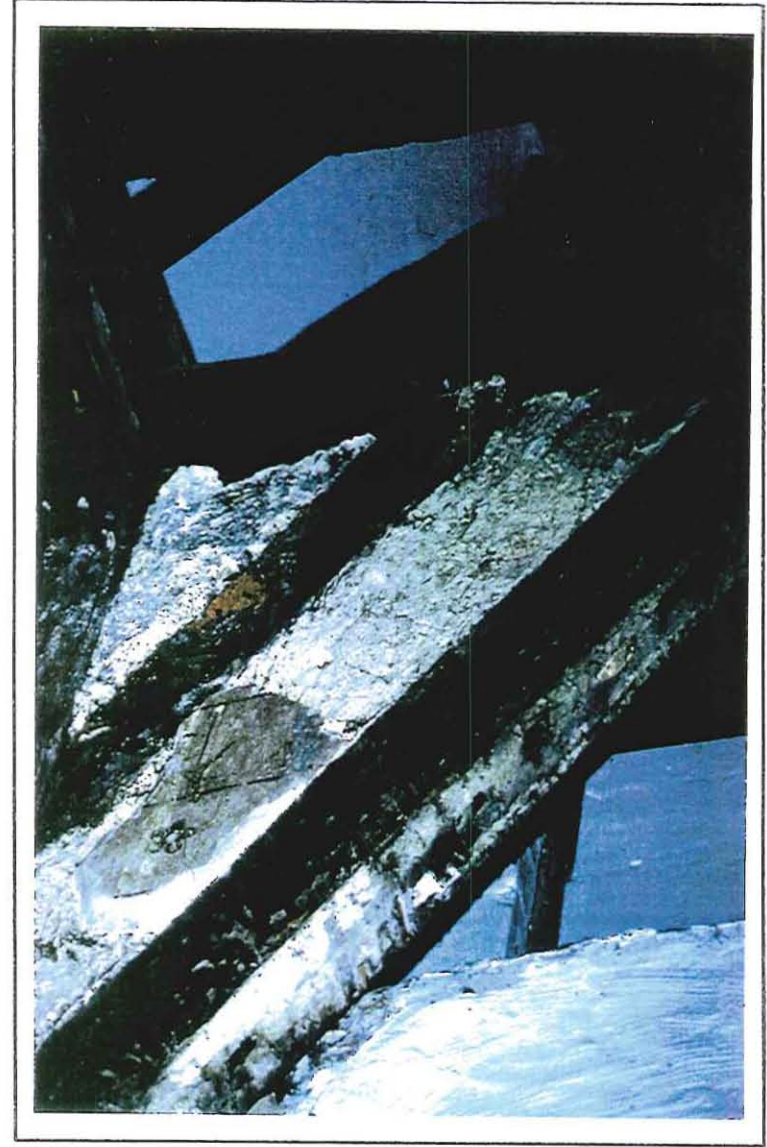
East wall, upper zone, detail painted plaster on lath and plaster support

EAST WALL: A large chunk of plaster (3/4 of the fragment on the south side) has been lost since the photographs taken in 1983. This area must be examined more thoroughly (access is difficult due to the height of the room), and the edge repair replaced around what survives. The edge repairs of the other fragments on the north side should also be assessed.

EAST WALL: Deterioration and loss of plaster has occurred since the painting was photographed in 1983. This area requires detailed examination from scaffolding (access is difficult due to the height and position of the paintings).

It is highly likely that some conservation treatment, including edge repairs and consolidation, will be required.
