Ancient Monuments Laboratory
Report 20/97

WALL PAINTING CONDITION AUDIT,
CASTLE RISING CASTLE, NORFOLK

J Davies

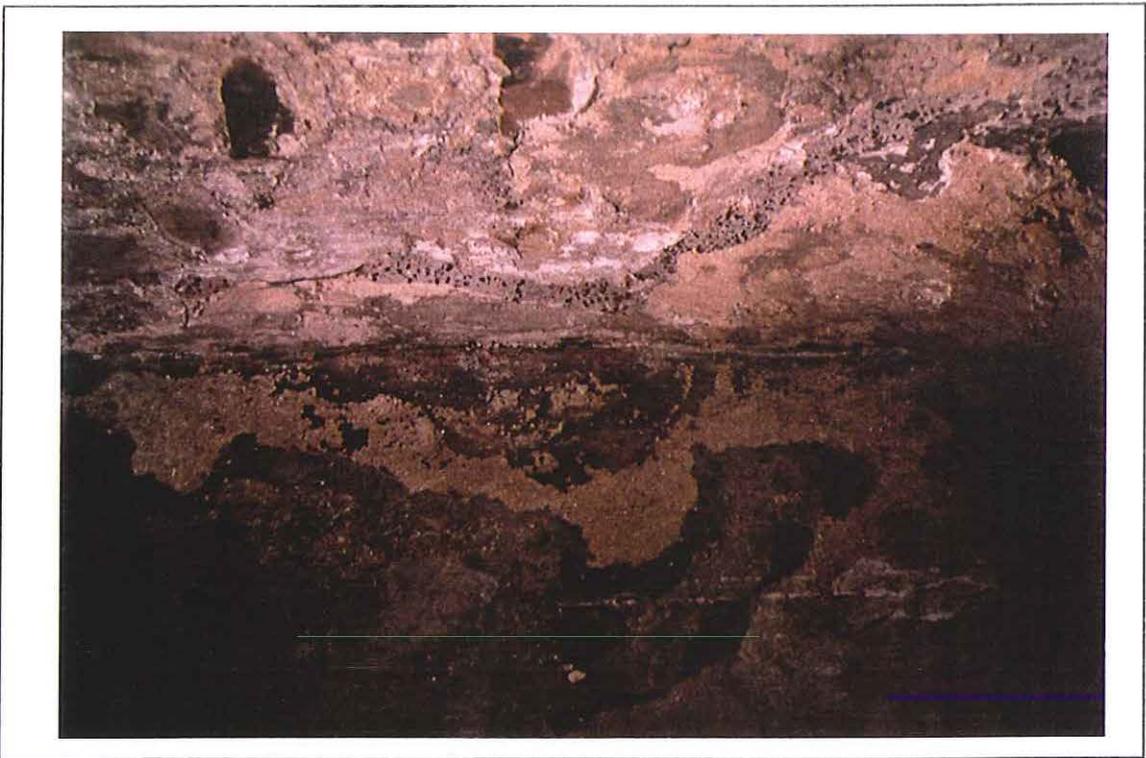
Chapel, west wall, south side, detail upper area

Comments A small amount of limewash is present apparently overlying coloured decoration.
