Ancient Monuments Laboratory
Report 21/97

WALL PAINTING CONDITION AUDIT,
GAINSBOROUGH OLD HALL,
LINCOLNSHIRE

J Davies
T Manning

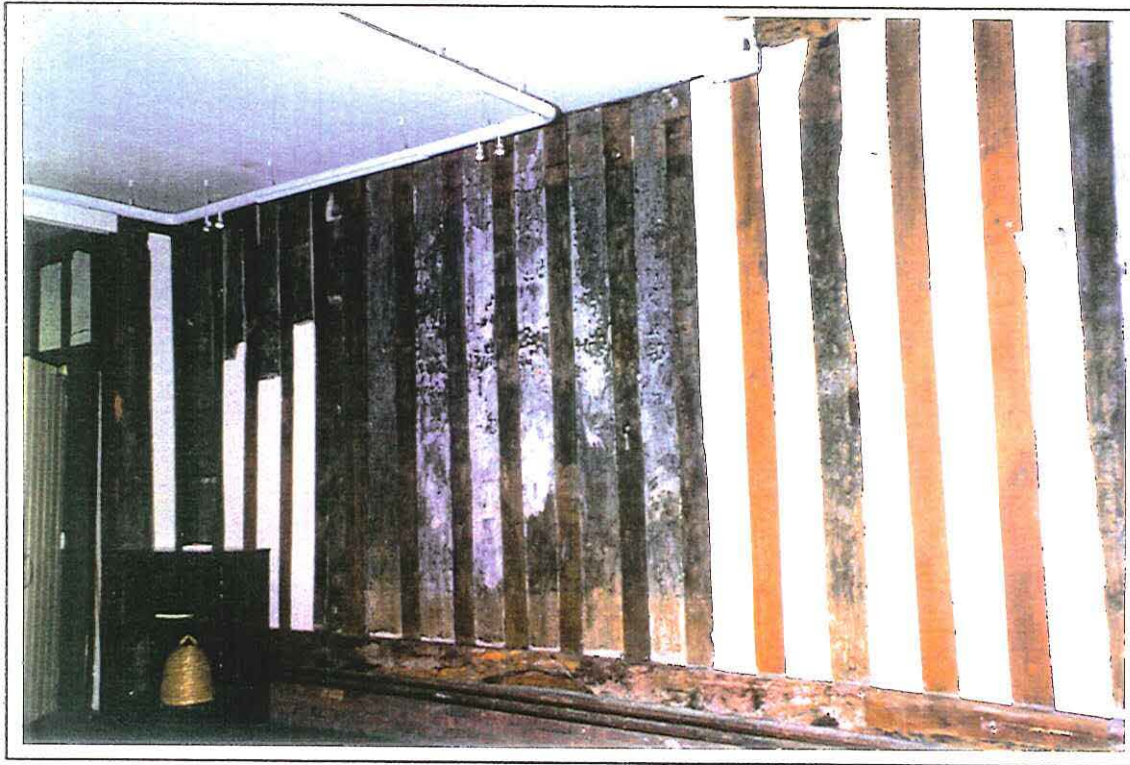
Lower great chamber, west wall, general view.

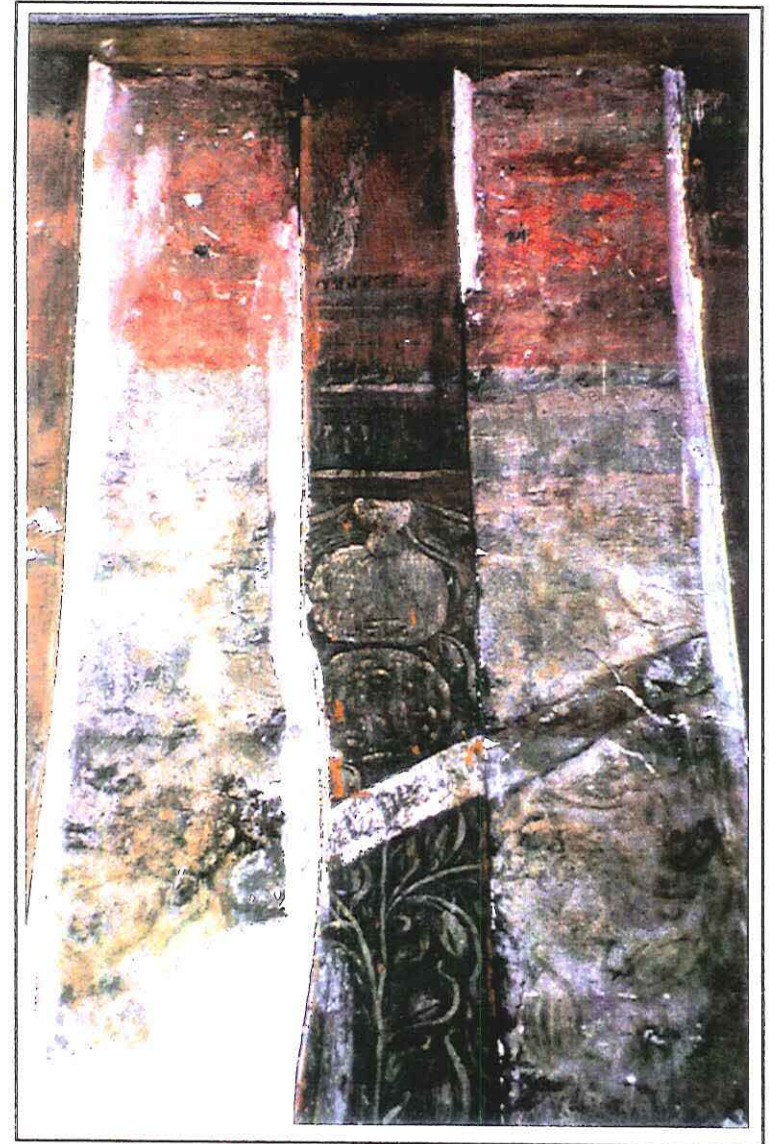
Detail, imitation brocade tapestry painted directly on stud and plaster wall
