Ancient Monuments Laboratory  
Report 28/97

WALL PAINTING CONDITION AUDIT,  
ARCHER PAVILION, WREST PARK,  
BEDFORDSHIRE

J Davies  
T Manning

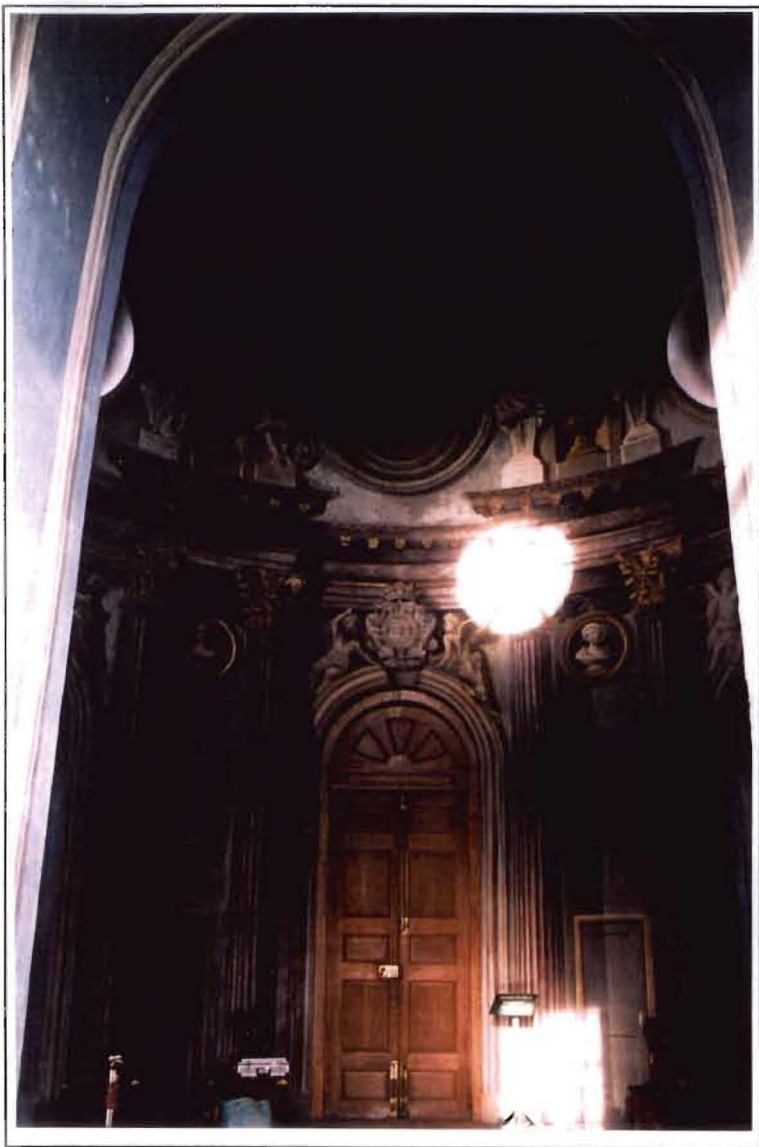
Interior, general view to north

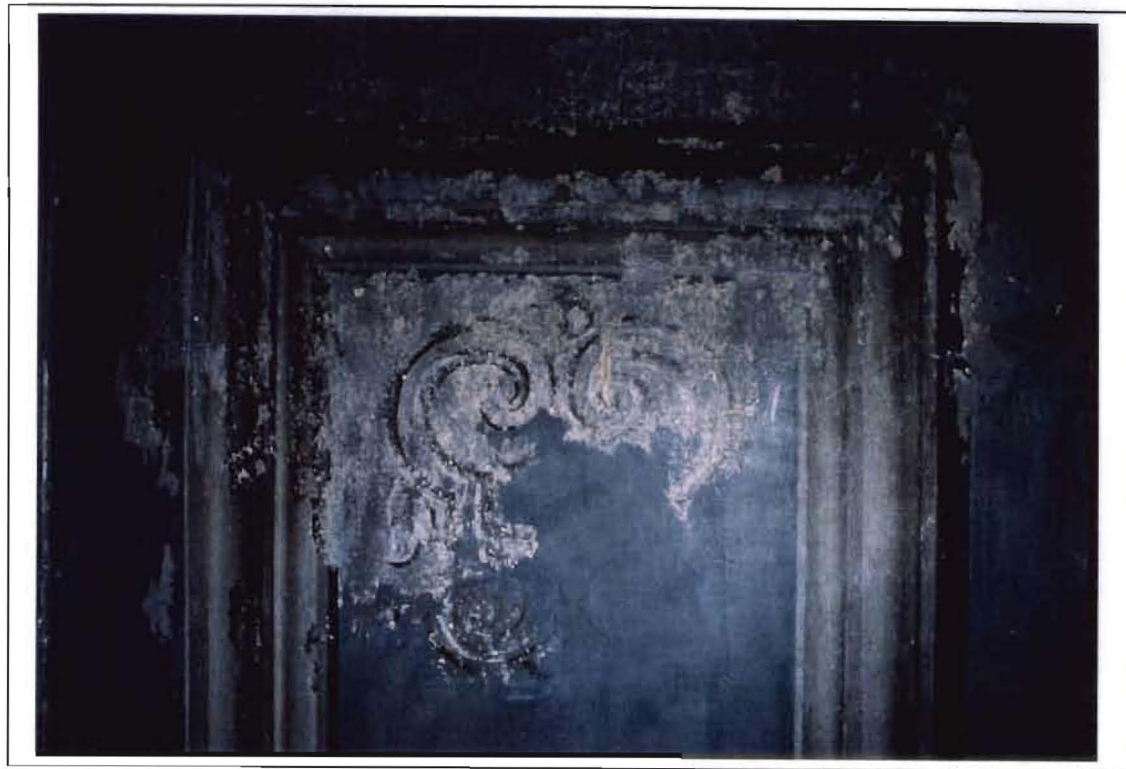
| Heavily abraded paint layer. Entirely repainted, except for one area uncovered in 1990 (east side, lower part of northeast chamber). Medium probably oil. Original painted scheme in muted colours of brown on greyish-white. | |

**Type** flaking  
**Location** Especially, NE ante-room, but also throughout, mainly of retouching  
**Comments**

Northeast ante-room, north side, area uncovered in 1990
