Ancient Monuments Laboratory
Report 23/97

WALL PAINTING CONDITION AUDIT,
GREYFRIARS CLOISTER, GREAT
YARMOUTH, NORFOLK

C Babington
S Stewart

This condition audit of wall paintings at Greyfriars Cloister includes a wall painting record, general audit information, documentation of original materials and execution of the painting, and deterioration and damage including previously used materials and treatment, as well as proposals for treatment and monitoring strategies.

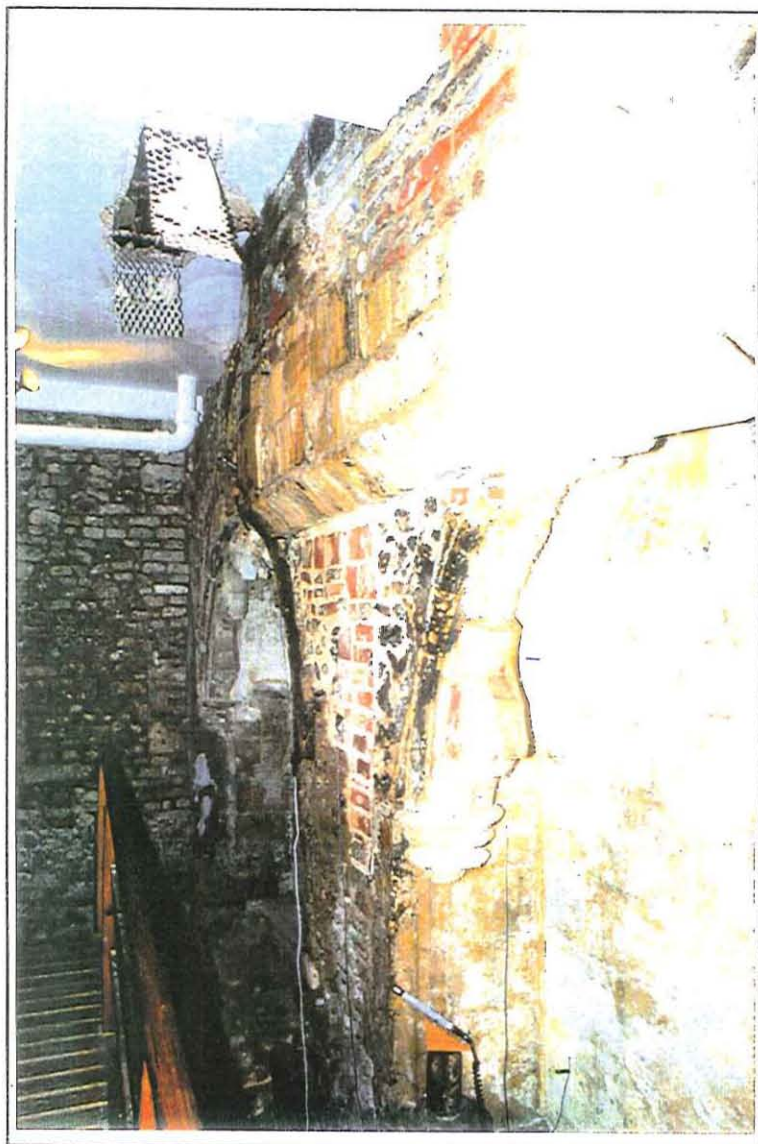
General view of tomb recesses to the east

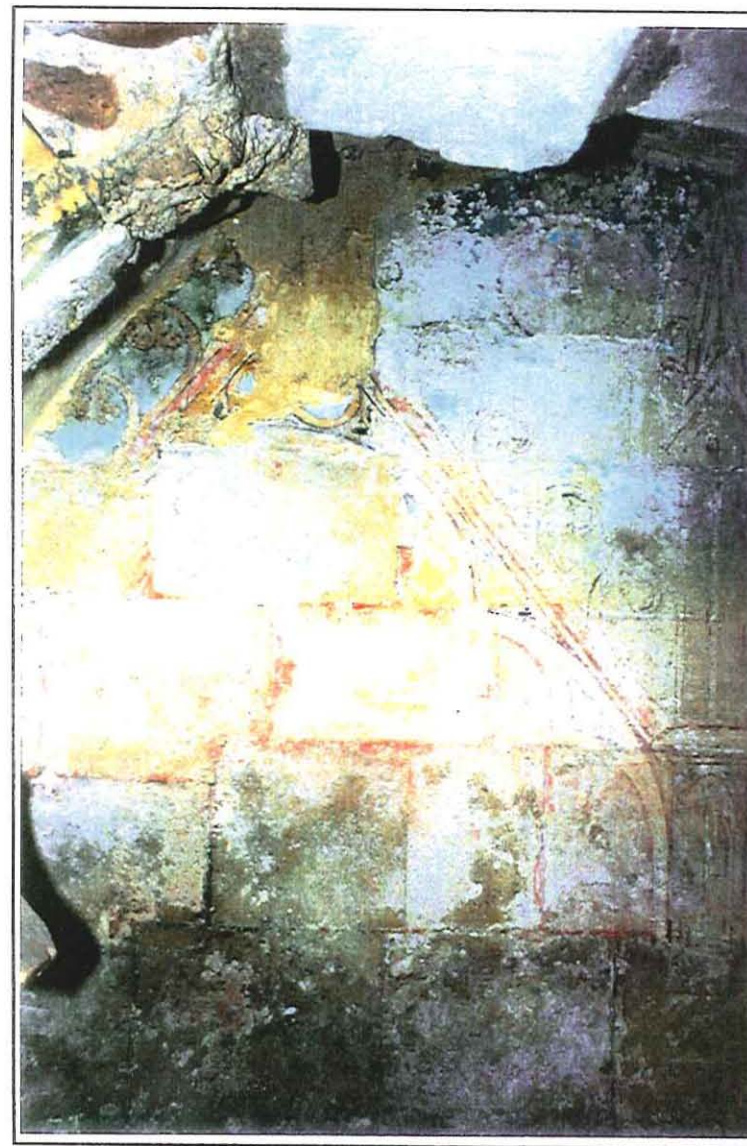
West tomb recess, detail of painted decoration
