Ancient Monuments Laboratory  
Report 27/97

WALL PAINTING CONDITION AUDIT,  
TILBURY FORT, ESSEX

J Davies  
T Manning

## Tilbury Fort

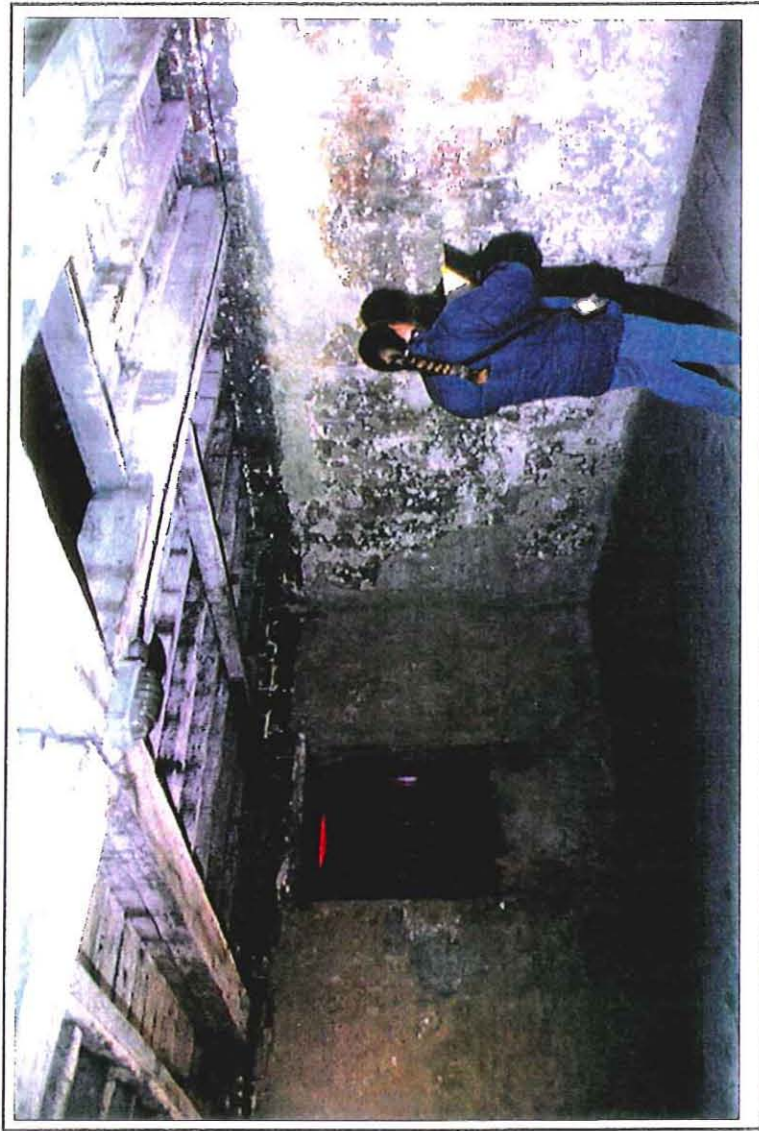
Dead House, general view to southwest

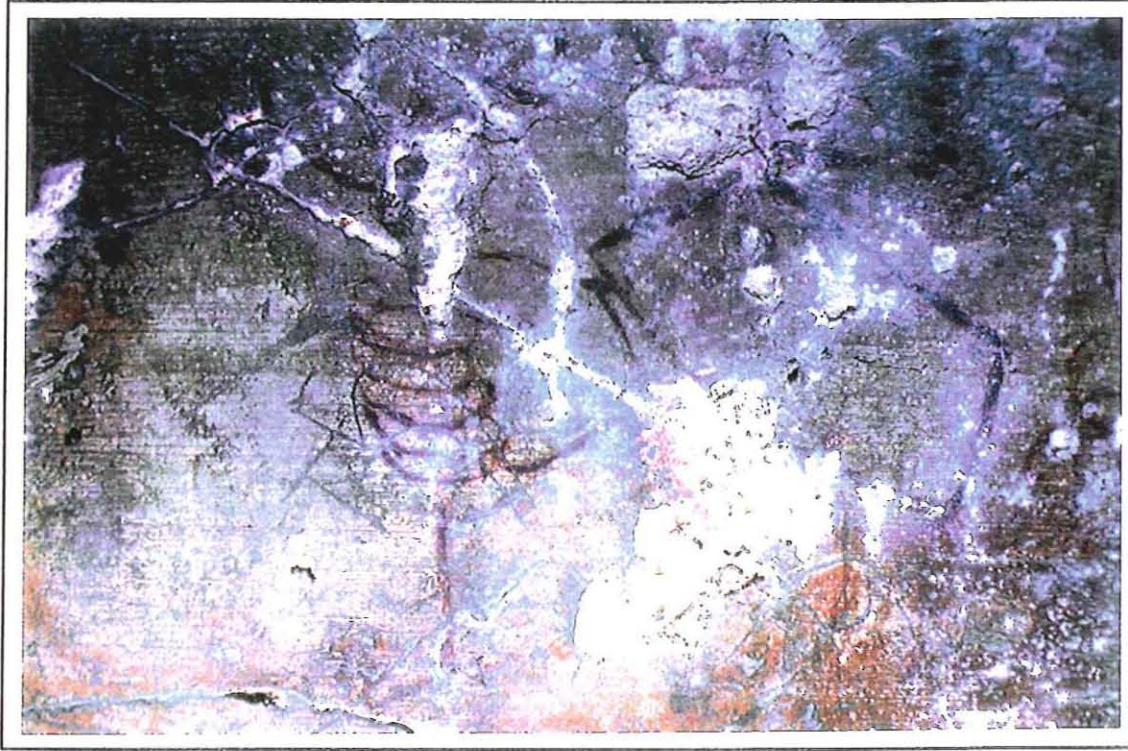
West wall, detail, man with pipe
