Ancient Monuments Laboratory  
Report 29/97

WALL PAINTING CONDITION AUDIT,  
BELSAY CASTLE, NORTHUMBERLAND

C Babington  
S Stewart

This condition audit of wall paintings at Belsay Castle includes a wall painting record, general audit information, documentation of original materials and execution of the painting, and deterioration and damage including previously used materials and treatment, as well as proposals for treatment and monitoring strategies.

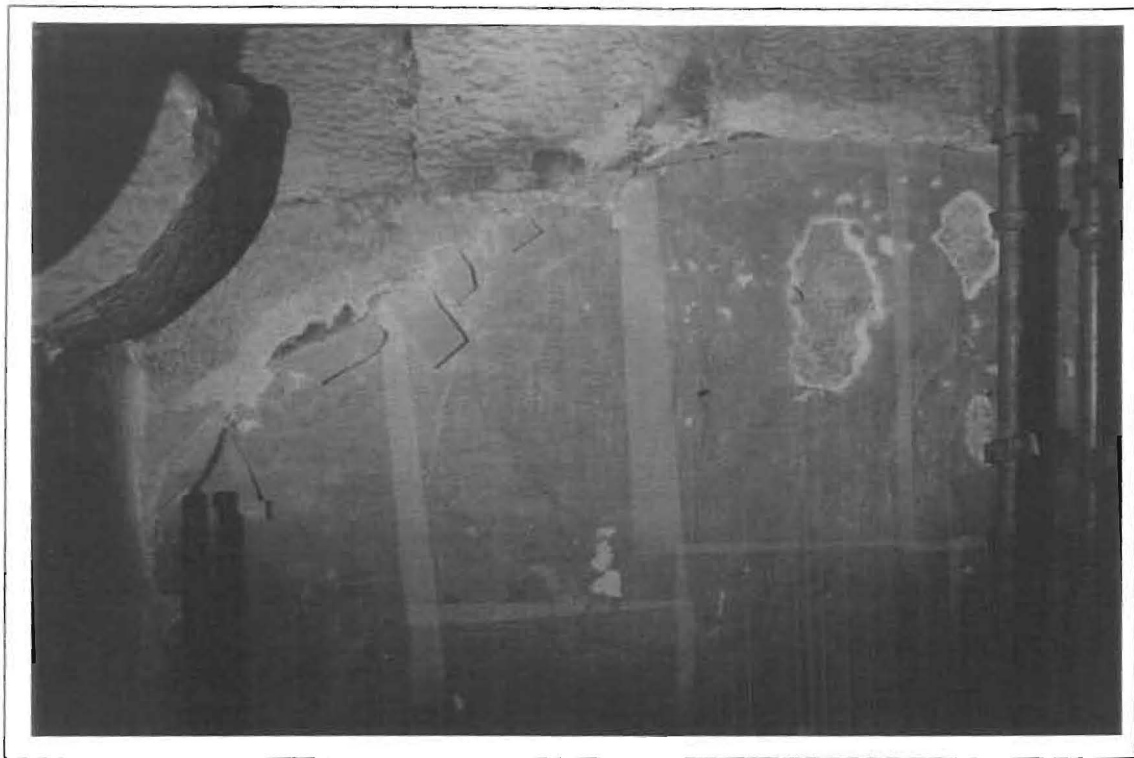
**Comments** Applied over ship and heraldry scene. Note in Studio files (5 October 1981, A. Stanzyck?) states that 'the overriding priority at this stage should be the protection of the paintings to stop any further deterioration in their condition. This could be achieved by the application of a protective facing which could then be removed just before the final restoration takes place. I would suggest that the facing should be applied before any building work commences and not removed until it is complete. If there is to be major work, roofing etc. requiring scaffolding some more substantial form of protection, for example hardboard on a wooden frame erected approximately four inches from the face of the painting would be desirable'.

South wall, east side, naval scene, *before* removal of  
tissue facing and Polyfilla repairs, May 1996

**Comments** The tissue facing should be removed as part of an overall campaign of conservation.

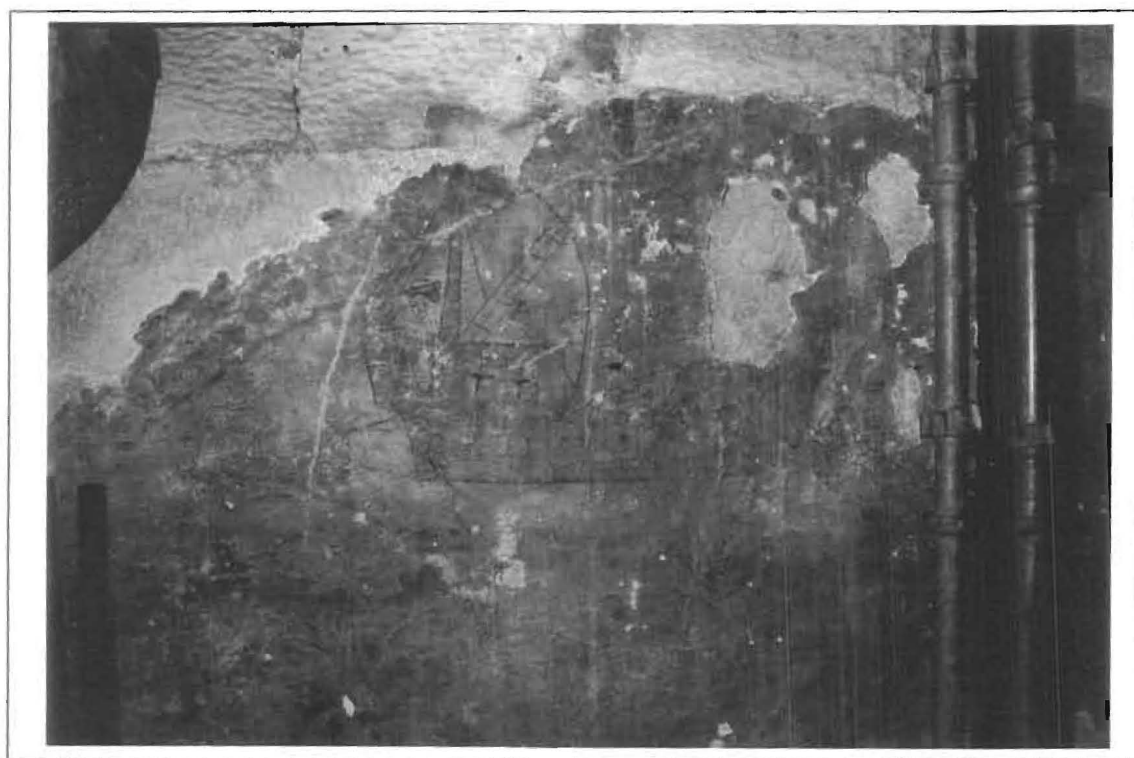
South wall, east side, naval scene, *after* removal of  
tissue facing and *during* removal of Polyfilla repairs, June 1996

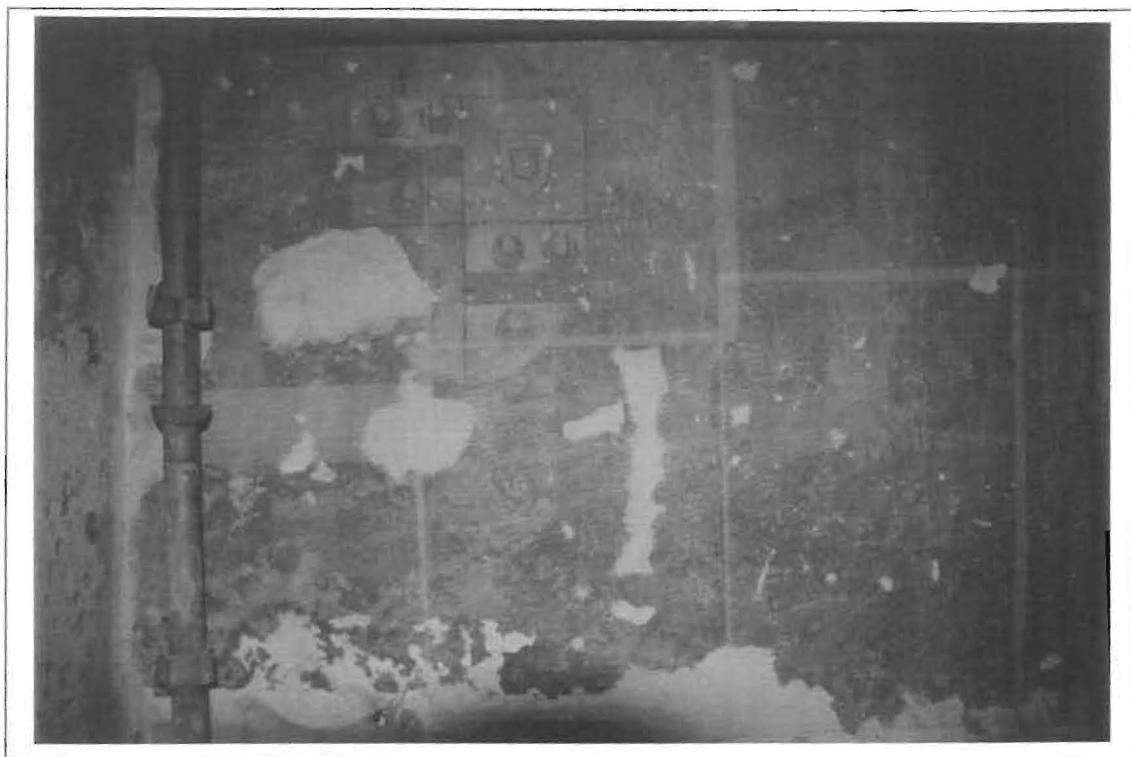
**Type** gypsum  
**Location** south and north walls  
**Comments** Plaster of paris or probably pollyfilla applied in the mid 1980s. All repairs have an untidy application and are unlikely to be functioning efficiently. Used as repairs for large losses throughout.

South wall, east side, area of fictive tapestry and heraldry, *before* removal of tissue facing and Polyfilla repairs, May 1996

**Type** FILLS/REPAIRS REMOVAL **Date** 08/11/94  
**Person** CB/SS  
**Comments** All of the plaster of paris and cement repairs should be removed and replaced with a more suitable material.

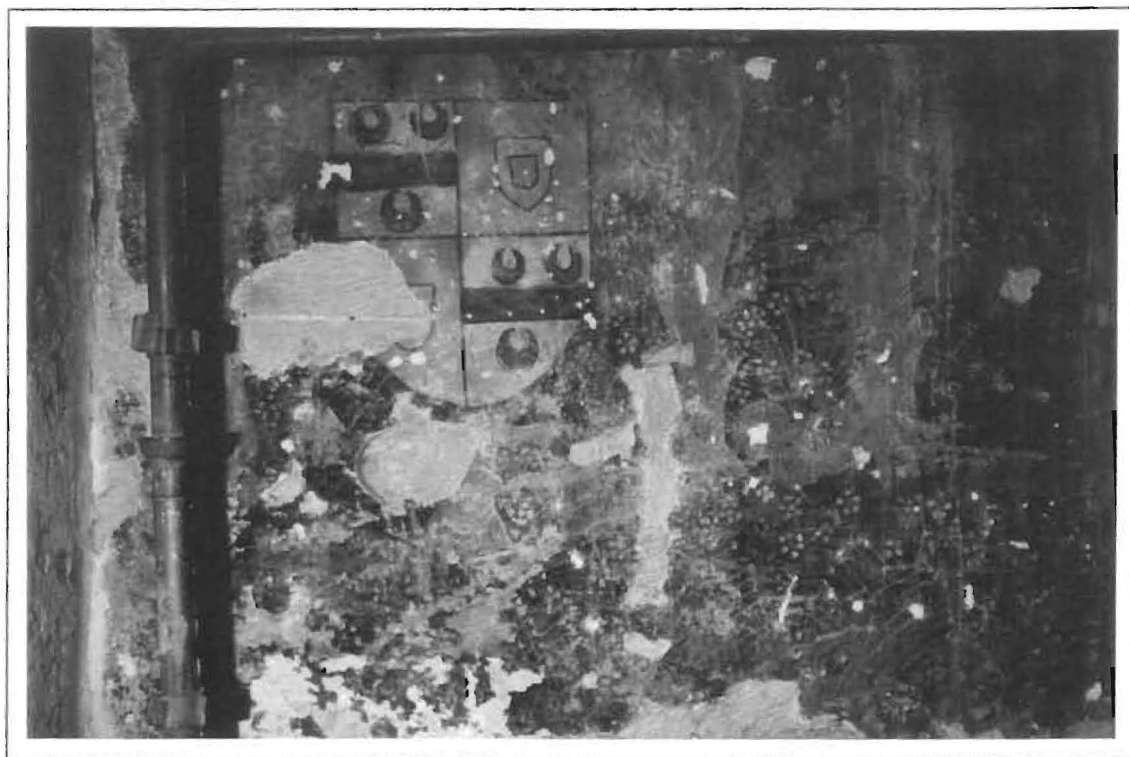
South wall, east side, area of fictive tapestry, *after* removal of tissue facing and *during* removal of Polyfilla repairs, June 1996
