Ancient Monuments Laboratory  
Report 31/97

WALL PAINTING CONDITION AUDIT,  
BRODSWORTH HALL, SOUTH  
YORKSHIRE

J Davies  
T Manning

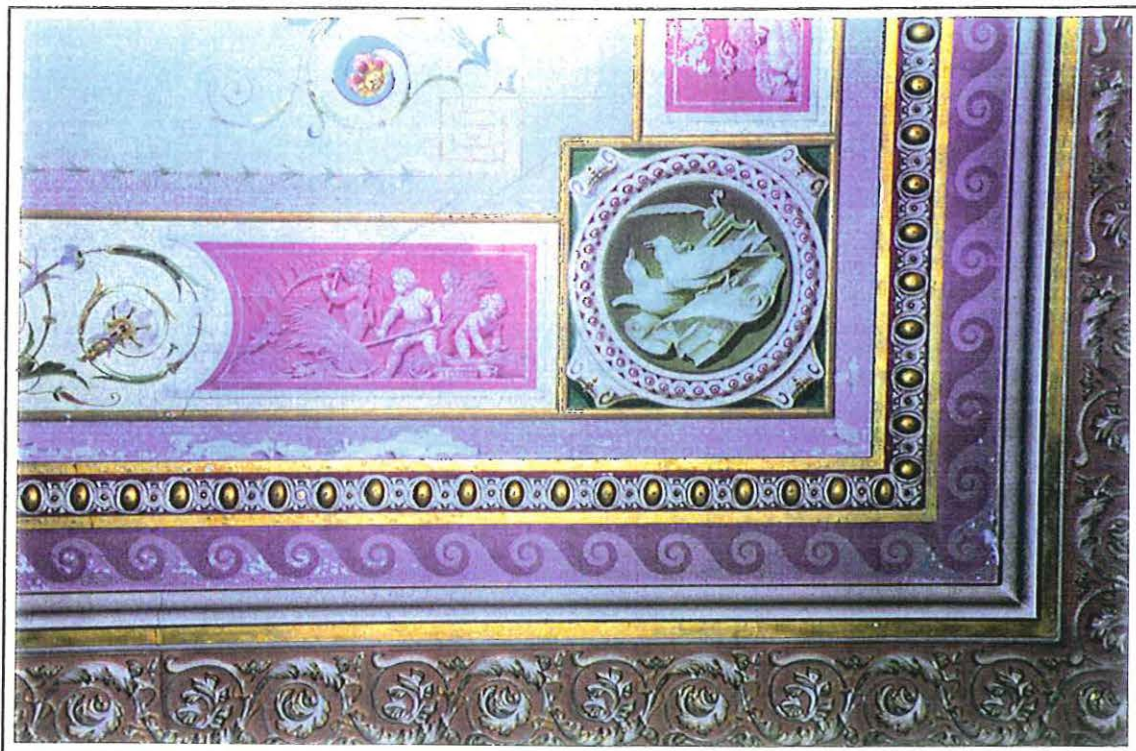
Drawing Room, ceiling, detail, before conservation in 1993

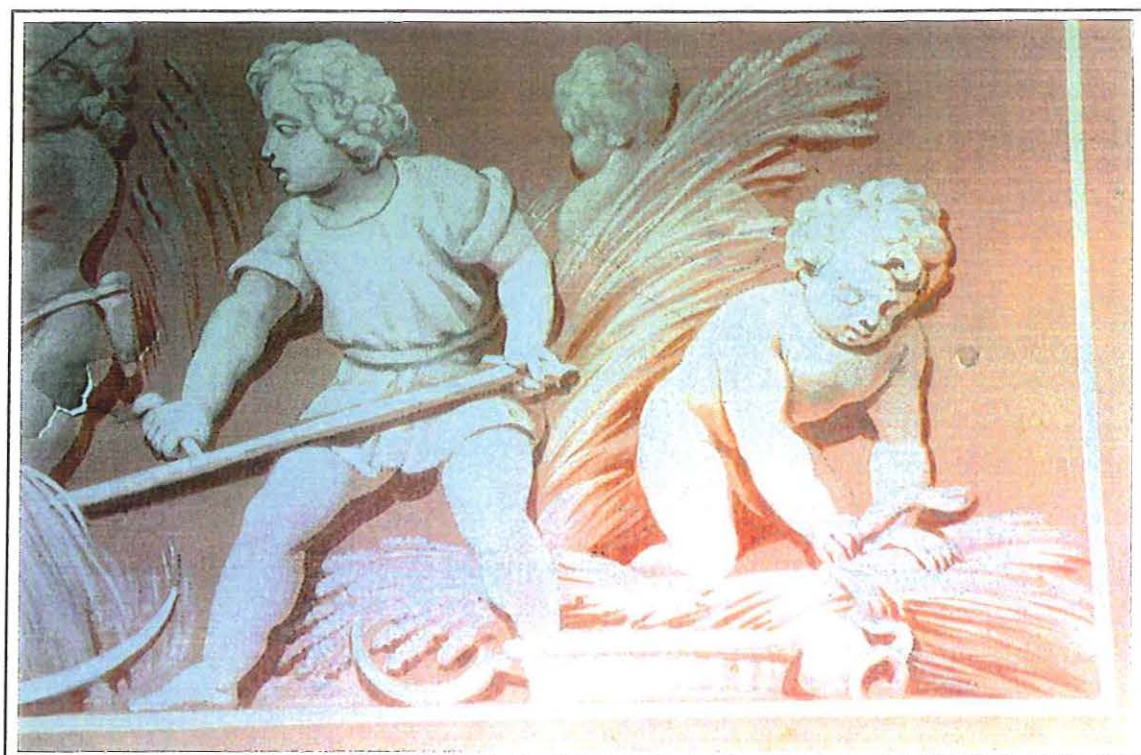
Drawing Room, ceiling, detail

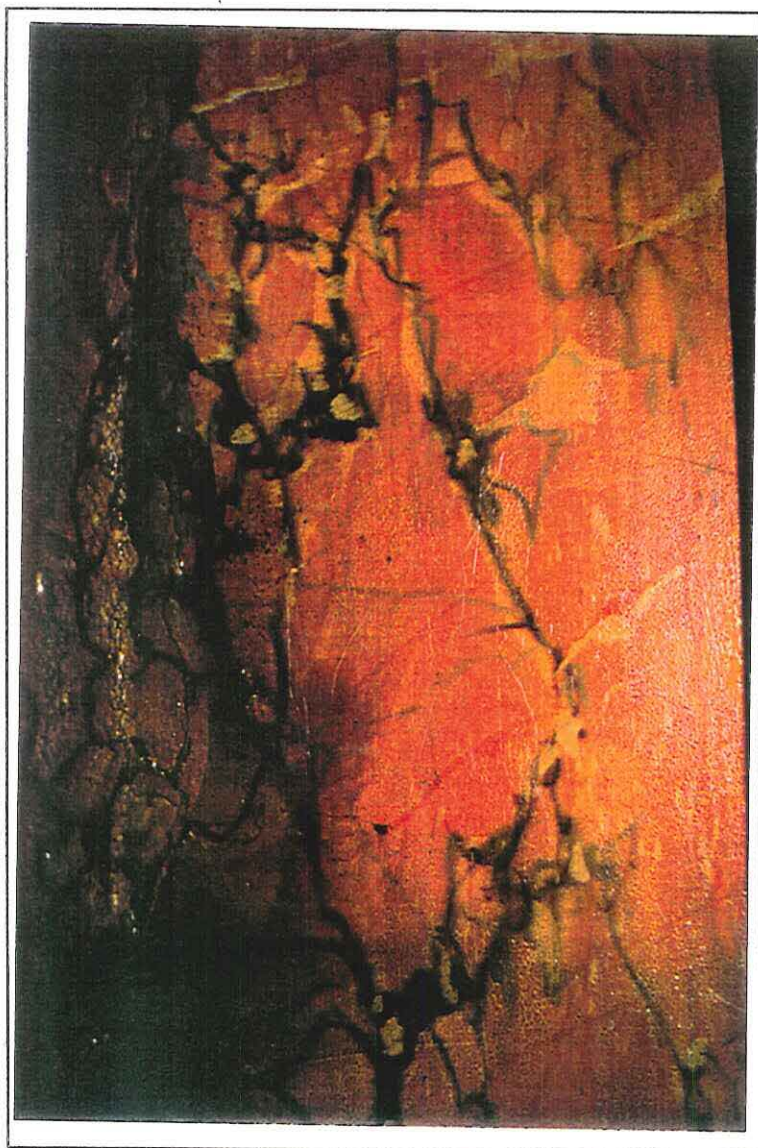
Entrance hall, detail of marbling

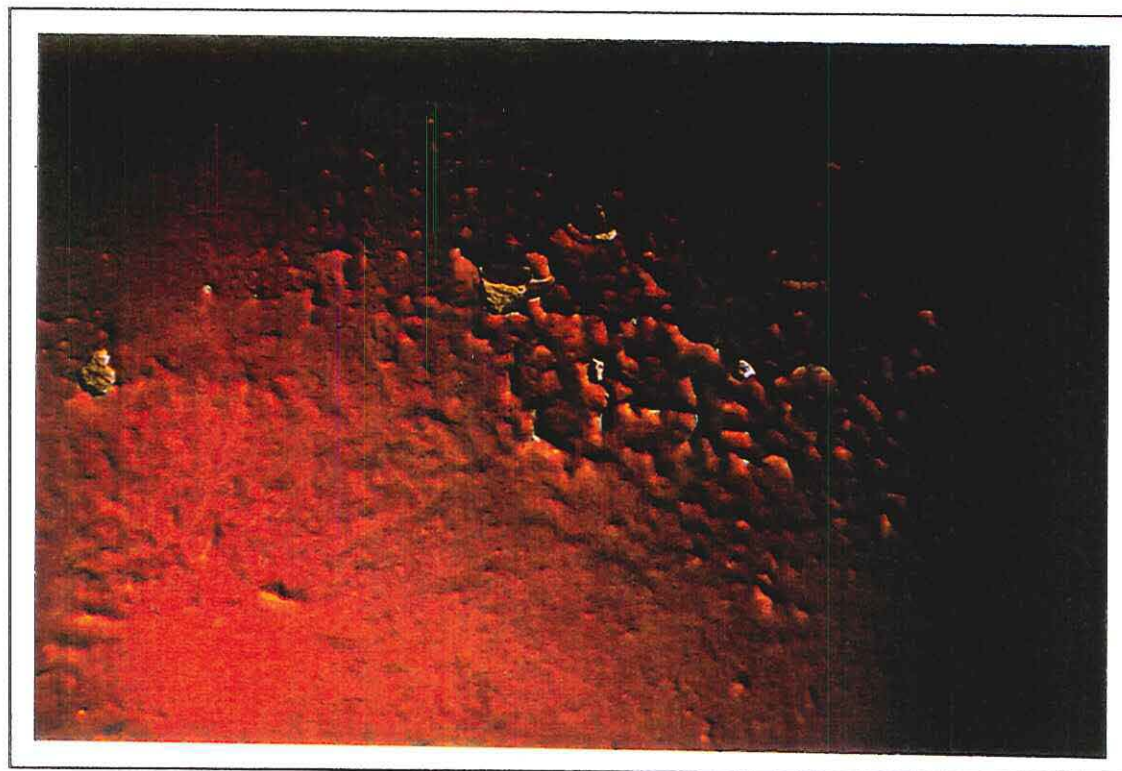
**Comments** Areas of flaking were fixed c. 1993-4, obviously further deterioration has occurred, indicating that the underlying cause is still active. Further flake fixing to the following areas is required:  
GC1- S. and E. walls; FC1- S. and E. walls; FC3 - N. wall below windows; FC9 - E. wall; FC10 - W.wall, N.end (n.b. wood graining to door rebate to Bedroom 15); GC8 (stairs to FC8) N. and S. walls; GC9 - E. wall, above and S. of lift door.

First floor, corridor, detail of typical flaking found throughout the marbled decoration, in raking light

Further flake fixing to the following areas is required: GC1- S. and E. walls; FC1- S. and E. walls; FC3 - N. wall below windows; FC9 - E. wall; FC10 - W.wall, N.end (n.b. wood graining to door rebate to Bedroom 15); GC8 (stairs to FC8) N. and S. walls; GC9 - E. wall, above and S. of lift door.[Timescale: 2 conservators, 4 weeks].
