Ancient Monuments Laboratory
Report 35/97

WALL PAINTING CONDITION AUDIT,
FINCHALE PRIORY, DURHAM

J Davies
T Manning

Finchale Priory Durham

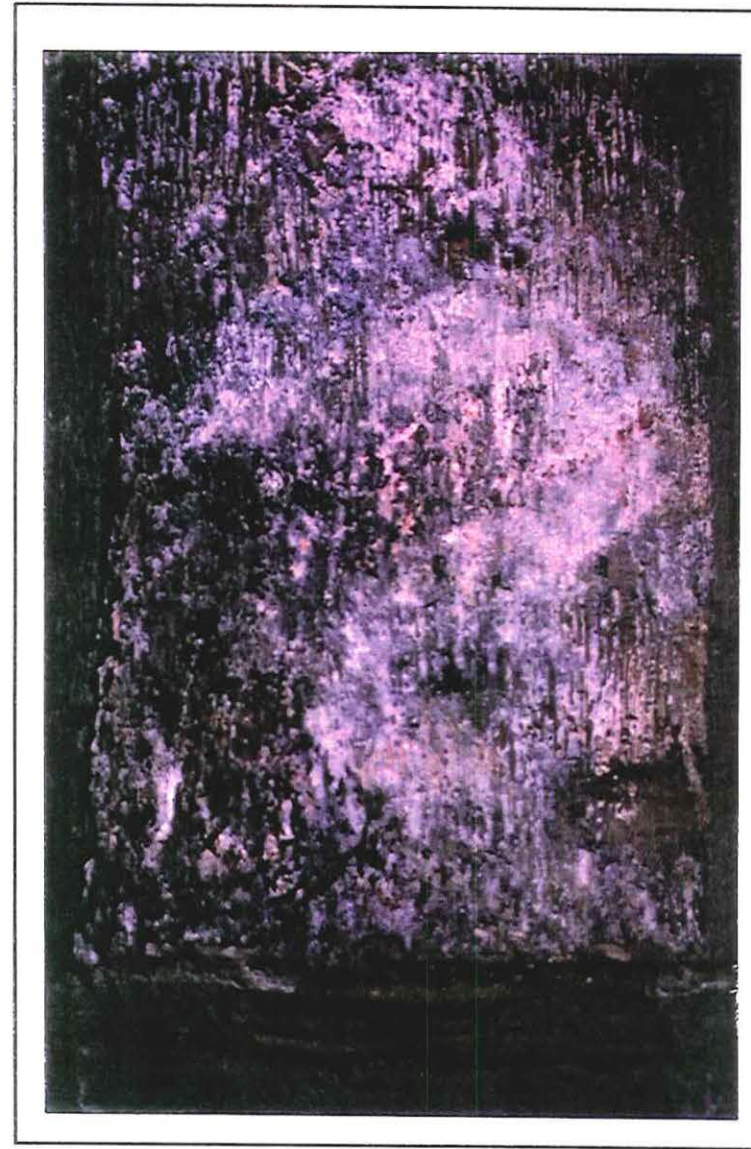
The paintings have deteriorated significantly over the past 70 years, and as of the August 1995 audit only the chevron pattern (on the first pier) and part of a roundel (on the second pier) was barely visible.

Detail, embedded column with traces of red chevron pattern
