Ancient Monuments Laboratory  
Report 39/97

WALL PAINTING CONDITION AUDIT,  
ROCHE ABBEY, SOUTH YORKSHIRE

## **Roche Abbey** South Yorkshire

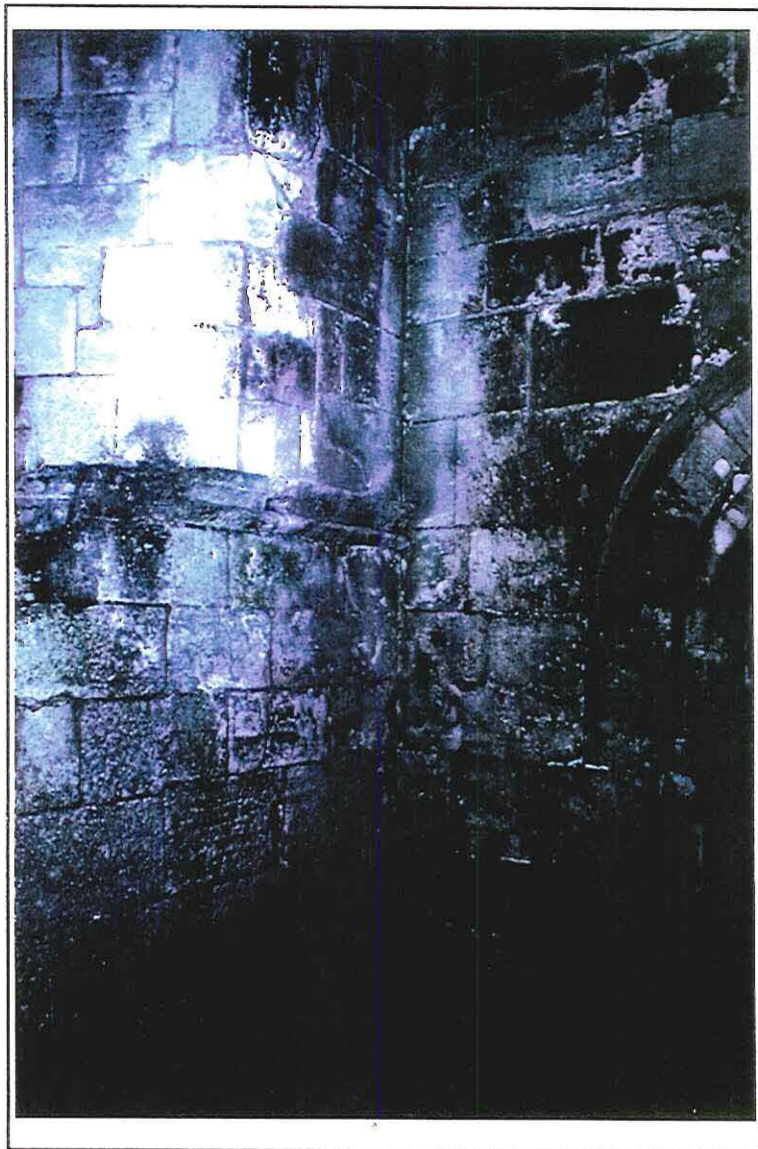
North transept, southeast corner, general view

This is an extremely exposed site which survives as a ruin. The limestone fabric is heavily weathered and there is extensive lichen growth. However, it appears to be well-maintained, with lead caps on much of the stonework, and several tell-tales throughout the site to monitor structural movement.

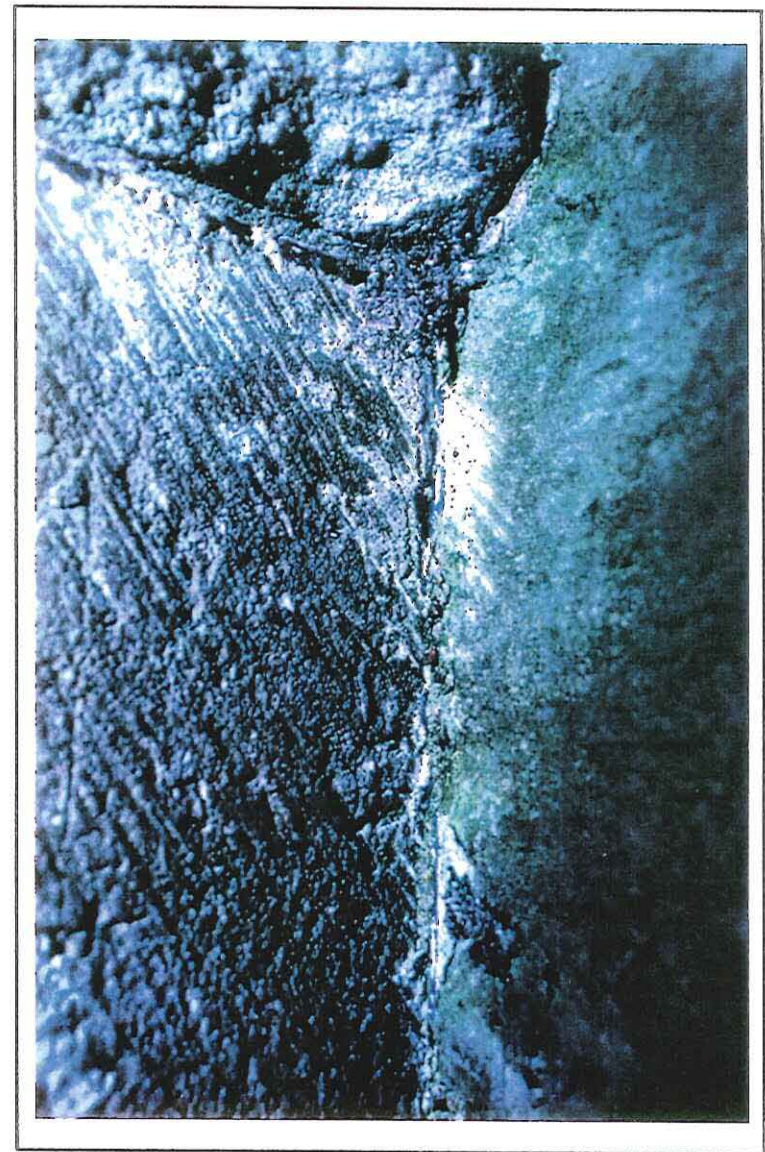
Minute traces of decoration survive in the north transept, within the southeast corner of the southern chapel. These consist of late 12th- or early 13th-century single black line masonry pattern. This was recorded in the 19th century, and again noted by D. Park in 1981. However, little now survives (D. Park noted traces of red as well but these are no longer visible).

Type general erosion  
Location All layers including support  
Comments Exposed structure which survives as a ruin. Directly affected by driving rain and wind. This has caused a general erosion of the painting and support. The paint, where it does survive, adheres better to the pointing than to the support (which appears to be more vulnerable).

Detail, traces of single black-line masonry pattern

**Comments** The existence of these scant remains of painting has been recorded, and the fragments photographed. The custodian should be made aware of their existence, in order to ensure their safety during building repairs. However, the remains are now purely of archaeological interest, and as long as they are recorded properly, do not warrant any conservation treatment.
