Ancient Monuments Laboratory  
Report 43/97

WALL PAINTING CONDITION AUDIT,  
BATTLE ABBEY, EAST SUSSEX

J Davies

## Battle Abbey East Sussex

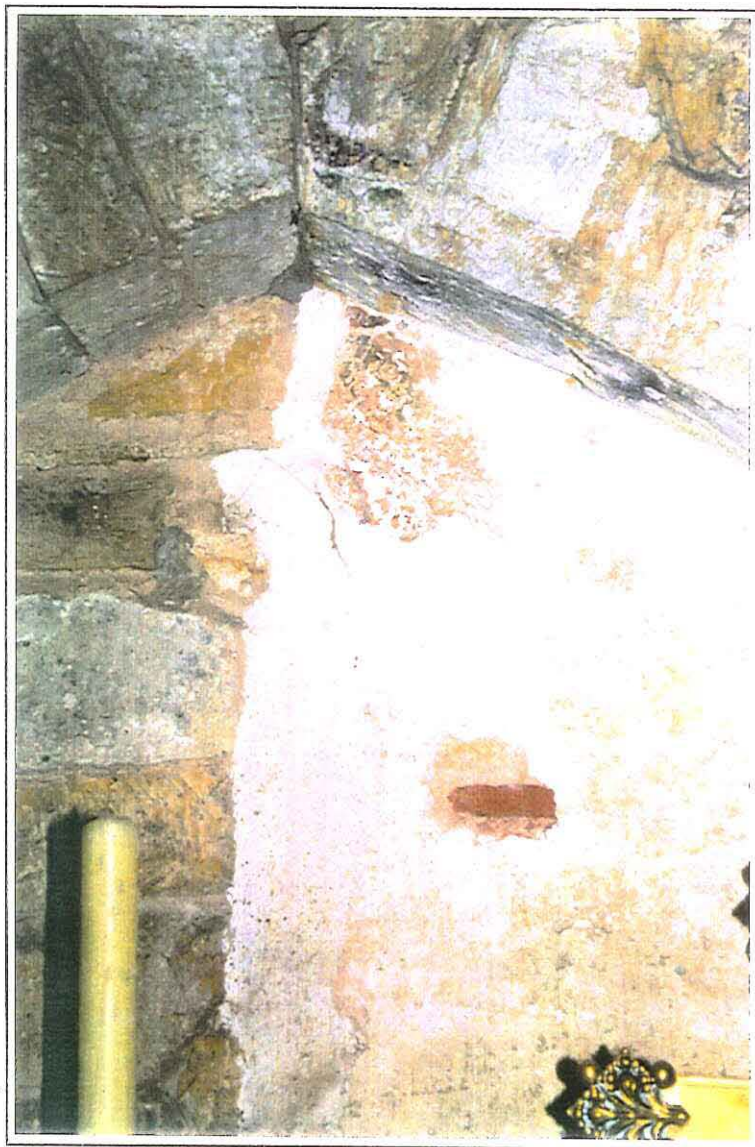
Abbot's chapel, east wall, altar recess

Red and yellow earth, black and white pigments appear to be present. Paint layer is discoloured, brown and flaking, which obscures the original pattern.

Comments The paint layer is suffering from extensive and severe flaking.

Comments The plaster support is bulging from the wall, and several losses of plaster have occurred.

Comments Cracking appears to be associated with delamination of the render layers and consequent movement.

Comments There are two holes through render layers below the remaining area of paint which appear to be the result of the insertion of nails, possibly for hanging of decorations.

**Comments** The paint has a slight surface sheen and has become discoloured to a golden brown, indicating that a wax or wax/resin 'preservative' may have been applied at some date.

**Comments** Hard, dense and dark grey repairs appear to have been carried out in cement to apex of arch soffit and general area.

Fixing of flaking paint, grouting and edge repairs to delaminating plaster are urgently required [Time scale: 2 conservators, 1 week, within 3 years].

**Comments** East wall, altar recess: flaking paint is in a fragile condition and requires consolidation urgently.

**Comments** East wall, altar recess: grouting to refix the delaminating plaster renders to the support is required. However, the paint layer is in a very fragile condition and consolidation of the paint layer is recommended before any grouting is initiated.

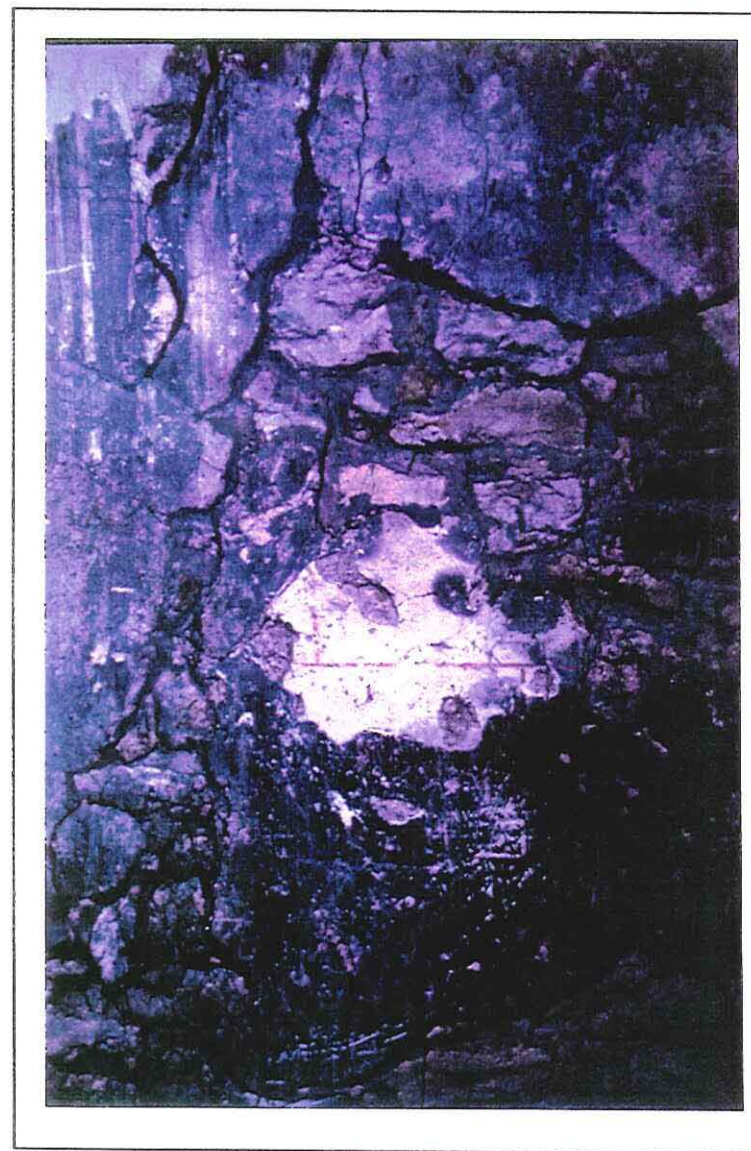
Abot's chapel, north wall, overall view of masonry pattern

The support has very obvious repairs and repointing in a grey mortar, possibly cement. Several areas of early plaster still remain. No original pointing is visible.

Red masonry pattern.

Comments General wear and tear probably accounts for abrasion and minor scratches on plaster surface.

**Comments** Edge repairs and repointing have been carried out in what appears to be a cementitious mortar.

Further areas of masonry pattern probably exist below smoke deposits, limewash and repairs and uncovering tests may reveal the extent of painted decoration. In the meantime further edge repairs are required to remaining early plaster. Light surface cleaning could also improve the appearance of the painting [Timescale: 2 conservators, 1 week, within 3 years].

**Comments** North wall: examination and trial uncovering tests may reveal further areas of painted decoration.
