Ancient Monuments Laboratory
Report 49/97

WALL PAINTING CONDITION AUDIT,
LULLINGSTONE ROMAN VILLA, KENT

J Davies

Lullingstone Roman Villa Kent

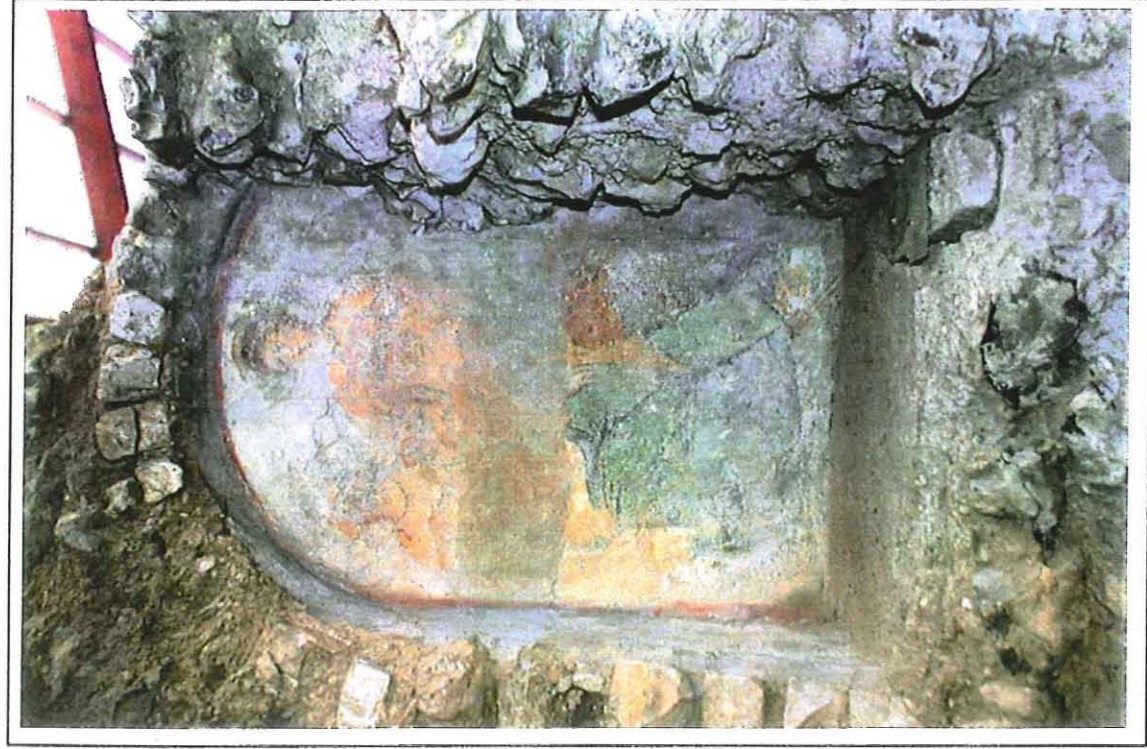
Detail, south wall, niche

Comments Erosion probably occurred when the painting was buried.

Comments Large horizontal loss across centre (approx 10 cm high)

Comments Insect activity was associated with a plastic foam which was placed on the painting by archaeologists as a protective measure (1958). It was kept covered until June 1966, when 'sand and packing materials' were removed at the request of A.N. Stewart, Chief Restorer. At this time the foam was discovered to have deteriorated and was infested with insect and mould growth, which had resulted in a blackish discolouration on the paint surface.

Comments Surface cleaning should be undertaken to remove dirt, dust and cobwebs. [Timescale: 2 days within 3 years].

Comments The condition of the painting appears stable and no active deterioration was apparent. However, it would be a prudent measure to install environmental monitoring equipment to assess the stability of the surrounding microclimate and to assess the impact of the fan which has been placed directly in front of the niche. In addition, the painting should be inspected every 3 years.
