Ancient Monuments Laboratory
Report 51/97

WALL PAINTING CONDITION AUDIT,
OSBORNE HOUSE, ISLE OF WIGHT

Summary

Osborne House Isle of Wight

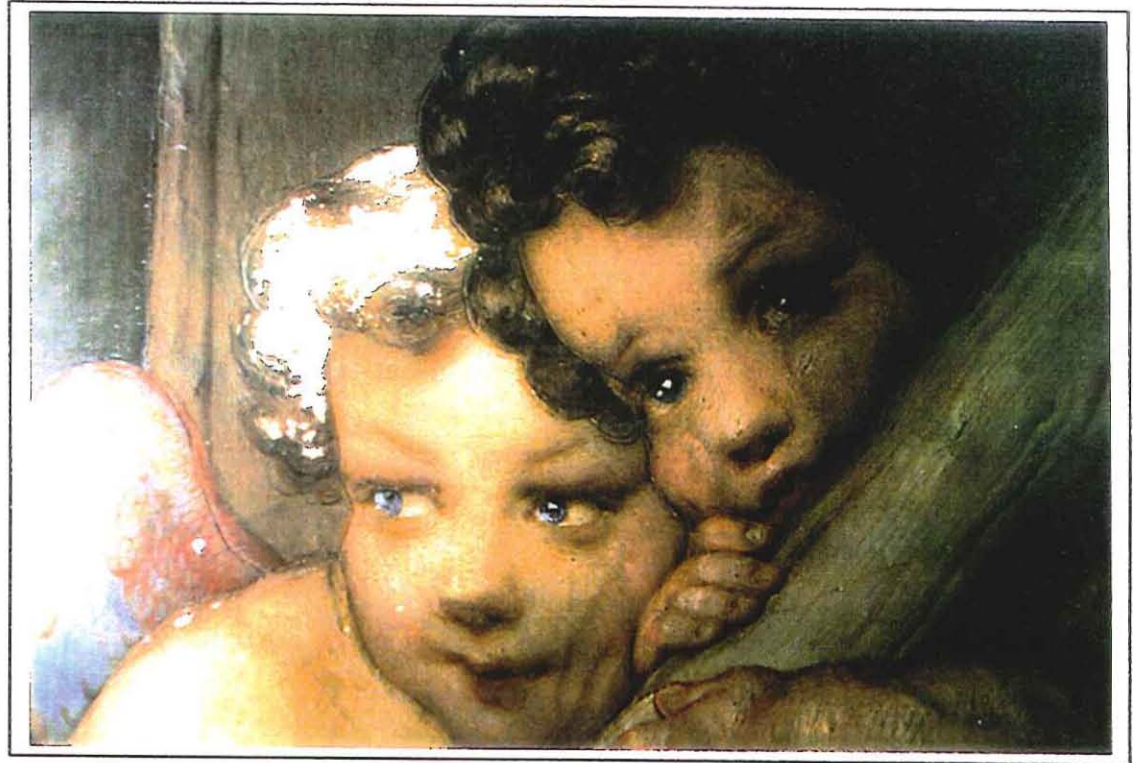
Prince Albert's Bathroom, SW wall, framed painting, detail lower right corner

Comments In limited areas (secco paint?) quite extensive loss due to flaking has occurred. In several areas losses have been retouched and then further losses have taken place, leaving islands of retouching. This is an indication that deterioration may be active.

Comments Cracking of the render has occurred in several places. Some minor flaking, associated with the cracking, has taken place.

Comments The edges of cracks have been overpainted to disguise their presence, however this paint has now darkened and is fairly conspicuous. The overpaint has an oily appearance.

Some treatment, including, flake fixing, light dusting/cleaning and sympathetic reintegration, is required. However, the present audit was undertaken without removal of the perspex sheet, and without access to the back of the painting. Any proposed timescale for treatment can therefore only be produced after the painting has been investigated directly and the technique and condition of the painting are better understood.

In addition it should be noted that whilst the perspex sheet currently provides protection from inadvertent mechanical damage it may also be producing a micro-climate which is contributing to active flaking of the paint layer. An examination of the environmental conditions affecting the painting should therefore be made and any necessary alterations made accordingly.

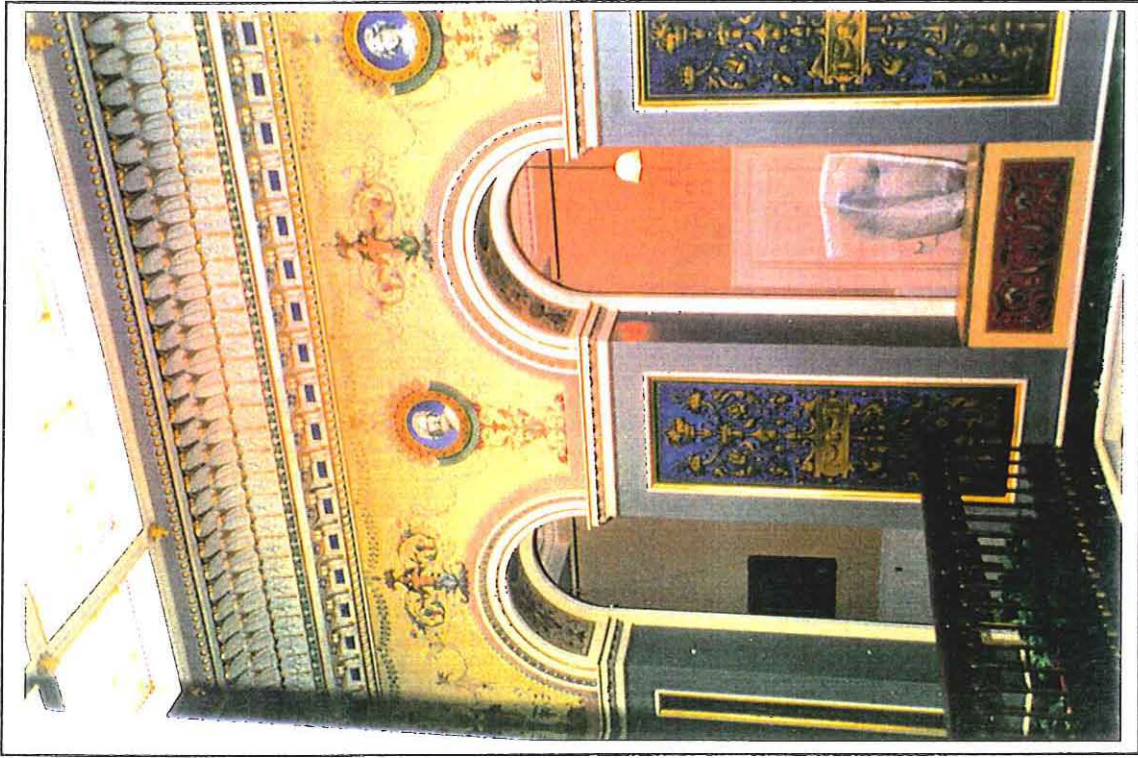
· · Nursery Landing, general view of decorative scheme

Comments Drying or 'alligator' cracks were noted to blue background areas. These cracks are likely to have occurred relatively soon after drying and may be considered an aspect of the original scheme.

Comments Flaking and loss of paint has occurred to the painted perimeter of the ceiling at the south-east side. This deterioration appears to be associated with moisture ingress.

Ingress of moisture from the glazed ceiling above the painted decoration is known to have caused considerable damage in the past to both paint and plasterwork. During the audit inspection evidence of continuing infiltration was noted and therefore further remedial building works are required to repair the ceiling.

Comments Remedial building work to repair the leaking area of the ceiling should be carried out. It is understood from discussion on site (with Rowena Shepherd [Conservator, Historic Properties, South East]) that this work is in hand.

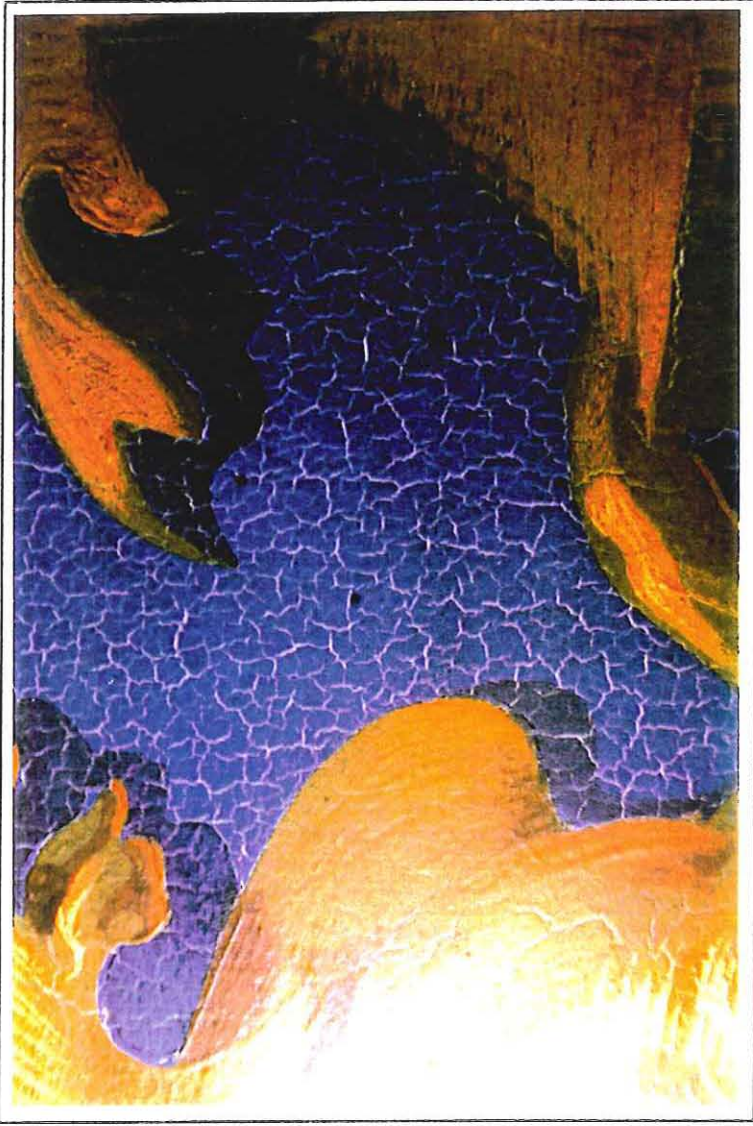
Detail, showing crackleure of painted surface
