Ancient Monuments Laboratory
Report 53/97

WALL PAINTING CONDITION AUDIT,
PORTCHESTER CASTLE, HAMPSHIRE

T Manning
S Stewart

Portchester Castle Hampshire

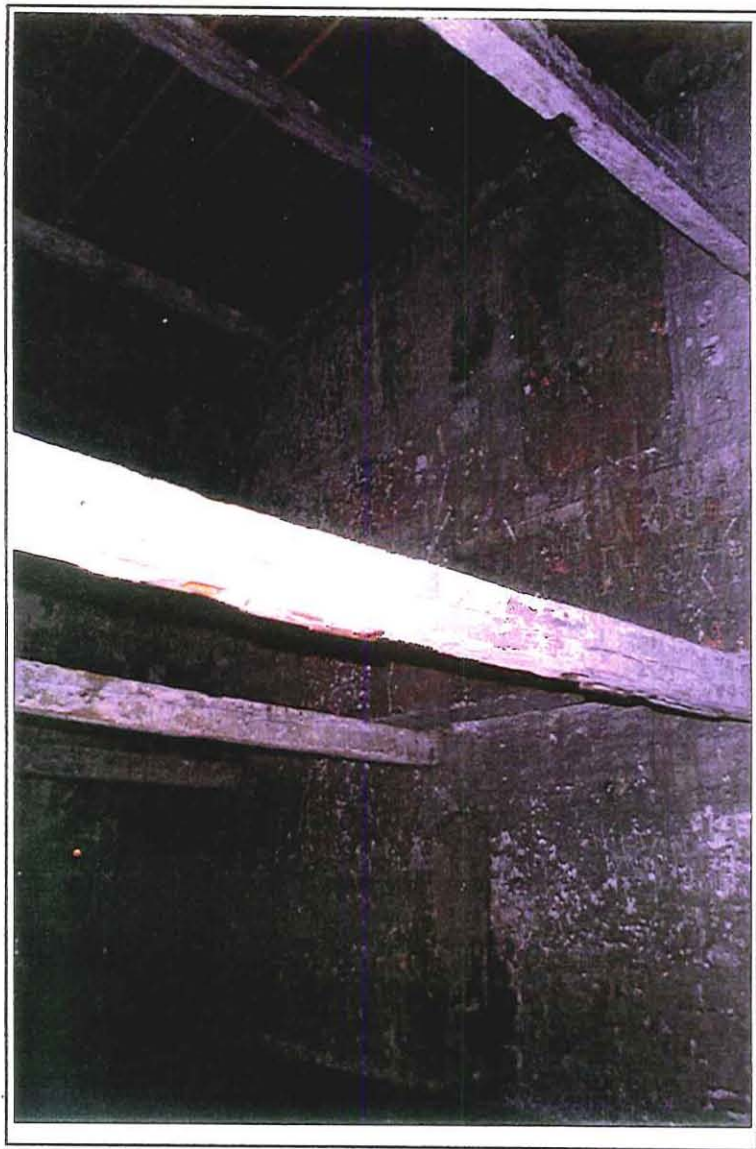
Keep, second floor, south room, general view to northwest

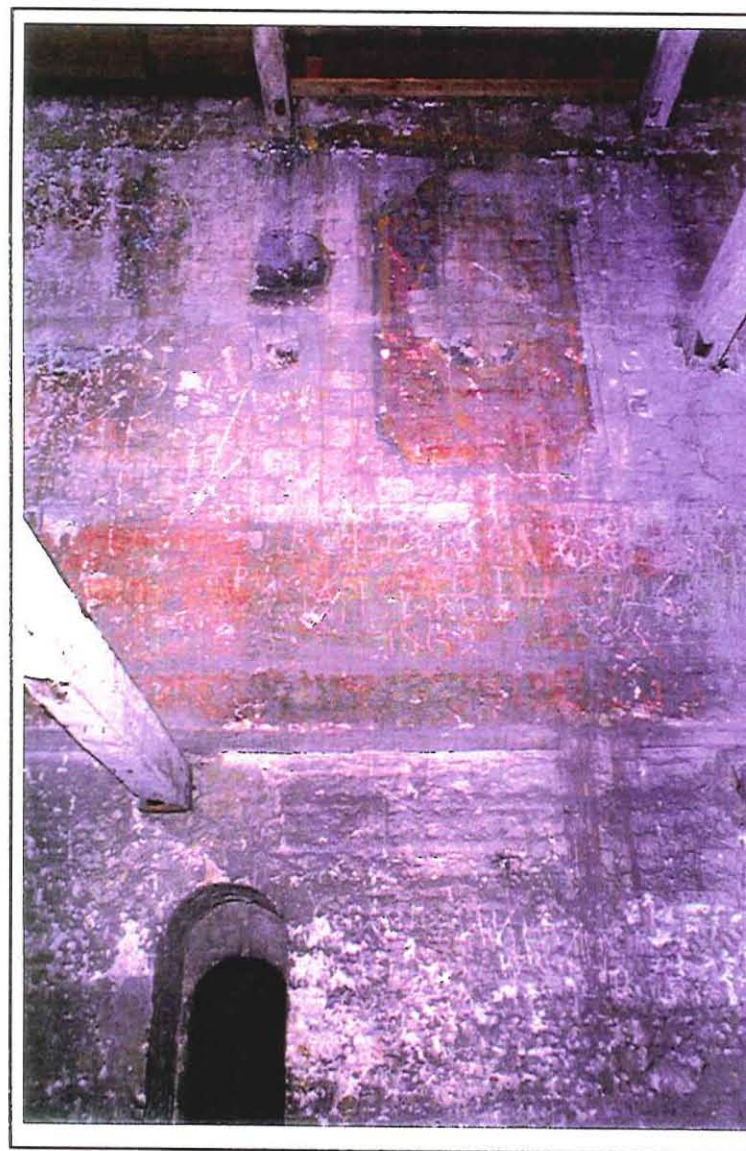
Detail, south side of spine wall, painted cartouches
