Ancient Monuments Laboratory  
Report 57/97

WALL PAINTING CONDITION AUDIT,  
WAVERLEY ABBEY, SURREY

J Davies

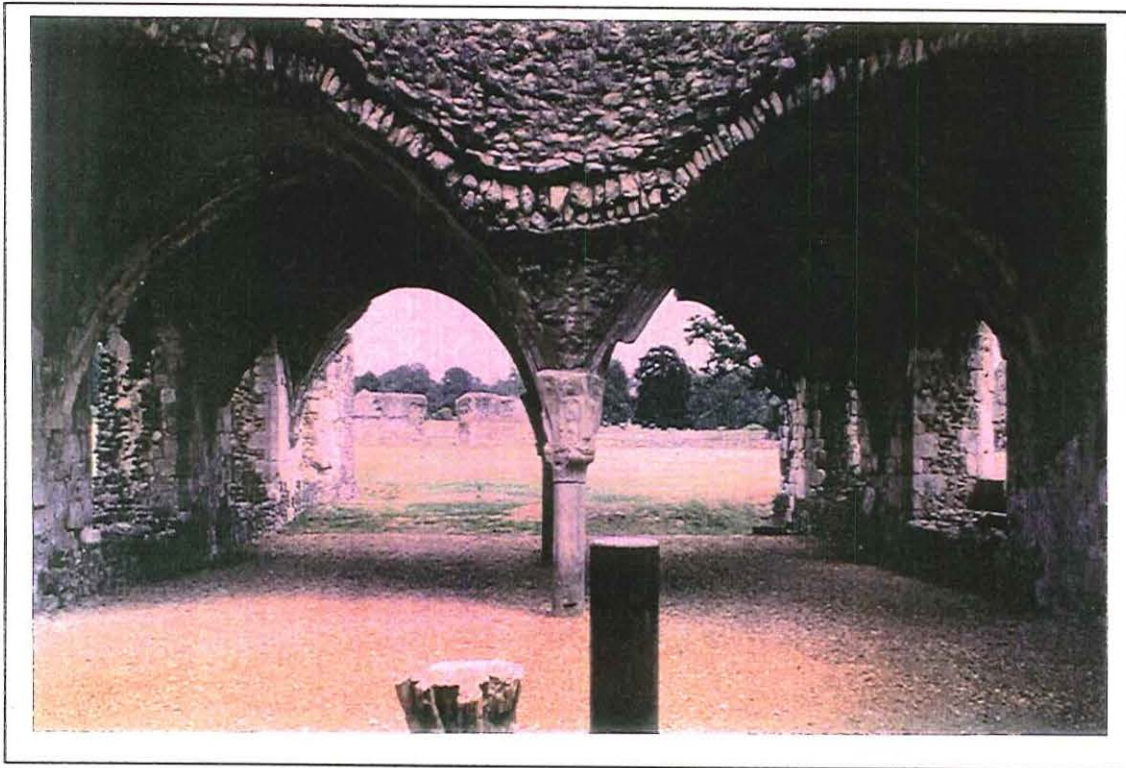
Lay-brothers range, general view to north

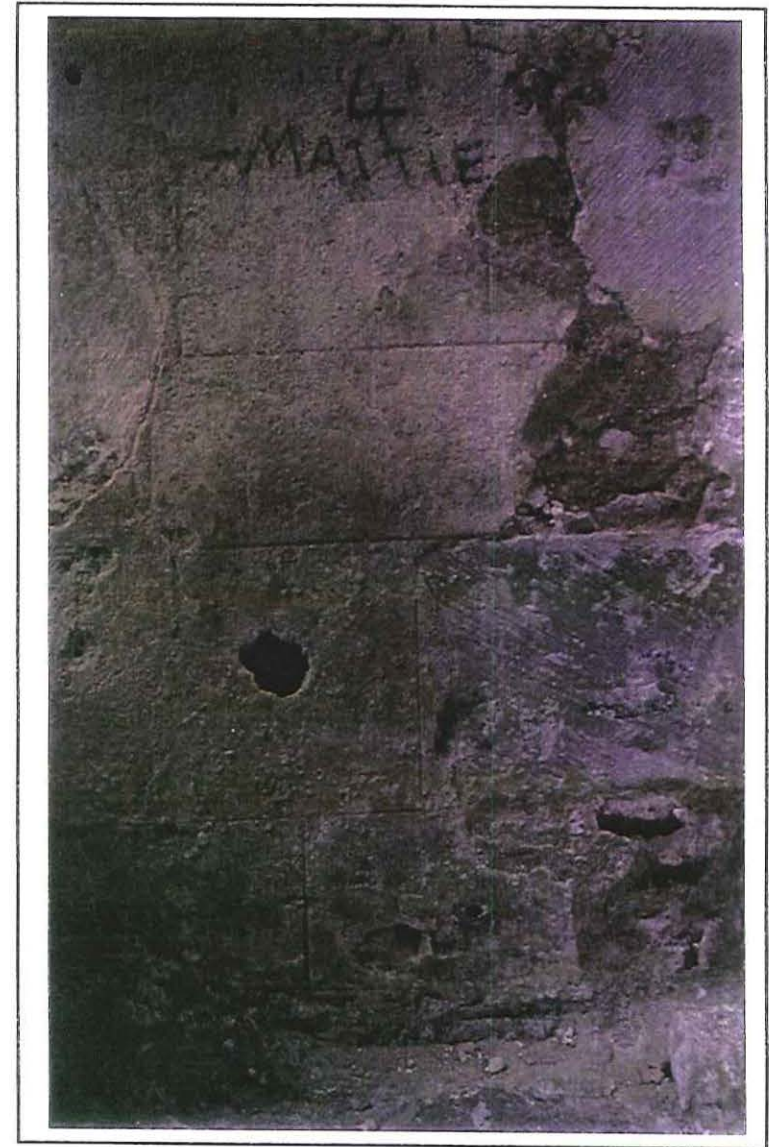
Lime/sand render with incised imitation ashlar layer. Aggregate varies from 0.4 cm down to fine sand. Render has a white appearance. No ground, limewash or paint layers remain on surface. The ruins are on an exposed site, therefore delicate surface finishes are likely to have been lost. The incisions have apparently been formed by pressing a straight edge (0.3-0.5 cm wide) into the damp plaster.

Detail of incised masonry pattern
