Ancient Monuments Laboratory
Report 58/97

WALL PAINTING CONDITION AUDIT,
BERRY POMEROY CASTLE, DEVON

Berry Pomeroy Castle

Property name	BERRY POMEROY CASTLE		
Region	South West	County	Devon
Location of painting	Gatehouse		
Orientation	EAST TOWER, EAST WALL.		
Century 15 th	Date	Height (cm) 130	Width (cm) 262
Subjects included	Adoration of the Magi

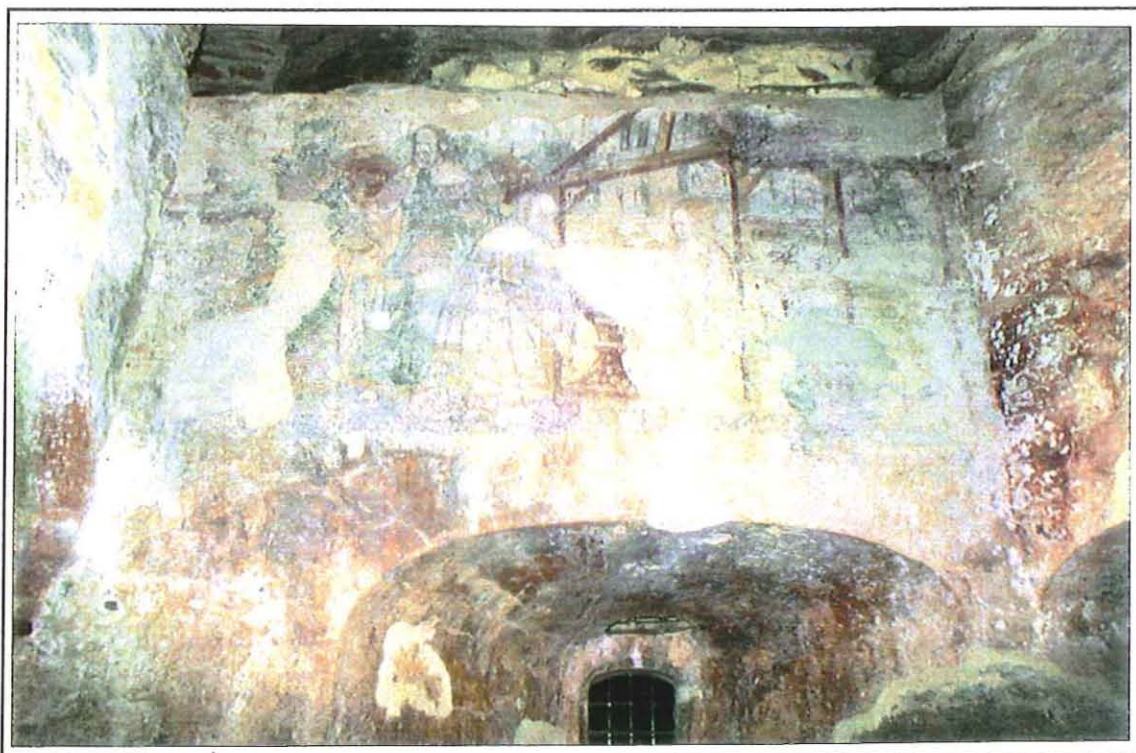
Overall condition score **2**

Type delamination (render layer)
Location Virgin's robe and areas below.
Comments These areas are hollow but appear to be stable.

Type salt activity
Location efflorescences visible in areas of loss below and to the right edge of the painting
Comments Fine white powder and crystalline efflorescences surrounding losses.

Type delamination (paint layer)
Location localised areas
Comments Some limited flaking.

Type minor losses
Location general
Comments There are numerous losses and the painting generally has an abraded appearance. This is probably a result of the previous mechanical action of ivy suckers and roots plus other vegetation and micro-biological growth.

Comments The veil, previously identified as a crust of soluble salts, was thinned during treatment in the 1980's but is still present over much of the surface. Comparison of photographs dating to the early 1980's and the current condition of the painting indicates that the white veil is relatively stable. However, Barakan noted that it appeared to re-form several years after treatment. The technical examination in 1995 identified that this veil is possibly cerussite, an alteration product of the red lead pigment present in the paint layer, which would explain its constant re-formation.

East wall, *Adoration of the Magi*

The painting has been treated in recent years and would appear to be in a relatively stable condition. However, there is some limited flaking of the paint layer which should be stabilised in the near future. Bat excreta should also be removed from the surface of the painting. [Timescale: 1-2 days within one year].

It is recommended that the paintings are inspected every 2 years. The auditor should be aware of the possibility that the lead-based pigments may be darkening. There are currently no preventative measures that can be taken to prevent this occurring.

Comments Removal of bat excreta. 1 day within 1 year.

Type FLAKE FIXING **Date** 01/10/95
Person SS/TM
Comments 1-2 days within 1 year.
