Ancient Monuments Laboratory
Report 59/97

WALL PAINTING CONDITION AUDIT,
CLEEVE ABBEY, SOMERSET

C Babington
A Heritage
T Manning
S Stewart
P Welford

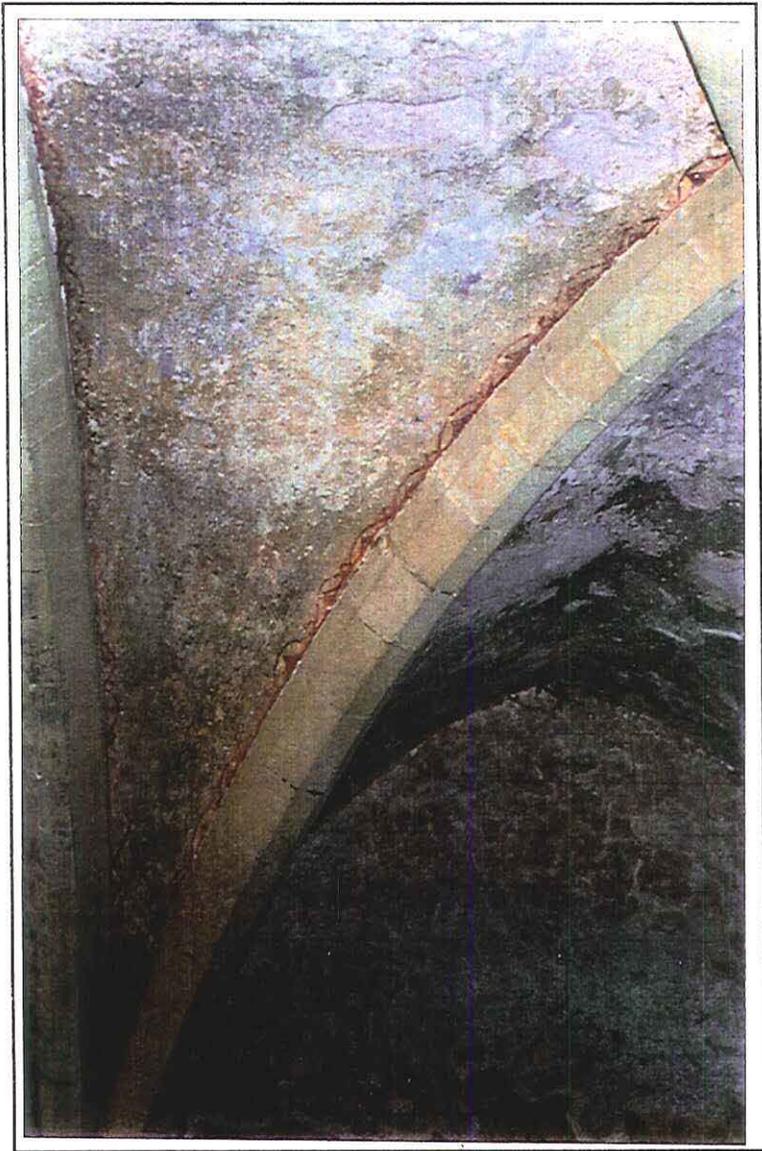
Chapter house, detail of decoration on vaults

VAULTS: Remedial treatment appears necessary but should follow a more thorough investigation [Timescale: 2 conservators, 1 week]. Treatment will probably include: flake fixing, grouting, removal and replacement of repairs [Approximate Timescale: 2 conservators, 6 weeks].

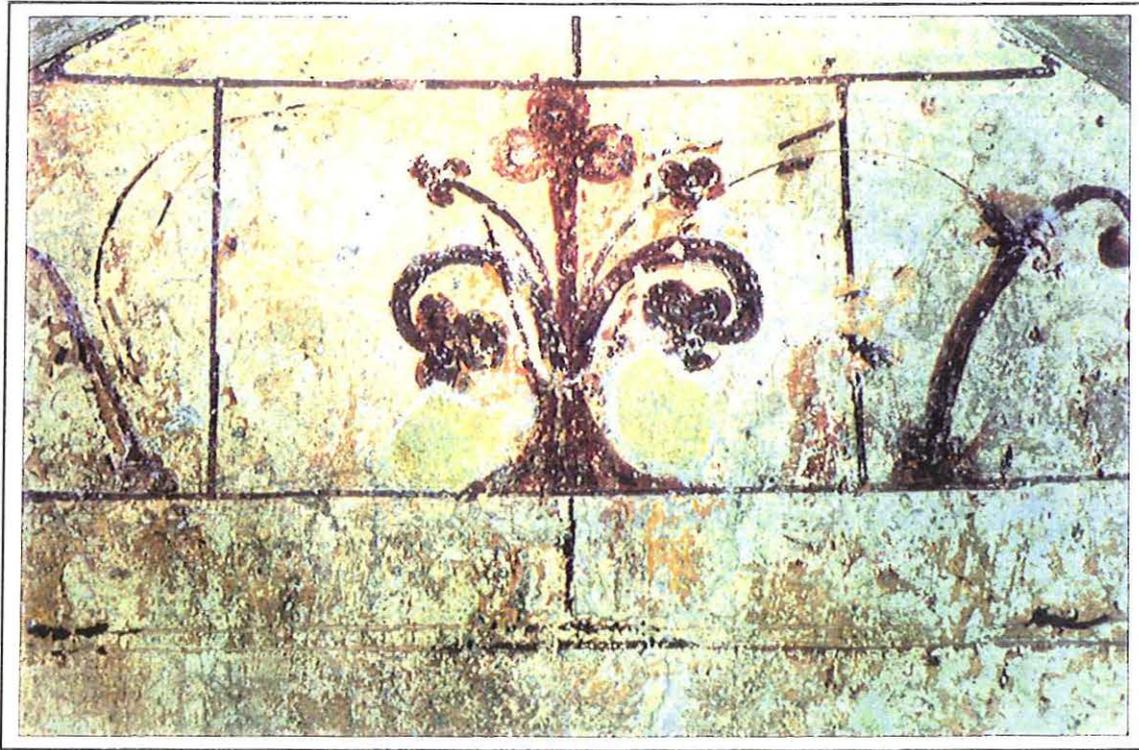
Sacristy, piscina, detail painted decoration

Type salt efflorescences
Location VAULT: centre; SOUTH WALL PISCINA; SOUTH WALL generally; EAST WALL
Comments VAULT: efflorescences on central area of vault;
SOUTH WALL PISCINA: substantial quantity of fluffy crystals over surface, NB. salts effloresce preferentially through original plaster rather than the 1962 repairs at base, suggesting they are too hard and compact.
SOUTH WALL: extensive fluffy efflorescences throughout, identified as potassium nitrate in 1993.
EAST WALL: Efflorescence on walls and window splay up to 140 cms height, but evidence of damage throughout; crystal growth in window splay has a 'cotton wool' appearance.

Type biodeterioration
Location VAULT; SOUTH WALL PISCINA; EAST WALL; WEST WALL
Comments VAULT: surface stained in patches - appears black-green; SOUTH WALL PISCINA: green growth concentrated in pitting of eroded plaster, also on one repair (15 cms from base at centre, S face); black growth concentrated on lower half, especially S face;
EAST WALL: at apex of window splay/soffit including voussoirs and south side of wall, upper part.
WEST WALL: southern fragment, on vault, adjacent microbiological growth which could spread

SOUTH WALL: The piscina requires removal and re-insertion of repairs, removal of salt crystallization as necessary and possible desalination trials [Timescale: 1 conservator, 2-3 weeks within 1 year].
