Ancient Monuments Laboratory
Report 61/97

WALL PAINTING CONDITION AUDIT,
FIDDLEFORD MILL HOUSE, DORSET

J Davies
T Manning

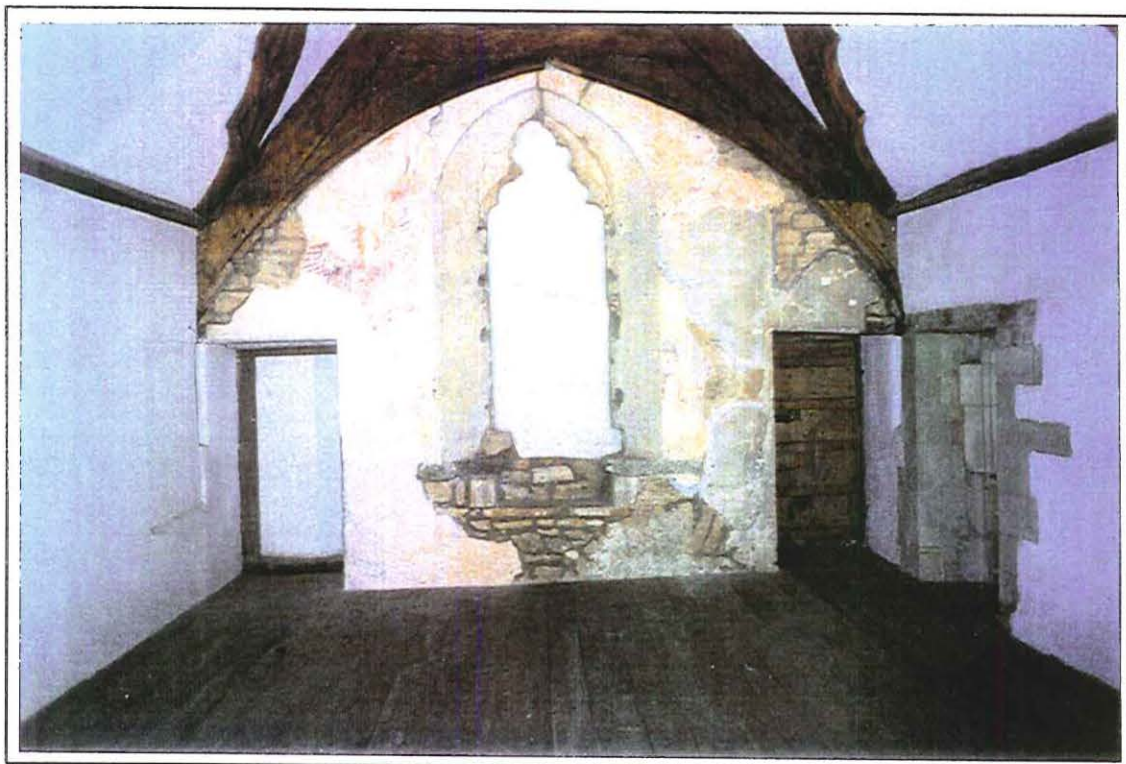
Solar, general view of north wall

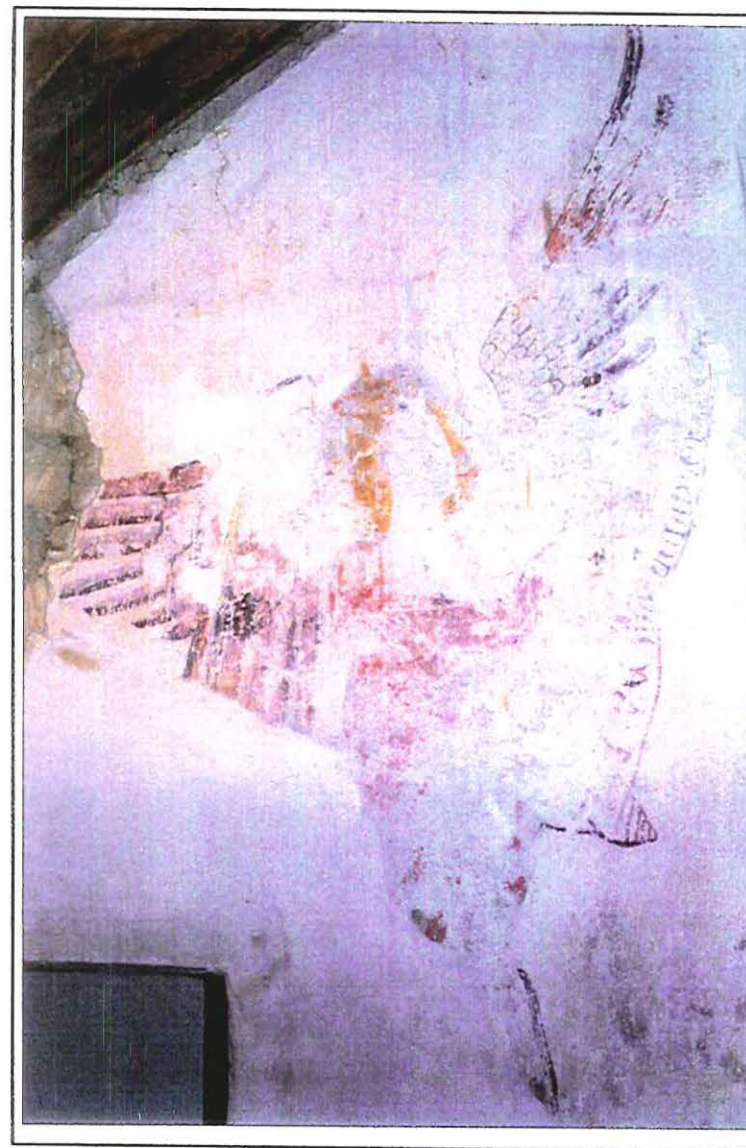
Type cracking
Location head of Archangel Gabriel
Comments Cracks occurred prior to 1991. They have been repaired. The painting now appears structurally stable.

Type loss of cohesion (paint layer)
Location red paint
Comments The poor condition of the early red painted areas was noted in 1991. The paint was consolidated at that time using Paraloid B72 1% in IMS. The paint layer appears vulnerable and further consolidation may be required in future.

Detail, archangel Gabriel, west side of north wall

Type CONSOLIDATION **Date** 06/09/94
Person JD/TM
Comments The red paint still appears friable, as it did in 1991 after treatment. However, if the environment remains stable, this should not pose a problem. Further consolidation of the red paint may be required in future.
