Ancient Monuments Laboratory  
Report 62/97

WALL PAINTING CONDITION AUDIT,  
GLOUCESTER, BLACKFRIARS,  
GLOUCESTERSHIRE

J Davies  
T Manning

Summary

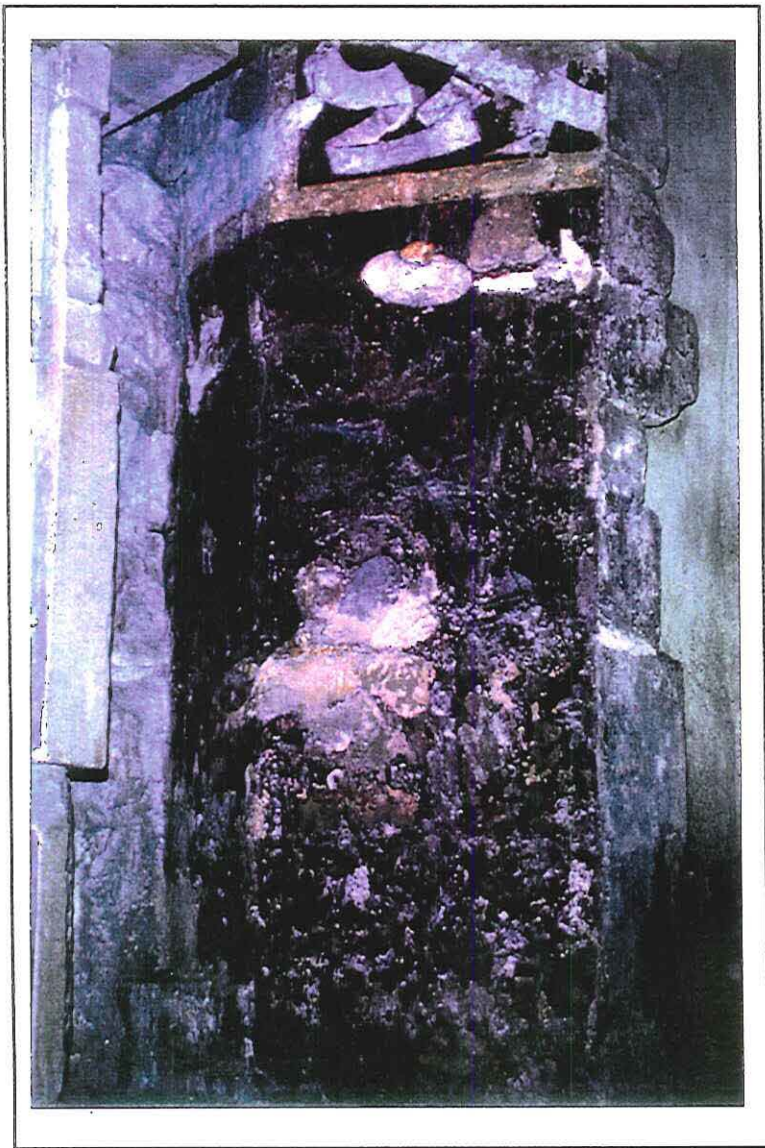
East range, east wall, south window, south splay

Type spalling  
Location support; especially north splay, lower level  
Comments The surface of the stone support is scaling/spalling.

Type losses (paint layer)  
Location general  
Comments Losses to upper paint layers. Only ground remains which is lacking in cohesion. Approximately 60-70% loss.

Type delamination (paint layer)  
Location ground layers, generally  
Comments Macro-flaking of ground layer

Type flaking  
Location general  
Comments Micro-flaking of paint layer

Type substantial losses  
Location general - to plaster support  
Comments Damage associated with blocking-in of window, subsequent removal of blocking material, and renovation of window. Loss especially to north splay.

**Type** FLAKE FIXING **Date** 20/09/94  
**Person** JD, TM  
**Comments** There is some limited active flaking to the lower part of the north splay. Flake fixing is required.

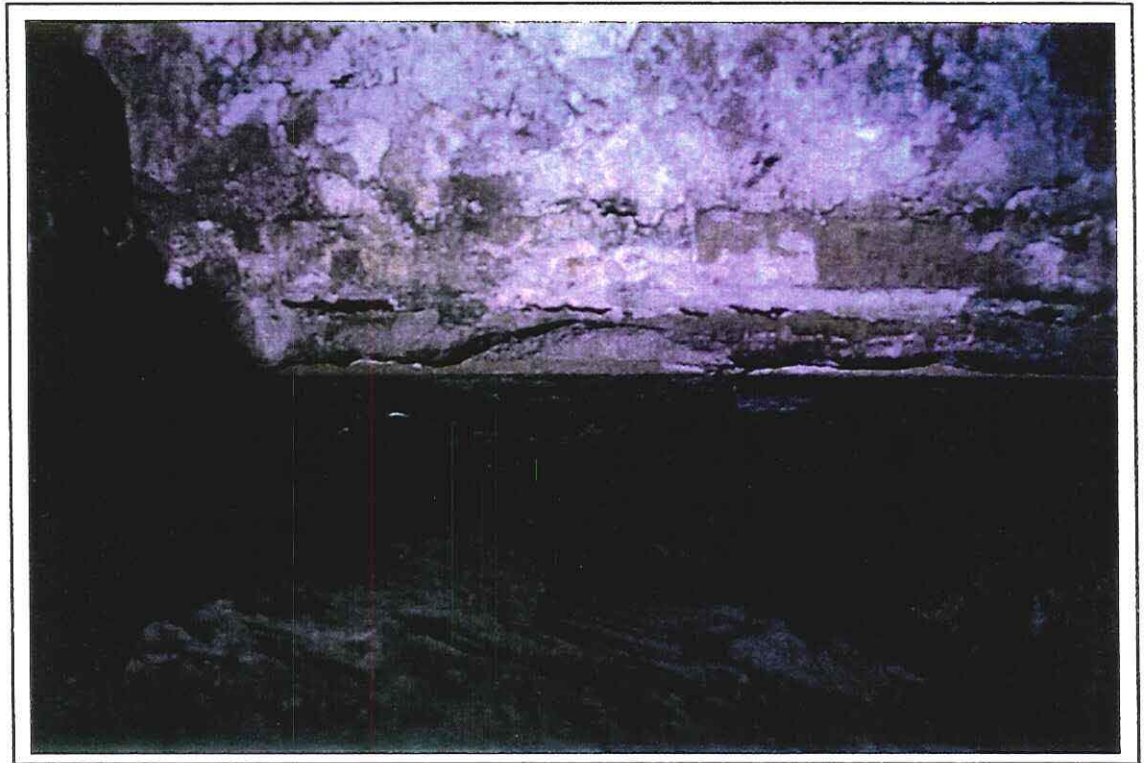
Cloister, south side, laver, third niche from west, detail painted inscription

The inscription is painted on a thick limewash ground which is severely delaminating. Urgent treatment is required including flake fixing and small repairs to the edges of the delaminating limewash. [Timescale: 1 day asap].

**Comments** The flaking limewash ground was consolidated and flakes fixed on 22/12/94 in response to recommendations in first condition audit. The area below the inscription (still formed by partial unblocking) was dusted using a soft bristle brush, directing dust away from the paintings. The flakes were pre-wetted using a distilled water:acetone (1:1) solution which was injected behind the flakes. Plextol B500 10% in water was injected behind the flakes. Where possible the flakes were gently pressed back against the stone support using a pad of cotton wool covered with a nitrile rubber sheet. Proud edges and pockets of limewash which it was not possible to fully readhere were supported by injection of lime milk:Plextol B500 (5:1) which formed miniature edge repairs. A photographic record of treatment was made kept in Studio.
