Ancient Monuments Laboratory
Report 66/97

WALL PAINTING CONDITION AUDIT,
OKEHAMPTON CASTLE, DEVON

J Davies
T Manning

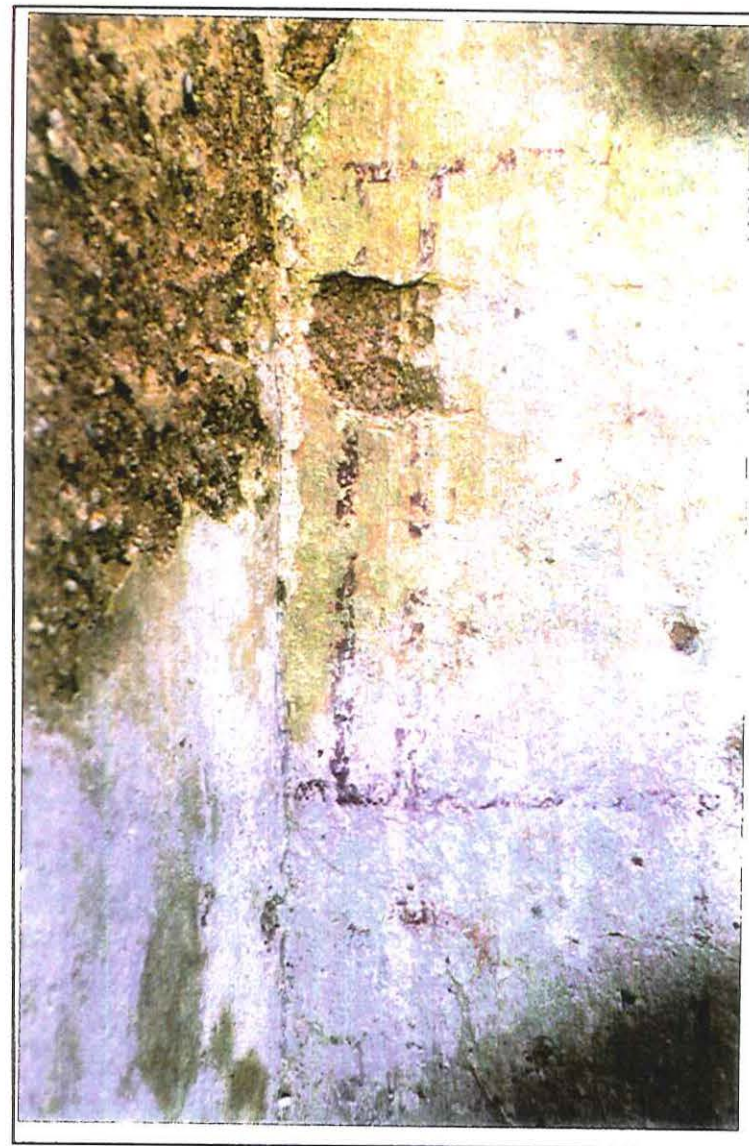
Fragments of red and white paint survive in patches over the south wall of the chapel and there are traces of red, black, yellow and white on the window splay. The scheme comprises a simple double red line masonry pattern on the walls, with a black chevron pattern against traces of red and yellow within the window splay.

Detail, south wall, double-line masonry pattern
