Ancient Monuments Laboratory
Report 67/97

WALL PAINTING CONDITION AUDIT,
RYCOTE CHAPEL, OXFORDSHIRE

J Davies
T Manning

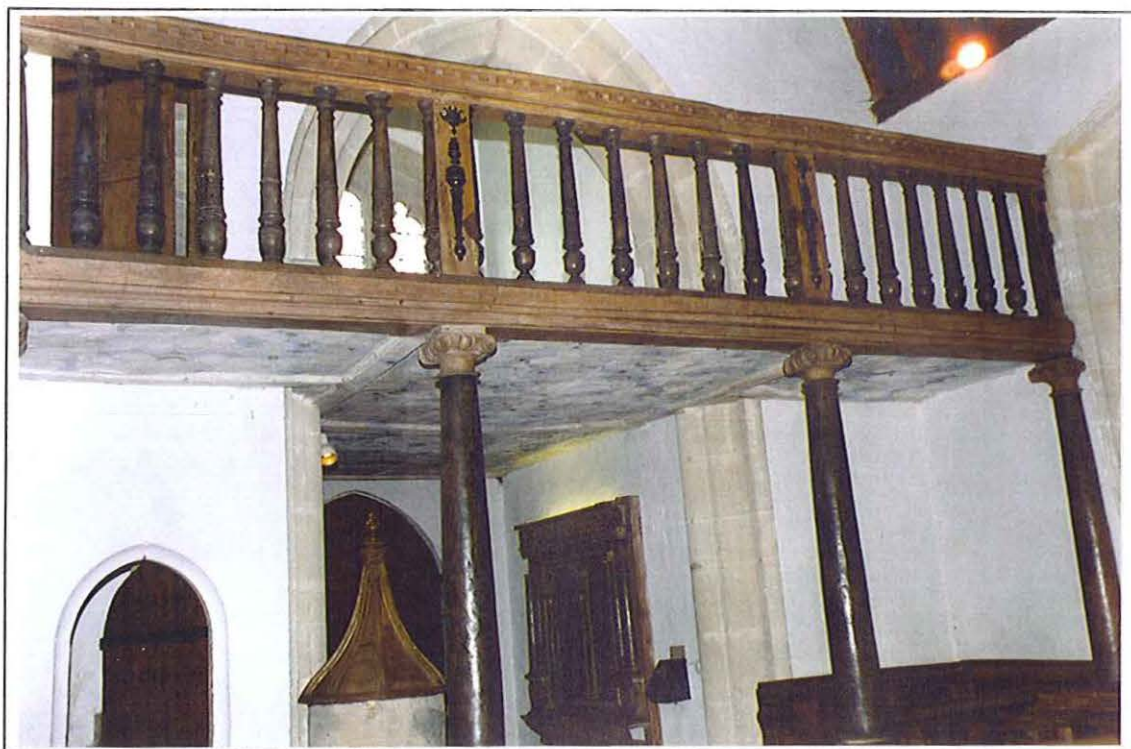
Western Gallery, general view to west

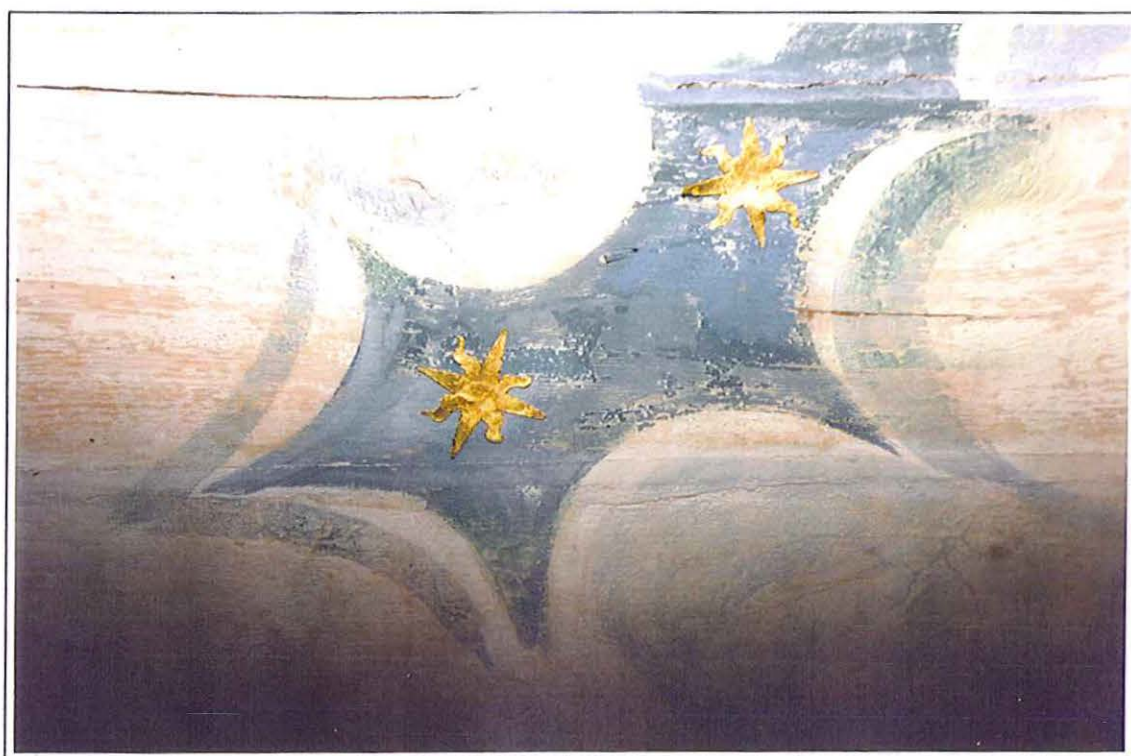
Norrey's Pew, ceiling, detail of condition: note various past retouchings, and flaking

Type FLAKE FIXING **Date** 18/08/94
Person JD, TM
Comments The most immediate problem is that of micro-flaking. It seems that the Norreys Pew is now in much the same condition that the Western Gallery was in before it was treated in 1990, and the latter appears stable, therefore a similar methodology might be employed (i.e. a lime-based adhesive such as lime milk and Plextol B500).

Conservation treatment of the Norreys Pew painting is recommended following further technical analysis. This will mainly involve minor flake-fixing in order to prevent the loss of original material. [Timescale: 2 people, 1 week, within 5 years].
