Investigation of a Composite Artefact from Gallows Bay, Nevis (Lesser Antilles)

Dylan Cox (E.H. Research Fellow, University of Southampton)

The report focuses on the investigative conservation of a composite object of iron and wood from Gallows Bay, Nevis (Lesser Antilles). The main aim was to compile analytical information (X-radiography, XRF analysis) which would serve to clarify the function(s) and technology of this device.

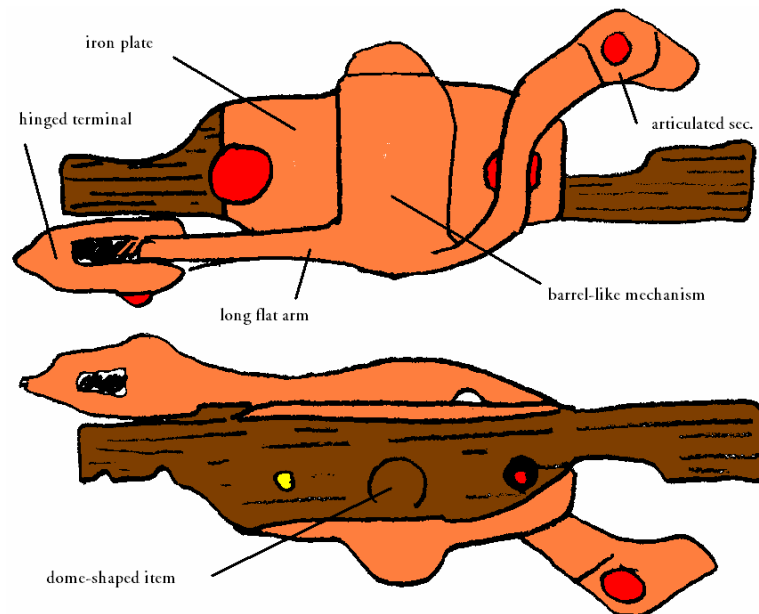
Figure 3: Diagram of object

The object is currently damp and appears to be stable. There are no obvious signs of active corrosion, areas of particular weakness or warping/shrinking/splitting of wood. The wood has rounded edges (like driftwood), presumably a consequence of the erosive action of water currents. Some parts of the wood are quite dark (particularly

The iron components appear quite stable, though some corrosion products have obscured some details. Flaking of some surfaces appears to have occurred at some point in the past, but certainly not recently.

The articulated section of the 'arm' has almost certainly suffered some physical damage: part of the 'arm' appears to have been bent back, and the shortest section of the articulation has been broken off.

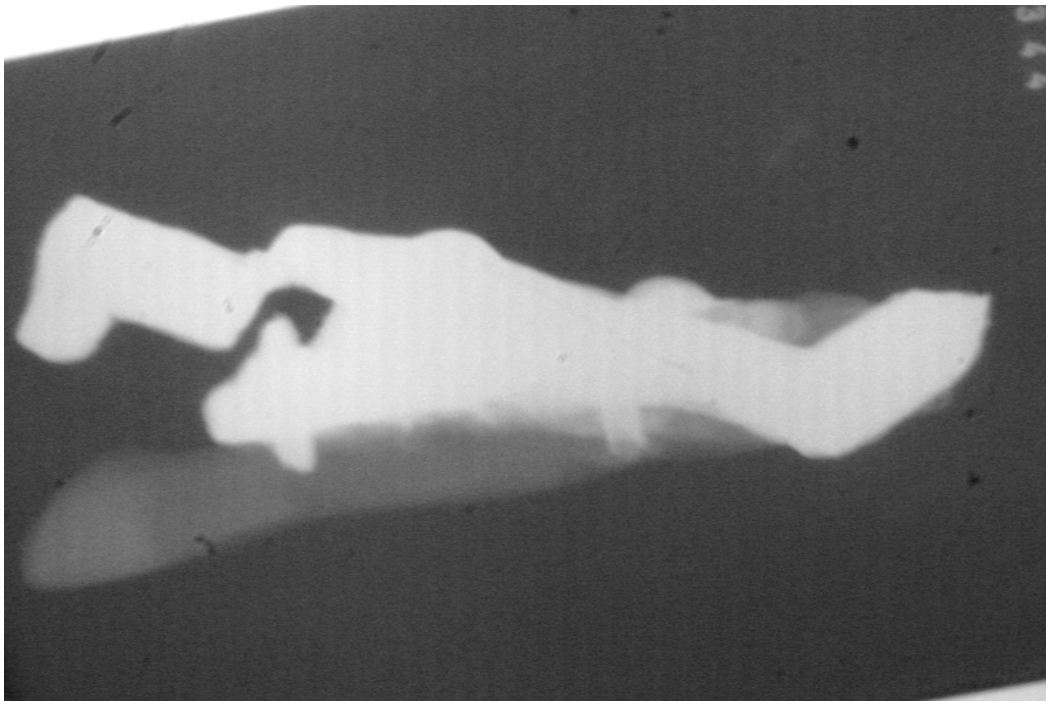
Figure 4: X-radiograph showing relationship between metal and organic components

- The iron is in fairly good condition (a large proportion of metal survives), with few areas showing extensive corrosion.
- Some parts of the wood appear to have been replaced with iron corrosion products, particularly in and around the areas closest to the main mechanism and plate.
- The articulated terminal is indeed broken off (**see figure 5**)

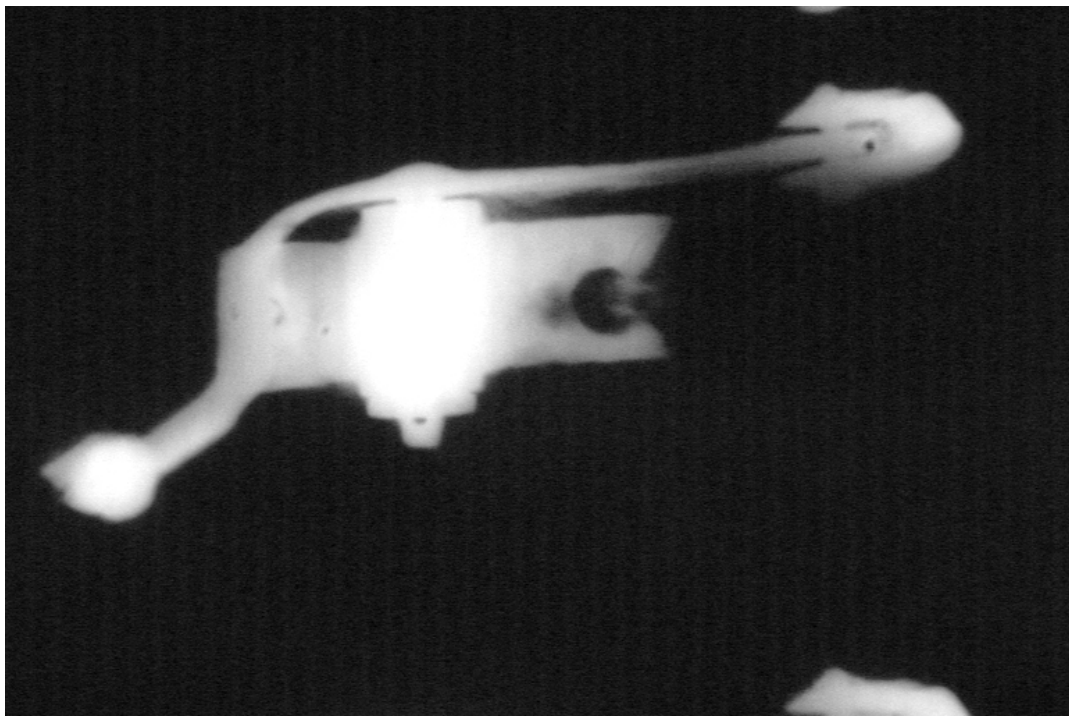
Figure 6: X-radiograph showing shape of iron plate and perforated terminal of barrel-like component

- The iron plate has a straight edge at one end but a deliberate, triangular-shaped opening or cut-out at the other (**see figure 6**)
- Emerging from the centre of the long arm is a short, cylindrical pin or bolt which penetrates or is contained by the barrel-like component. The opposite end of this pin or bolt has what appears to be a deliberate, perforated terminal. It has been suggested to me that this would have been designed to receive a split pin (Chris Underwood, pers comm)

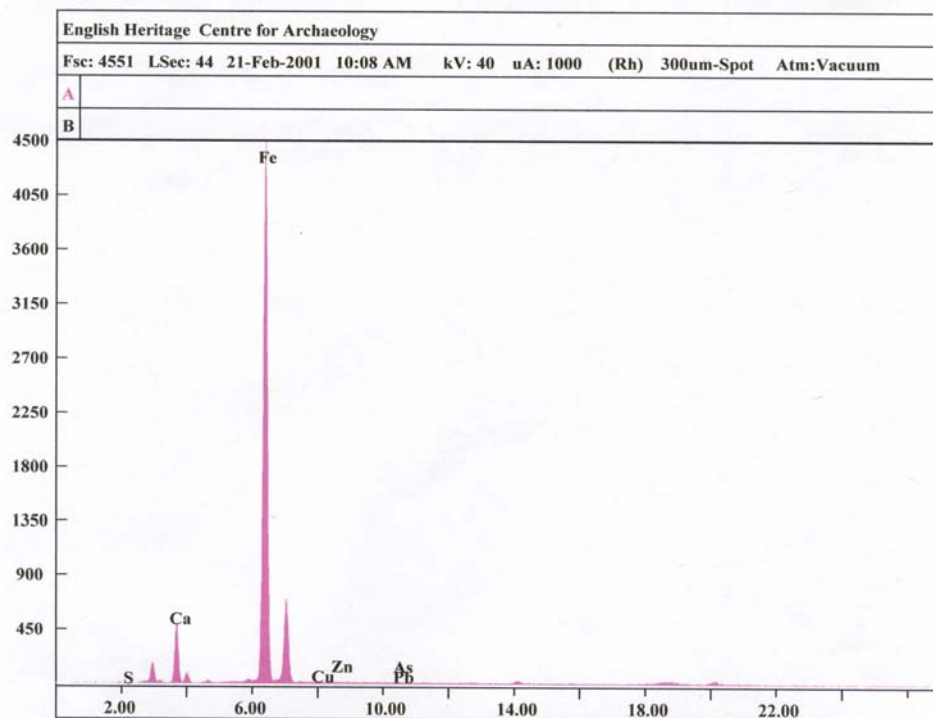
Figure 7: XRF analysis for the outer section of the barrel-like mechanism

Results (see figure 7), however, show that lead is not present in this component (only in trace form) and that it is mostly composed of iron. It is thus more likely to be the density and condition of the metal that is preventing the acquisition of a more informative x-radiograph.

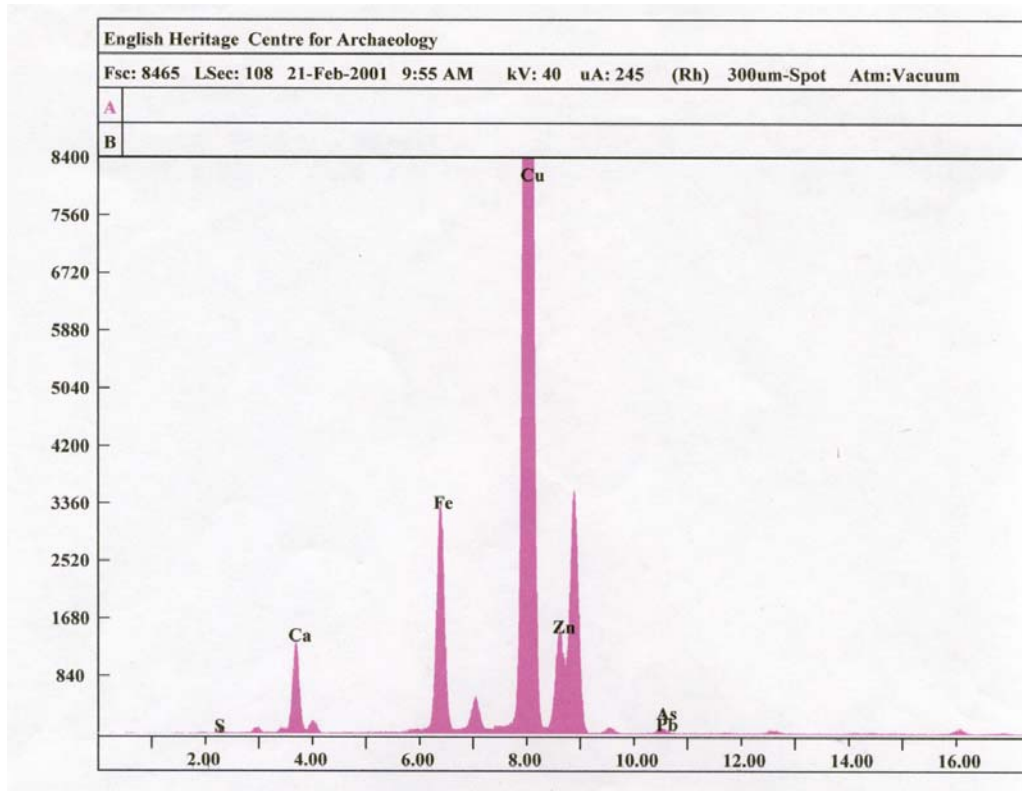
Figure 8: XRF analysis of the Copper-alloy section of the barrel-like mechanism

Further analysis (see figure 8) of the outer section of the barrel-like component with the emerging long, flat 'arm' (where light green corrosion products seem to be forming) detected the presence of a copper alloy (Cu and Zn). This might indicate that parts of this device are made of brass.
