Centre for Archaeology Report 73/2001

# **Report on the Excavation and Survey of Two of the Bomb Craters at Fort Cumberland**

David Fellows

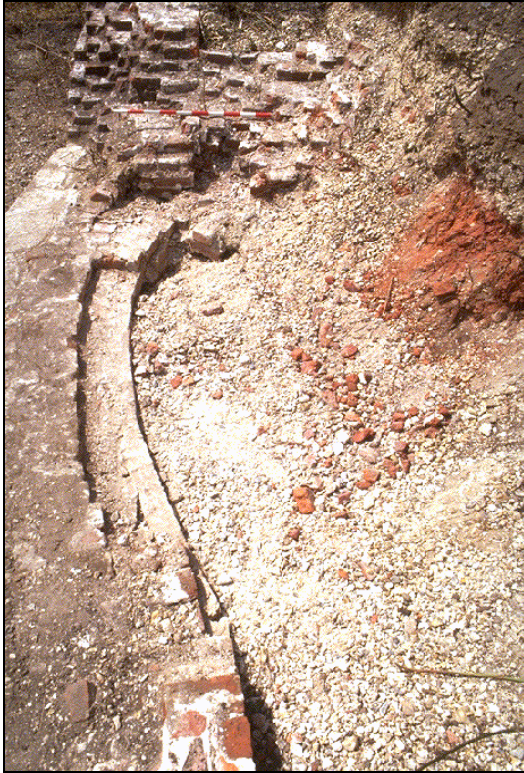
At the upper edge of the crater a roughly constructed and makeshift fence had been erected using a variety of timbers and metalwork, but subsequent movement of the soil had caused this to shift and partially fall into the crater. This movement was a cause for concern, and it was decided that excavation to remove the unstable crater fills would be undertaken to reveal the extent of the damage. It could be seen from within the ditch that a large section of the counterscarp wall had been demolished by the blast and subsequent disrepair, as far down as

the Portland limestone foundation course. The Portland blocks had withstood the damage but had collectively been forced into the ditch as the wall line had buckled (*see figure 3*).

The crater excavations revealed the method of construction of this section of the counterscarp. The extents of the bomb crater exposed three brick walls running perpendicular to the line of the counterscarp wall. This had the effect of compartmentalising the counterscarp outside the inner wall. The space between the walls had been infilled with beach gravel consisting of water worn pebbles of varying size in a sandy matrix.

The separation of the walls varied slightly, with the distance between the northern and central wall being 3.24m, compared to 3.4m between the southern and central walls. The walls were fairly substantial, up to 1.20m in width, and were constructed of red bricks typical of those used at the time of construction of the defences between 1793 and 1812. The bricks and light grey coloured lime mortar used for these walls are very similar to those used in the counterscarp wall. The southern and northern walls survived to the height of the top of the counterscarp whereas the central wall was badly damaged by the bomb and survived to a height of 0.5m above the limestone foundation level.

*Figure 3 Photograph showing the breach in the counterscarp wall and the Portland limestone foundations (formerly a straight wall line) 2m scale*

Following the partial excavation of the fills the gravel ballast was landscaped and raked back. The extent of the damage remains visible and is now safe from collapse, with the gravel covering protecting the bomb-damaged brickwork.

The decision to leave the bomb damage open followed the general philosophical approach that has been used to guide the conservation works around the Fort to date – that is that evidence of the bombing is to be left unless it is causing health and safety problems or structural problems to other parts of the monument. In this case there was the additional problem caused by the distortion of the foundations and the fact that any repair or rebuild would have been very difficult without removing most of the historical evidence.

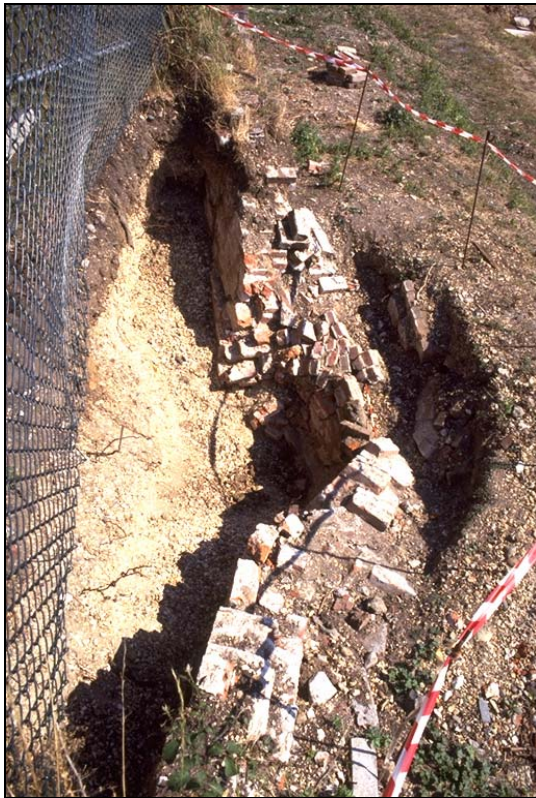
The breach in the wall caused by the bomb measured c.5m in length (*see figure 4*). It was hoped that this length of wall, being the site boundary and for site security, could be rebuilt and the fence line re-established as part of the restoration works. Prior to the investigation, a concrete fence post with a concrete pad from the chain-link fence had been removed from the crater.

The excavation was c.4.5x2.5m in size along the length of the section of damaged walling. The maximum depth excavated was 0.60m below the covered way ground level. The material removed consisted of loose gravel with many red brick fragments as inclusions. The excavation revealed that the brickwork of the wall had been very badly damaged and had broken into sections. The upper sections had been blasted over a metre through the covered way make up material, with the lower less-damaged sections buckling badly and being forced up to 0.8m out of alignment. The brick sections had also slumped towards the centre of the area damaged by the bomb.

*Figure 4 Photograph showing the bomb damage to the parapet wall of the covered way*

It was decided that the brickwork was too badly damaged and had moved too far out of line to enable the wall to be rebuilt, and so the excavation was stopped and the archaeology recorded. The chain-link fence line was re-established using clay packing around a concrete post, and the crater was backfilled to the level of the covered way.

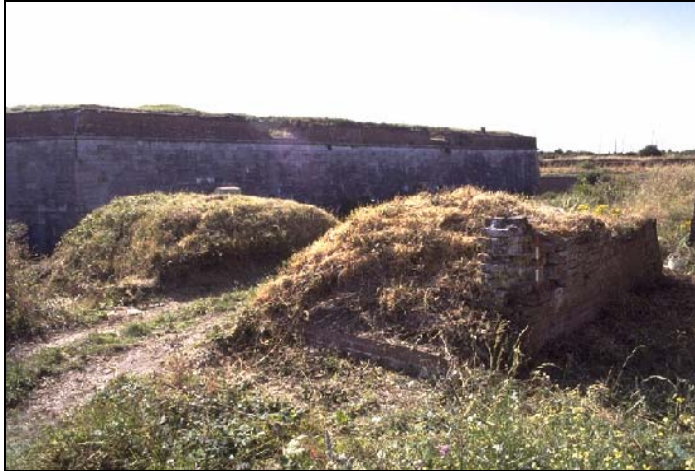
Following the clearance of the vegetation, the northern of the two traverses on the counterscarp was seen to be in a very poor state of repair. A path had been established along the top of the covered way, and this cut through the middle of the traverse. Rubbish had subsequently been used as infill against the traverse brickwork.

*Figure 5  
Photograph showing  
the condition of North  
Traverse following  
removal of overlying  
debris and vegetation  
(1m scale)*

No further work has been undertaken on the repair or consolidation of this traverse, although the long-term intention is to re-construct the original form. The timing for this is dependent on the stabilisation of the brickwork on the ditch side for which proposals have been worked up but are yet to be implemented.

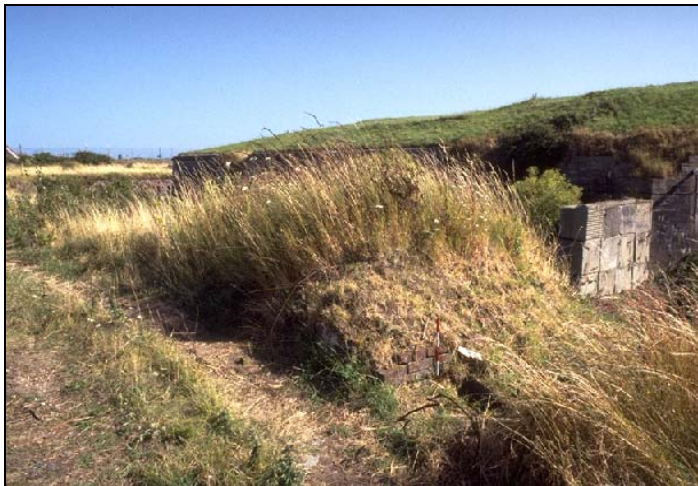
Short upstanding lengths of brickwork were all that survived of the southern traverse. The pathway along the top of the covered way cut through the traverse, and most of the earth infill had been removed. The remains of the traverse were recorded, photographed (*see figure 6*) and surveyed.

*Figure 6  
Photograph showing  
the condition of the  
South Traverse prior  
to restoration  
Work (1m scale)*

Removal of the vegetation and limited excavation revealed the footings of the dismantled lengths of walls, and this evidence was used in conjunction with a study of the more complete examples elsewhere on site to enable an accurate reconstruction of the traverse to be undertaken (*see figure 7*).

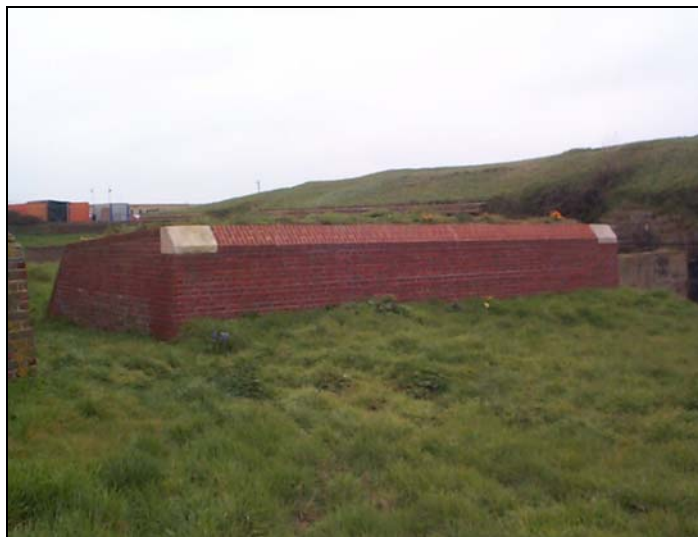
*Figure 7  
Photograph showing  
the South Traverse  
following restoration  
work*

The partial excavation and survey of the traverses have enabled the accurate reconstruction of the southern traverse to be undertaken (*see figure 7*) and the pre-consolidation state of the traverses to be recorded. This work has been added to the digital record that has been compiled of Fort Cumberland and will be available for future reference and use.
