Centre for Archaeology Report 75/2001

## **Report on the Survey of the Hospital Complex at Fort Cumberland**

David Fellows and Patrick O'Hara

### **Summary**

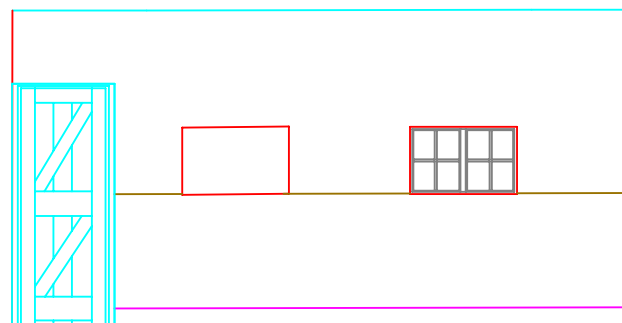
east elevation

The eastern elevation had a planked door at its northern end giving external access, and had two metal-framed casement windows, each with sixteen lights in two frames (see **figure 16**). These were replacement windows within the openings for the original larger windows. The original brick segmental-arched headed openings measured 1.30 x 1.10m (4ft 3"x 3ft 7").

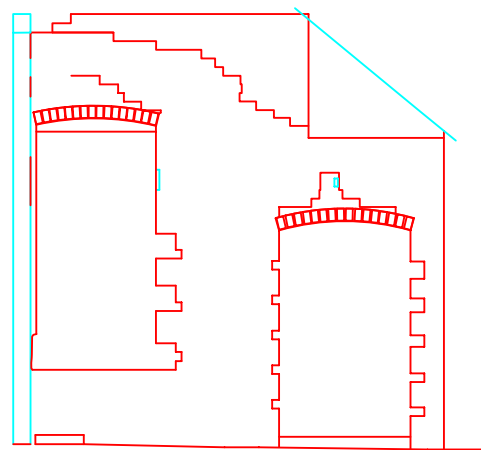
north elevation

In the northern elevation of the existing Passageway there is a blocked window and a blocked door. At the eastern side there was also the roofline for the post-Second World War damage repair (see **figure 17**).

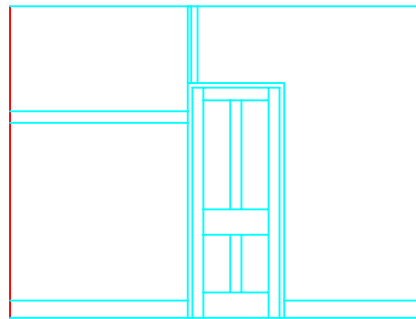
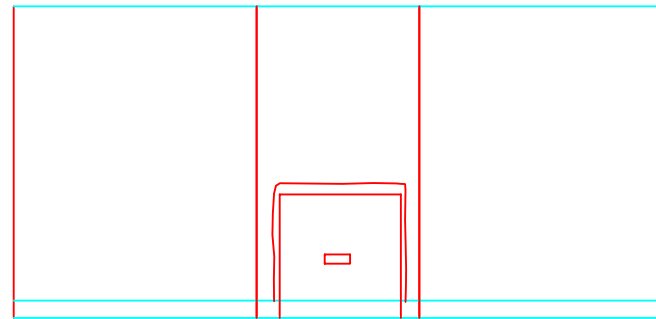
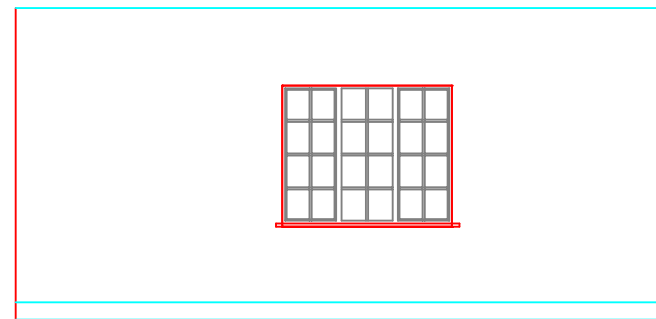
Figure 18 Internal Elevations of the Surgery

Following the Second World War bomb damage, the building was demolished and the present building replacing the Surgery was constructed. This structure was very plain, with access from the Passageway to the north. There was a metal-framed window on the eastern elevation and in the western elevation there was a disused fireplace, the opening of which had recently been plastered flush to the wall face. Internally the room had been dry-lined and painted (see **figure 18**).
