Centre for Archaeology Report 76/2001

## **Report on the Survey of the Cookhouse at Fort Cumberland**

### **Summary**

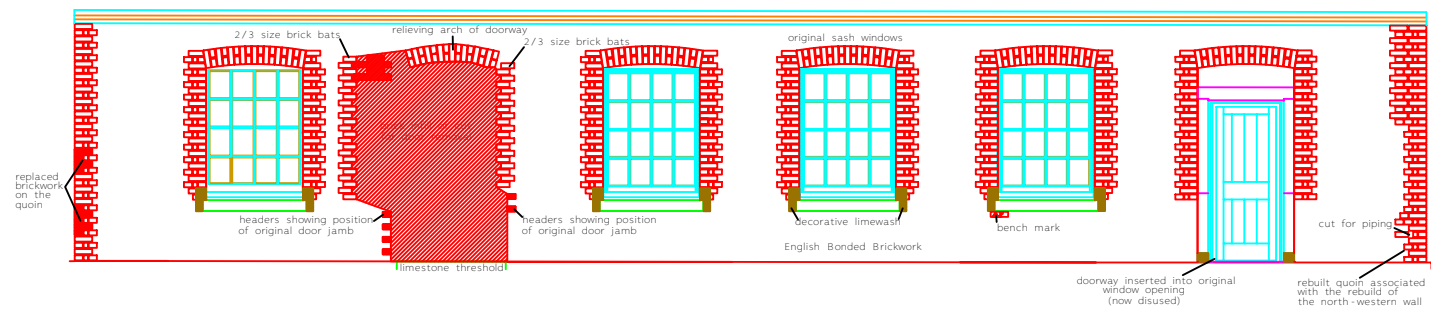
Figure 2 Survey Drawing of the North East External Elevation of the Cookhouse

The 1861 plan of the Fort shows the Cookhouse as a simple rectangular structure without internal divisions or external additions (see figure 8 of the Conservation Plan, Roebuck 1998). On the plan of the Fort dating from 1886 a rectangular structure had been added to the north-eastern corner of the building (see figure 10 of the Conservation Plan, Roebuck 1998). This may have been a porch corresponding to the disused doorway seen in this position (*see figure 2*).

The door has been blocked with bricks of a very similar nature to those used to construct the rest of the building, and it is very difficult to establish the extent of the removal cut. Following the coursing pattern in the expanse of brickwork that contained the door, it was possible to establish the position of two vertical lines of brick headers that appear to have remained undisturbed and thus indicate the positions of the door jambs. Also of interest on either side of the door there were two vertical alignments of two-thirds brick bats, and these appear to indicate the position of the extents of the bricks that surrounded the door that it was necessary to remove prior to blocking the door (*see figure 2*).

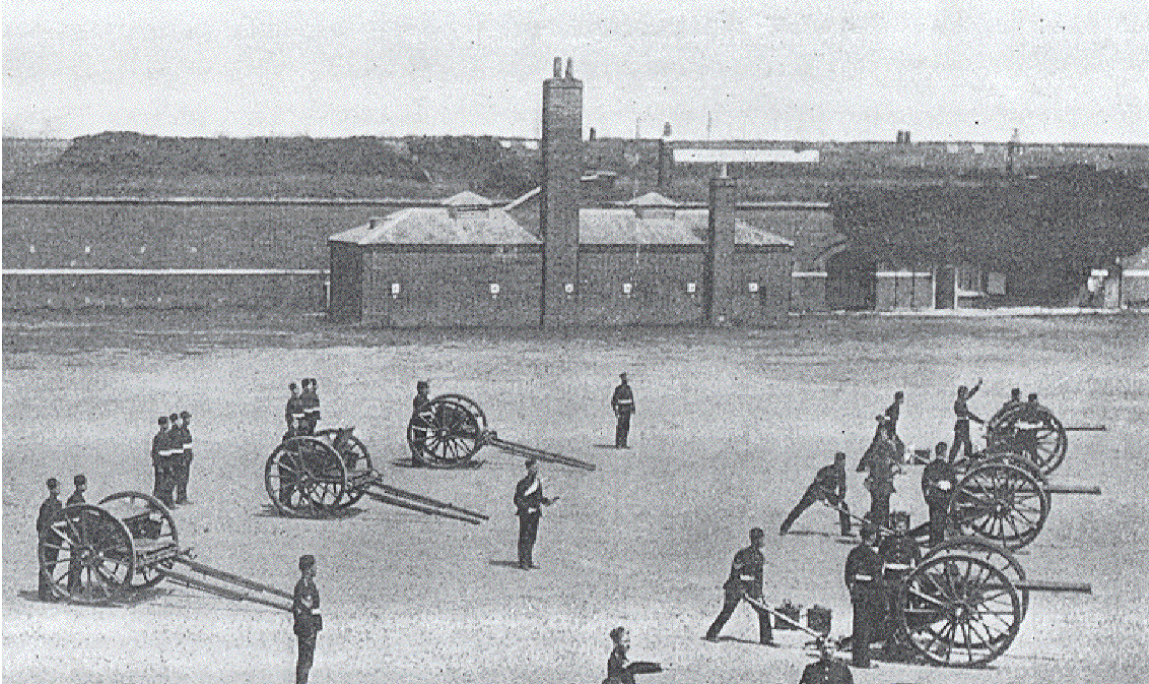
*Figure 3: Photograph showing Cookhouse with roof louvres and northern dormer clearly visible*

**Figures 3 and 4** show the building to have two chimneys along the south western wall, one slightly to the north of centre and towering above the building (at least twice its height), the other smaller and situated towards the southern end of the wall. The sash window that still survives is shown on the south-eastern end wall of the building. The roof appears to be slate

covered, is hipped in style, and has two lantern louvres along the ridge. Visible on the roof hips are small dormer windows. The survey evidence for these is recorded in Section 3 - The Roof.

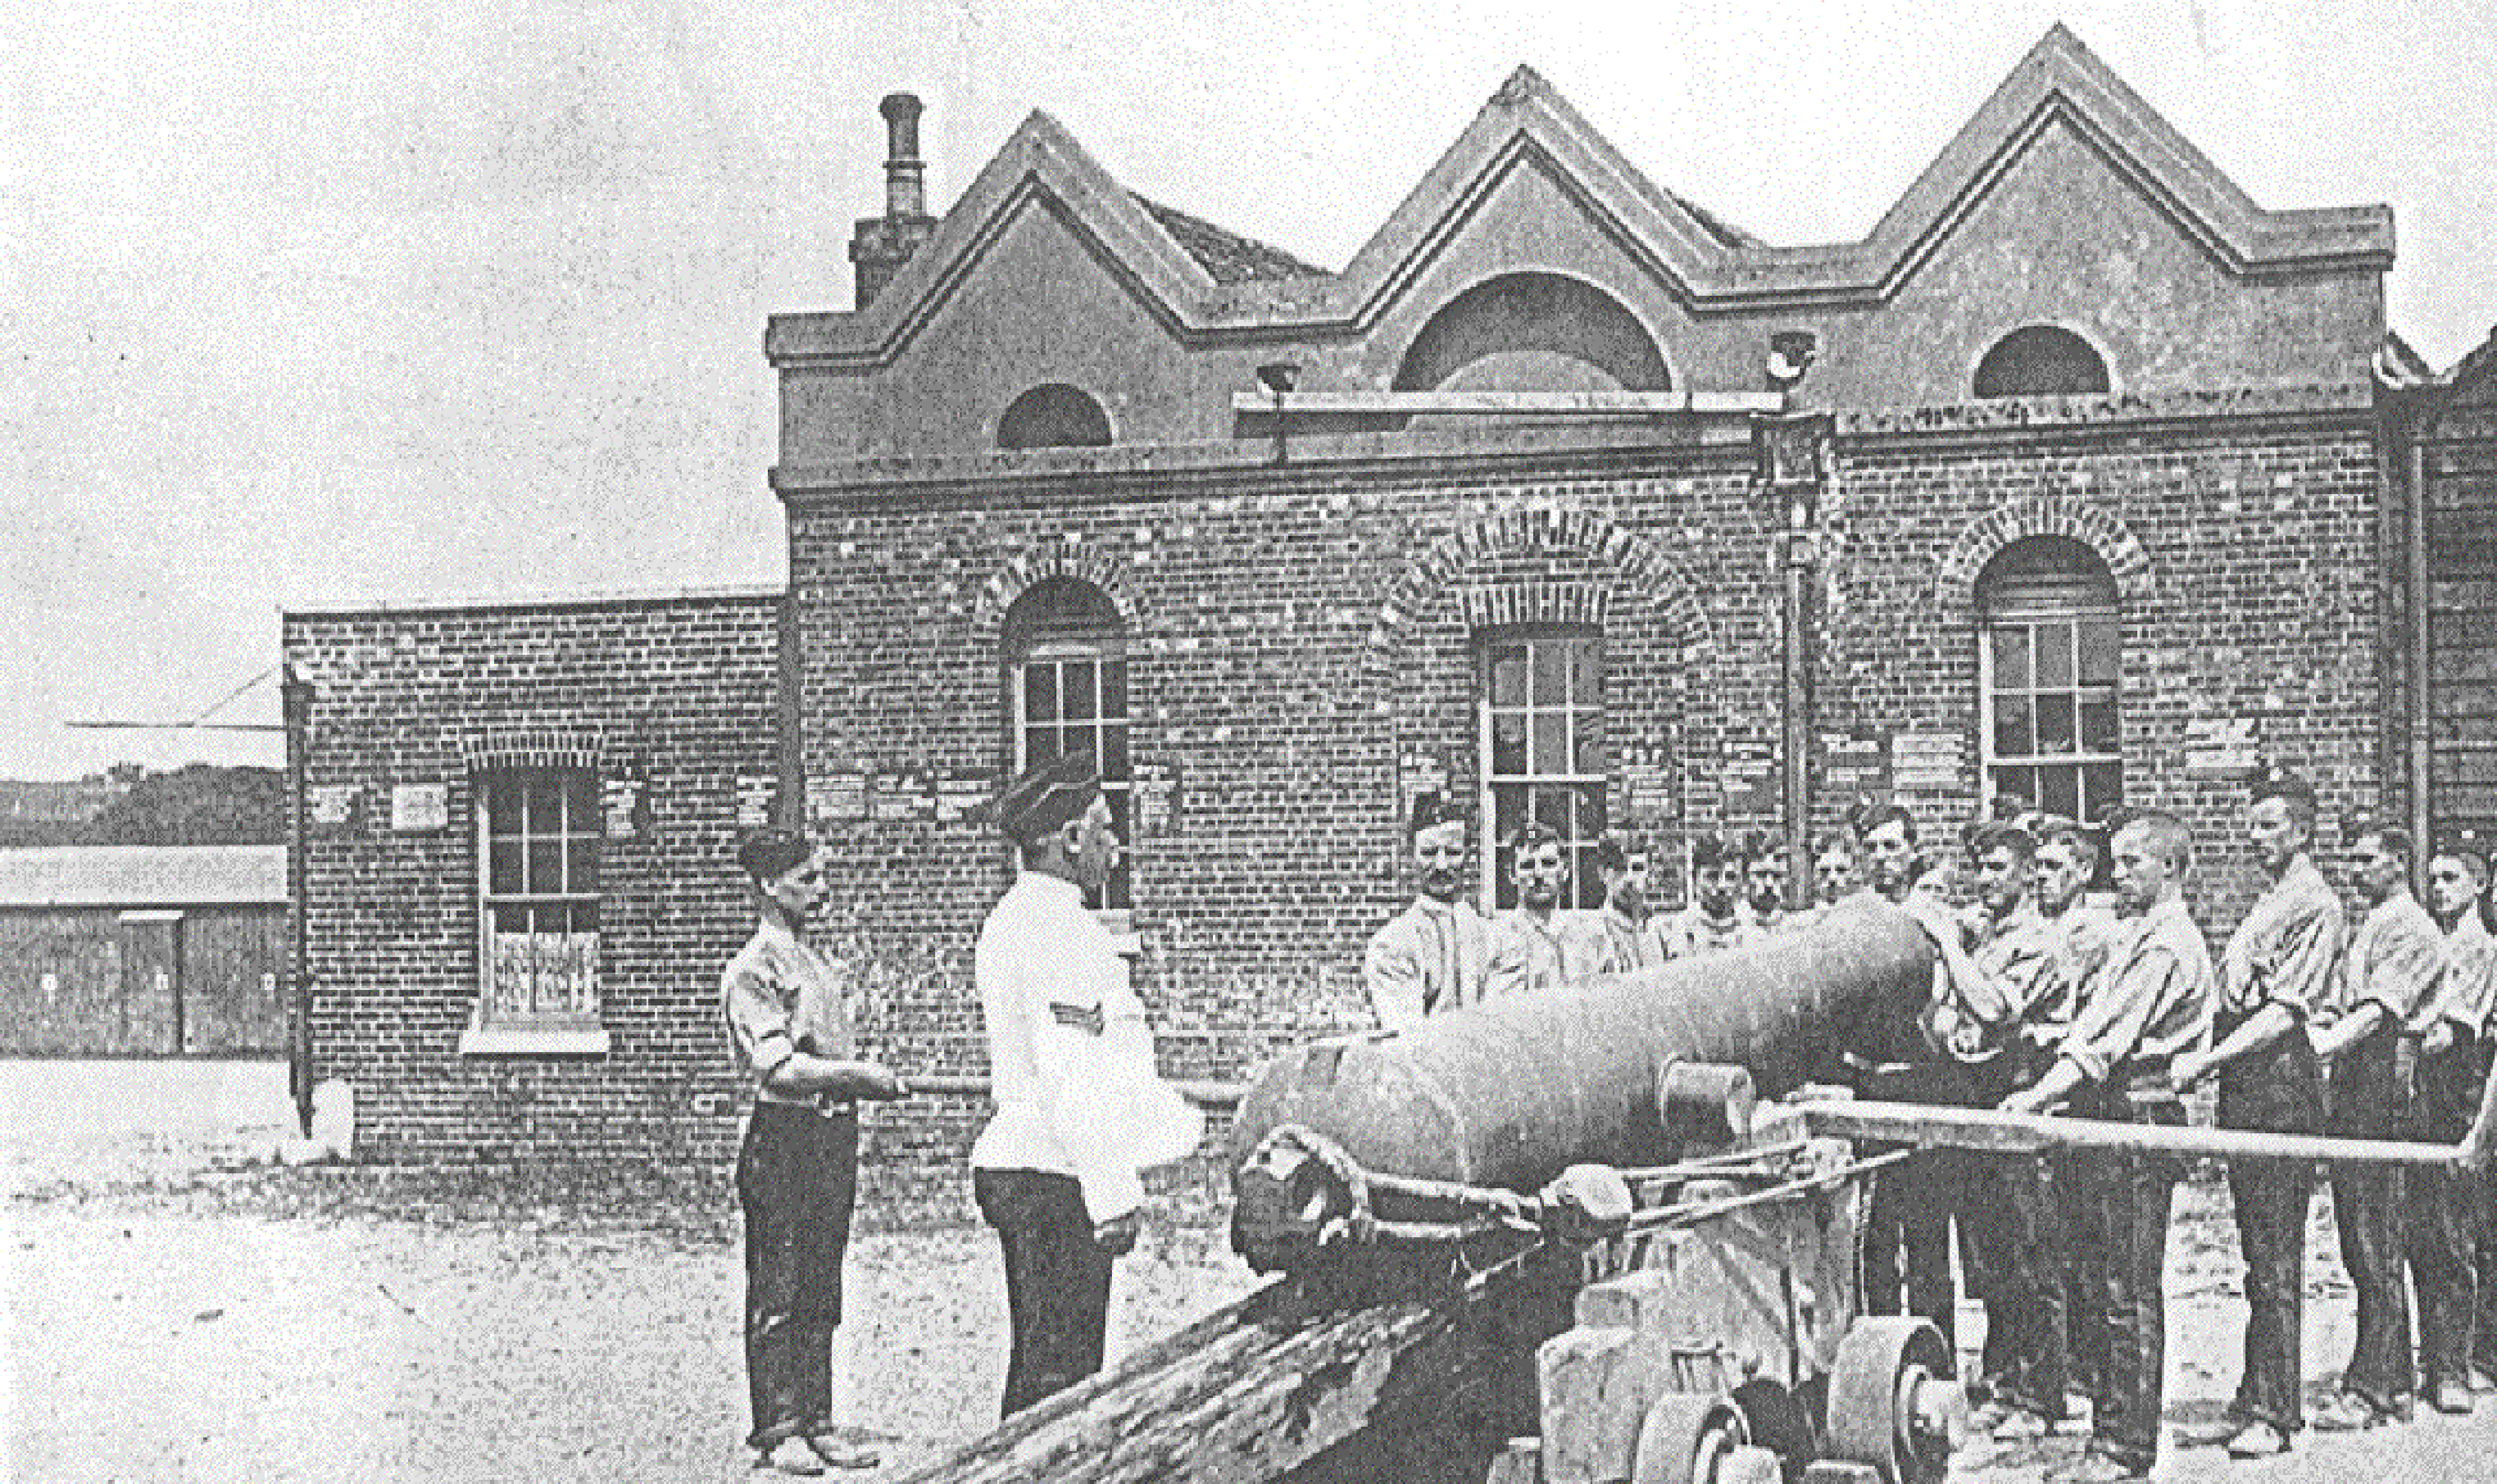
The final photograph of the sequence, **figure 6**, shows the results of the repair work, and reveals a building in a very similar state to that surviving today. The chimney visible on the photograph has been capped with a coping stone, and the re-tiled roof no longer has the louvres or dormers.

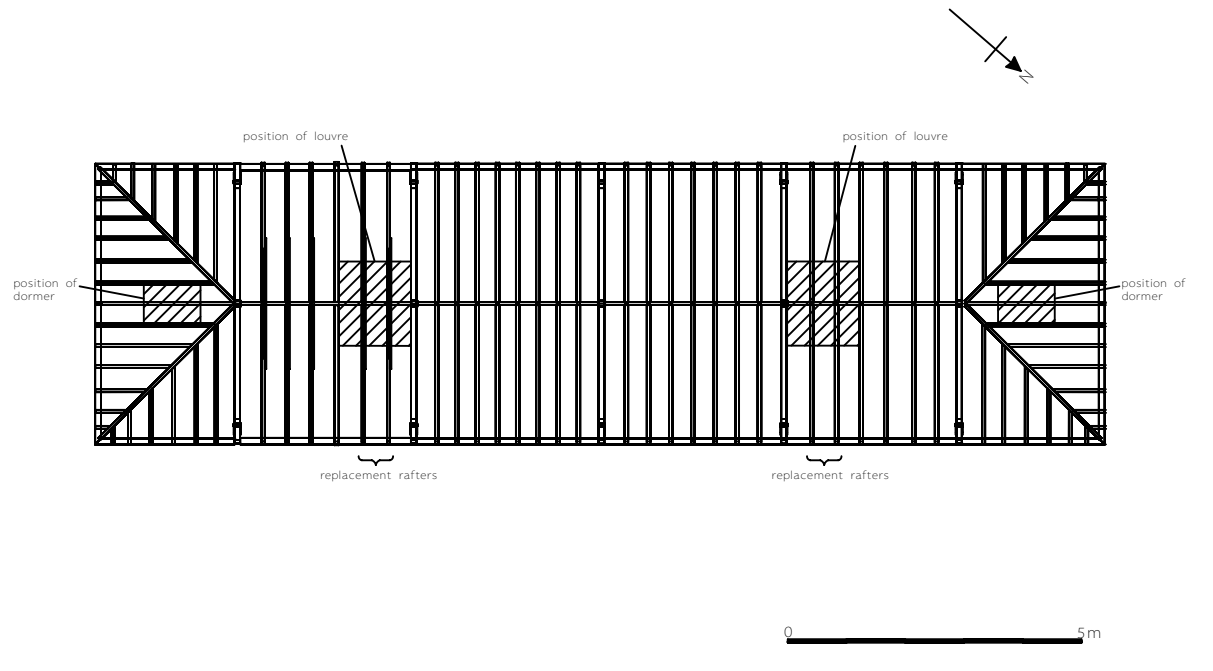
Figure 6: Projected Plan of Cookhouse Roof

The Cookhouse roof is a simple king-post structure with hipped ends. The roof is c.17.15m long in six bays and spans a width of c.4.5m. One bay at either end forms the hip of the roof (*see figures 9 and 10*).

Located in the second bay from the south-eastern end of the roof was an interesting arrangement of replaced common rafters. The two sets of common rafter pairs to the south-east of the second truss consisted of less substantial timbers than the other visible common rafters (0.10 x 0.05 cf. 0.12 x 0.05m, 4 x 2 cf. 4: x 2 inches) and were not notched to accommodate the wall plate. The next set of rafters were more substantial (0.15 x 0.075m, 5φ x 3 inches), and on each was a mortise. These had corresponding mortises in the principal rafters in the roof truss to the north-west. The location of the mortises and the separation of the truss and rafters formed an opening measuring c.1.25m square, initially perplexing but solved by the early photographic evidence described above (1.2.2). The space had originally been a louvre through the roof, and it had been dismantled when the building was reorganised in the early years of the 20<sup>th</sup> century. The two sets of less substantial common rafters could not have coexisted with the louvre structure as they were between the mortise positions, and so were obviously part of the repair to the roof prior to reinstatement of the tiles following the removal of the louvres. The photographic evidence shows a second louvre in the corresponding position to the north although the intact ceiling boarding meant evidence for this was not accessible.

The photographs also show a small dormer window in the hip of the south-eastern bay of the building. Evidence for this was located during the survey in the form of two angled notches into the common rafters on either side of the central ridge piece of the hip. The timbers forming the dormer sat in the notches and were nailed to the rafters, the nails still being
