**BARN AT MANOR FARM  
HALESOWEN ABBEY  
WEST MIDLANDS**

INVESTIGATION OF THE REMAINS OF THE SOUTH  
AISLE AND CLOISTER OF THE ABBEY CHURCH

Research Department Report Series 64/2006

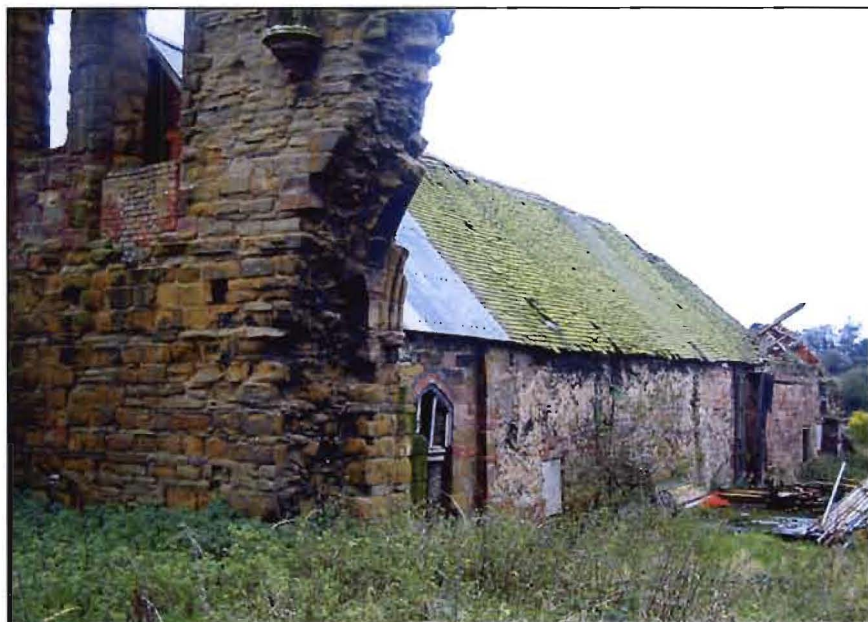
**Figure 1.**

*The barn viewed from the north east, with the south transept of the abbey church in the foreground. [DP021006]*

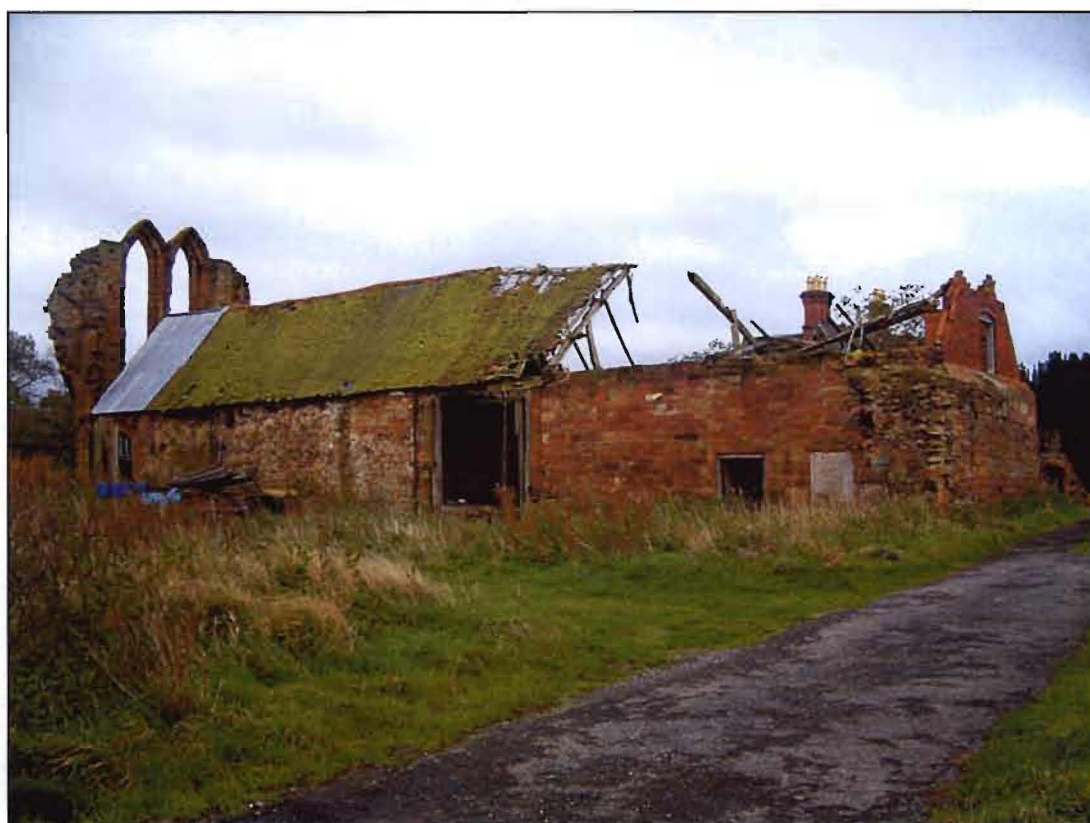
**Figure 2.**

*The barn viewed from the north west, showing the diverse range of materials used in its construction. [DP021007]*

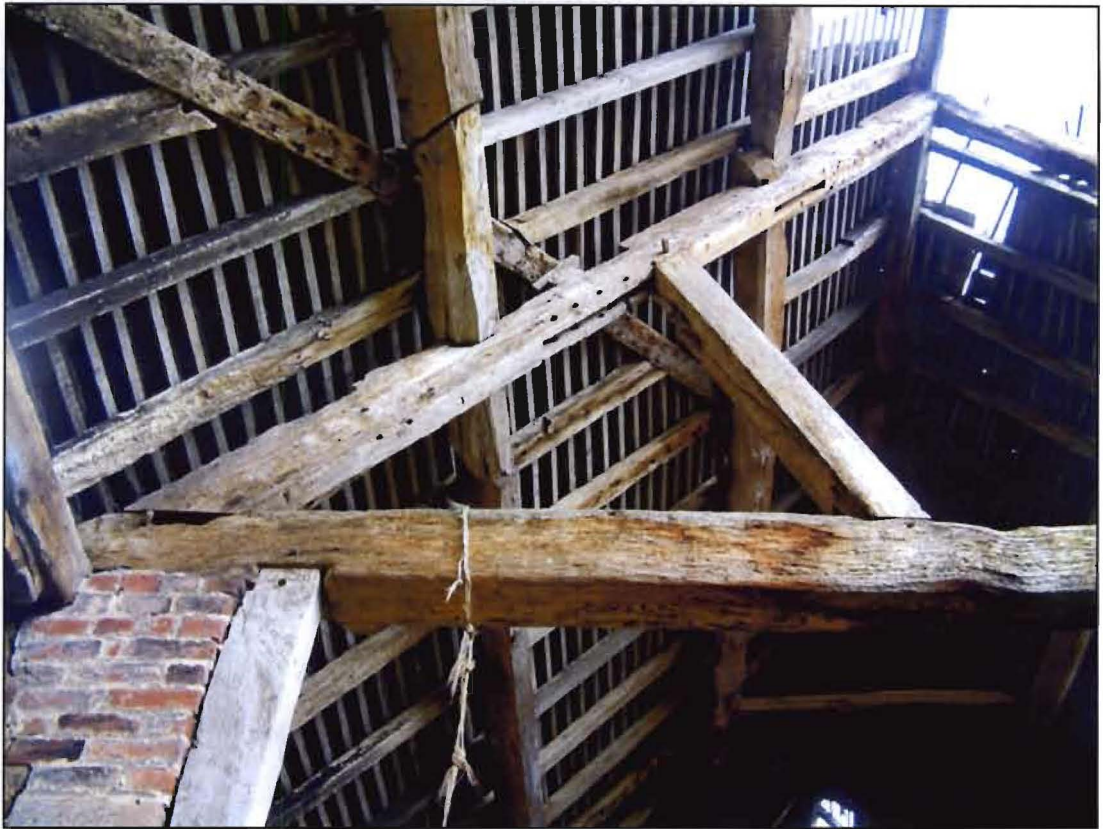
**Figure 3.**

*Detail of the roof structure, showing the truss on the east side of the cart entry. Note the reused timber forming the principal rafter. [DP021008]*

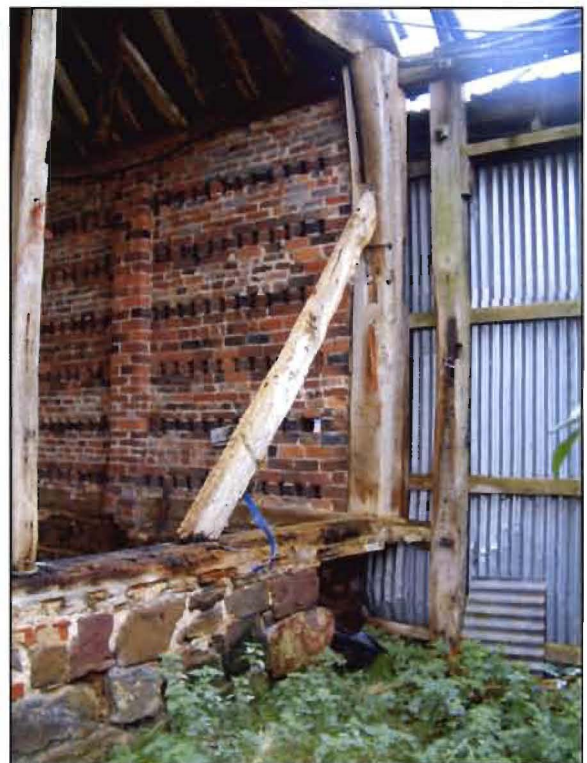
**Figure 4.**

The barn is partly floored to give a two-storeyed arrangement, principally toward the eastern and west ends, and has a central section, with opposed cart doors, that is of a tall single storey open to the roof. The barn has a long roof of gabled form, which has a covering of plain tiles, with an area of corrugated iron used at the east end. The western end of the roof has collapsed, and much of the central part is in a perilous condition.

*Detail of reused timbers in framing of the barn. Interior of cart entry, viewed from north west. [DP021009]*

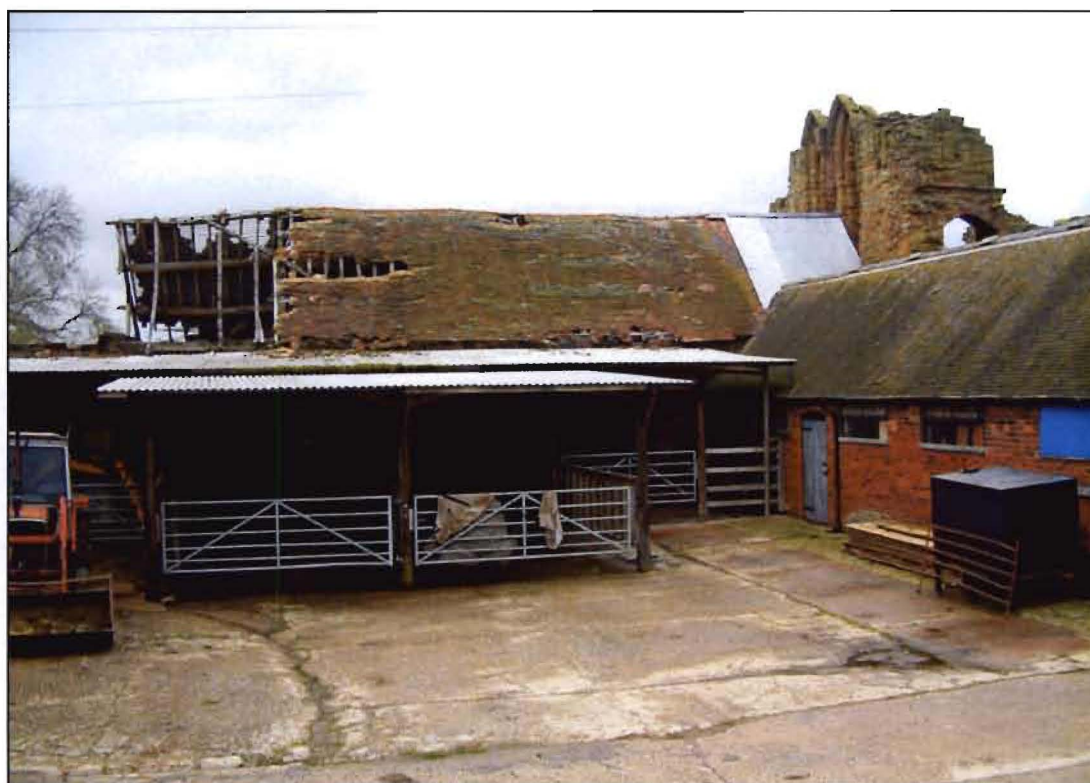
**Figure 5.**

*The barn and brick-built east range, with the south transept beyond. Viewed from south. [DP021010]*

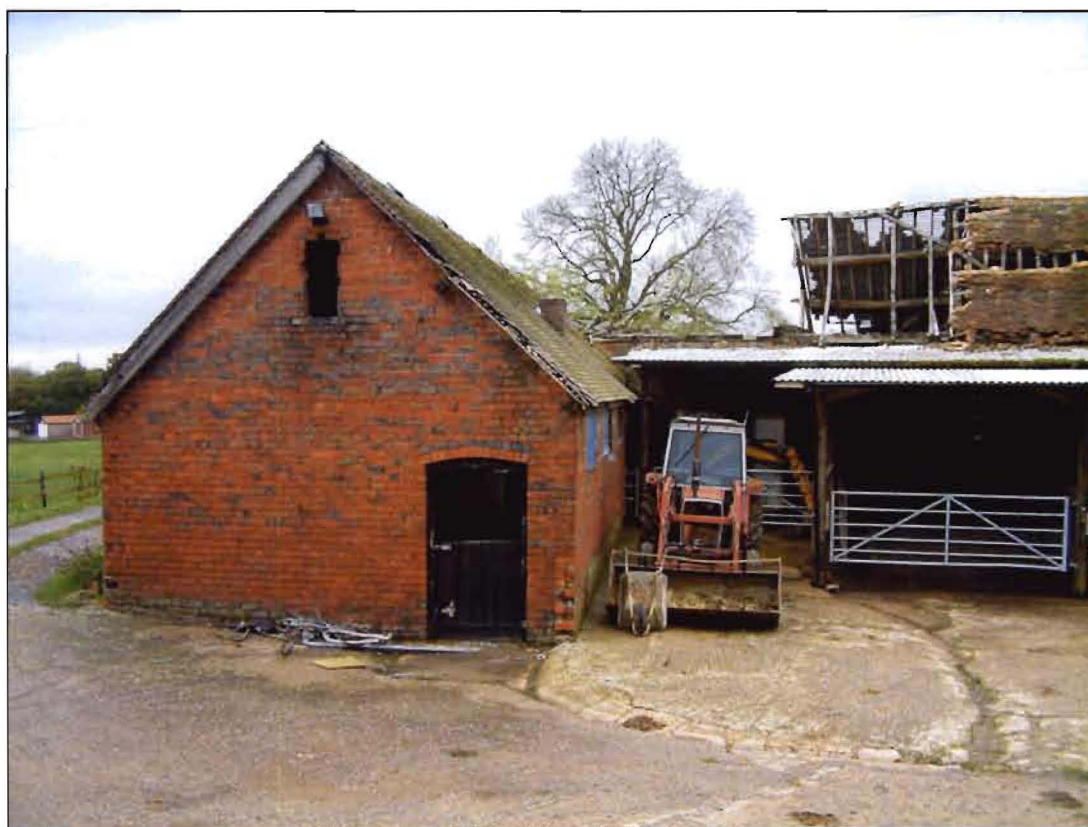
**Figure 6.**

*The west range, viewed from the south. [DP021011]*

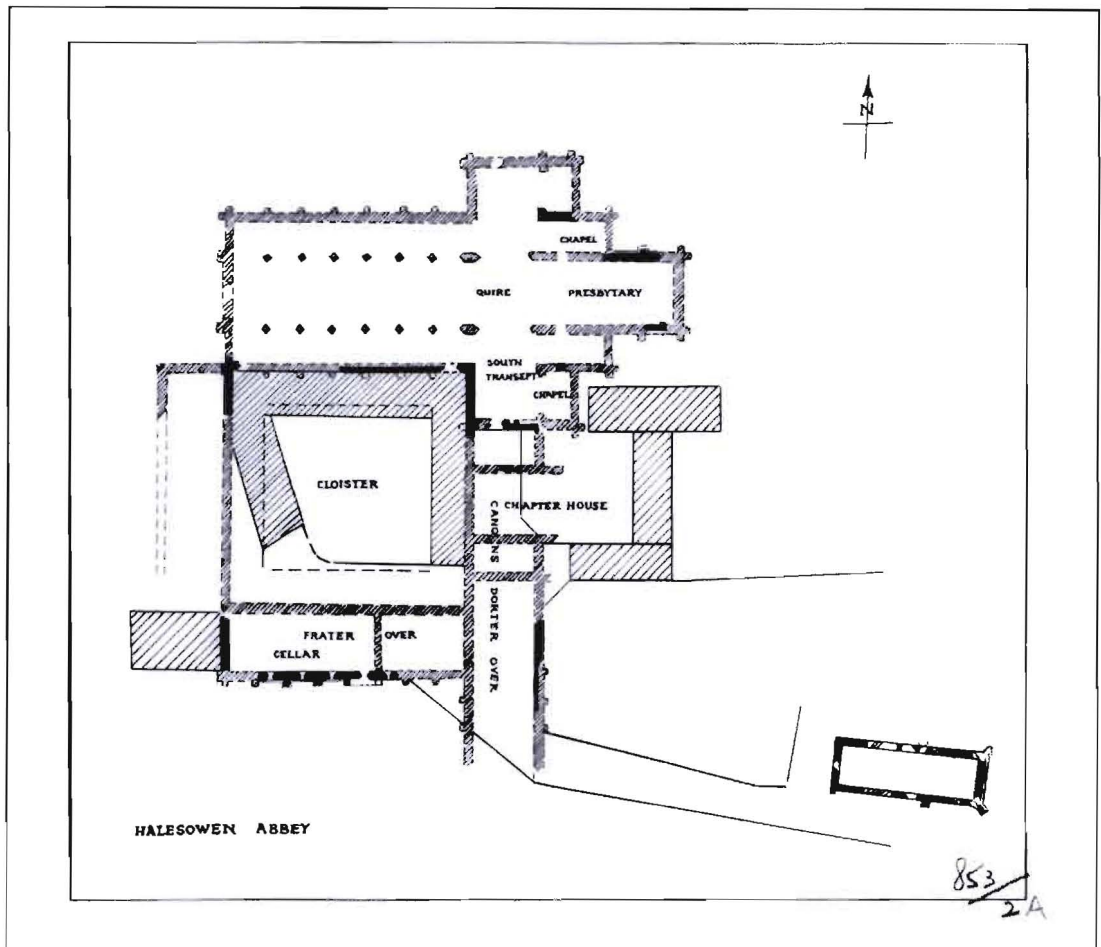
**Figure 7.**

Nevertheless, the NMR and Brakspear plans omit to show remains in the barn's north wall, to the west of the cart entry, where elements of the aisle's south wall survive at low level. These elements have been added to an amended version of the NMR plan, to show the full extent of the remaining in-situ medieval fabric incorporated within

*Undated plan of Halesowen Abbey held at the National Monuments Record (EH plans room reference: 853/2A). The extant masonry is shaded in solid.*

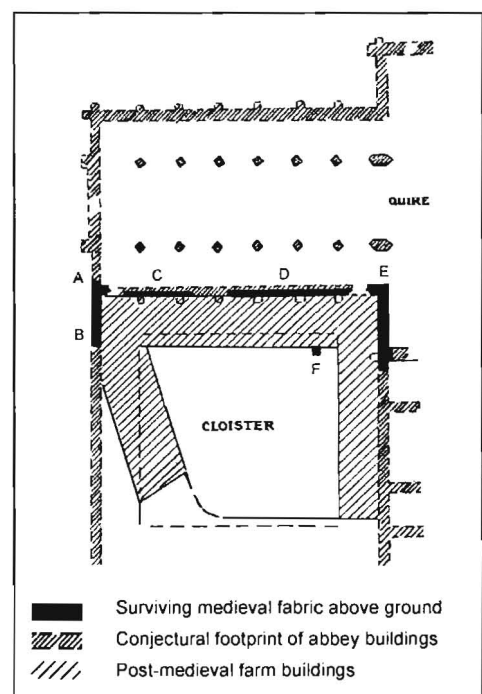
**Figure 8.**

the barn (see figure 8). In addition, the south wall incorporates a substantial stone buttress (at 'F' on figure 8) that may be of early origin, although whether or not this is medieval is unclear. The buttress does not relate to the post and truss construction of the barn's south wall, and therefore may have been retained from an earlier structure. If it formed part of the claustral buildings, its position dictates that it would have formed part of the south wall of the cloister's north range.

*Amended extract from the NMR plan of Halesowen Abbey, showing the extent of surviving fabric incorporated into the barn as at November 2005.*

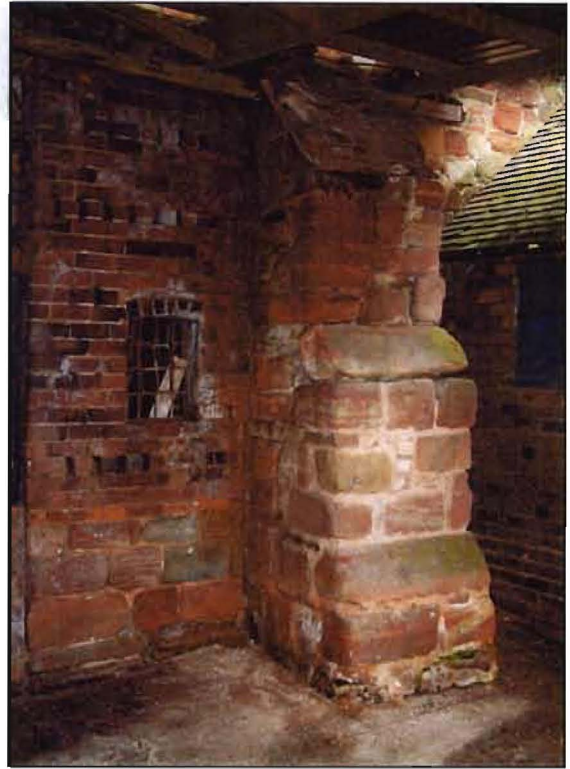
**Figure 9.**

*The buttress adjoining the south wall of the barn. Viewed from south west. [DP021012].*

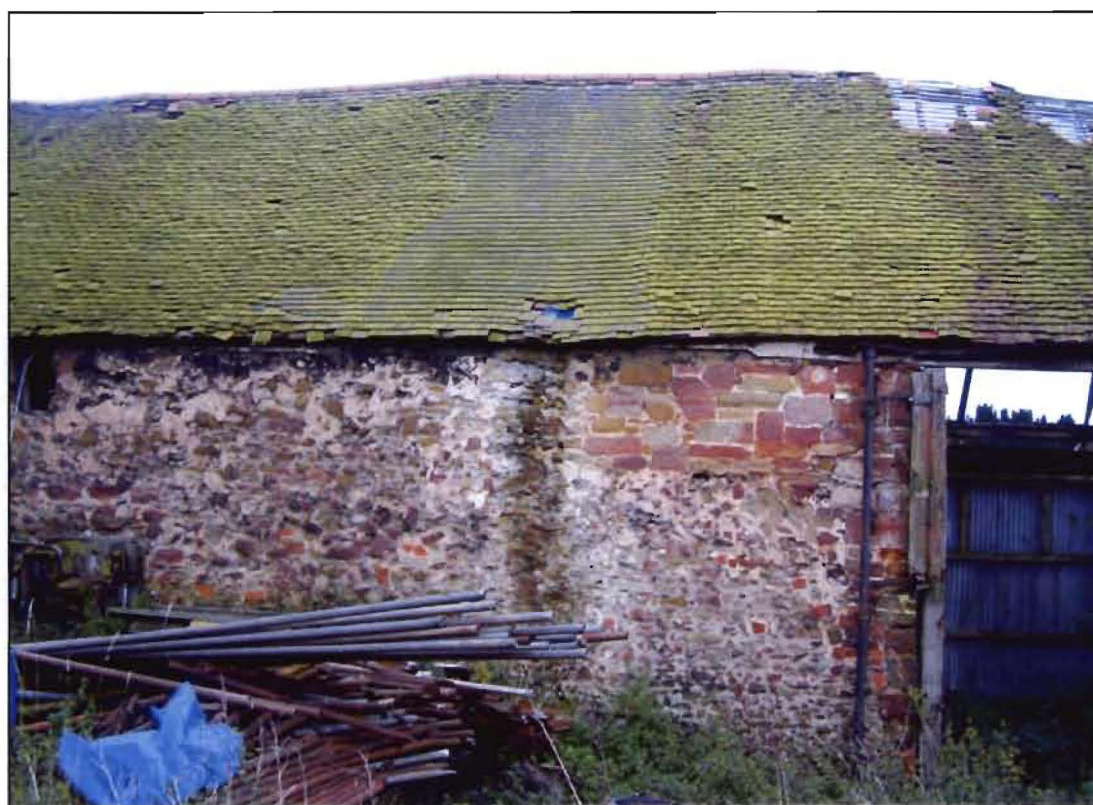
**Figure 10.**

Detailed inspection of the barn's north wall reveals that the extent of in-situ medieval masonry from the south-aisle wall is considerable, especially in the area to the east of the cart entry (identified by letter 'D' on figure 8). In this area the medieval wall survives almost to the height of the eaves of the barn. The wall in this position is treated differentially on the external and internal elevations, with exposed, random, sandstone rubble visible externally (on the north face of the wall) and better-quality stonework, with dressed, coursed, sandstone blocks used on the internal wall face, to the south. This contrast would be unexpected in a barn derived from a single build, in which case the better-quality stonework would be expected to occur on the external wall face, where it would be most visible and provide protection from weathering. The

*The north wall of the barn, viewed from the north, showing rubble construction, with ashlar and random-brick patching. [DP021013]*

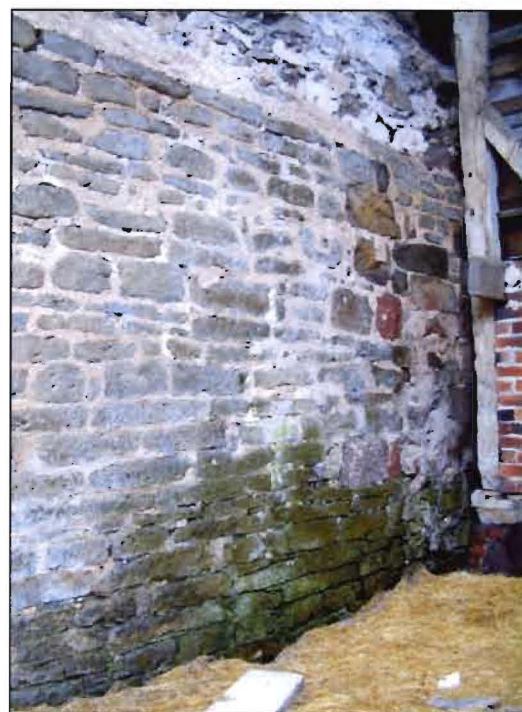
**Figure 11.**

*The north wall seen from within the barn. Note the vertical scar to the left of the timber post. Viewed from the south west. [DP021014]*

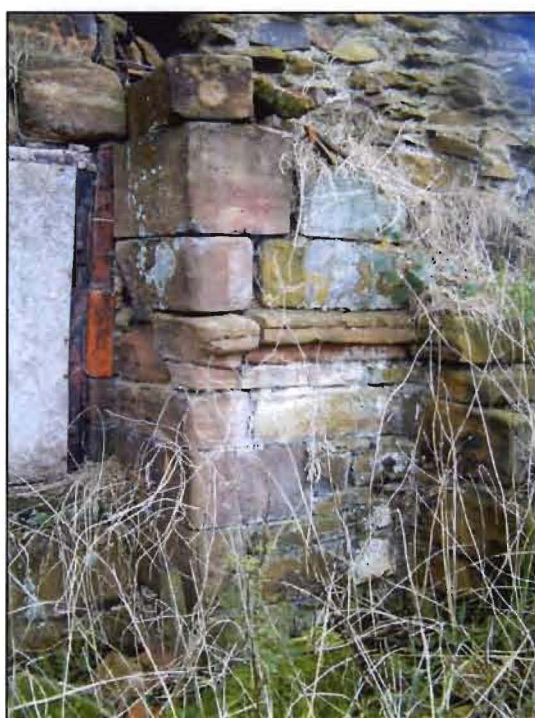
**Figure 12.**

*The north face of the south-aisle wall showing the original moulded string course. Viewed from the north east. [DP021015]*

The exposed rough rubble found on the north face of the barn's north wall, to the east of the cart entry, is probably medieval core walling (with some areas of consolidation) left exposed after the ashlar skin has been robbed out. This interpretation is supported by a chance survival associated with the western claustral doorway (to the left of C on figure 8). At this point, to the west of the doorway, a fragment of the original north face of the aisle wall has survived intact, in conjunction with a surviving piece of the aisle's west wall (described below). Here, the western jamb of the claustral doorway survives in conjunction with ashlar masonry forming the in-situ south-west corner of the aisle. This is built of pink and ochre-coloured ashlar sandstone, with a pink sandstone string course that

returns at the corner. The string course, which is moulded, terminates at the original door reveal, where the last stone of the string is integral with the masonry reveal. There is a 0.35-metre set back between the north face of this ashlar masonry (the northern face of the aisle's south wall) and the remainder of the barn's northern wall face. This setback measurement would allow for an outer skin of ashlar masonry to have faced the wall, concealing the rubble stonework and producing a wall surface compatible with those found on the in-situ walls of the abbey-church ruins. A corresponding set back occurs at the east end of the wall, at high level, where a fragment of the aisle's original internal wall face survives attached to the pier at the angle of intersection between the south transept and the south aisle (at 'E' on figure 8).

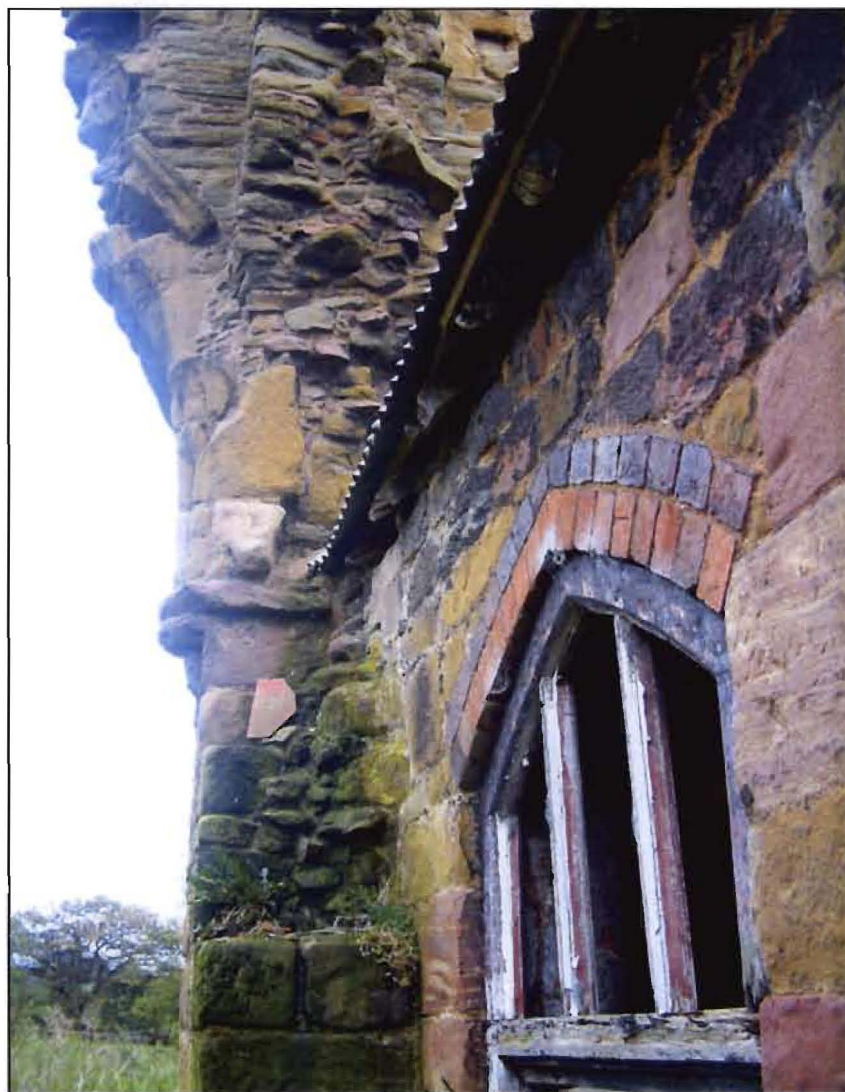
**Figure 13.**

*The pier at the intersection between the south transept and south aisle, showing fragments of the aisle wall at high level (centre) and towards the bottom left of the photograph. This shows that the original alignment of the aisle's northern wall face stood forward of the north elevation of the barn (right). Viewed from west. [DP021016]*

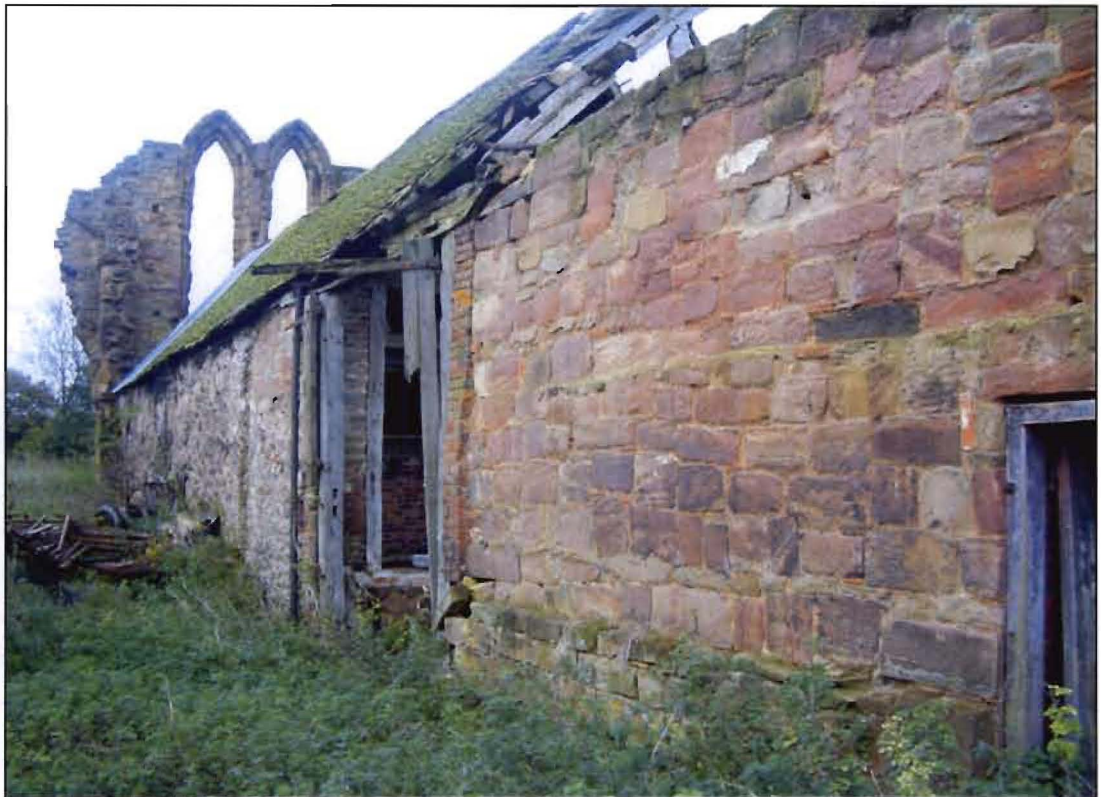
**Figure 14.**

This evidence, therefore, determines that an area of red/pink sandstone ashlar in the barn's north elevation, to the west of the cart entry (at 'C' on figure 8), is not original in-situ wall face, but is a post-medieval facing of reused stones. It is interesting that an engraving by Samuel and Nathaniel Buck, titled *The east view of Halesowen Abby* and dating from 1731, shows that the north face of the south-aisle wall was marked by a series of six, arched profiles that appear to be the outline of the aisle vault.<sup>31</sup> There is no longer any evidence of these features. The engraving omits to show the barn roof, either as a deliberate means of romanticising the ruins or perhaps because it is concealed, conveniently, by undergrowth sprouting from the top of the adjoining transept wall.

*Reused ashlar on the north wall of the barn, to the west of the cart entrance. Viewed from north west.  
[DP021017]*

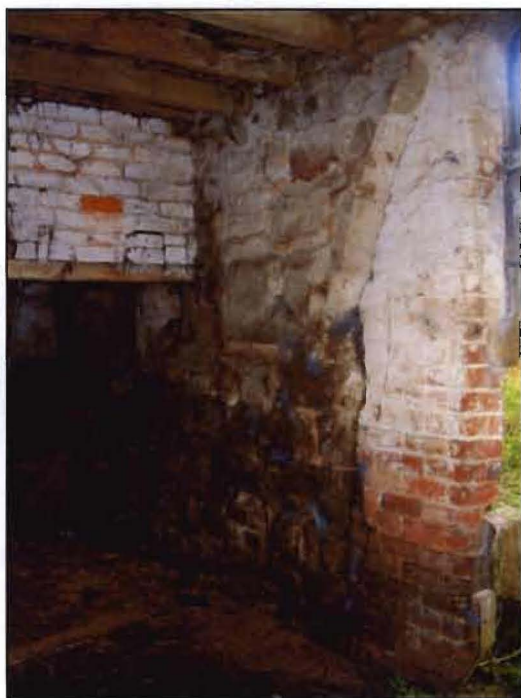
**Figure 15.**  
*The eastern claustral doorway, viewed from within the barn. [DP021018]*

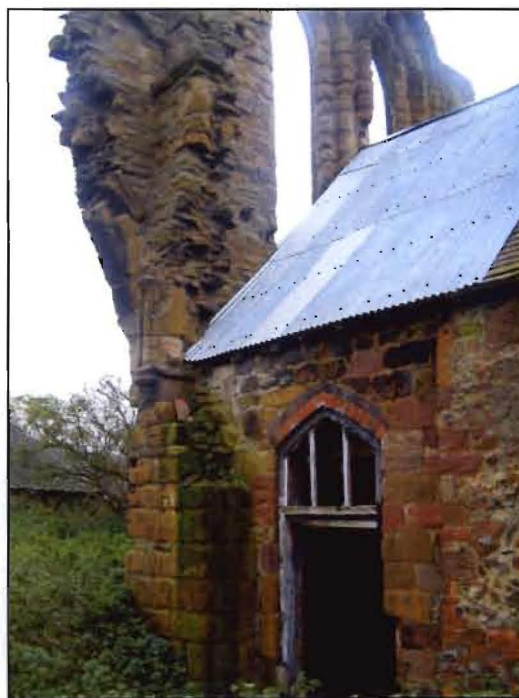
**Figure 16.**  
*The position of the eastern claustral doorway viewed from north west, showing the original reveal to the left of the doorway. [DP021019]*

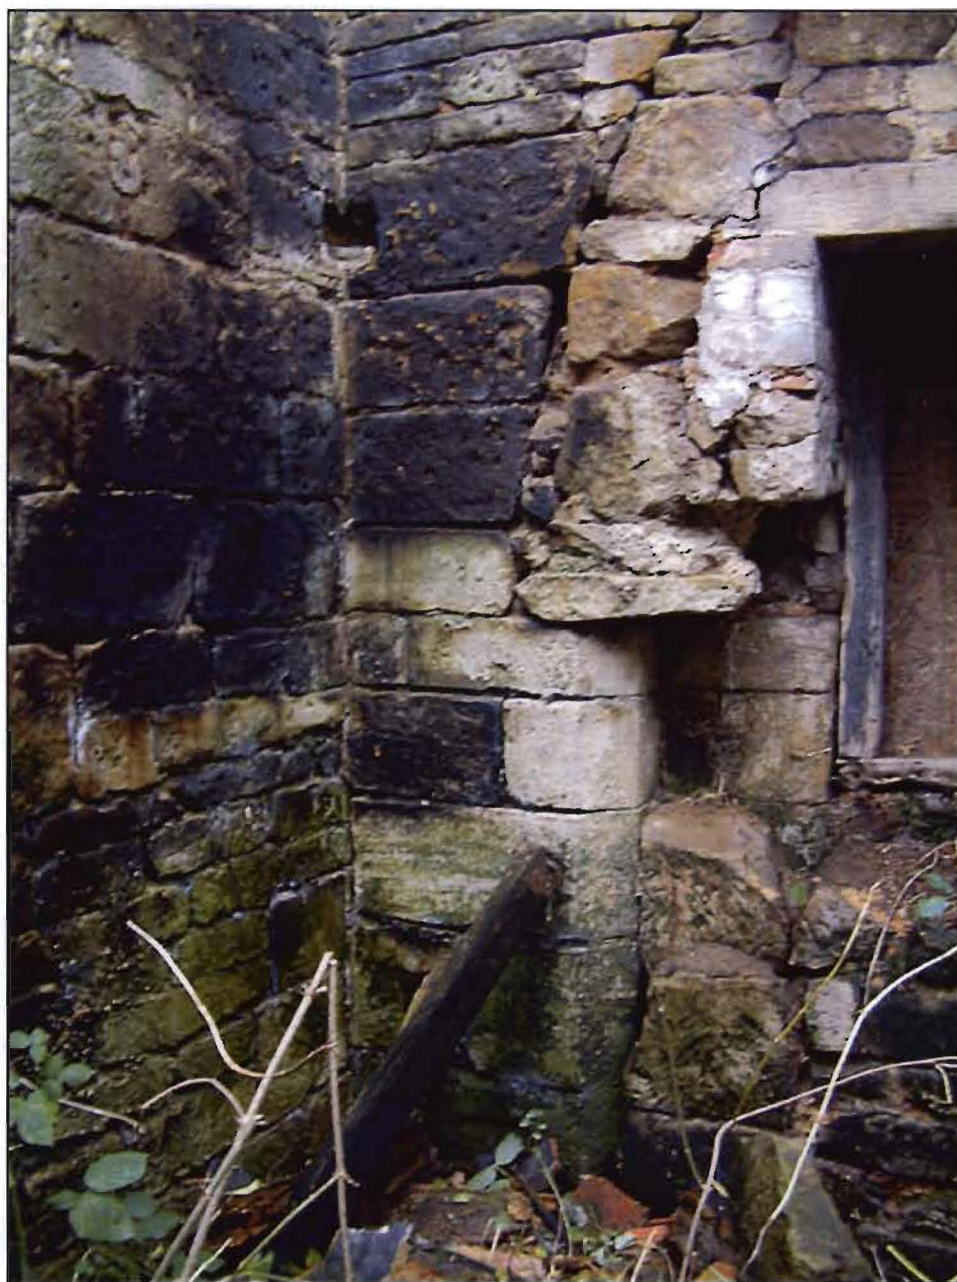
**Figure 17.**

*The western claustral doorway, viewed from within the barn, showing the chamfered jamb on the west side of the original opening. [DP021020]*

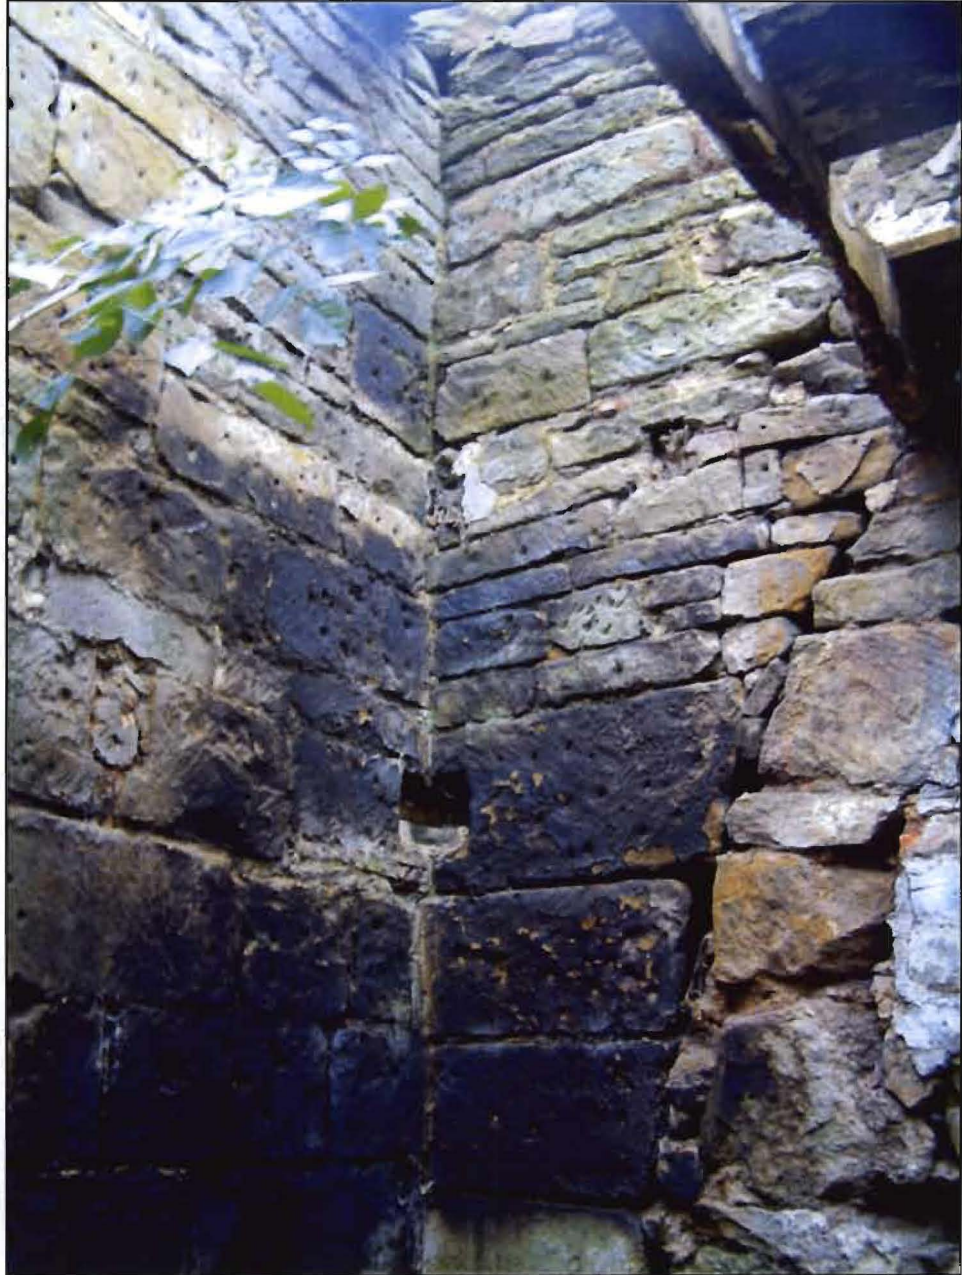
**Figure 18 .**

*Interior view of the north-west corner of the barn, showing in-situ medieval masonry and curved scar formed where the original stone surround of the western claustral doorway has been robbed out. [DP021021]*

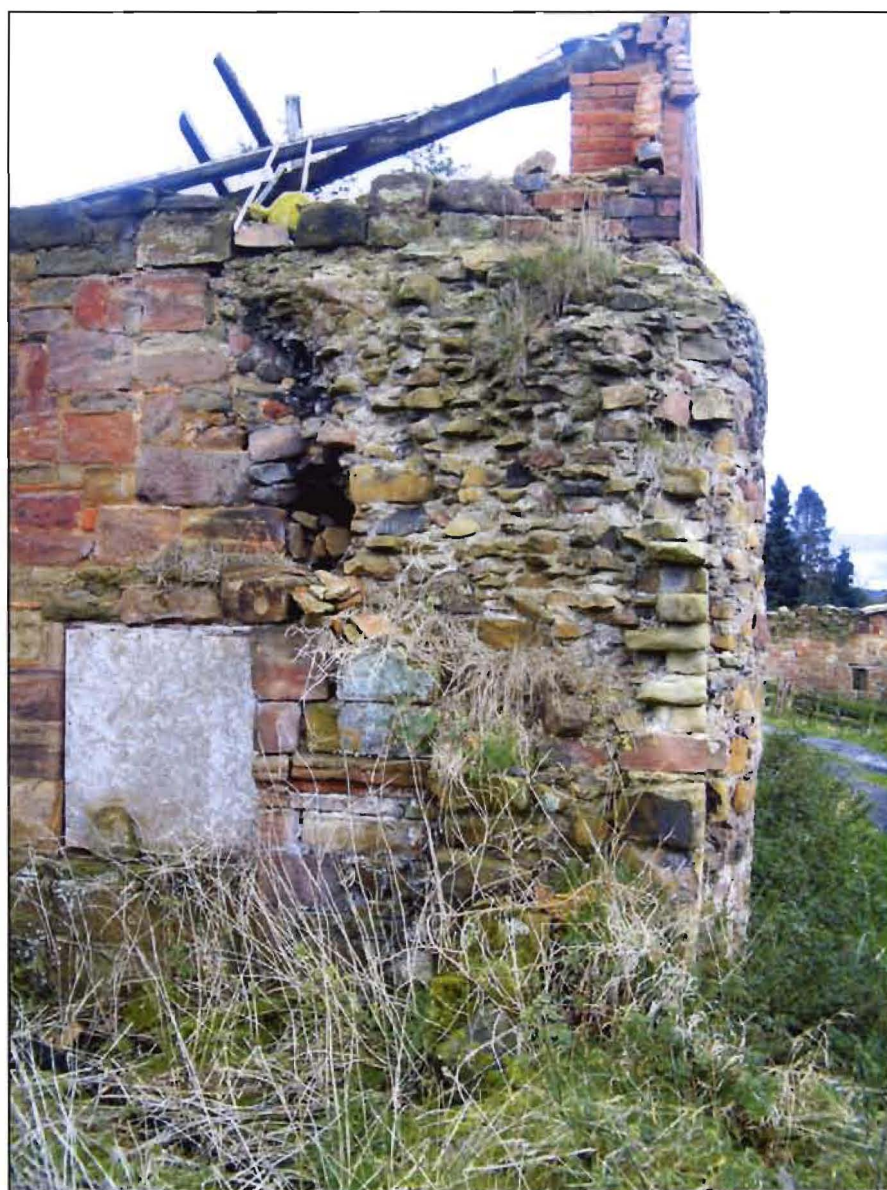
**Figure 19.**

*'Pillar' of medieval masonry at north-west corner of barn. Viewed from north.  
[DP021022]*

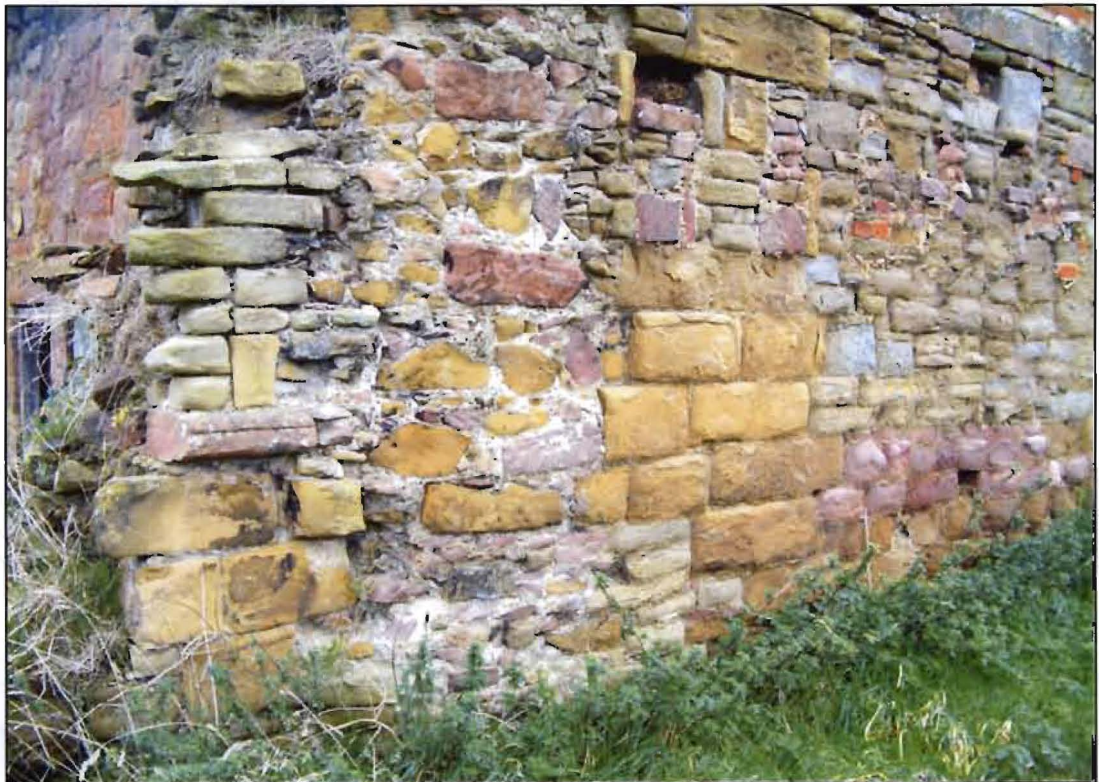
**Figure 20.**

*The remains of the west front of the south aisle (left), viewed from the west, showing scar where medieval buttress, or wall, has been removed (left of centre). [DP021023]*

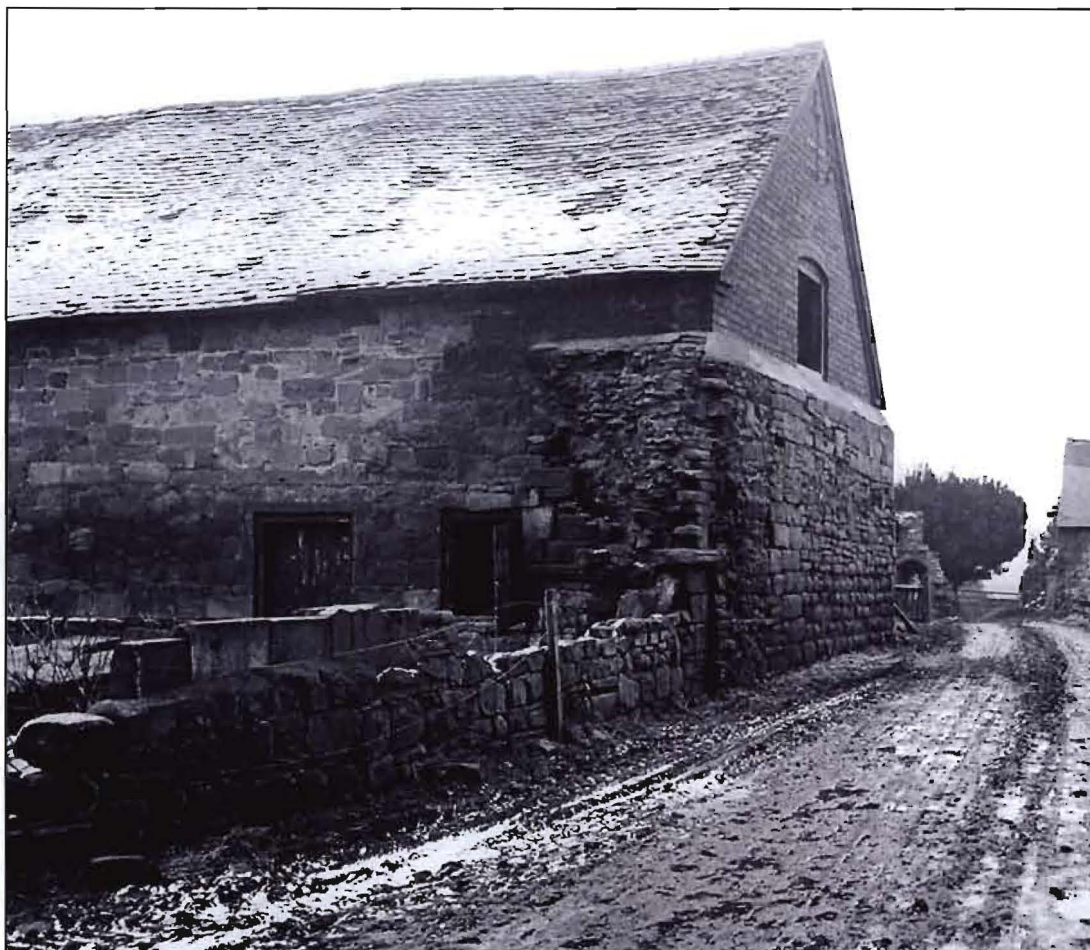
**Figure 21.**

with the western claustral doorway. The remains of a boundary wall continue, in a collapsed state, to the north of the in-situ masonry of the west front, but this does not appear to include any in-situ remains of the church, at least above ground level. It is likely that there are archaeological remains of the west front concealed below ground level. A photograph taken in February 1966, and held in the National Monuments Record, shows these features in a slightly better state of preservation, especially the boundary wall (see figure 21).

*Photograph of north-west corner of the barn, taken 15 February 1966. (NMR: Halesowen Abbey, Blue Album, No. AL0718 A.7031/11)*

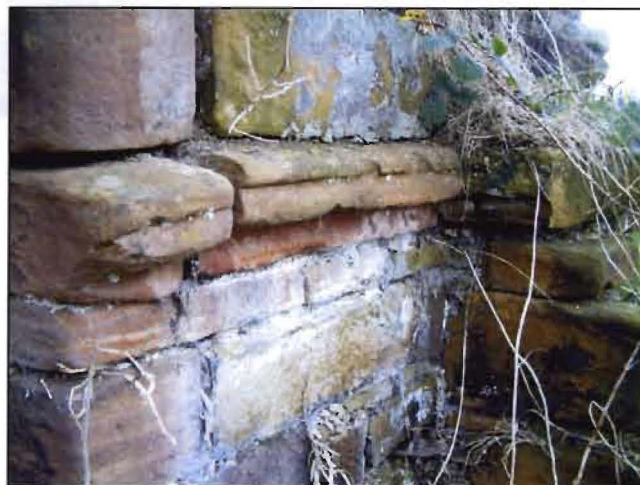
**Figure 22.**

*Detail of the original internal wall face at the south-west corner of the south aisle. Viewed from the north east. [DP021024]*

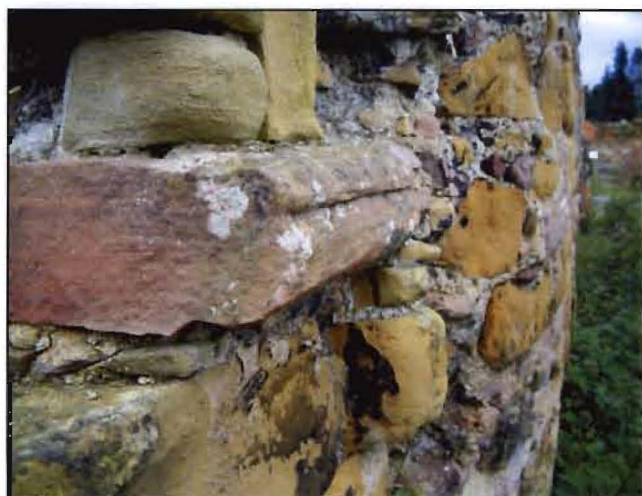
**Figure 23.**

*Detail of the moulded string course on original external face of west wall of aisle. Viewed from north west. [DP021025]*

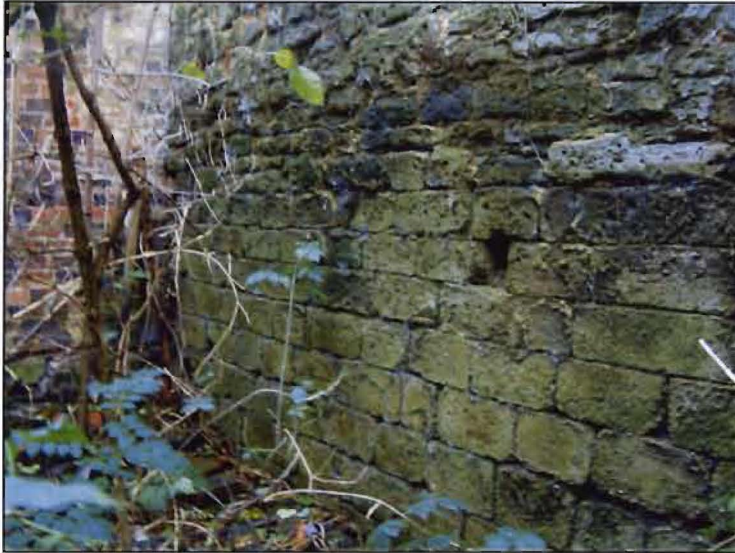
**Figure 24.**

*Internal view of west wall of barn, showing in-situ medieval stonework, viewed from north east. [DP021026]*

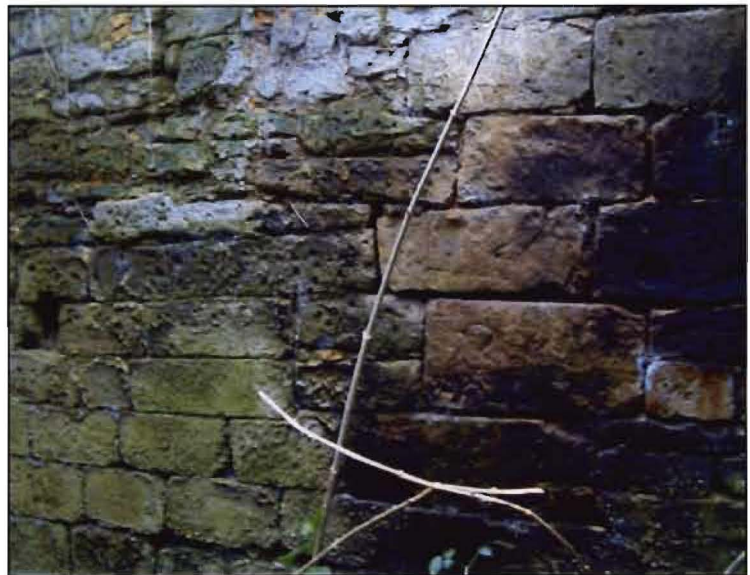
**Figure 25.**

*Detail of internal face of west wall of barn, showing ragged joint formed between masonry of two phases. Viewed from east. [DP021027]*

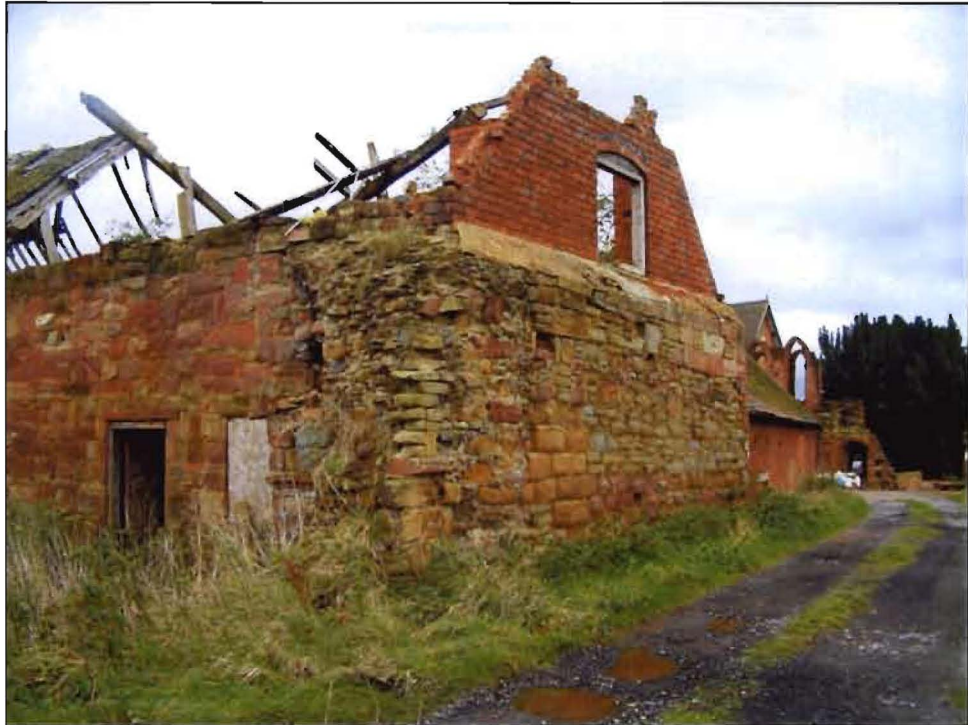
**Figure 26.**

*West end of barn showing in-situ medieval masonry, reused stonework and 19th-century brick gable. Viewed from north west. [DP021028]*
