RESEARCH REPORT SERIES no. 36-2012

# BEXWELL BARN, BEXWELL, NORFOLK ANALYSIS AND INTERPRETATION

Olivia Horsfall Turner

NGR: TF 63144 03525

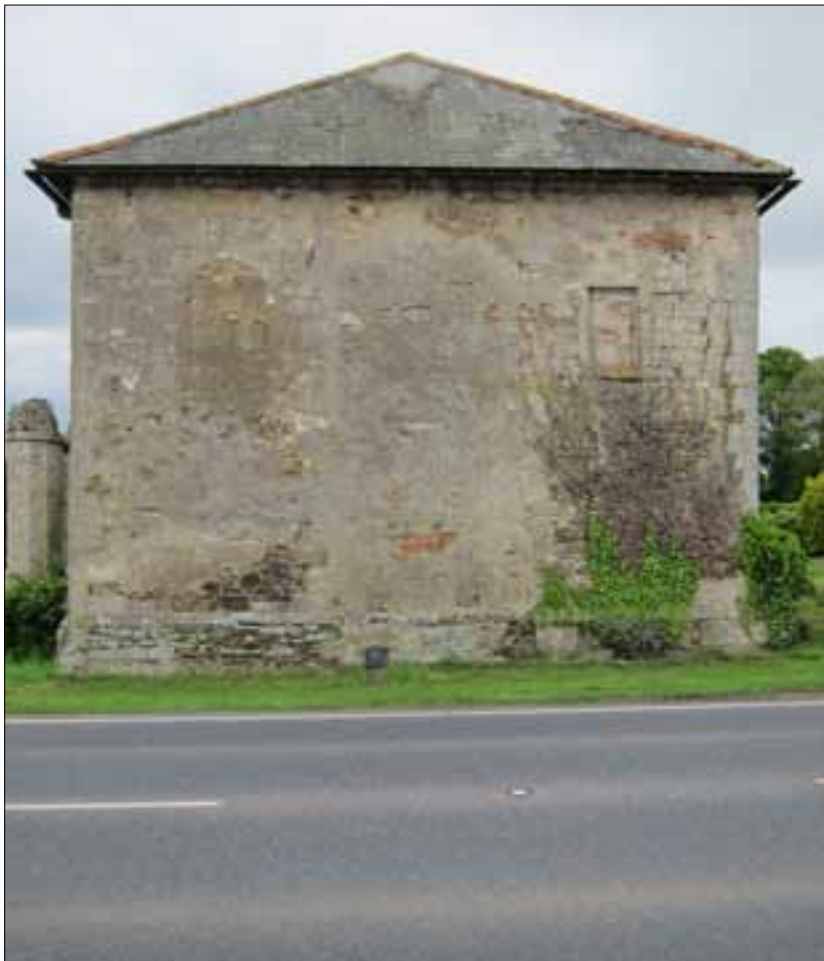
The north face of the building is constructed of a combination of ashlar and rubble (including some carstone) and some brick, with ashlar quoining (Figure 2). Certain areas of brick are infill for blocked features, others may be repairs. There is one blocked window located on the right-hand side at upper level. The window is square-headed with an ashlar surround with curved chamfer, probably dating to the 15th century. It is infilled with bricks that are partially covered with render, making them difficult to date, but their mid-red colour and medium size suggest they are probably 19th century. A shadow on the left-hand side of the wall appears to indicate another blocked aperture. This is confirmed by infill visible on the internal face of the wall. The left-hand aperture may have had a matching stone surround to that on the right, but it is no longer extant. The wall has a plinth, again mostly of ashlar, but containing some carstone, which appears to run across the façade. The middle section, however, is actually infilled. Two chamfered ends are visible within the plinth, respecting an aperture in the middle of the north wall, and there is evidence of quoining in the wall above. This is consistent with two vertical straight-line joins expressed on the wall, indicating that there was once a reasonably wide aperture at least at ground-floor level in the north face.

Figure 2. North façade.

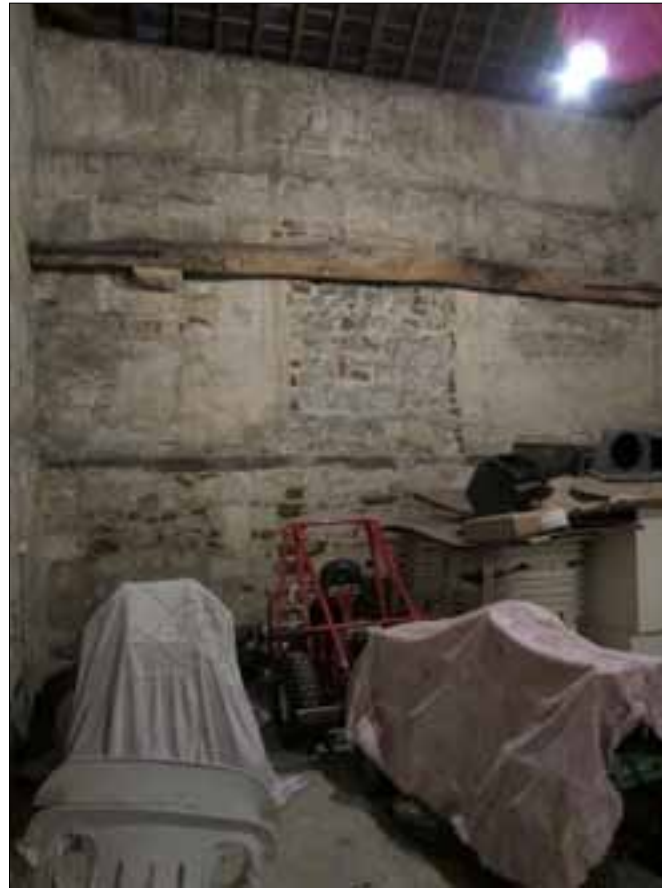
This is confirmed by interior evidence, which shows there were two different openings in the north wall (Figure 3). The first was at ground level – potentially a wide doorway providing access directly from the road – and the second at upper level – probably a window or opening for taking-in. Above the head of the lower aperture is a wooden beam which runs across the wall's entire face and appears to be an integral part of the wall construction, suggesting that the doorway was primary. Whether or not the upper aperture was primary is impossible to say, but its infill appears to be slightly rougher and higher in brick content than that of the infill of the lower aperture, suggesting that they may have been infilled in different phases.

*Figure 3. North wall, interior, showing evidence of earlier openings.*

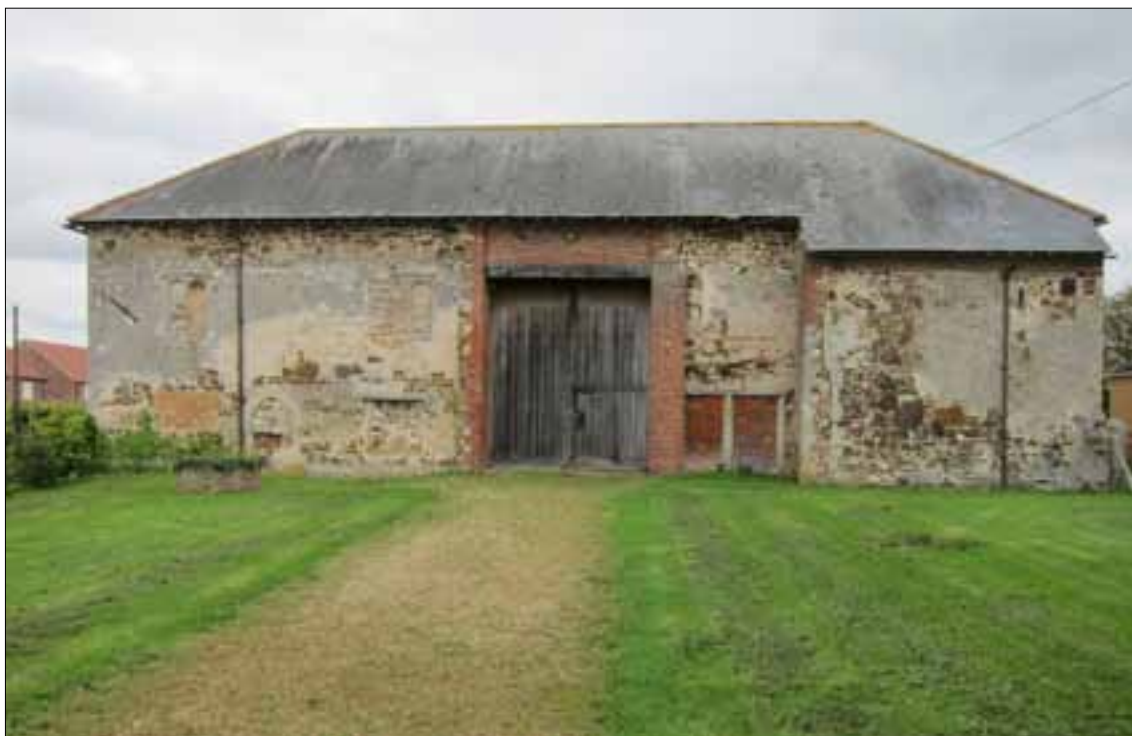
The west face is constructed of a combination of ashlar, stone rubble – including some carstone – and brick, with a number of ashlar windows and one ashlar door surround (Figure 4). There is also evidence of worked-stone fragments, as well as ashlar mullions and mouldings, used as walling material. At eaves level a break in the masonry and a change in building materials from the variety of materials outlined above to small carstone blocks suggest that the wall height has been raised at some point. This also appears to be expressed on the interior, though subsequent plastering makes it difficult to discern the change in materials.

Figure 4. West façade.

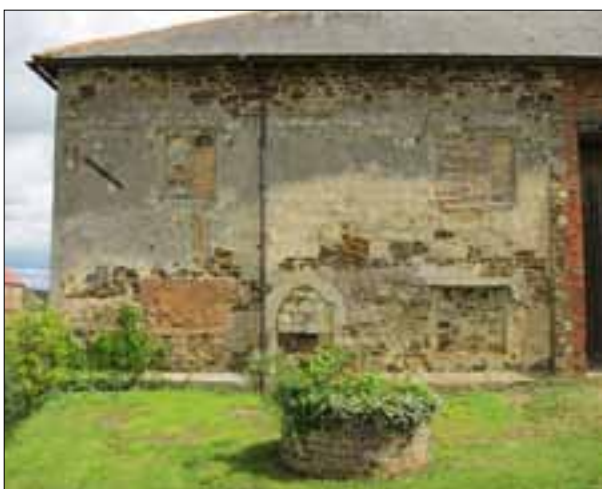
Figure 5. Blocked features on west façade.

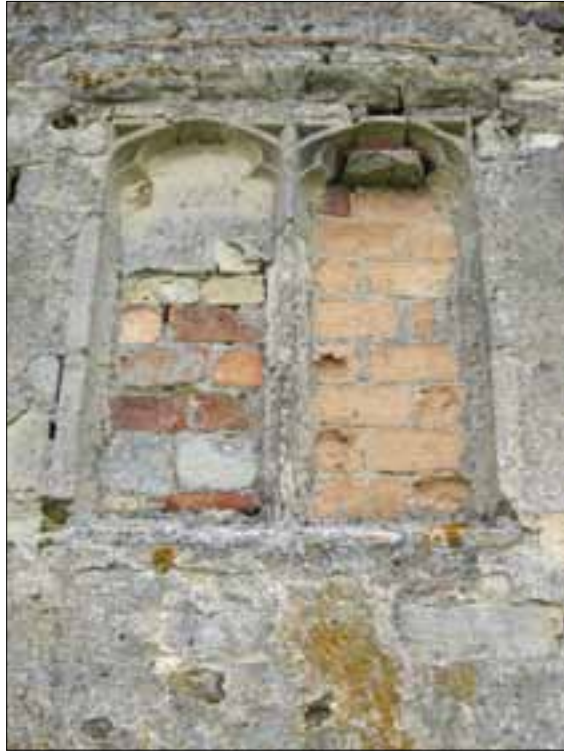
Figure 6. Blocked two-light window at upper level on west façade.

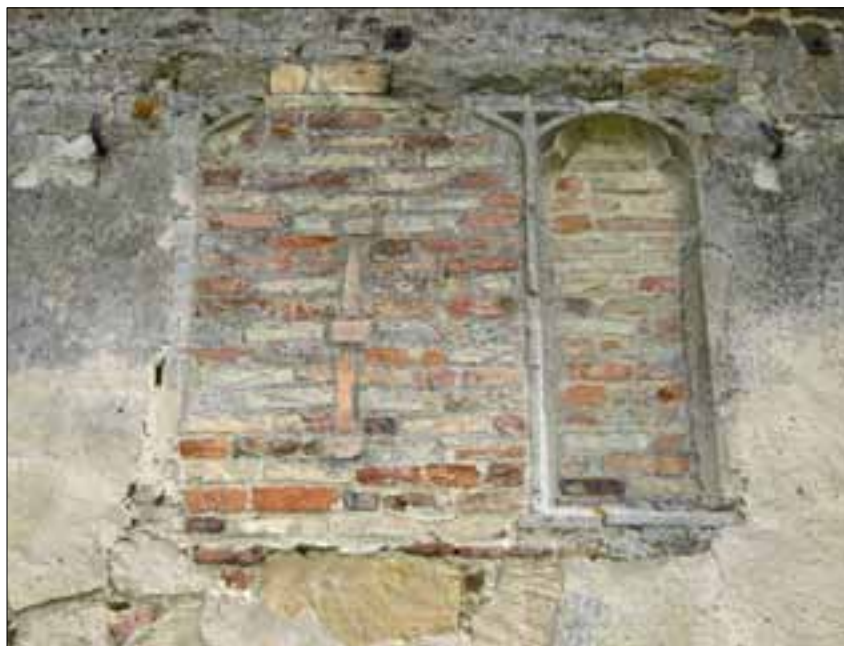
Figure 7. Blocked three-light window at upper level on west façade.

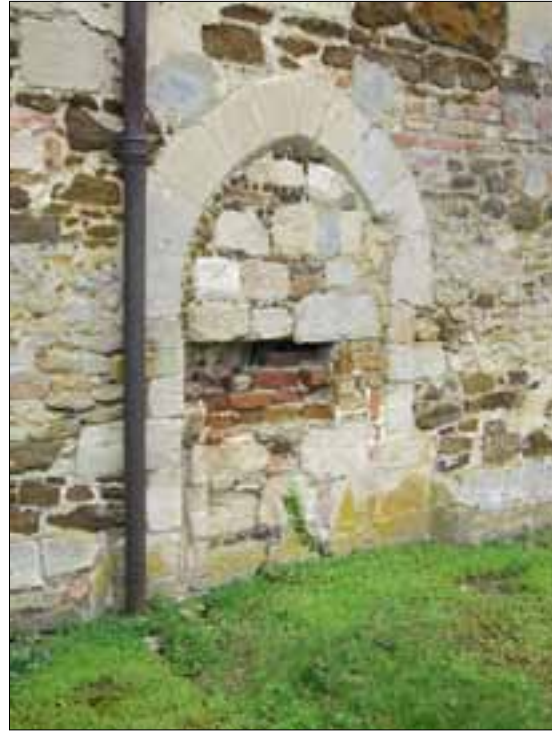
The extant lower-level apertures are a doorway (Figure 8) and a three-light window (Figure 9). In addition, an area of brick infill in the lower left-hand corner which corresponds to the sizes of the other three-light windows indicates that there was probably another three-light window in that location. The infill is of small light-salmon-pink bricks – different again from those of the upper-level windows and therefore suggestive of yet another phase of infilling. The infill is also visible on the interior, suggesting the former window aperture in that location was fully open at some point. Like the windows at the upper level, the extant ground-level window has a hood mould and flat head over shallow, cusped, trefoil-headed arches with simply carved spandrels. Only an indication of these details survives, however, as the arches and spandrels have been damaged and mostly lost. The door surround is a two-centred arch of ashlar blocks with chamfered edges on the inner face.

Figure 8. Infilled doorway on west façade.

The doorway and lower-level window are both infilled with a mixture of stone rubble (including carstone), worked-stone blocks, and brick. The infill is neatly coursed, and in places the mortar is galetted with small carstone chips – a decorative finish suggesting it was intended to be visible. The relation between the infill and the damaged window suggests that the damage occurred at some point prior to the infilling. The infill is visible on the interior, which would suggest that this window and the doorway were open at some point, but the fact that the infill is of the same type and size of material that is used in the main wall face suggests the possibility that these apparent 'apertures' may have been blocked from the original date of construction. Furthermore, if the windows had been open, their position is so low that they would not have afforded interior light at a useful level (the original interior floor level does not appear to have been substantially altered even though the interior floor surface has been covered in concrete). This also suggests that the ashlar features are not in situ.

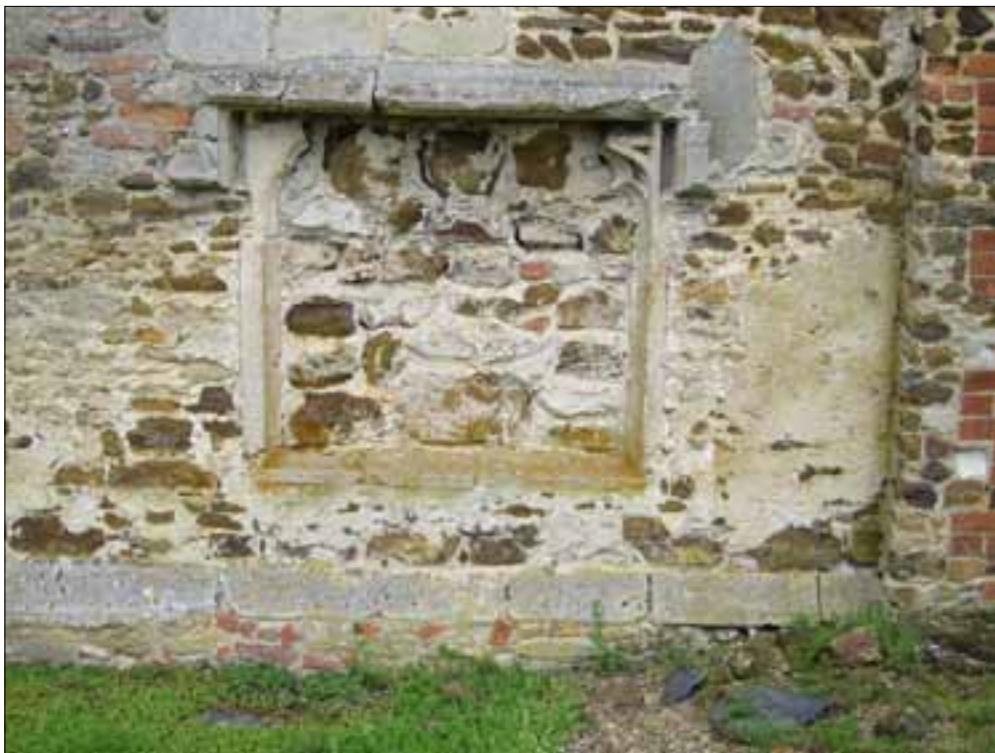
Figure 9. Infilled window at ground level on west façade.

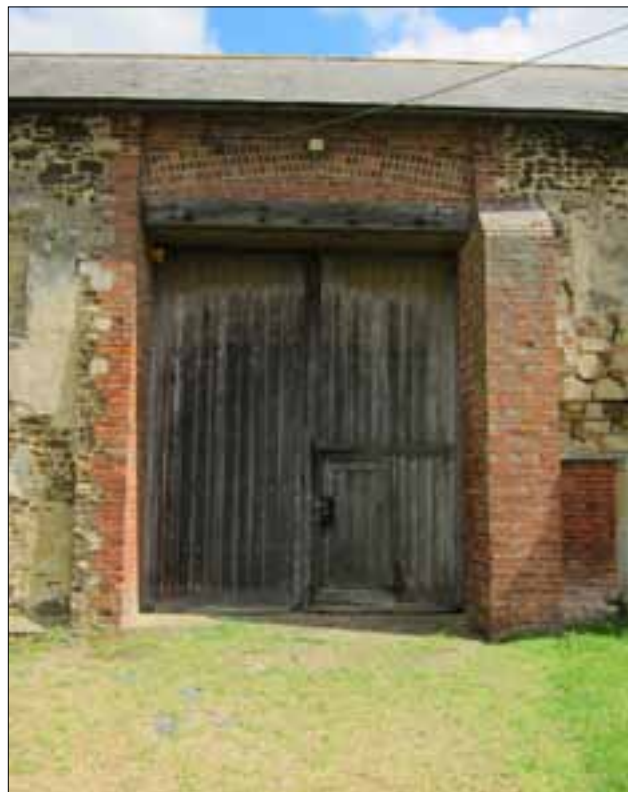
The central section of the west wall is dominated by a large wooden taking-in door which rises to almost the full height of the building (Figure 10). The large-scale jambs for the taking-in door are constructed of bricks which appear to be 19th century. The right-hand-side jamb is flush with the wall face at the top, but gradually projects to form a small buttress. It has brick quoining alternating with carstone and some ashlar. The left-hand-side jamb is entirely of brick and forms a more substantial buttress that rises up to about four-fifths of the height of the building. Above the taking-in door there is a wooden beam and several courses of brick containing a relieving arch. Given that the height of the taking-in door is the same as the original wall height, and that the brickwork above it rises to the same height as the increased wall height, it seems probable that the insertion of this doorway was the spur for the raising of the wall height.

Figure 10. Taking-in door, west façade.

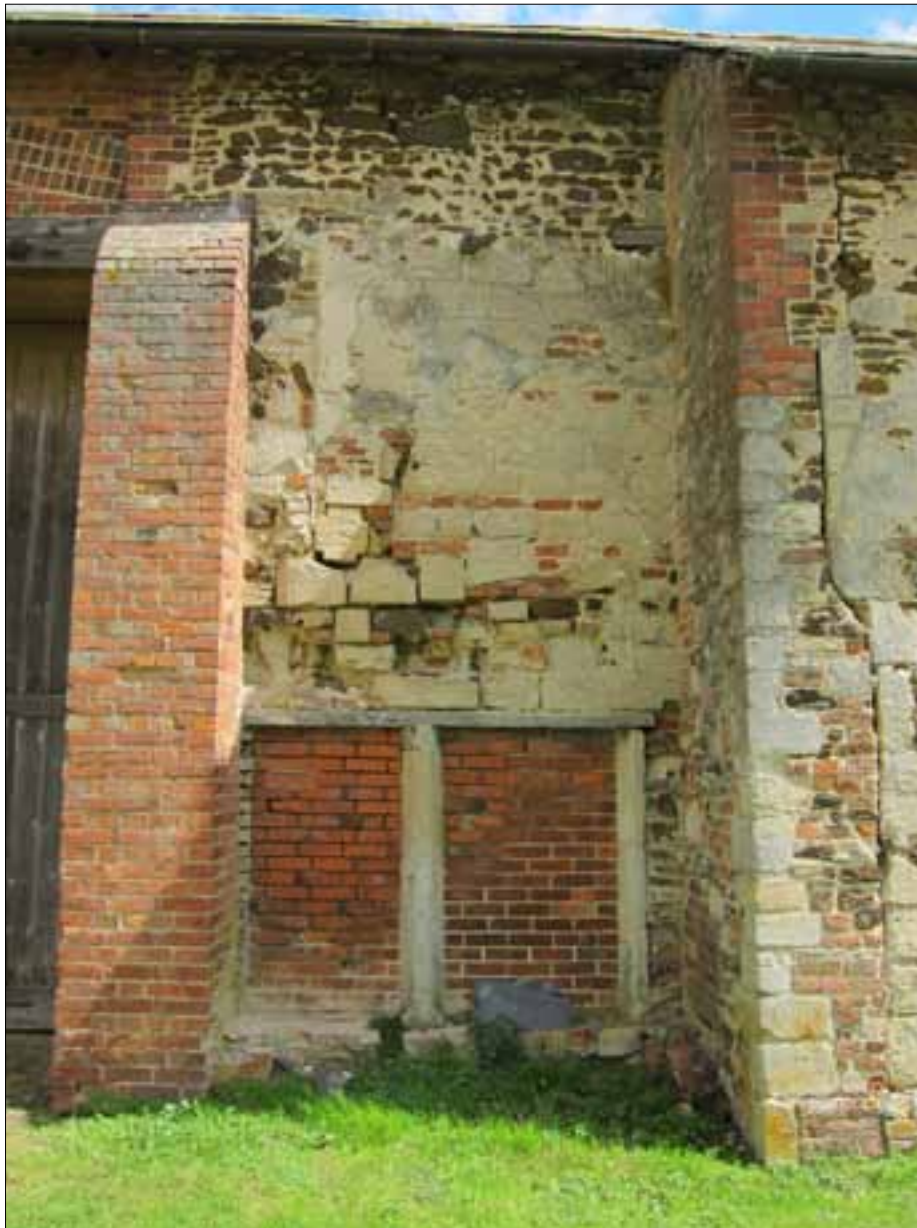
To the left of the taking-in door are the most obvious pieces of worked stone – including mullions and mouldings – reused as walling material (Figure 11). Unlike the section of the west façade further to the north, there is no plinth to this central section of wall. At ground level there are two large stone mullions set vertically with a small wooden beam resting horizontally across the two. The beam appears to be set into the wall thickness and therefore to be primary, but this area of wall is one of the most disrupted of the whole building and its external appearance suggests it has been substantially rebuilt. Certainly, the wooden beam does not appear to date to earlier than the 19th century. The spaces between the mullions are infilled with brick of two types, suggesting two phases of infill, or a repair. It is unlikely that the ‘window’ was ever open – a window at this height would not offer interior light at a useful level, and indeed, there is no corresponding expression of either an aperture or infill on the interior.

*Figure 11. Re-used mullions and worked stone in west façade.*

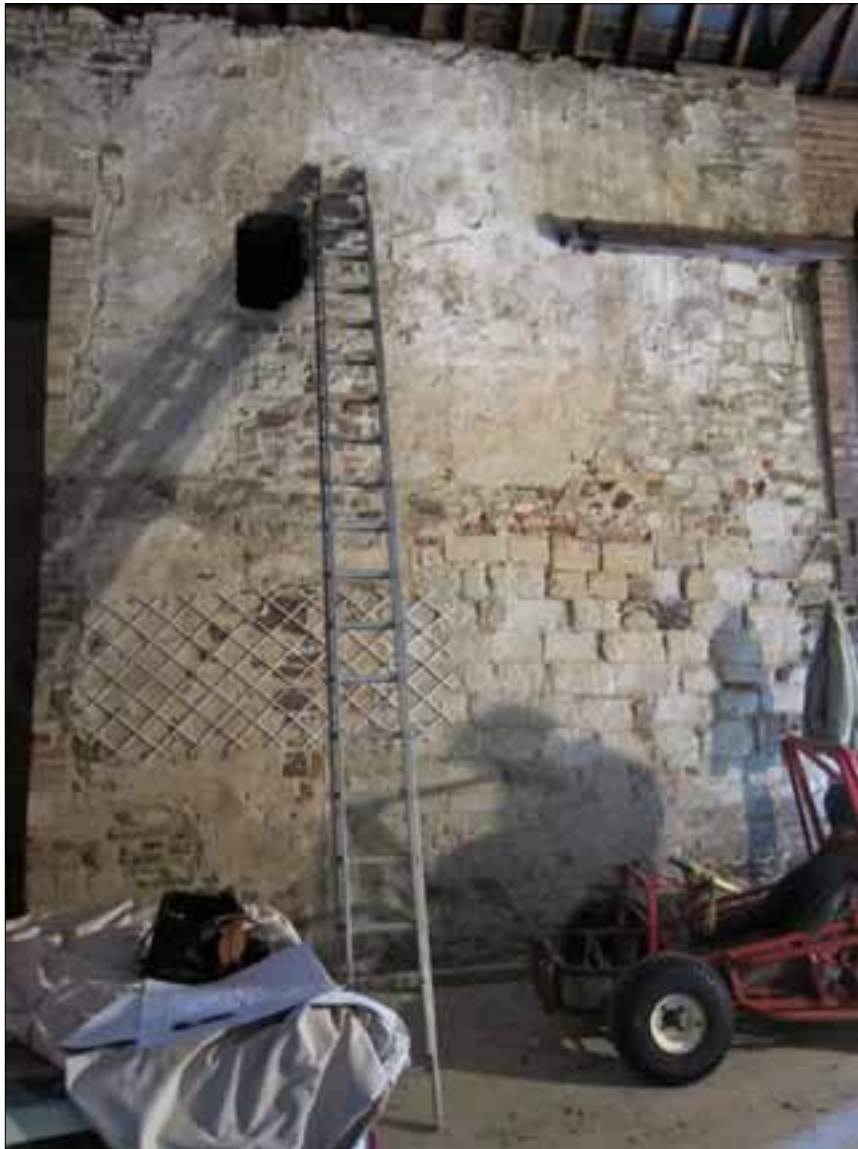
Above the re-set mullions there is a straight-line join just to the right of the shallow buttress, which appears to relate to an infilled door aperture to its left, now partly hidden behind the buttress. This suggests that at some point there was access at upper level, and also implies that at some point there must have been an additional structure further to the west of the current building. Whether or not the doorway and access were original is unclear. To the right of the doorway scar, before the wall face steps forward, there is a timber beam that is embedded in the wall, probably indicative of another aperture. The head of that aperture is at roughly the same height as the blocked doorway to the left. The position of this aperture, which is now partially hidden by the re-entrant section of the west façade, also suggests that the latter is not primary, in its current position at least. The interior wall face of this section complicates rather than elucidates the interpretation of this area: not only are none of the apparent apertures expressed on the interior, but also, the interior wall face displays areas of consistent construction which are completely at odds with the fragmented external finish (Figure 12).

*Figure 12. West wall, interior, where external features are not expressed internally.*

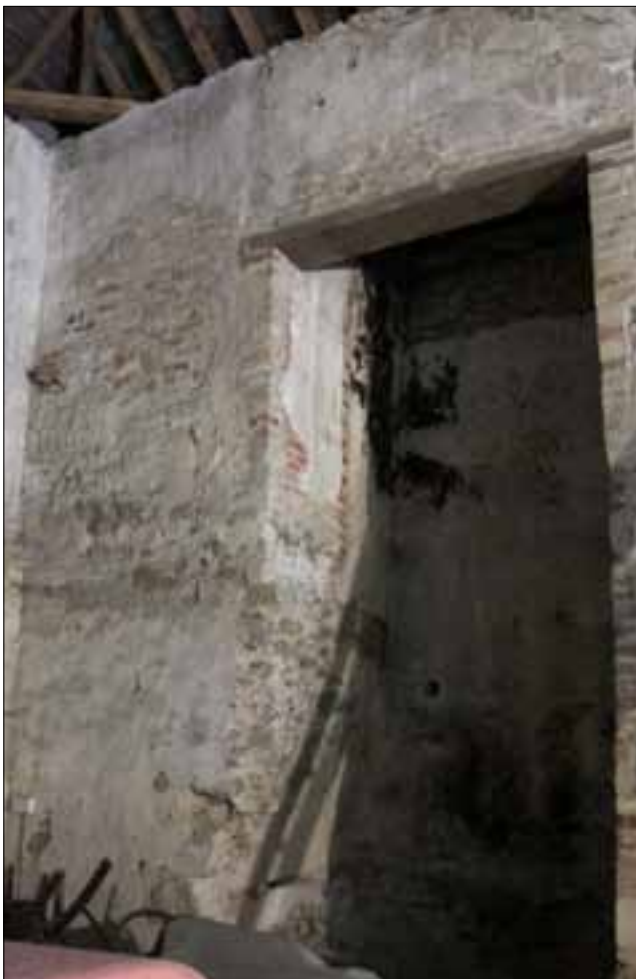
Figure 13. West wall, wing, interior.

The interior evidence reveals that the wing is a particularly complex part of the building (Figure 13). Although its exterior wall face is of one phase (plus the raising of the wall height), the wall depth is of at least two phases. The interior wall of the wing does not have any clear indication that it has been raised, although this may be hidden under the surface plaster. The wing is divided into three spaces, two of which are accommodated within the wall thickness – one of these is partially visible through a hole in the wall at upper level, the other is partially visible through an aperture at ground level. Some of the space is therefore enclosed within the wall thickness and is not accessible. The central section, open to the main interior, has been identified as either a stairwell or a fireplace, while it has been suggested that the two encapsulated spaces to either side might have been garderobes.<sup>3</sup> Archaeologically, the

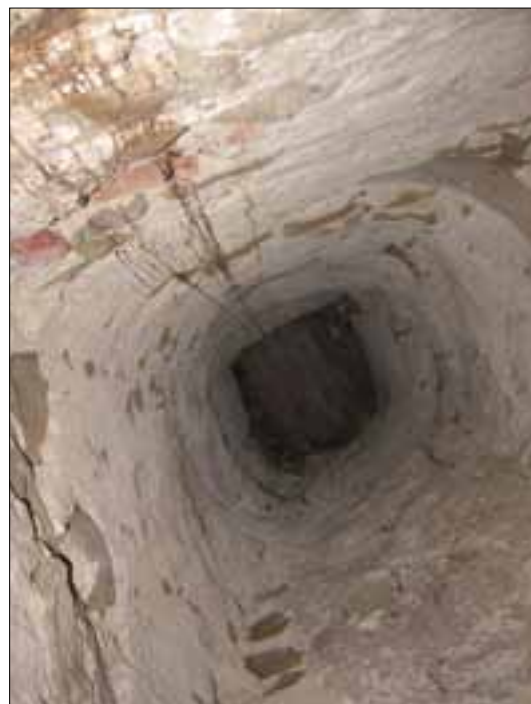
evidence of garderobes is coherent: there is a drop in each location (Figure 14), as well as associated fenestration. The top of the right-hand chute (as seen from the interior) corresponds to the single-light window and at the top of the other chute there is internal evidence of an aperture, though it is blocked and not expressed externally. There are also infilled doorways at upper level next to each cubicle, suggesting access. A lower ground level at the foot of the chute that is open at the bottom indicates that there were pits below the garderobe chutes, though there is no visible evidence for external access.

Figure 14. Probable garderobe chute in wall thickness of wing.

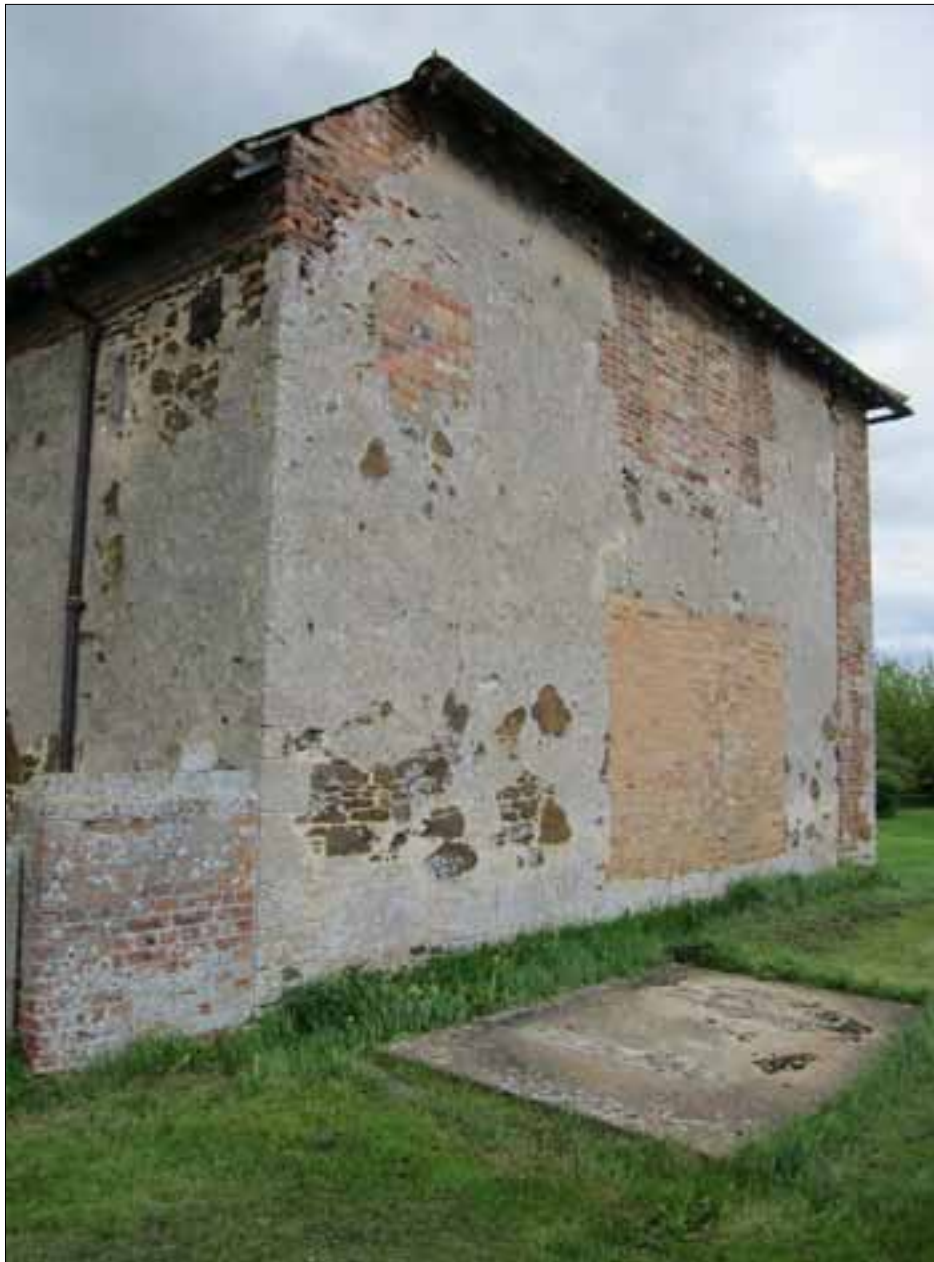
Figure 15. South façade.

The south face of the building is constructed of a combination of carstone rubble and brick, with ashlar quoining, and substantial use of ashlar on the left-hand side at ground level (Figure 15). The render on the south wall, though weathered, still covers and therefore obscures much of the underlying building material. There is no plinth, but along the base of the wall there are two courses of ashlar blocks in line with the wall face. On the left-hand side at eaves level disruption to the brick coursing indicates that the pitch of the gable on that side has been altered, necessitated by raising the west façade's wall height. There is no indication, however, from either external or internal evidence, that the height of the south wall has been raised, though evidence may be obscured by the interior plaster and exterior render.

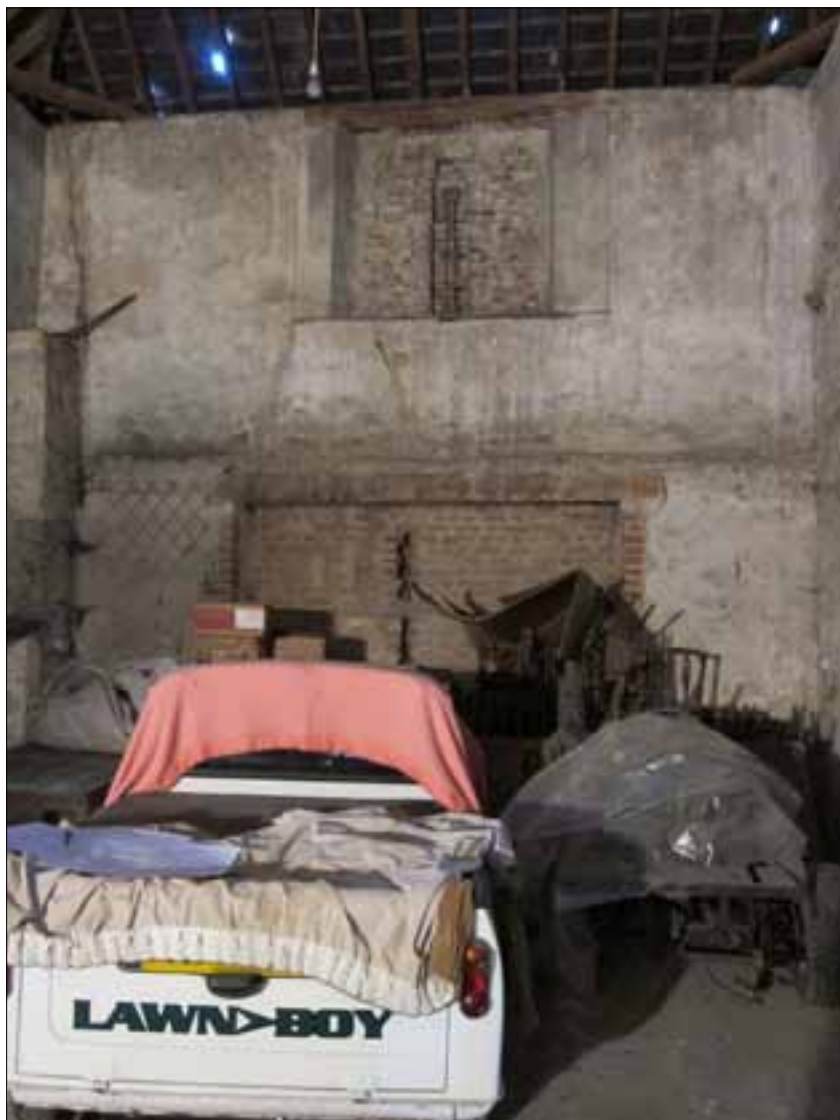
There have been at least two apertures in the south wall. The first, at upper level, is indicated by a large area infilled with small, dark-red bricks that may date to as early as the 16th century. Straight-line joins indicate that in fact, the area has been infilled in two phases suggesting two subsequent sets of fenestration and/or a doorway for taking-in. In the centre of the brick infill a vertical 'arrow-slit' indicates that even after the aperture was closed, there was still ventilation, but that too has since been blocked. Internally this aperture is also clearly expressed where the original window and subsequent infillings have created an inset window embrasure (Figure 16). The second aperture, at ground level, is indicated by a large square area infilled with large light-salmon-pink bricks. The breadth of the aperture suggests that it was a doorway rather than a window, though it does not appear to have gone down to the ground: there may have been a ramp to facilitate access. This too appears to have had a central arrow-slit vent which is now blocked. A third area on the south wall – on the left-hand side at upper level – may also be the site of a former aperture. There, a section of larger, mid-red bricks and what appears at the edge of the render to be a straight-line join may indicate where a window has been filled in, but there is no indication of such on the interior.

Figure 16. South wall, interior, showing evidence of earlier aperture.

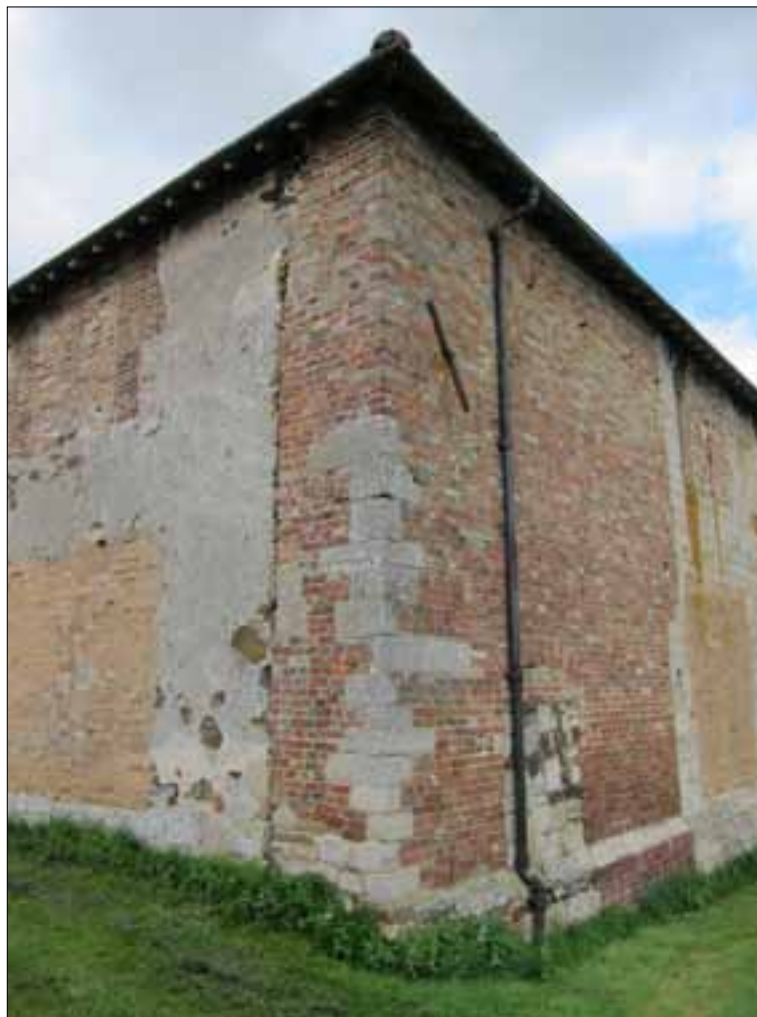
The most significant disruption to the south wall is at its eastern corner, where there is a straight-line join approximately two feet from the end of the wall. The render on the wall to the left of the break obscures the nature of the material underneath, but it appears to be carstone rubble without quoining. Beyond the break the wall is built of small, dark-red bricks which appear to date from the 16th century, with ashlar quoins that reach approximately halfway up the height of the wall. This suggests that there may have been a failure of the south wall at its eastern end and that the end of the wall had to be rebuilt using the brick and ashlar quoins that could be salvaged. This is corroborated by the evidence of the east wall, the southern end of which also implies that there was a partial collapse which was then repaired (Figure 17). The interior wall faces of the south and east walls, however, give no indication of such disruption, raising the question of whether the apparent phases are genuine or contrived.

*Figure 17. South-east corner, implying partial collapse and rebuilding.*

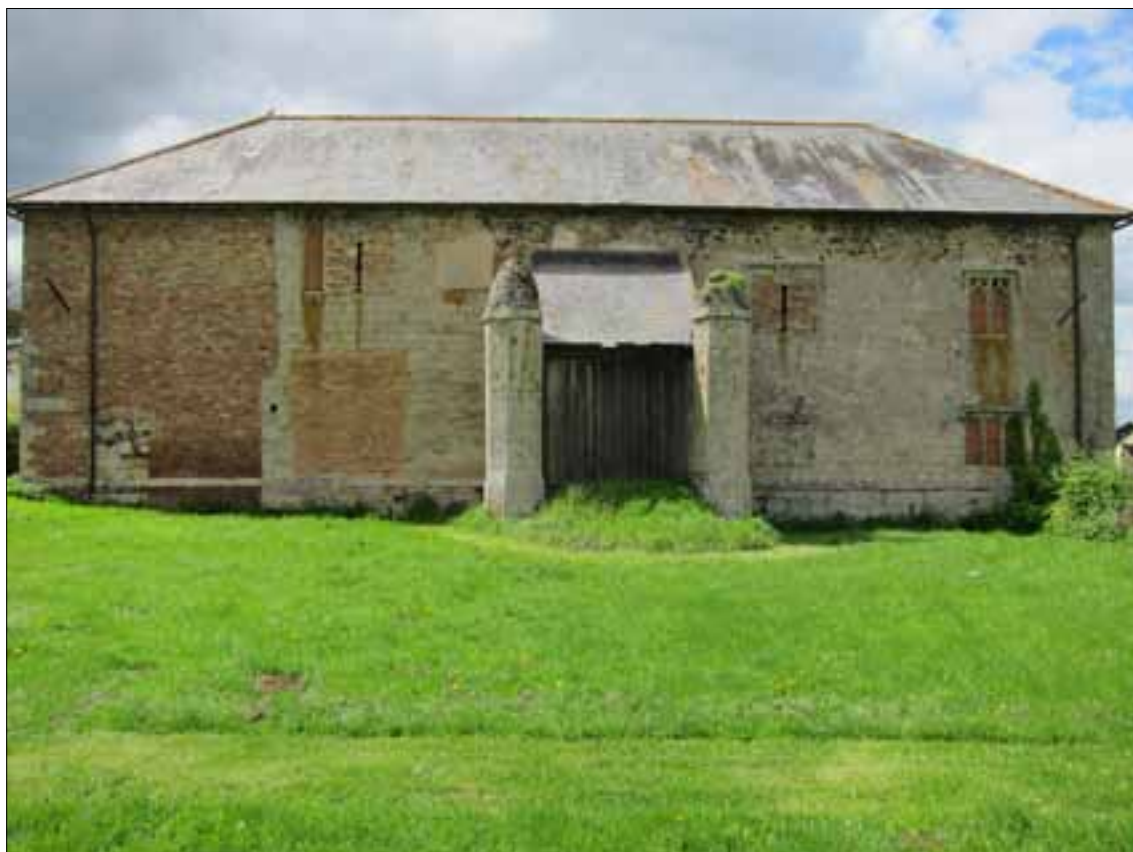
The east face is constructed mostly of ashlar, features ashlar medieval window surrounds and has a substantial porch centred slightly to the north of the centre line of the main building (Figure 18).

Figure 18. East façade.

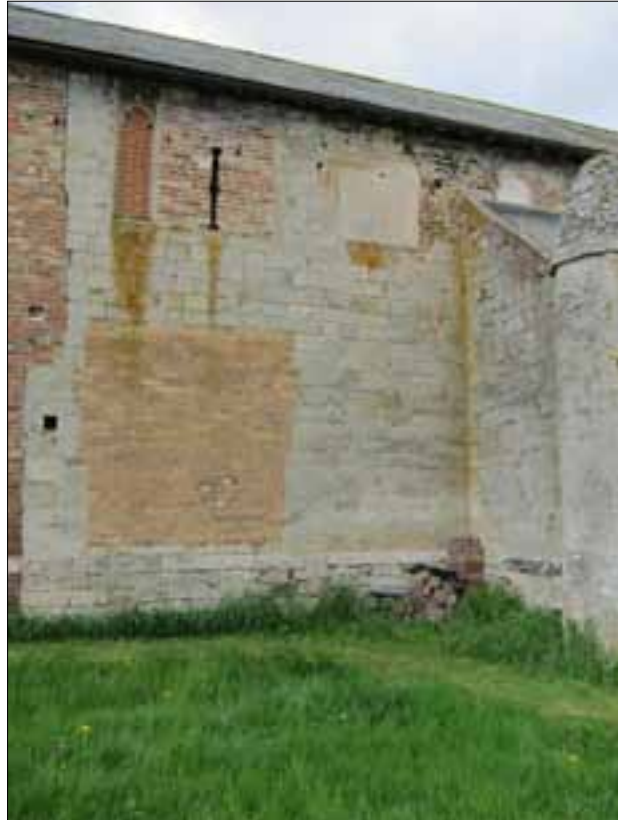
Immediately to the south of the porch there is evidence of four apertures which appear to have originated in different phases, and to have been infilled in different phases (Figure 20). At upper level there is a 15th-century traceried window – a flat-headed window over a single, cusped, cinquefoil-headed light with supermullion and cusping (Figure 21). This is blocked with what appear to be 19th-century bricks. Immediately adjacent to the right, scars indicate there was once a square aperture that has been infilled with bricks of early appearance. An ‘arrow-slit’ has been retained for ventilation (see Figure 21). The window aperture is also expressed on the interior, though the ‘arrow-slit’ has been infilled. To the right again is a square area of render that indicates a former aperture, now blocked, though the render obscures the infill. On the interior wall face the aperture and infill are legible. Externally at a lower level there is a large square area that is infilled with small salmon-pink bricks. Within the infill is a small diamond-shaped area of secondary infill which probably indicates that at some point a pipe or flue was located there, and subsequently removed. On the interior, this section of brick infill features two square niches.

Figure 20. Blocked features, south façade.

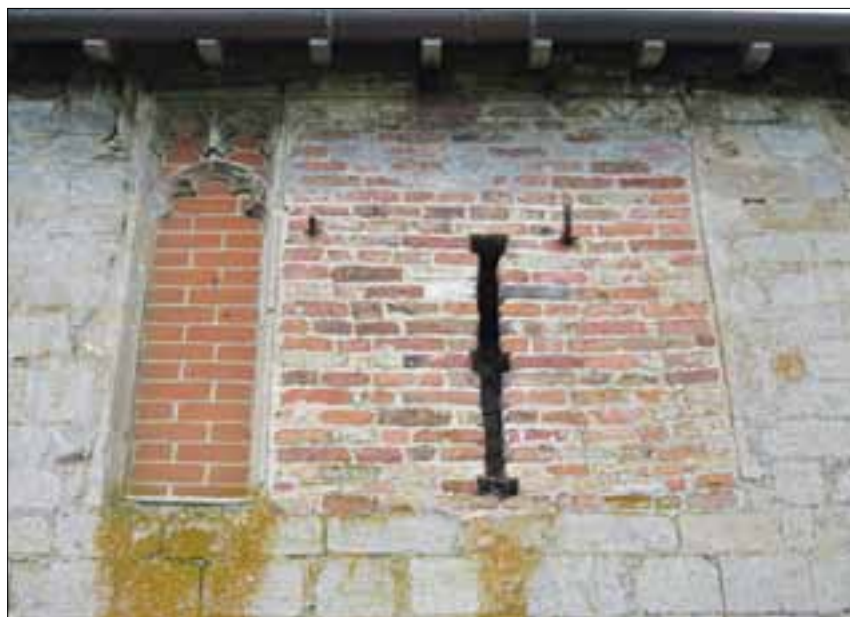
Figure 21. Blocked window, at upper level on south façade.

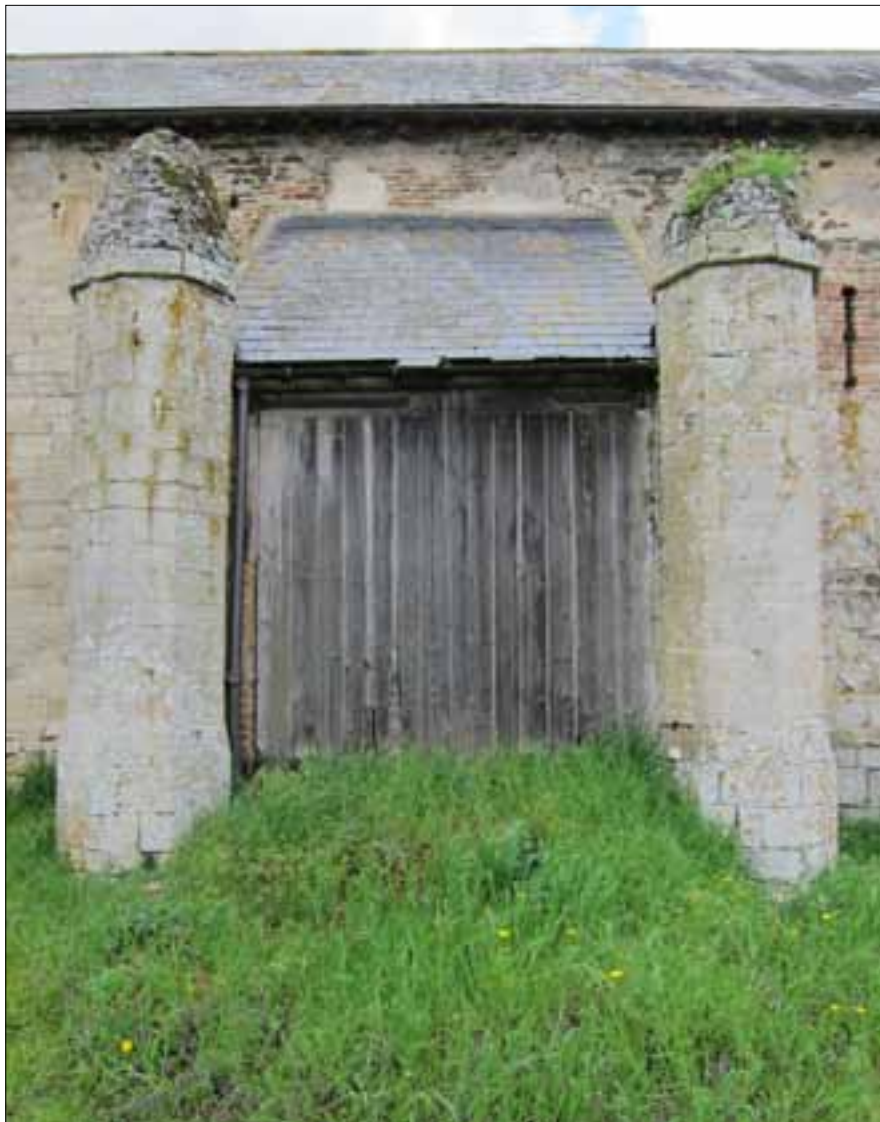
In the middle of the east façade, positioned slightly to the north of the centre line of the building, is a single-storey porch terminating in a pair of substantial polygonal turrets (Figure 22). The sides of the porch and the polygonal piers are constructed in ashlar; the piers are topped with cones of composite material. The sides of the porch are not completely consistently coursed in with the main building, though the main building's plinth does continue onto the porch. The porch roof is 20th-century and offers no information about the original structure. Likewise the door between the two piers is 20th century and provides no information about any earlier door. The wall face immediately above the porch is constructed of small carstone blocks and brick. It corresponds to the level where the wall height has been raised further to the north, but the presence of brick (which is not otherwise a material used in the raising of the eastern wall) suggests that a feature has been infilled, or a repair made. The sides of the porch slope diagonally down towards the polygonal piers. Brick infill at eaves level indicates that this does not represent the original termination of the wall, suggesting that the porch was previously higher.

Figure 22. Porch, east façade.

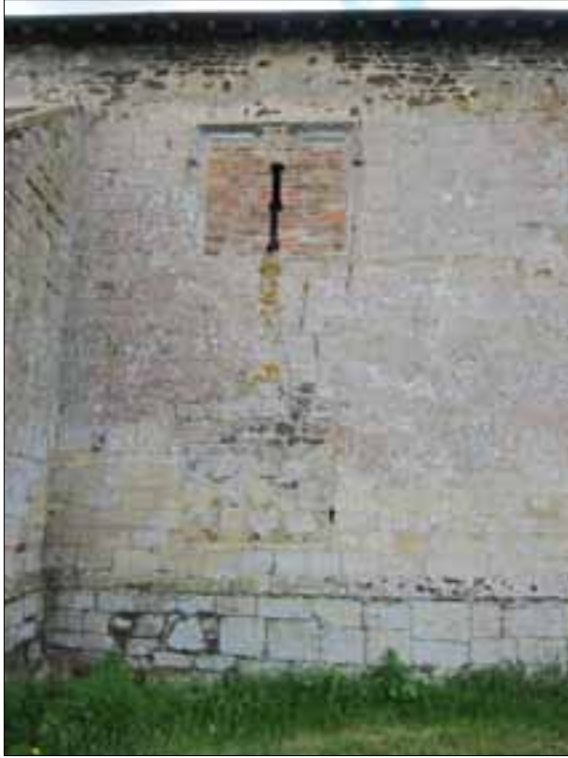
Figure 23. Blocked window at upper level with surviving hood mould on east façade.

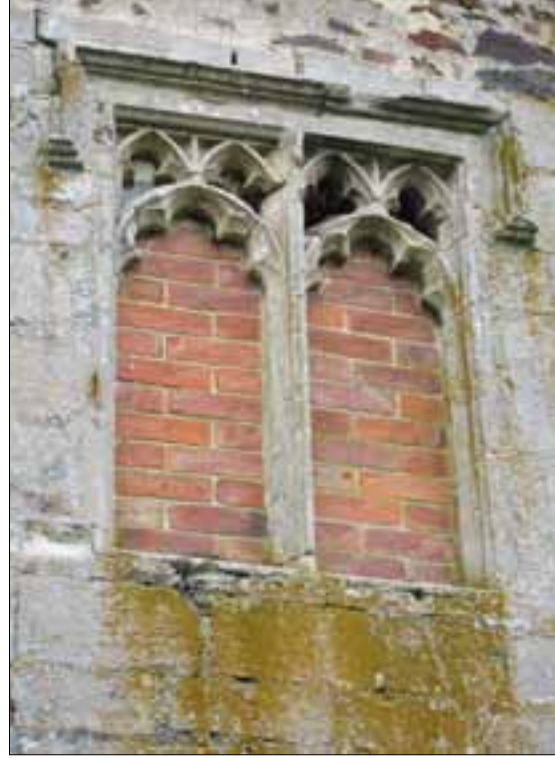
Figure 24. Blocked two-light traceried window with cut-down tracery at upper level on east façade.

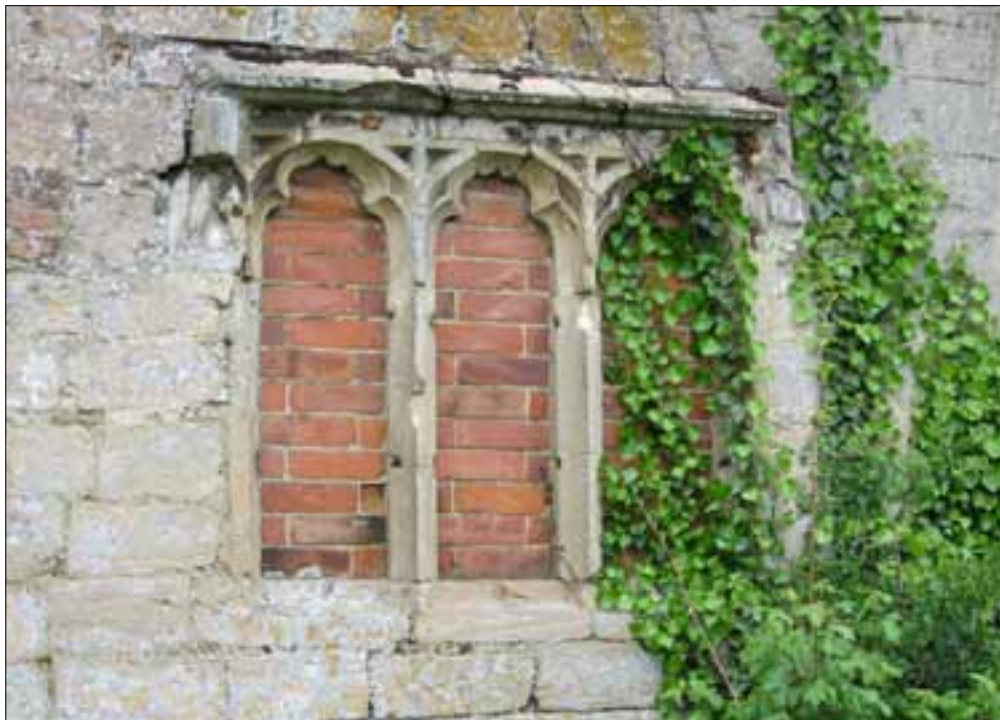
Figure 25. Blocked three-light traceried window at ground level on east façade.
