RESEARCH REPORT SERIES no. 19-2013

APETHORPE HALL, APETHORPE, NORTHAMPTONSHIRE DOVECOTE ROOF

HISTORIC BUILDING REPORT

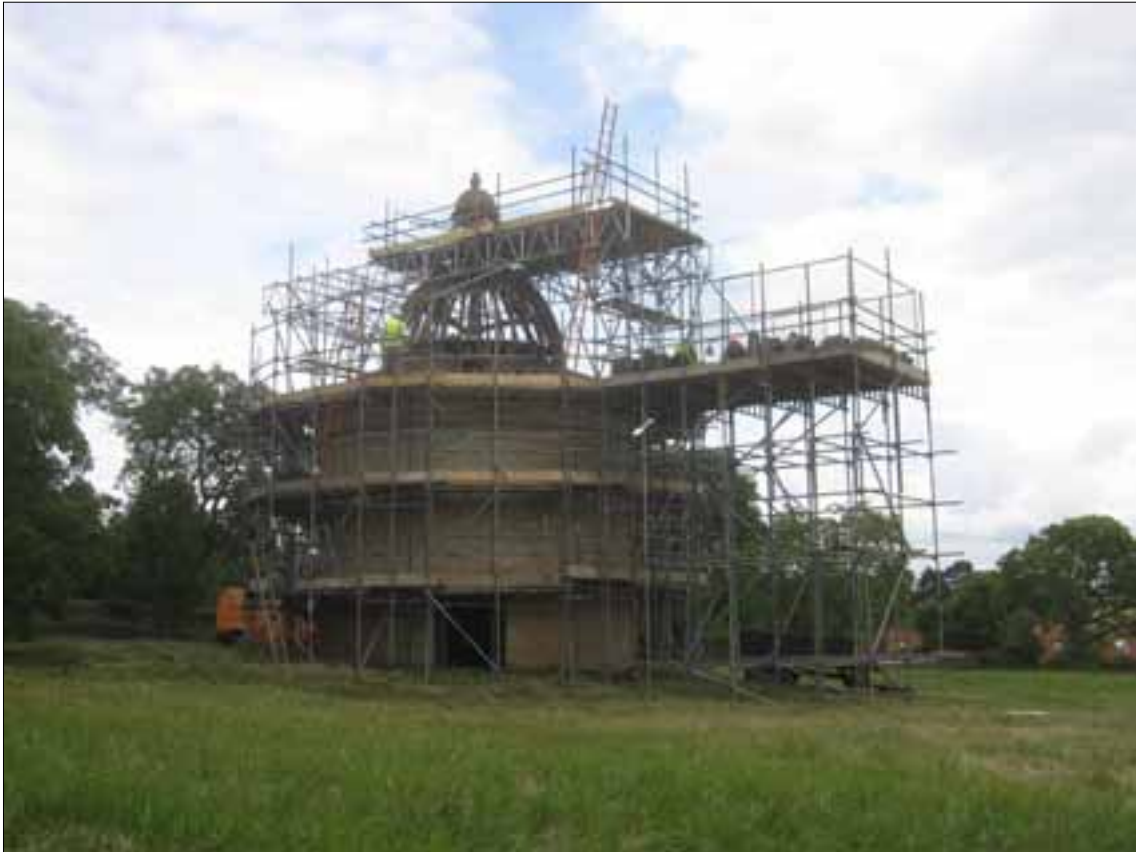
Fig 2 Works in progress, with roof covering stripped, June 2011.

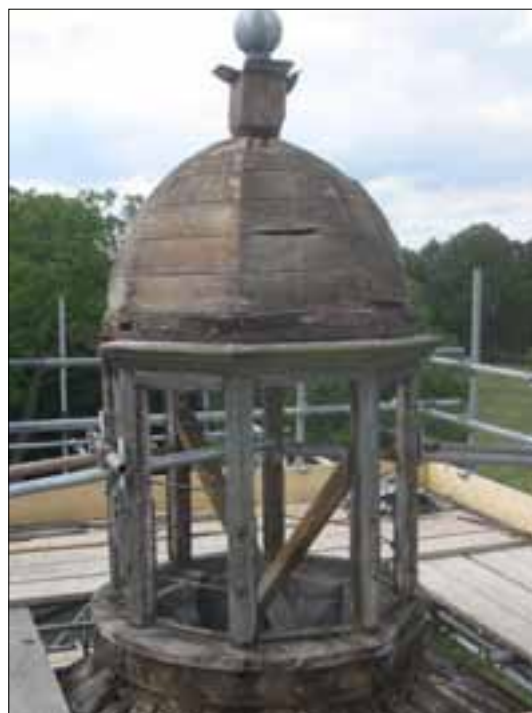
Fig 6 Lantern and cupola after roof stripping. The cupola retains its original boards, but the finial is of 20th-century date.

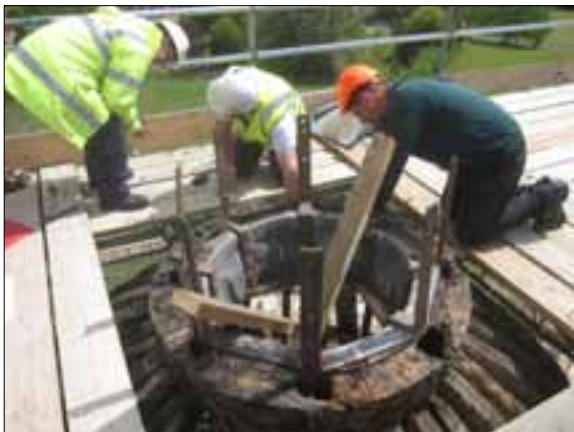
Fig 9 The two ring-beams after removal of the lantern. Note the iron straps which supported the eight posts of the lantern. These are applied over the internal lead flashing, which provided protection to the timber before the lantern was glazed.

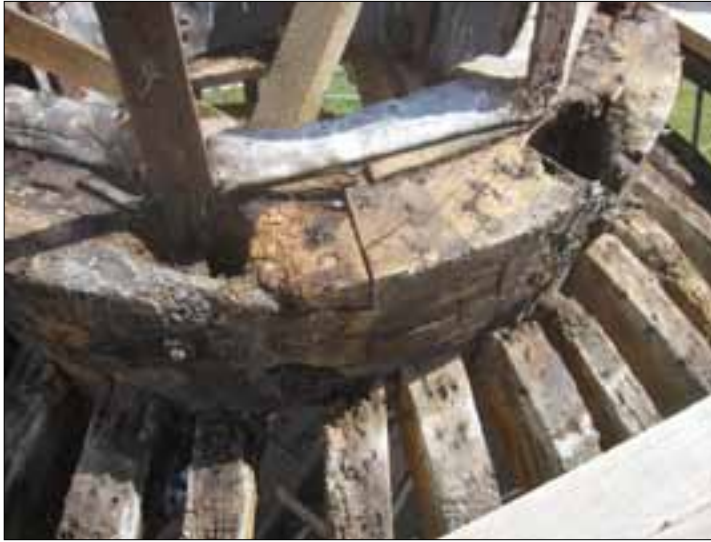
Fig 10 Detail of the upper ring-beam, with pegged, open-tenoned joints and decayed mortices for the original Glover posts.

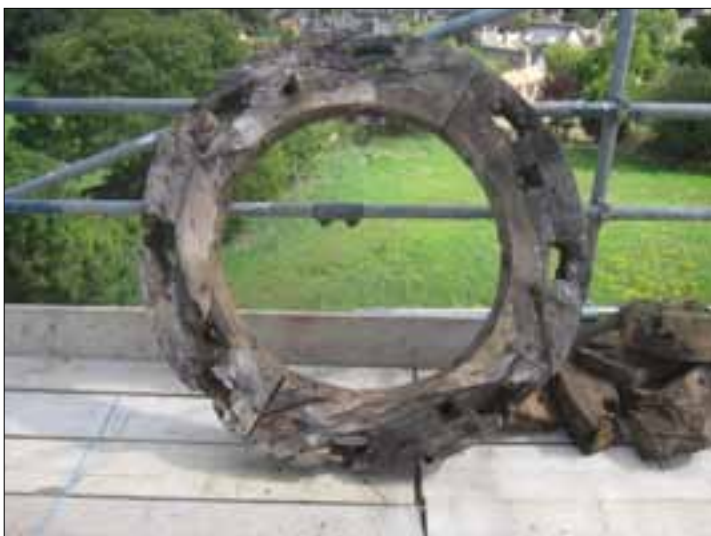
Fig 12 The upper ring-beam, formed in four sections. Note the eight decayed mortices for the Glover posts, and the four holes for forelock bolts, with square countersinking.

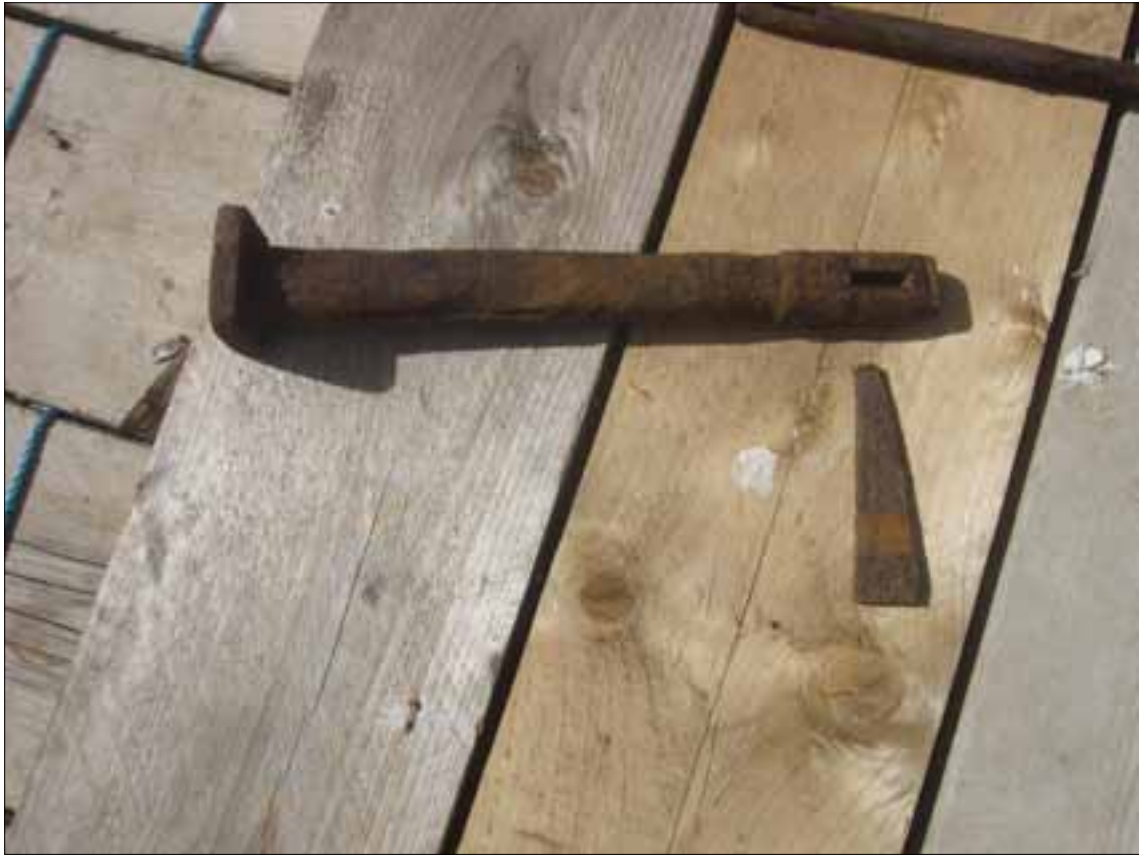
Fig 13 One of the large forelock bolts which were used to fix the upper ring-beam to the lower ring-beam. Driving the thin tapered wedge into the slot tightens up the bolt fixing. The forelock bolts are of various sizes, this being the largest.

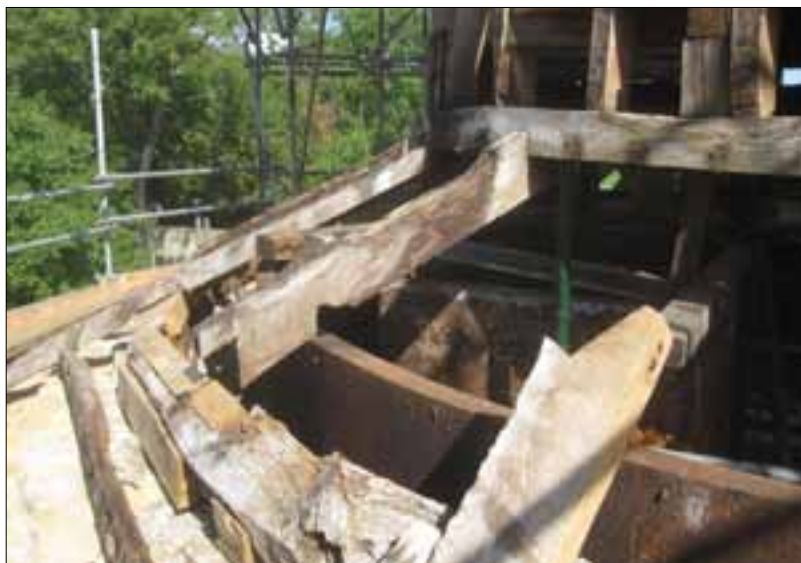
Fig 24 One of the principal rafters to the 'skirt', notched over the rim of the early 20th-century water tank.

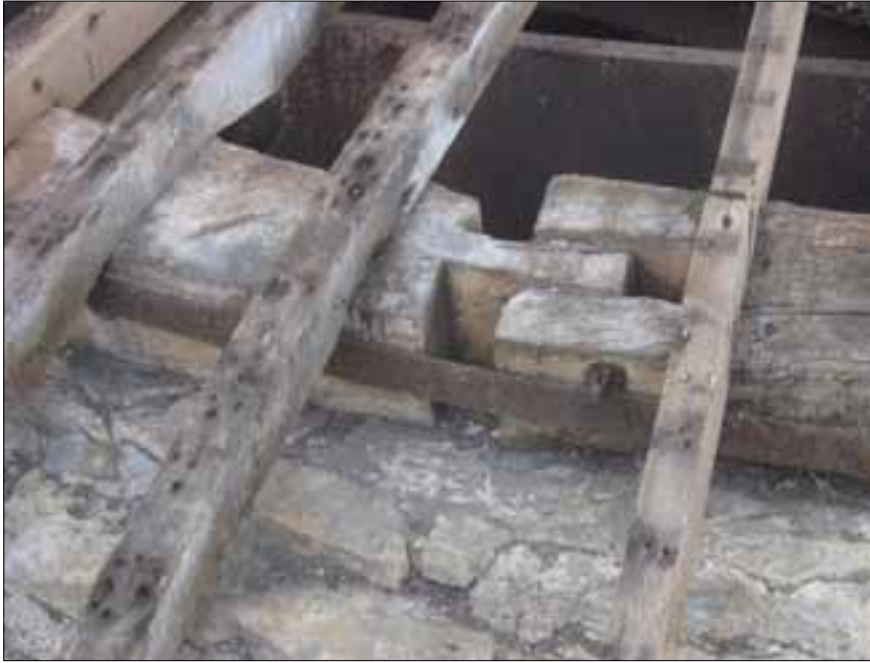
Fig 25 Joint to the wallplate, with dovetailed bridle, and failed forelock bolt fixing. The outer iron strap has been to provide restraint, after the original joint pulled apart.

However, while the structure of the main dome and lantern/cupola was well-designed and soundly constructed, the support structure of the lower 'skirt' roof was ill-conceived and proved inadequate. The whole weight of the dome had to be supported on the floating dome base plate. The forces imposed on the base plate generated considerable outwards thrust, which was intended to be restrained by the principal rafters of the 'skirt' and the dovetail-jointed ring of wallplate timbers. It was unrealistic to expect the 'skirt' structure, especially given its low pitch, to contain these forces. In spite of their forelock bolts, the wallplate joints failed under the tensile stress, and the dome suffered considerable subsidence. When the water tank structure was added in the early 20th century, with major steel beams, it provided vital support (whether by accident or design) to the dome roof, which by this stage must have been close to collapse.

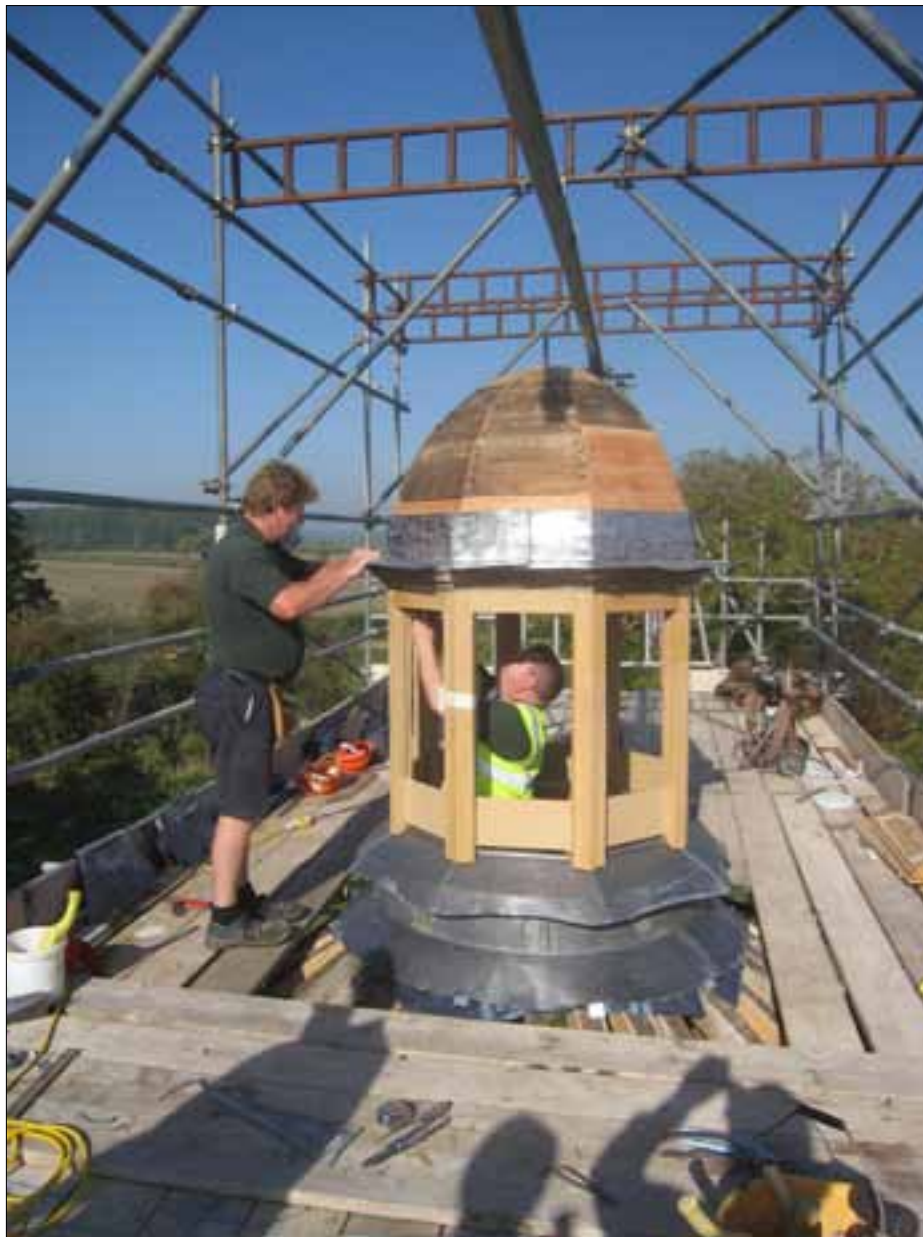
Fig 27 Reinstatement of the lantern and cupola

During the recent repairs, the cupola roof structure to the lantern was retained largely intact, including most of the original roof boarding (figs 27-28). The timber of the early 20th-century lantern structure was fully replaced, with the two iron pivot windows and leaded-light glazing reinstated. Both the upper and lower ring-beams had to be fully replaced, though the intact upper ring-beam has been left inside the building, together with a number of forelock bolts. The main dome ribs and base plate required only minor repair and re-fixing. Quite extensive repairs were needed to the lower 'skirt', but the majority of the wallplate and principal rafters remain in situ. The Collyweston slates and leadwork were fully stripped and reinstated. The water tank structure has been retained, and provides vital support to the dome base beam via added props.

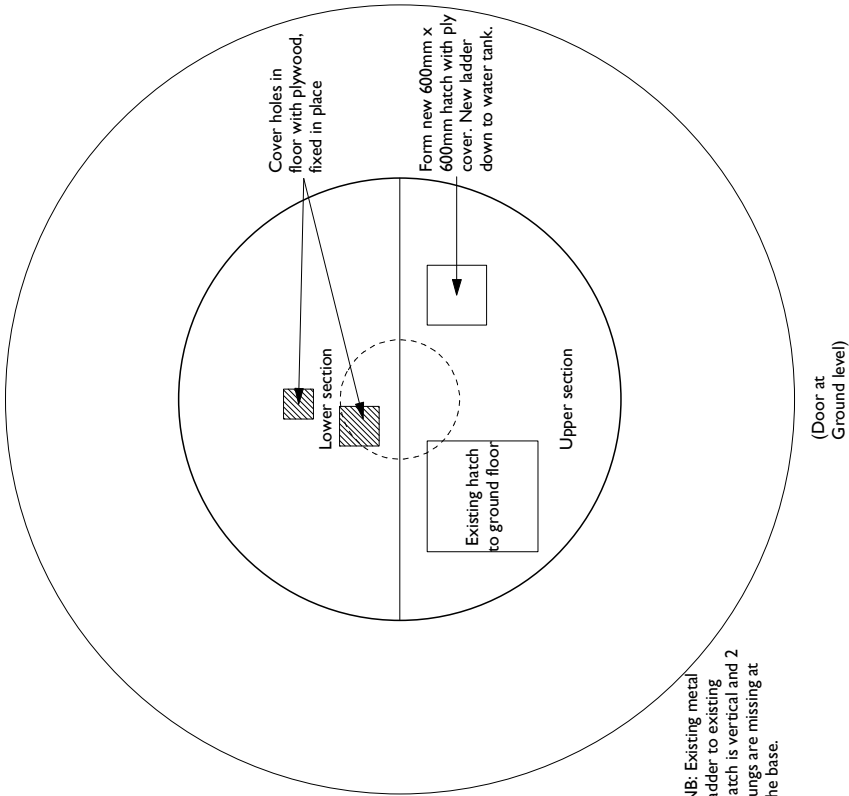
Plan at Upper Level

NB: Existing metal ladder to existing hatch is vertical and 2 rungs are missing at the base.

Clear all debris from both sections of upper level and from Water Tank
