GRASSINGTON LEAD MINES,
NORTH YORKSHIRE
A RAPID ASSESSMENT OF THE
THREATS POSED BY ROAD
MANAGEMENT AND EROSION
AN ARCHAEOLOGICAL INVESTIGATION

A rapid assessment of threats posed by road management and erosion

NGR: SE 0250 6650

Field survey August 2008 – September 2008; aerial photographs November 2008

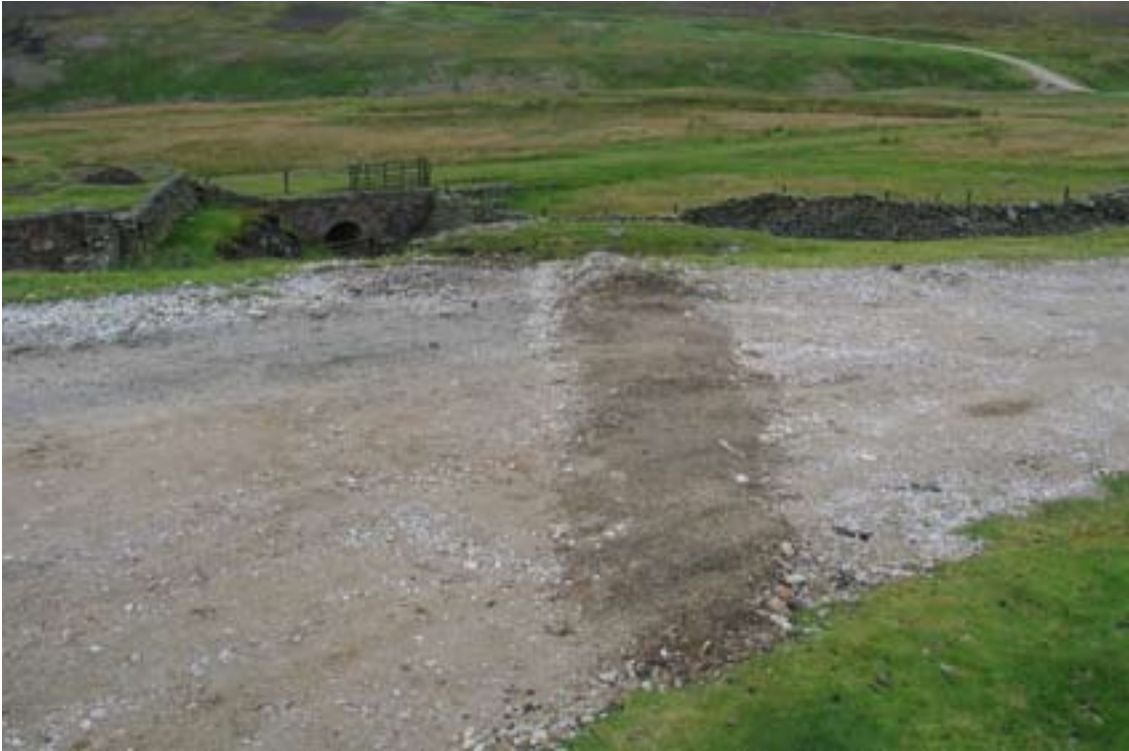
Figure 10: Example of Category 1a: deflection drain along Road 1 (85).

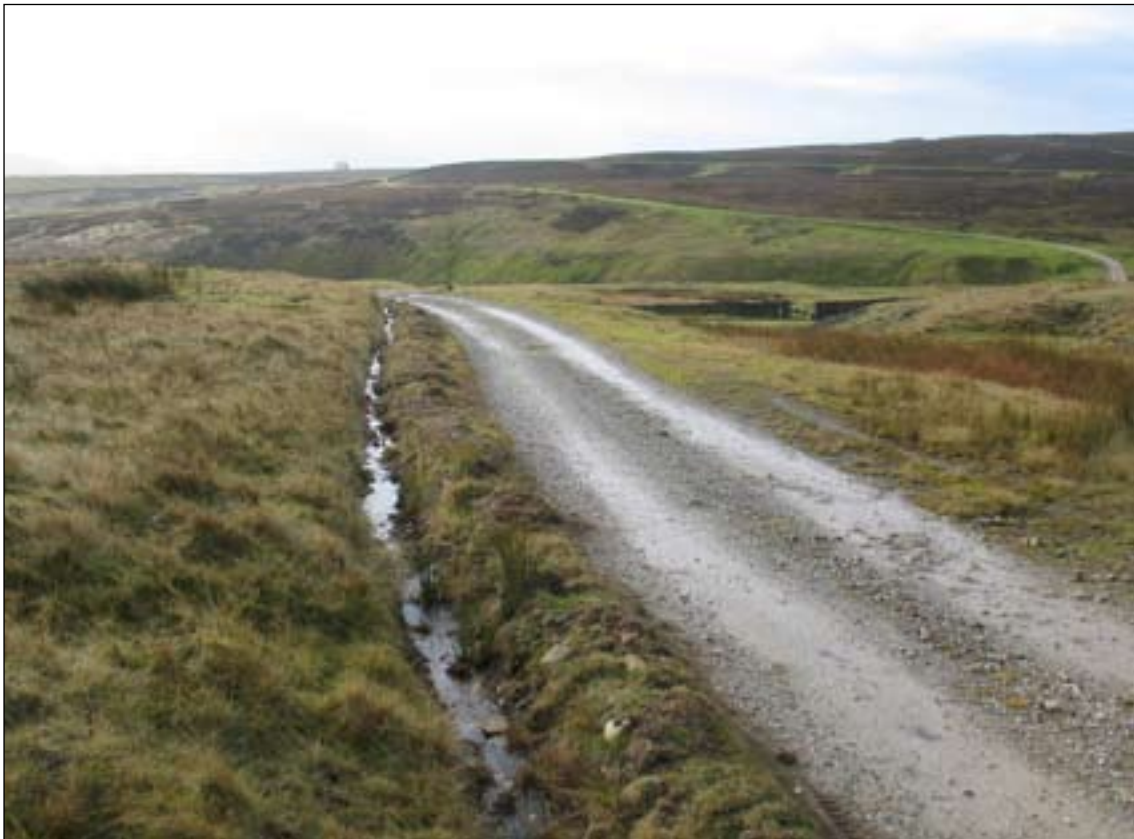
Ib: Roadside drain (Figure 11). A total of 13 instances of this type of drain were recorded. Of these, 6 (46%) are considered to be Low Risk, while 5 (39%) are Medium Risk and 2 (15%) are High Risk. Although the two High Risk instances (78; 341) have an impact on archaeological features, this method of drainage alongside the roads was one of the solutions favoured for management of water run-off when the mines were operating. The potential conservation benefits of re-activating this historic collection and distribution mechanism as part of a long-term management plan requires consideration (this is discussed further below).

Figure 11: Example of Category 1b: roadside drain along Road 1 (108).

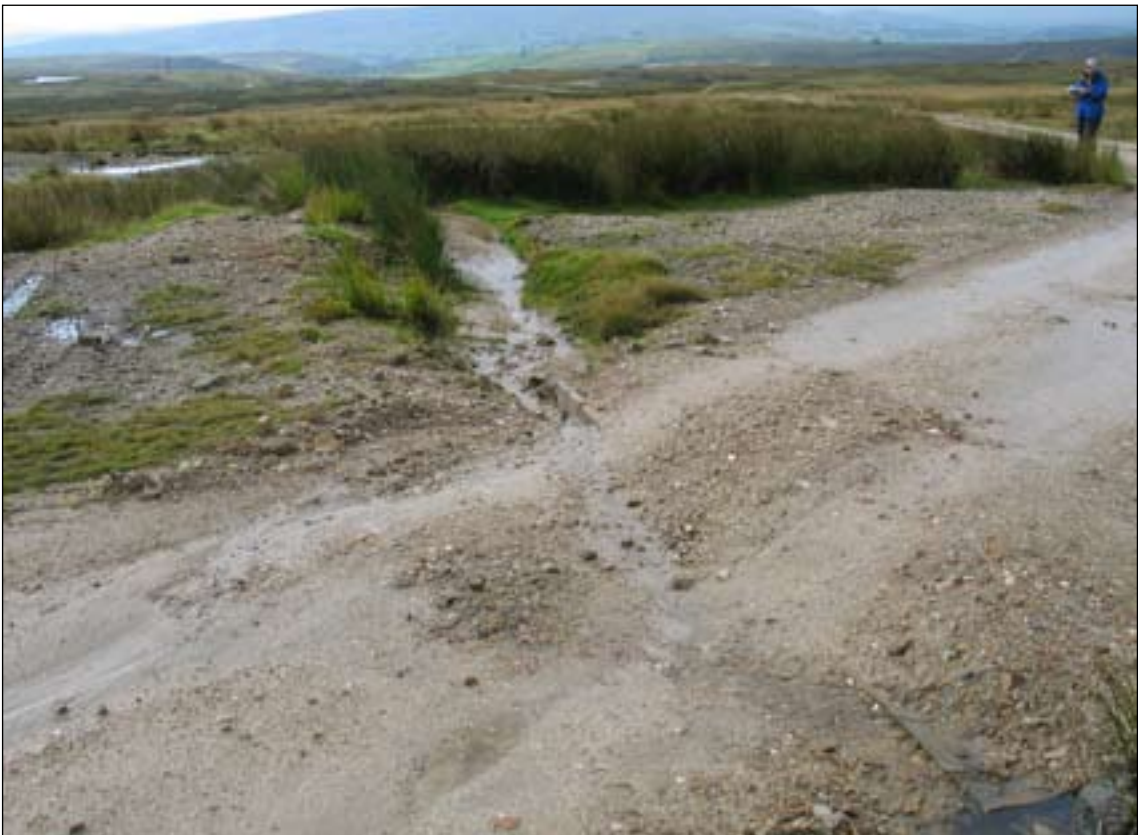
Figure 13: Example of Category 1d: wooden-trough drain along Road 1 (327).

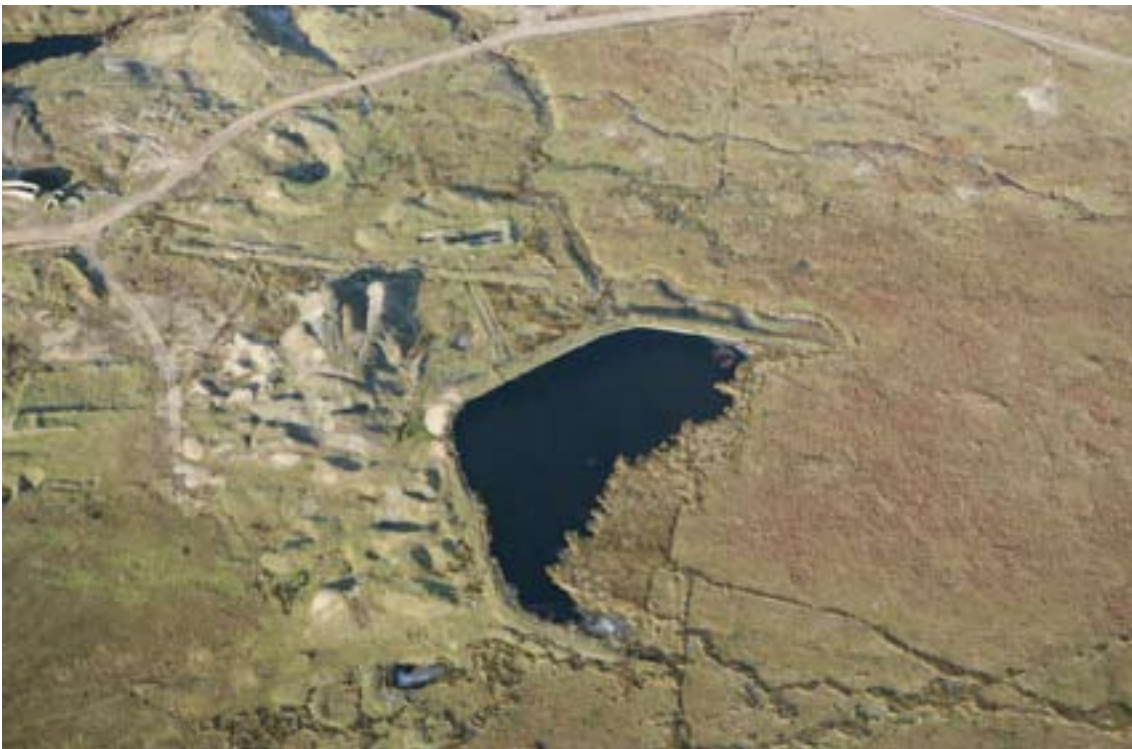
Figure 17: Example of Category 1g: oblique aerial photo showing standing water (artificial origins) (184 – Coalgrove Beck Dam). NMR 20843/040 25-NOV-2008 © English Heritage. NMR.

Ig: Standing water (artificial origins) (Figure 17). Within the Scheduled area are a number of reservoirs and small ponds which still contain standing water. All can be identified as integral components of the mining landscape and its historic water management. Although the historic reservoirs and ponds are largely neutral features in terms of erosion, they act as reservoirs which feed active erosion, and at times of increased precipitation they are the source of concentrated discharges along certain artificial and natural watercourses (now in the form of unmanaged overflows). The larger reservoirs and dams are inevitably at risk of breaches when they are no longer actively maintained. This type of discharge can concentrate flows into gully patterns because of the volume and speed at which the water is released. As reservoirs and ponds originally discharged into managed leat systems to feed dressing floors and so on, the overflows from these features will now tend to follow the same pattern after precipitation episodes, except

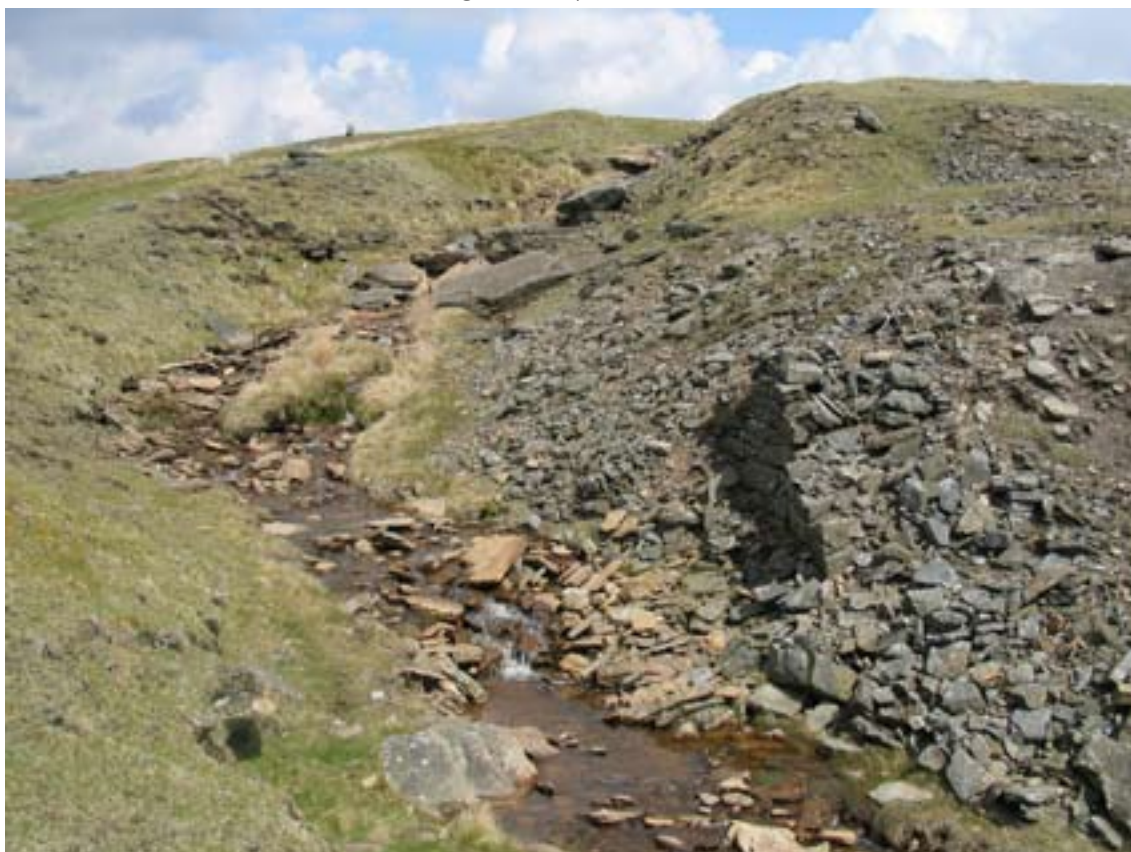
Figure 19: Example of Category 1h: natural watercourse (532). The Coalgrove Beck is the main stream through the survey area. The results of erosion and collapse of fabric can be seen here close to the site of the late 17th-century High Smelt Mill site (95). See also Figure 36.

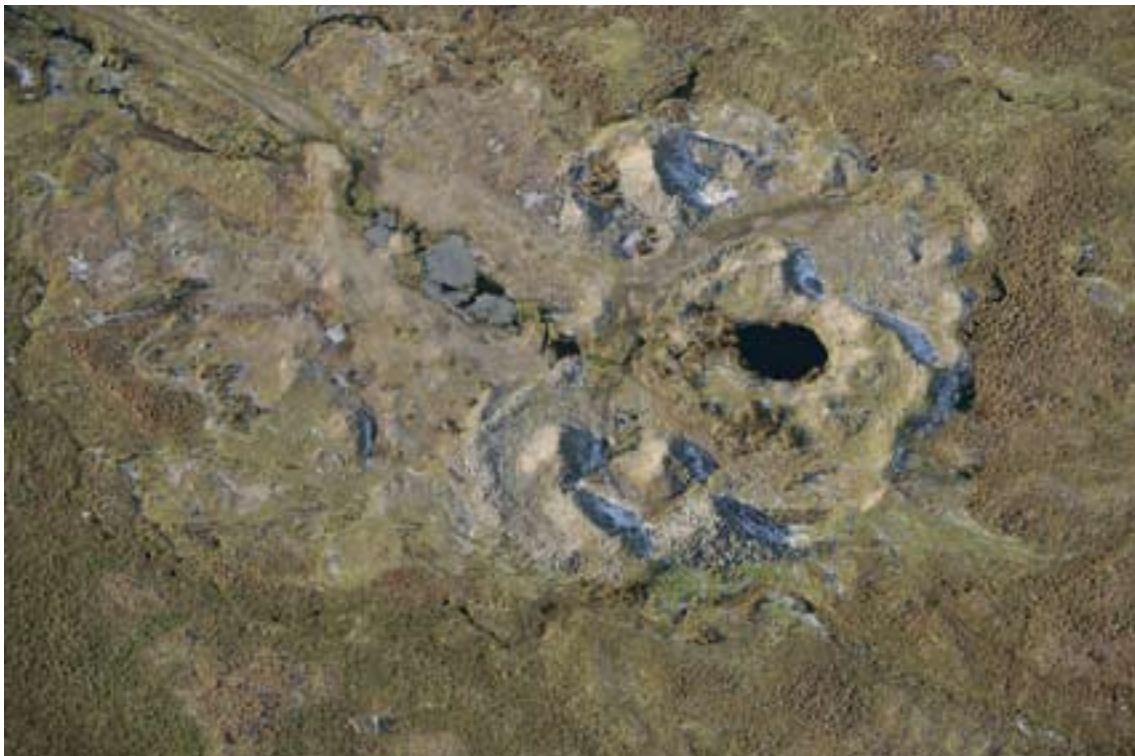
Figure 21: Example of Category 2a: oblique aerial photograph showing historic extraction of material for mineral re-working at Turf Pits Mine (399). NMR 20846/015/25-NOV-2008 © English Heritage. NMR.

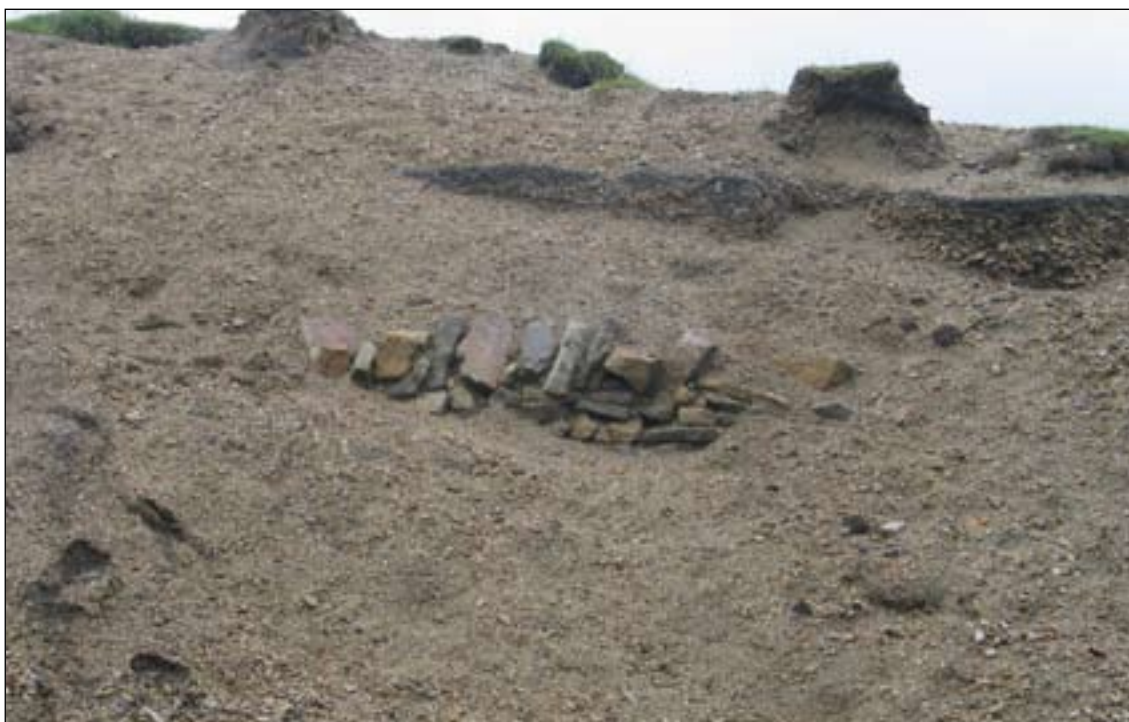
Figure 22: Example of Category 2b: recent extraction of material for road maintenance. Buried structural detail exposed by digging (505).

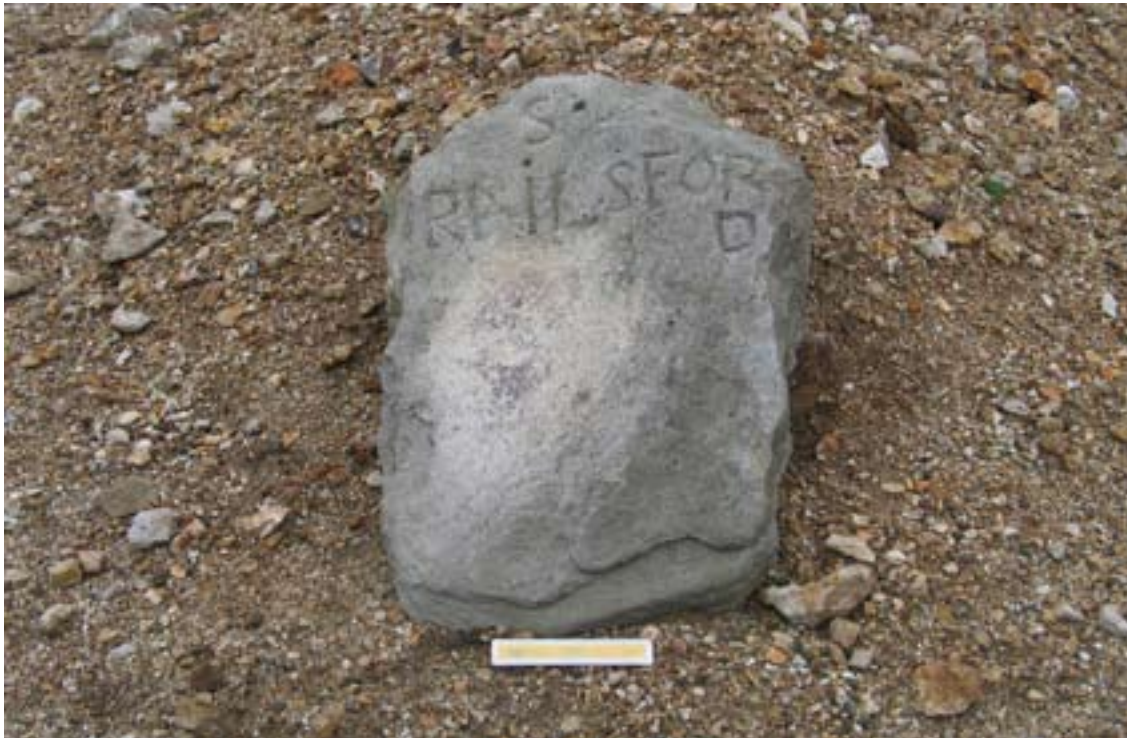
Figure 24: Meerstone lying loose on the surface (336).

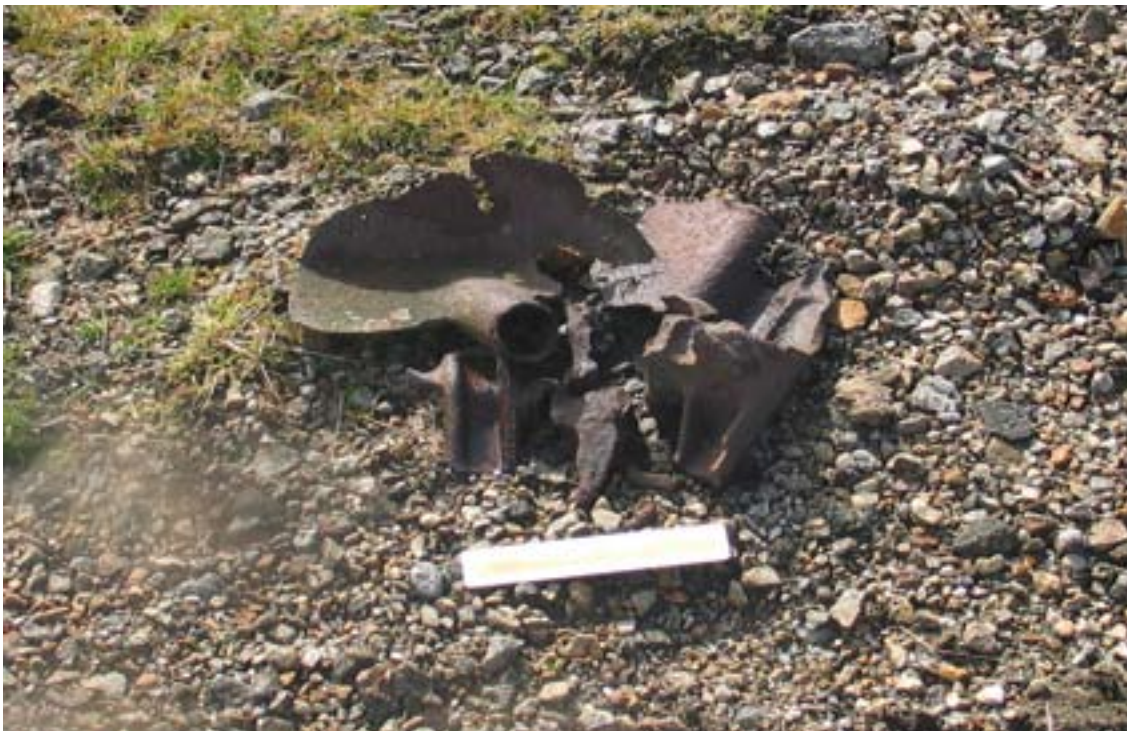
Figure 25: Example of Category 2b: recent extraction of material for road maintenance. Metal artefacts lying exposed on the surface (391).

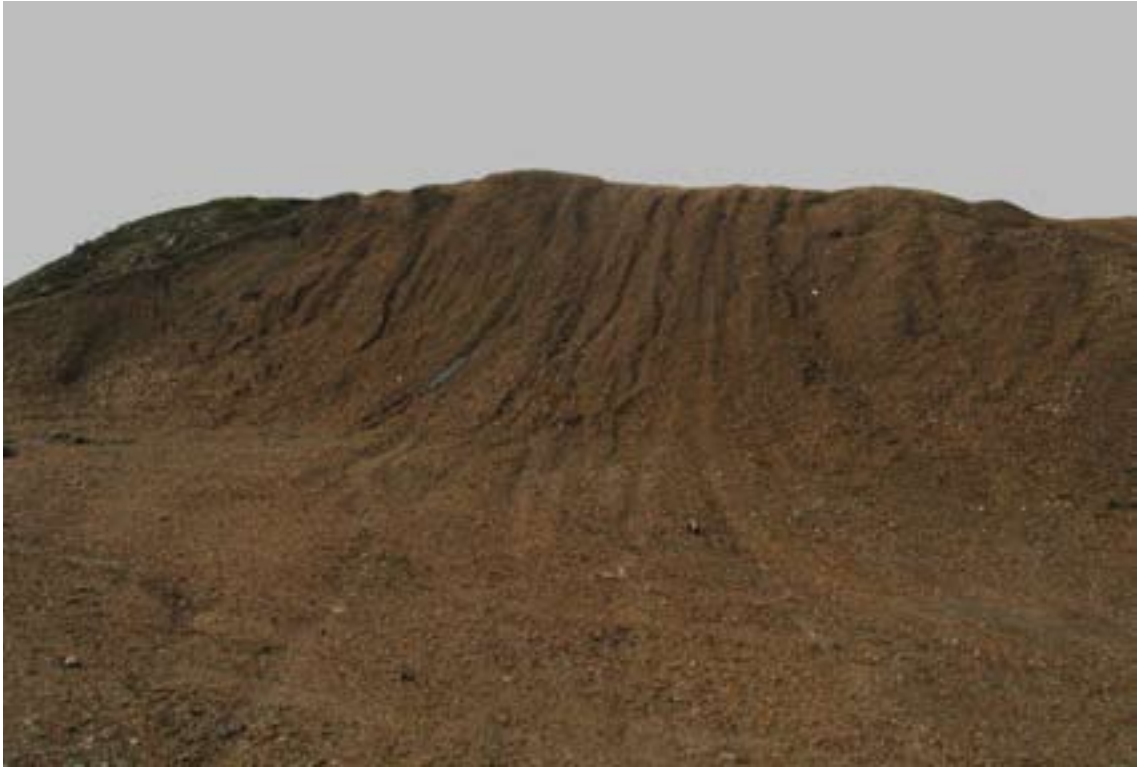
Figure 26: Example of Category 3a: vehicle (type 1). Large numbers of vehicle tracks over the spoil mound suggest recreational 'off-roading' (484).

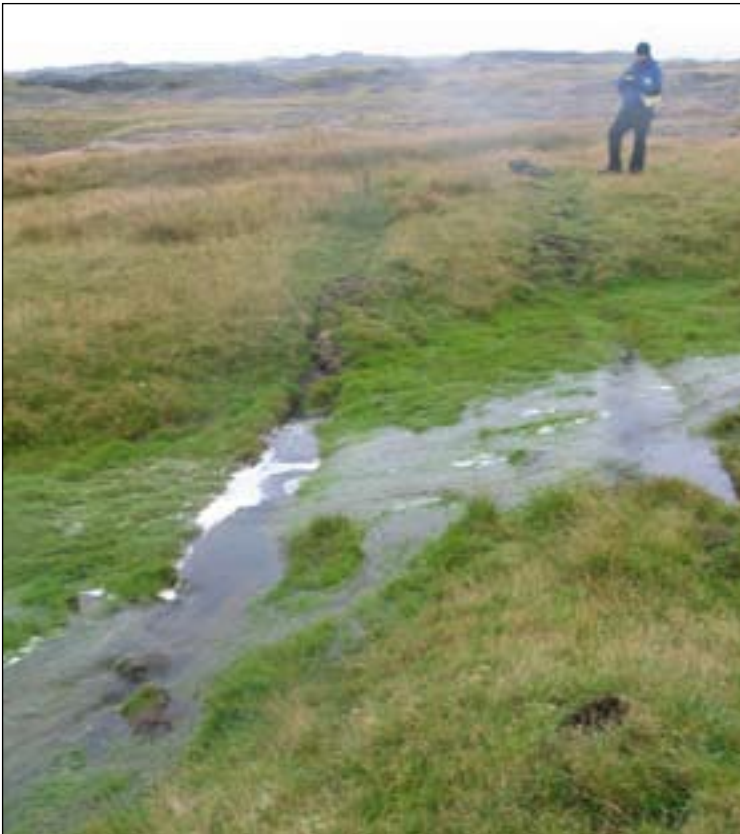
Figure 27:
Example of Category 3b:
vehicle (type 2).
During fieldwork it was noted
that deep ruts were being
cut in soft ground by a heavy
tractor turning off the road
(392).

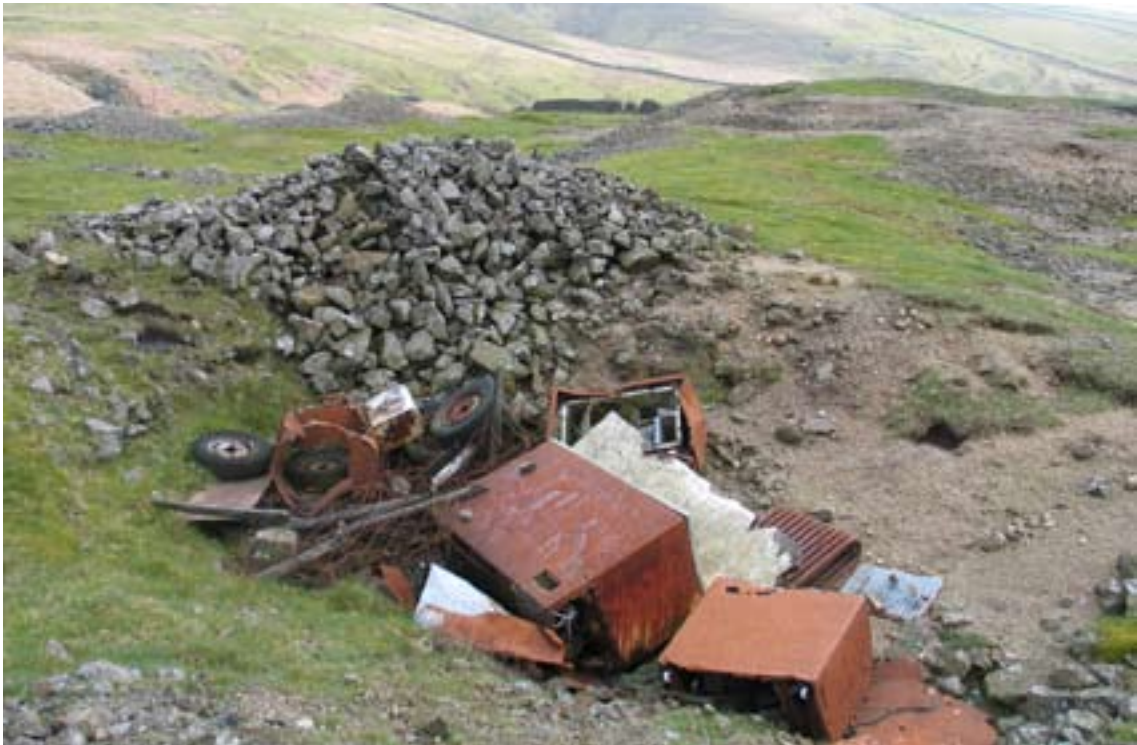
Figure 28: Example of Category 3c: dumping/tipping. Dumping of farm and domestic rubbish in an area of shafts and dressing floors (48).

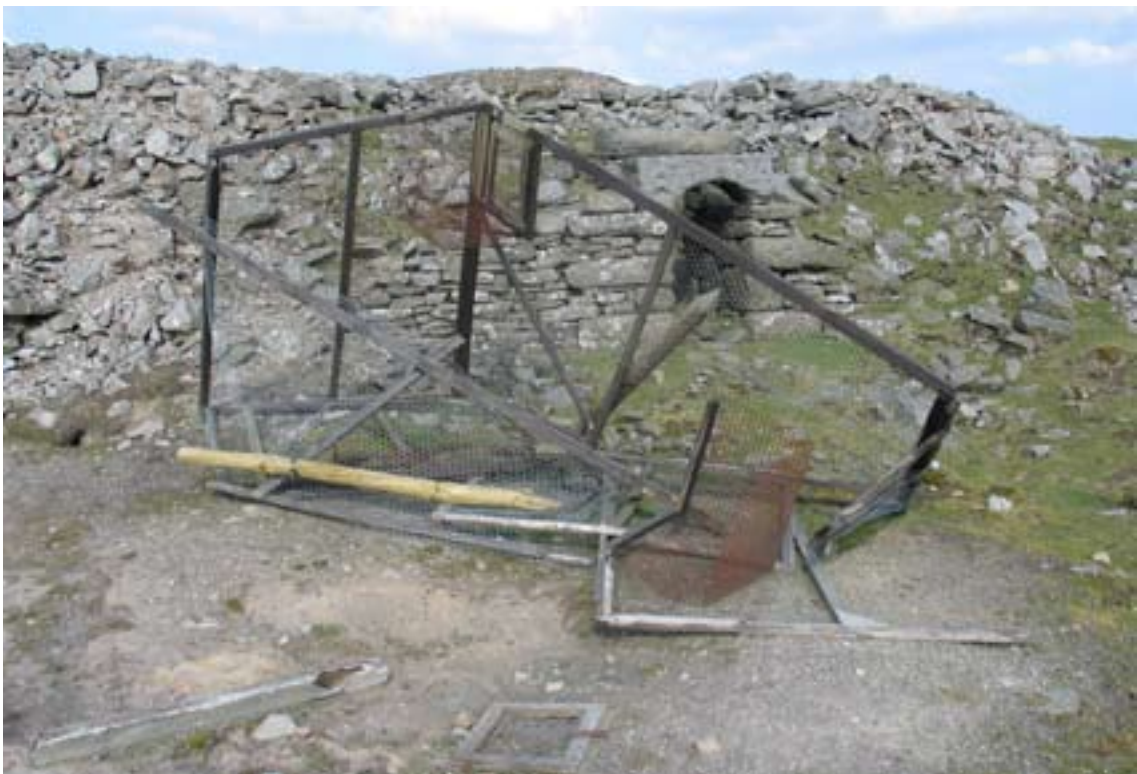
Figure 29: Example of Category 3c: dumping/tipping. Abandoned bird-feeding cage/crow trap? (261)

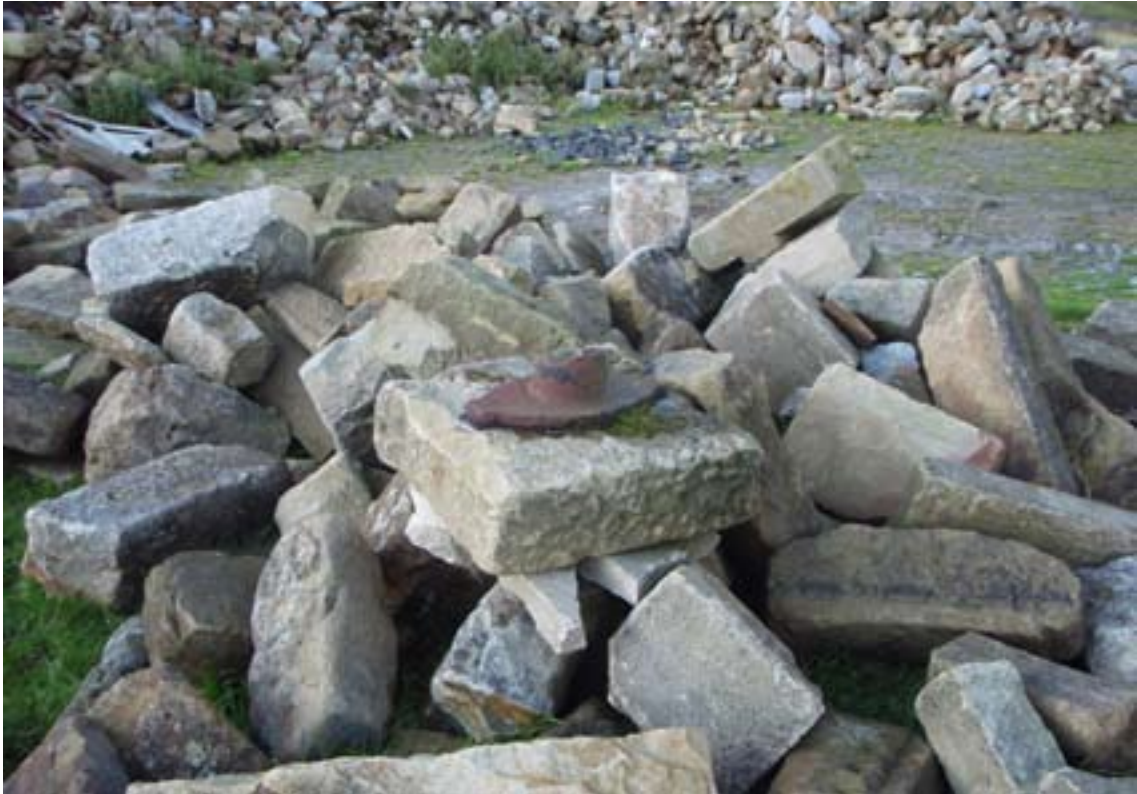
Figure 30: Example of Category 3d: stone gathering. Collection of stones, including dressed and architectural items piled close to Road 4, immediately outside the Scheduled area (395/396).

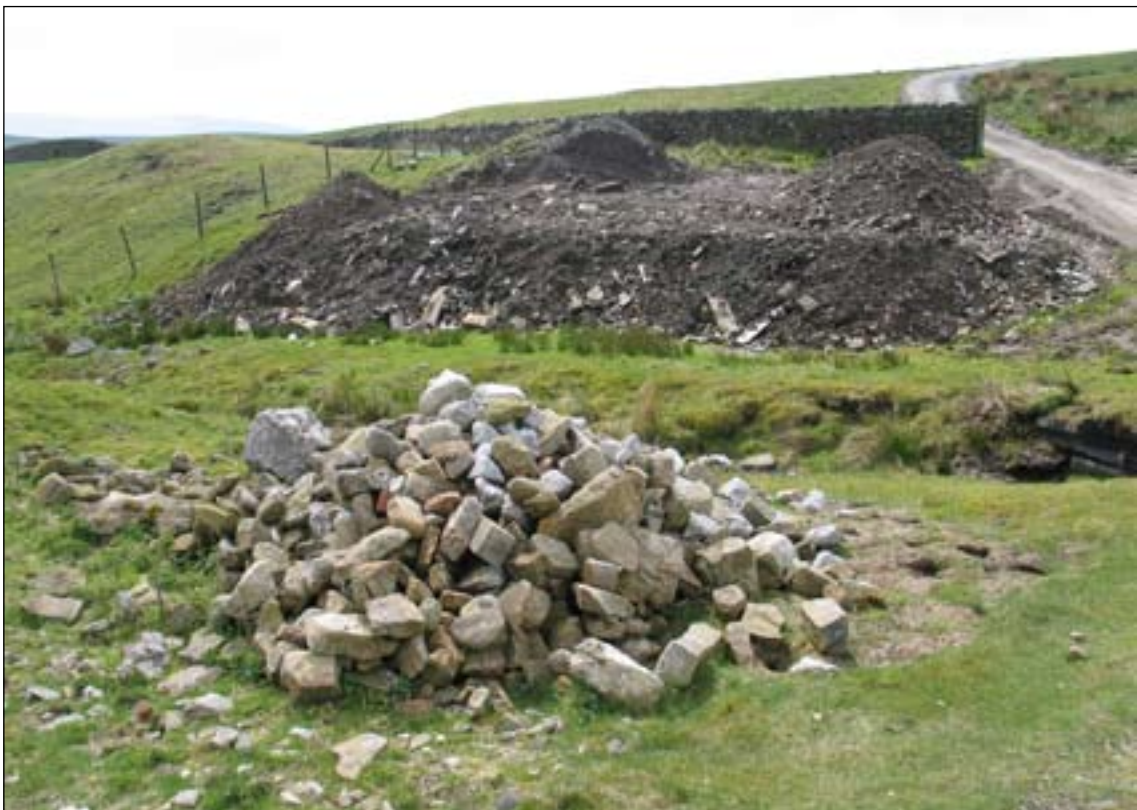
Figure 31: Example of Category 3d: stone gathering. Collection of stones, including dressed and architectural items piled close to Road 4, immediately inside the Scheduled area (549).

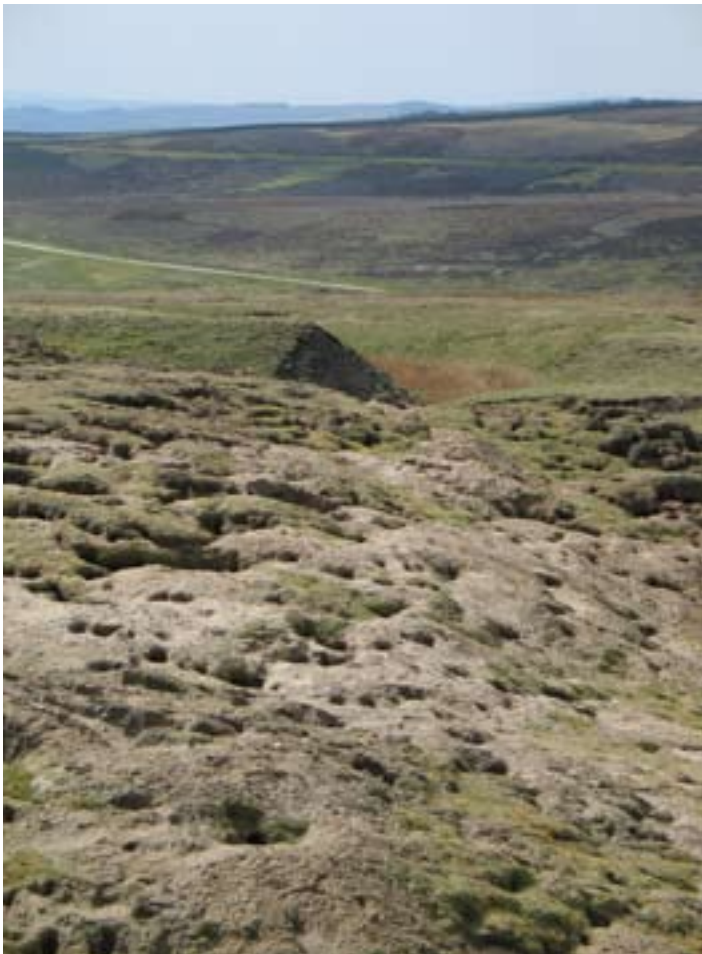
Figure 32: Example of Category 3e: animal. Extensive area of rabbit burrowing (118) in the area of the former Dales Chemical Company Plant.

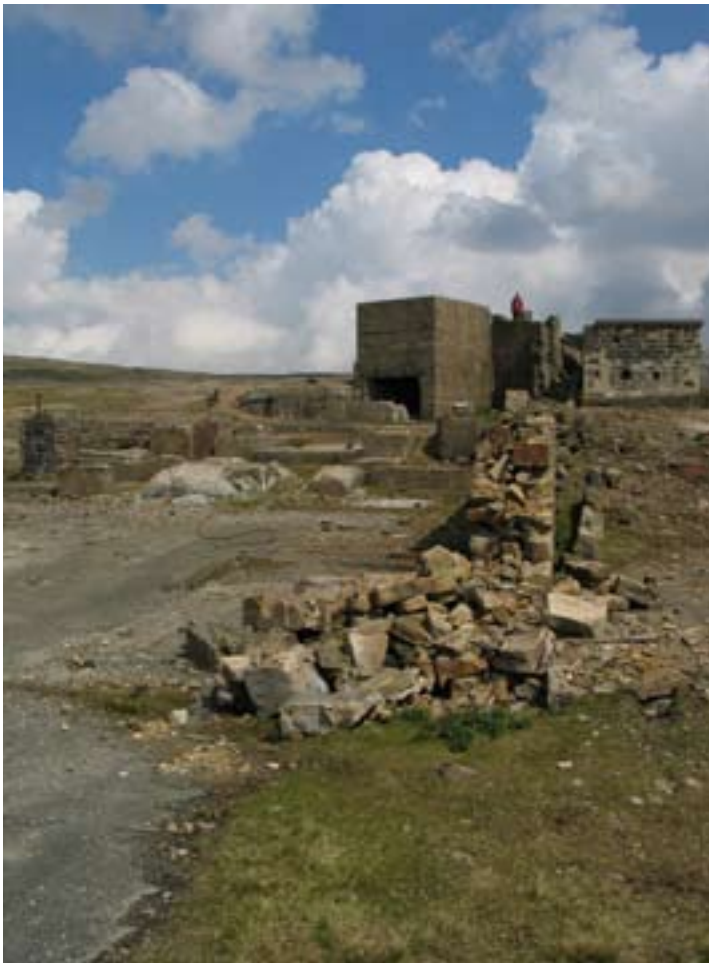
Figure 33: Example of Category 3f: visitor impacts. Visitors were observed climbing on the ruins of the Dales Chemical Company plant and the High Grinding Mill (in the background) and may have contributed to the collapse of fabric in this area (126).

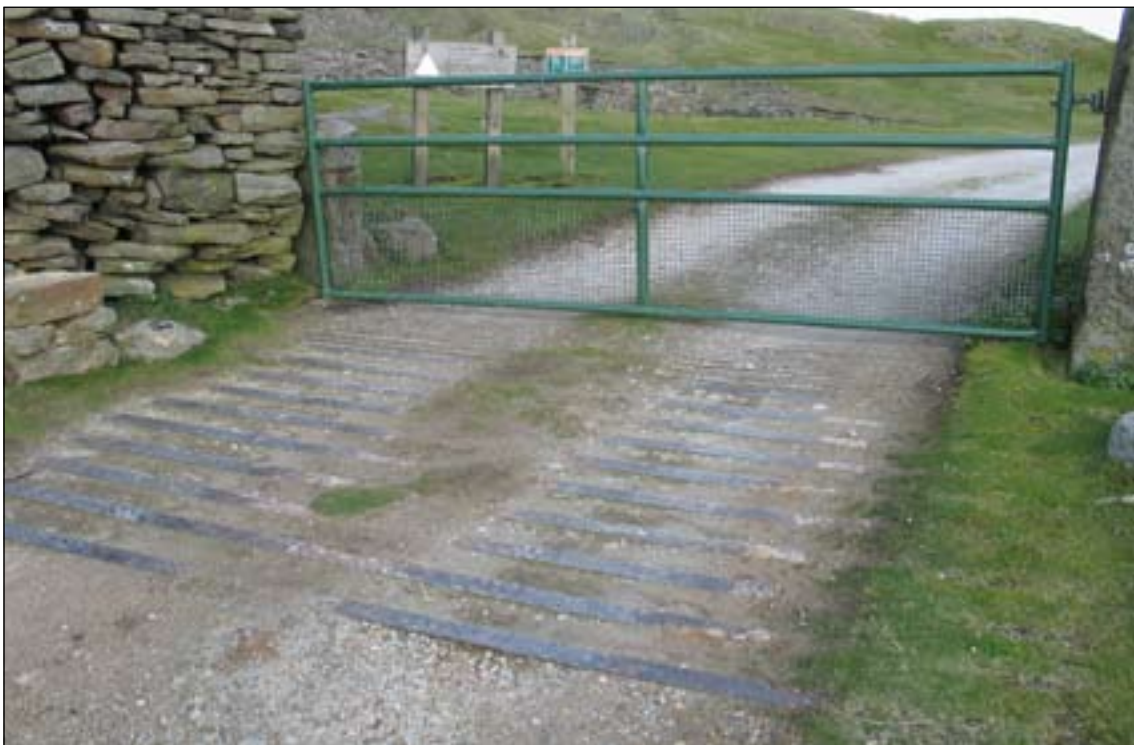
Figure 34: Example of Category 3g: miscellaneous. Cattle-grid (257) sunk into Road 1.

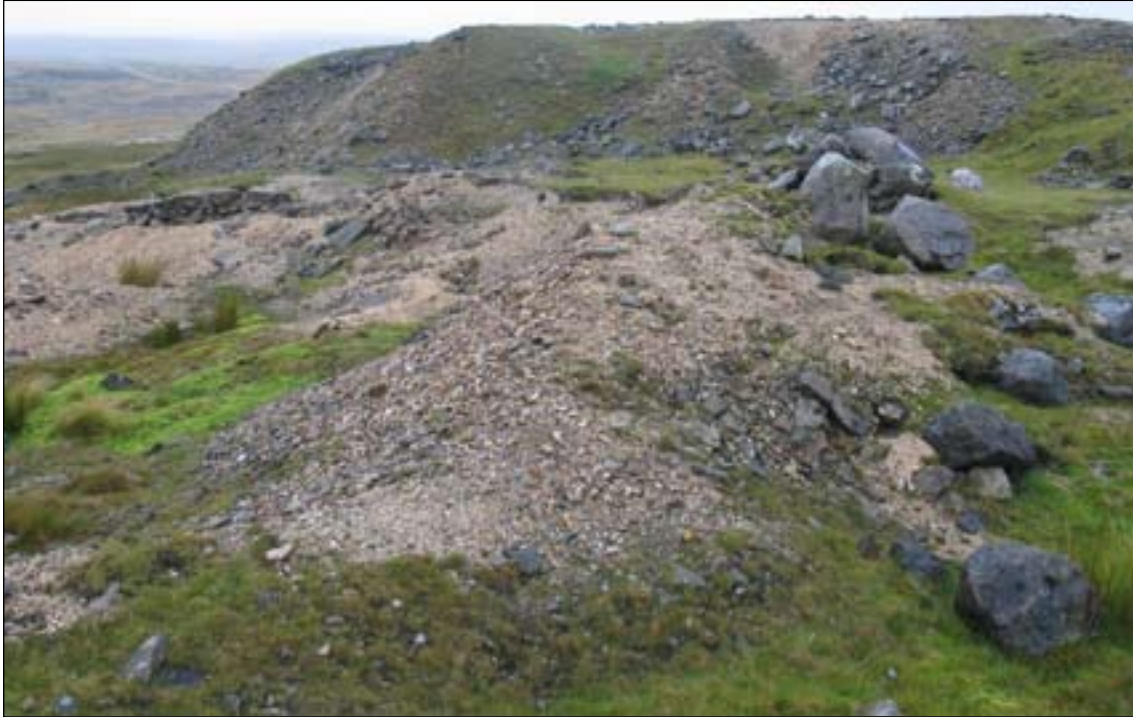
Figure 35: Example of Category 3h: removal of boulders. Boulders may have been moved from this area (205) to provide armour for a nearby culvert.

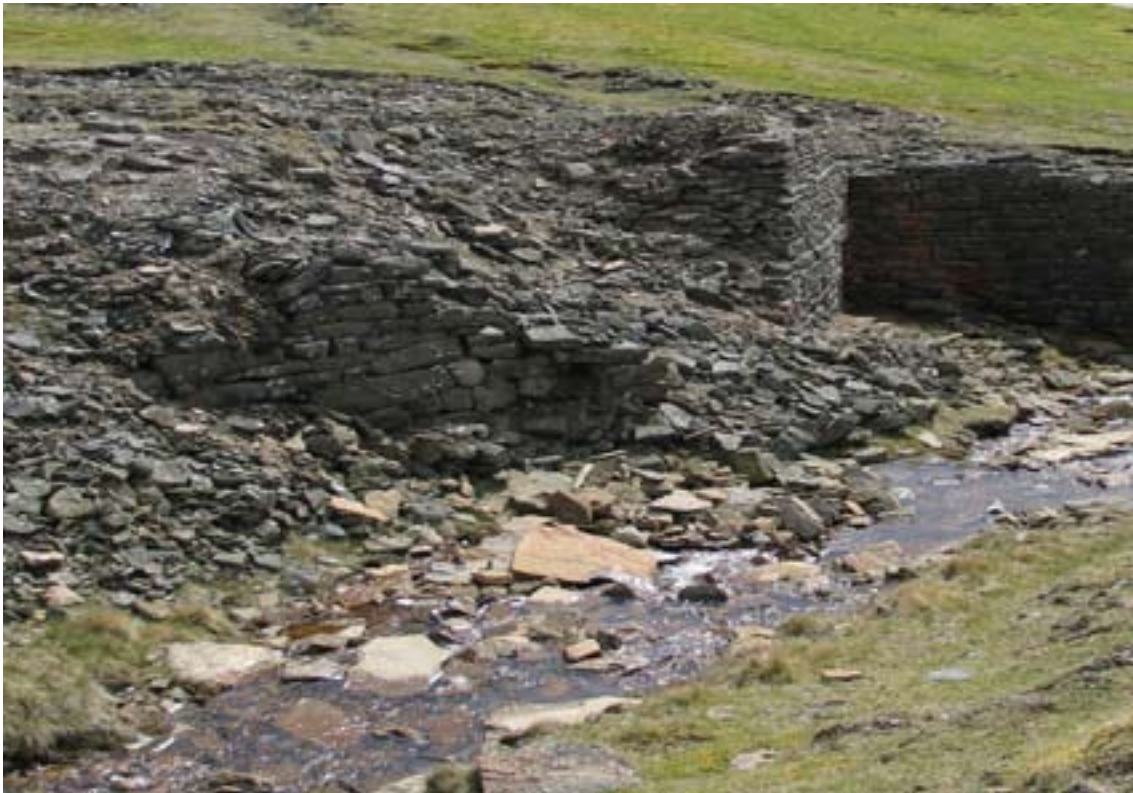
Figure 36 Example of Category 3i: collapse. Erosion along the Coalgrove Beck is causing collapse of structures (95) close to the site of the late 17th-century High Smelt Mill site.

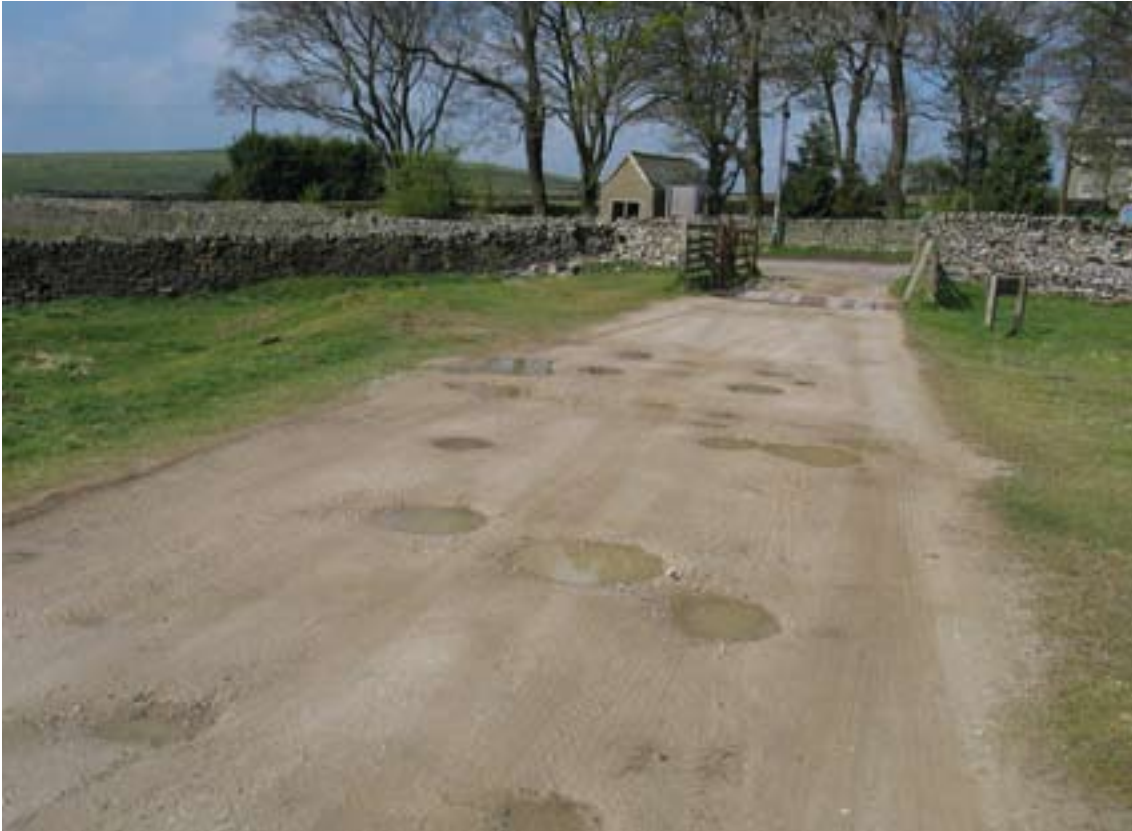
Figure 38: Example of Category 3j: pot-holes (8).

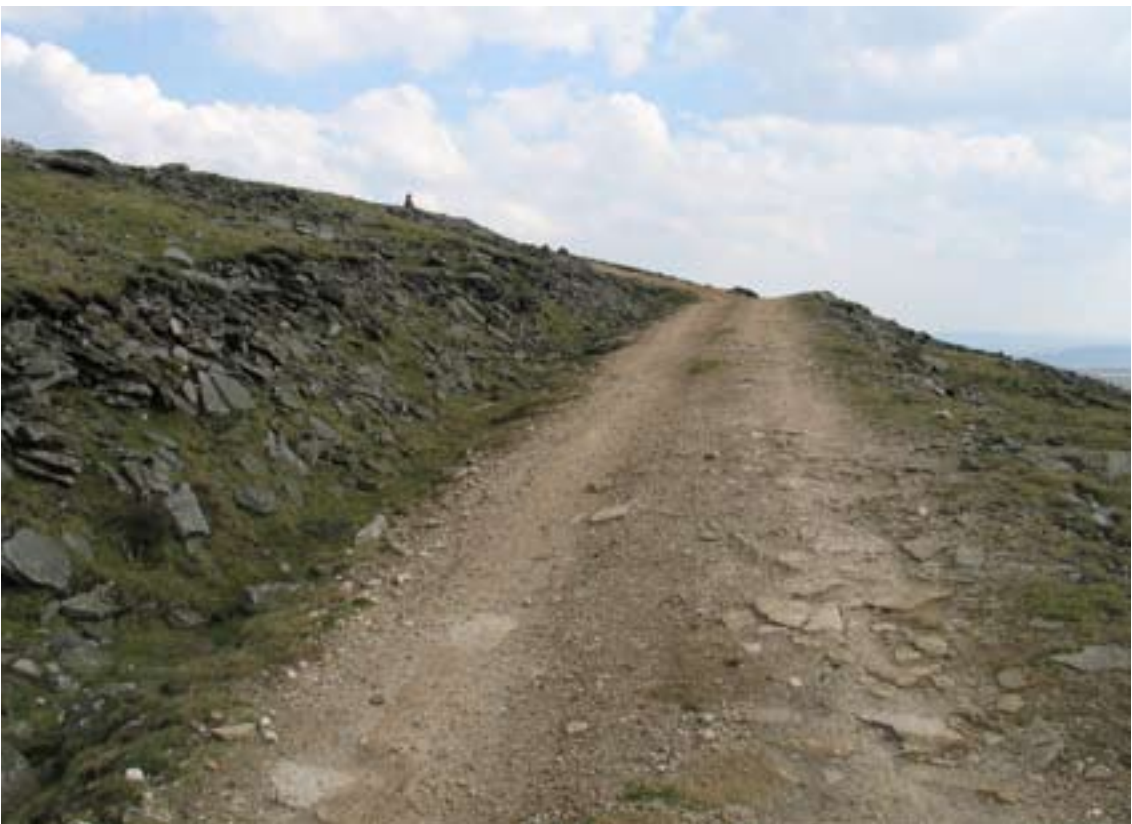
Figure 39: Example of Category 3k: scraping of road surfaces (546).

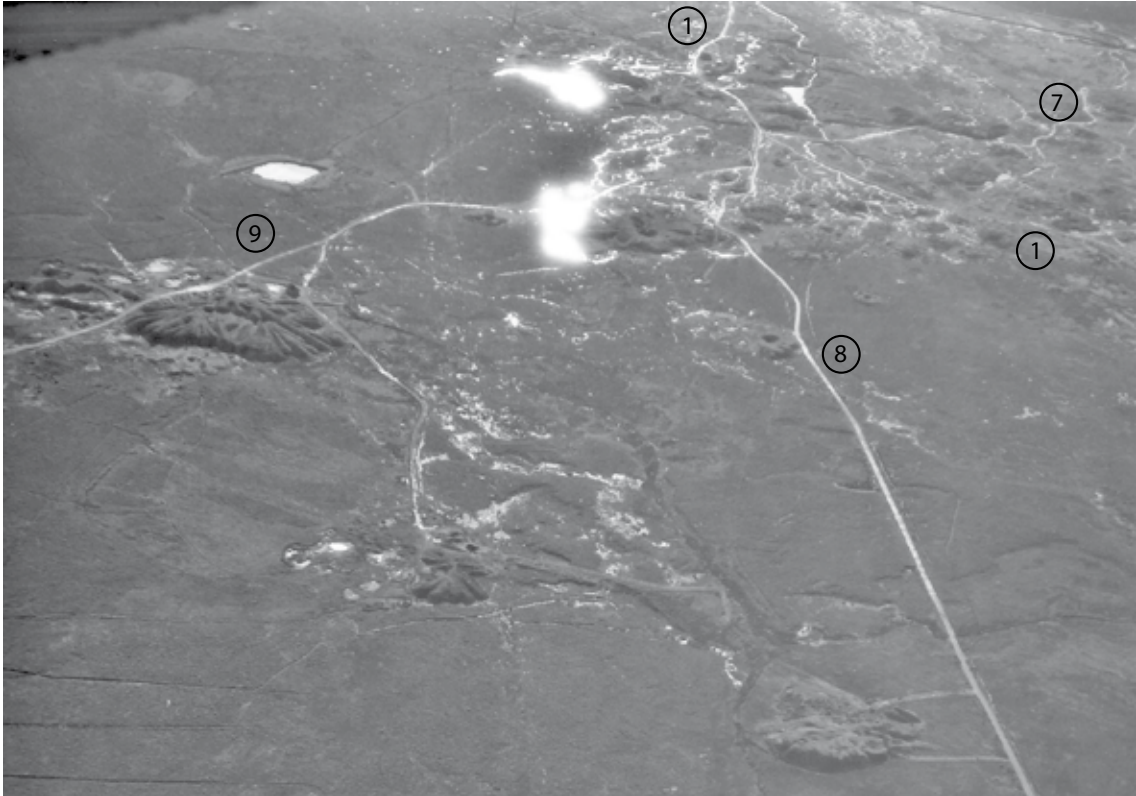
Figure 45: The area around the junctions of Roads 1, 7, 8 and 9 photographed after heavy rain in 1992. Reflections indicate where water was flowing along the complex matrix of hydrological flowpaths in this area. © Crown Copyright. NMR. SE0367/2 03-MAR-92 NMR 12228/023.

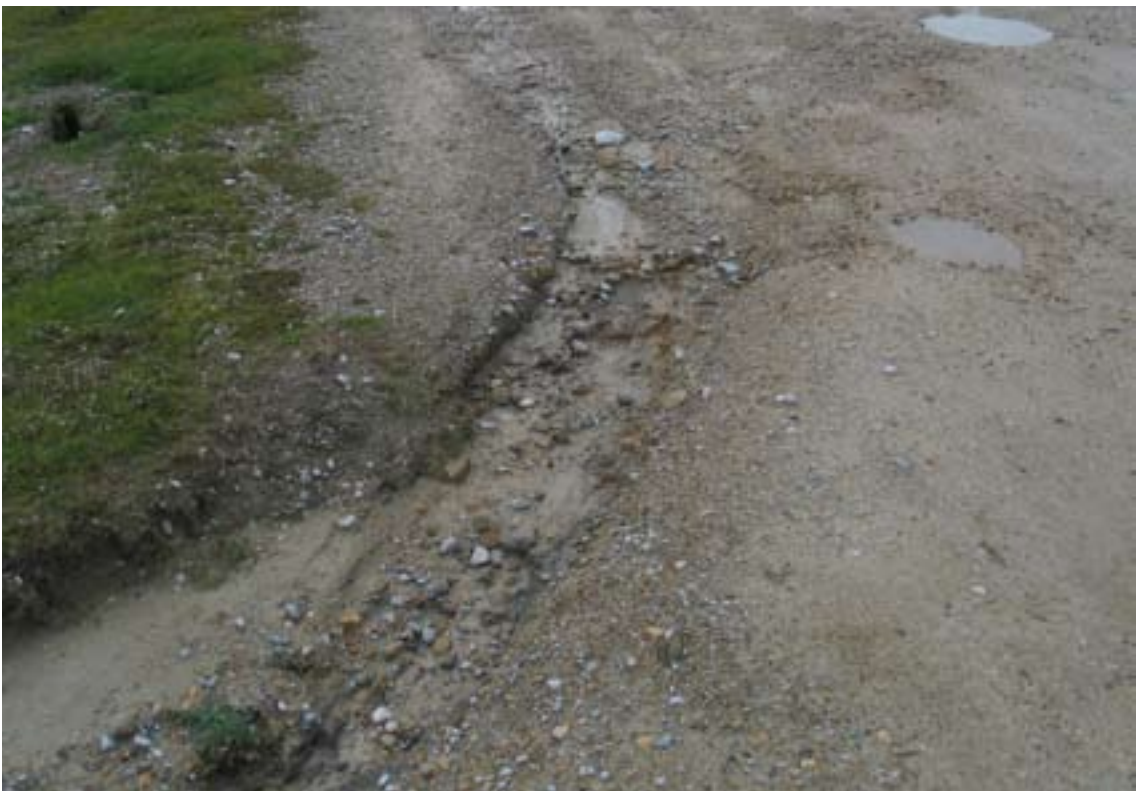
Figure 46: Gully erosion along Road 1 (8). The presence of pot-holes here may be contributing to the problem.

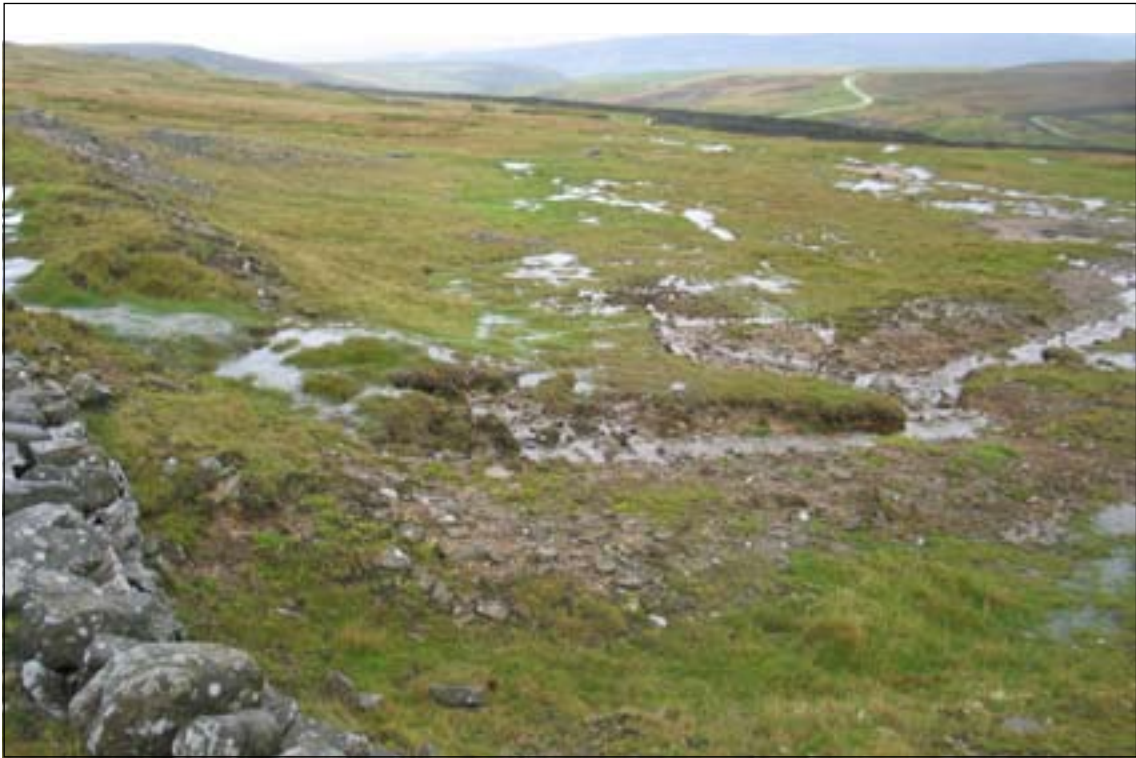
Figure 47: Gully erosion developing where leat (365) has been breached.
