GRASSINGTON LEAD MINES,
NORTH YORKSHIRE
A RAPID ASSESSMENT OF THE
THREATS POSED BY ROAD
MANAGEMENT AND EROSION
AN ARCHAEOLOGICAL INVESTIGATION

A rapid assessment of threats posed by road management and erosion

NGR: SE 0250 6650

Field survey August 2008 – September 2008; aerial photographs November 2008

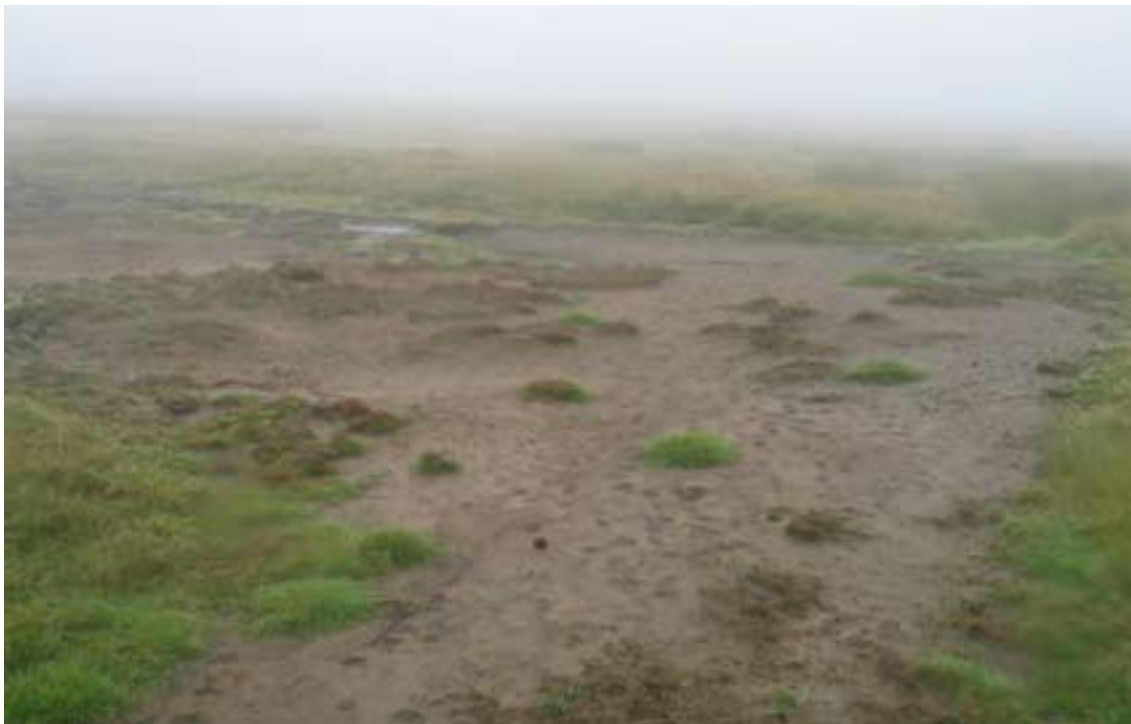
Figure 48: Sheet erosion where soils have been lost (272). Photograph taken in low cloud/ driving rain.
