The Use of Multi-Image Photogrammetry to Record At-Risk Archaeological Material from the Wreck of *Invincible*

Dan Pascoe, Ben Jones and Grant Cox

**PROJECT REPORT
2017**

May 2017

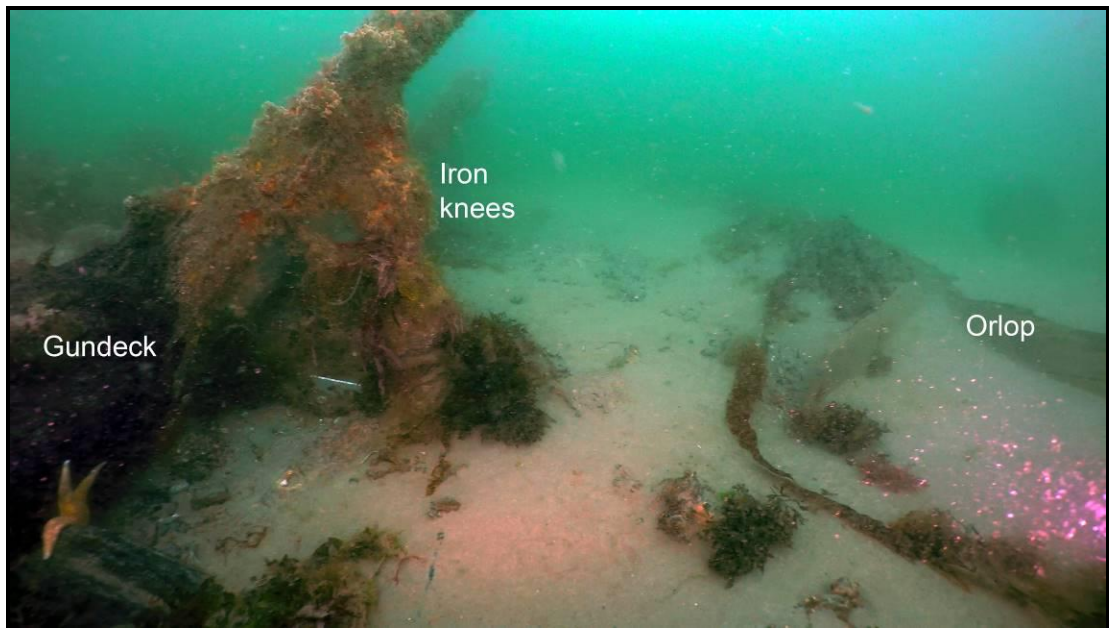
- 5.2.1. This area extends from the very point of the bow back to the third gunport and down to the floor of the hold. In this area, the entire remains of the gundeck are exposed. Below the remains of the gundeck are three upstanding iron knees, below which is the orlop. The space between the knees and deck beams of the orlop has been scoured exposing more of the ship's cable and a pine-clad deck. There is a 10m exposed section of the orlop consisting of the tops of deck beams, half beams and sections of deck planking clad with pine. Lying on top of much of the orlop are piles of cable (Figure 2-4).

Figure 2: View looking NW between gundeck and orlop © PAS.

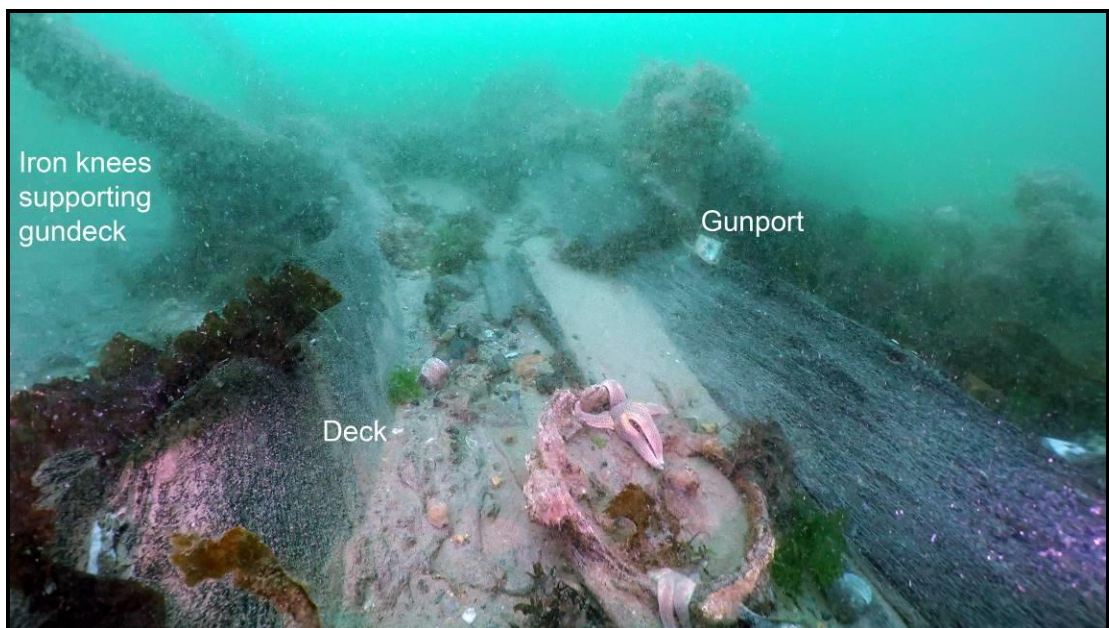
Figure 3: View looking SE along gundeck © PAS

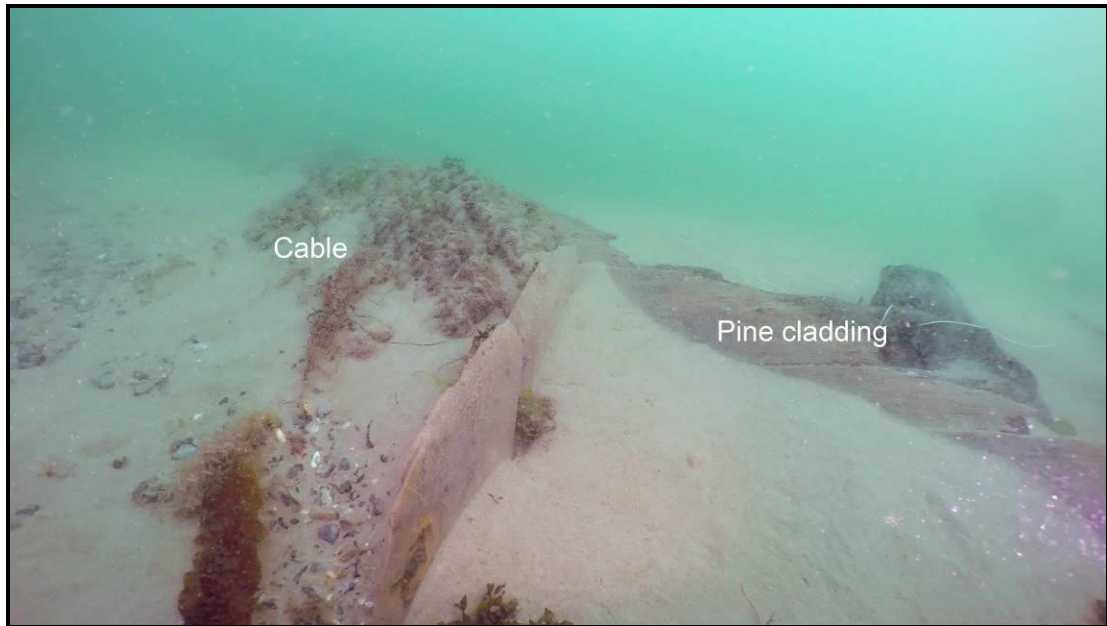
Figure 4: View looking North with cable lying on the pine clad orlop © PAS

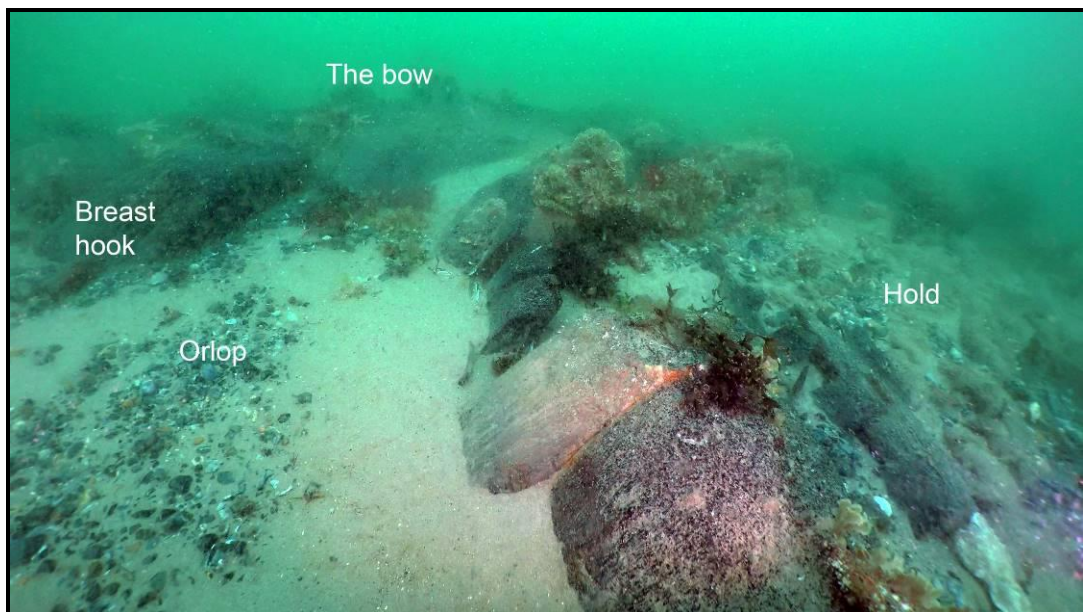
- 5.2.1. Towards the forward-most part of the bow, structural features of the orlop and internal structures and artefacts within the hold are exposed. Immediately below a section of exposed deck and half beams of the orlop are the remains of a compartment or shelving structure (Figures 5-6). Below this is an area of ship's cable and a partial barrel that have all been exposed since 2011. Although the cable and barrel have been observed for a number of years, the internal structures have only recently become clear. The height of exposure of the deck and half beams from the orlop has increased by 150mm. This would explain the recent exposure of the internal structures immediately below.

Figure 5: View looking NW towards the bow with the orlop deck and half beams aligned through the centre of the image © PAS

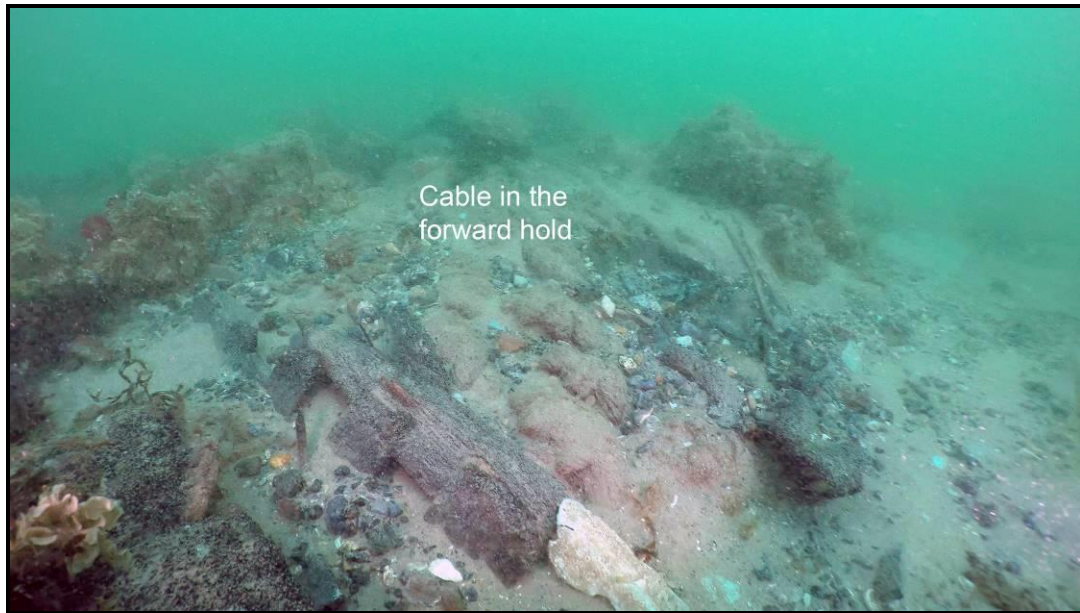
Figure 6: View looking North from orlop into the forward hold. Note the slighter constructed internal structures above a bundle of cable © PAS.

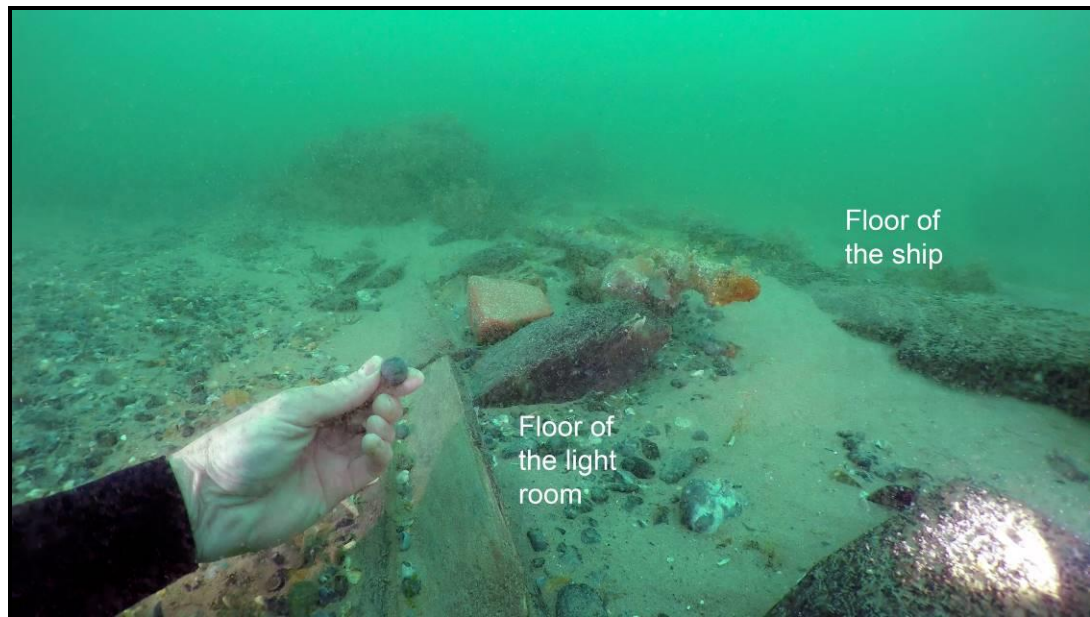
- 5.2.1. At the bottom of the forward hold are exposed floor timbers and futtocks and immediately above these large timbers are the remains of frames and planking of a slighter construction. These most likely represent the floor of a storeroom which was suspended above the ceiling of the hold (Figures 7-9).
- 5.2.2. From studying the internal forward plan of *Invincible* in Bingeman's 2010 publication following her major refit in 1752-56, this internal structure could be related to the light room or filling room (Figure 7). Above the light room and filling room was the gunner's store. On the seabed, scattered on the planks of this floor structure, are musket shot, probably originating from the gunner's store.

Figure 9: View looking NW, scattering of musket shot on the floor of a forward compartment, possibly the light room © PAS.

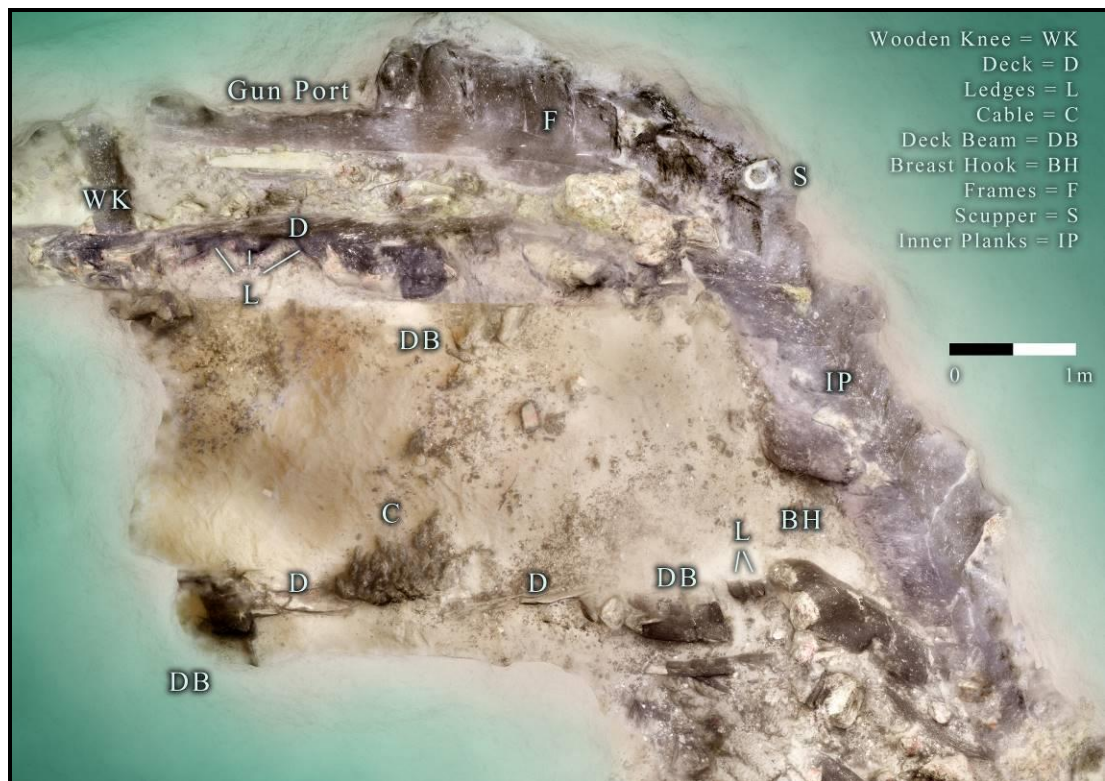
- 5.2.6. Figures 13 and 14 are close-up images from the photogrammetry model of Area 1, which focus on the exposed remains of the gundeck and orlop. Identified in these images are features that relate to the remains of the most forward gun station on the gundeck and a section of the orlop immediately below.
- 5.2.7. The gun station can be identified by the gap in the frames, which represents the location of the gunport. Immediately aft of the gunport are the remains of a hanging wooden knee. Below the gunport are the remains of the deck, which can be seen to be supported by ledges and deck beams. The deck only survives 0.5m out from the

side of the hull. Forward of the gunport the frames are clear to see, which are constructed and fastened in pairs. There are two lead scuppers at the end of the gundeck. One can be clearly seen lying in the sand just outside the frames. The other is still in its original location between the frames.

Figure 13: Close-up view of the forward gundeck and orlop © PAS.

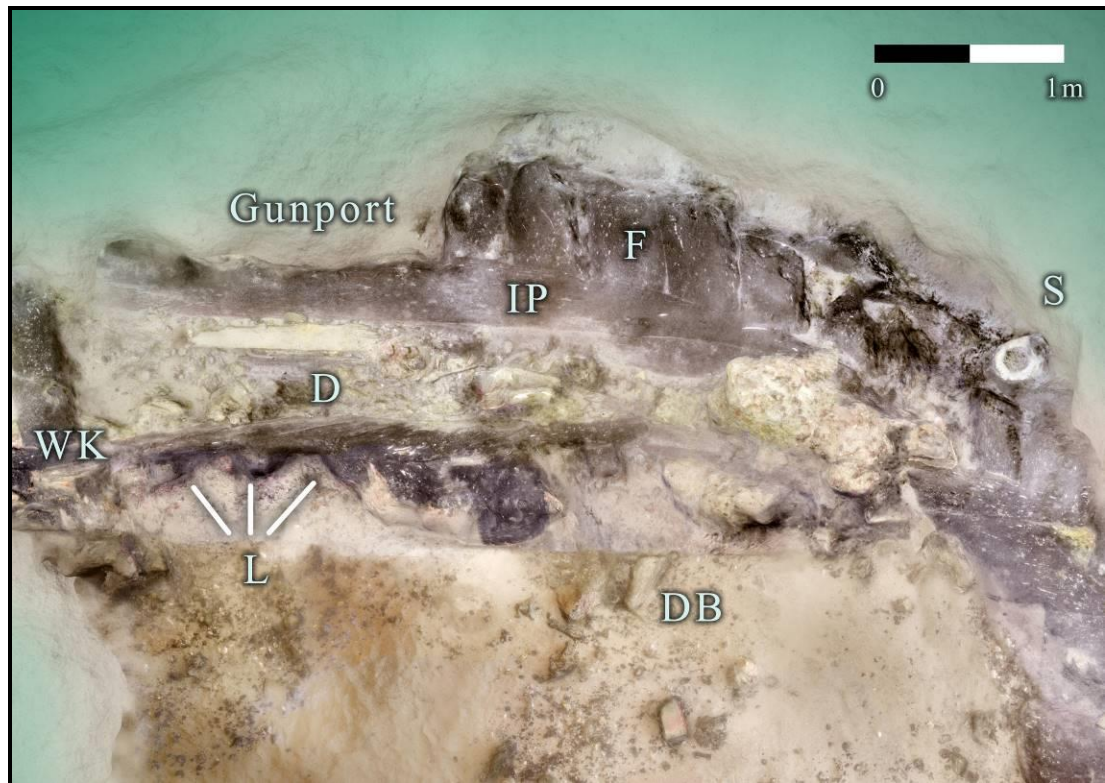
Figure 14: Close-up view of the forward most gun station (see annotations from Figure 11) © PAS.

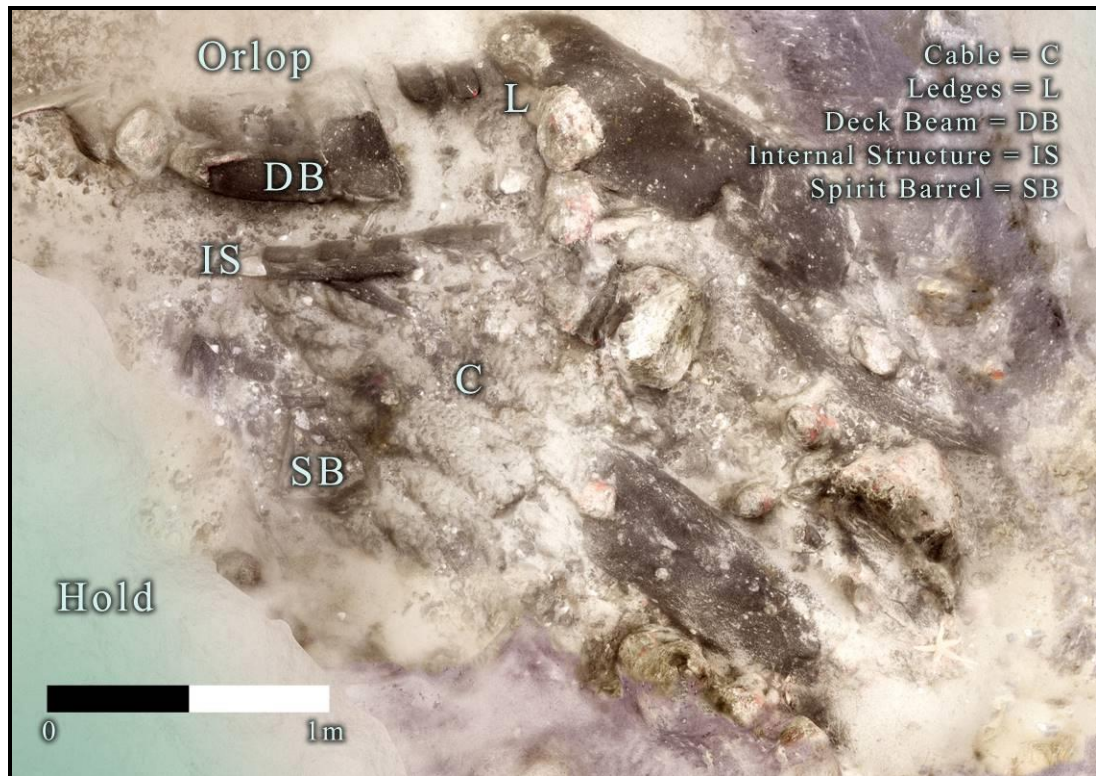
- 5.2.9. Figure 15 is a close-up view of a section of the forward hold. Within it is a jumble of cable and the remains of a spirit barrel. It is also possible to identify a section of an internal structure just below the beams and ledges of the orlop, which can also be seen in Figures 5 and 6. Looking closely, it is also possible to see that some sections of cable are served. This means the cable has been wrapped with a smaller gauge of rope which acts as protection against wearing and chaffing.

Figure 15: Close-up view of the forward hold immediately below the orlop © PAS.

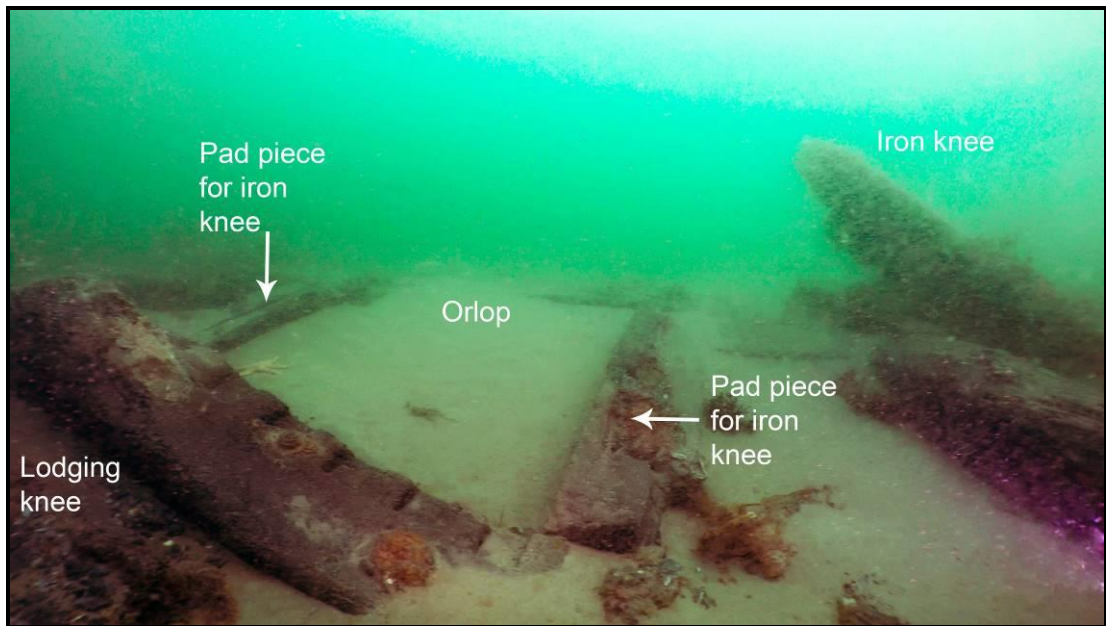
- 5.3.2. Further exposure over the winter led to the identification of structural features relating to the support of the decks. An in-situ lodging knee marks the line between the hold and the orlop. Above each end of the lodging knee is a section of deadwood known as an oak pad piece. This is where the iron knees were counter sunk into the pad piece and then bolted through the hull (Figures 16-18). The iron knees are missing from this particular location but there are a number surviving in locations either side. Although some iron knees have survived they are no longer in the upright position as found in Area 1 of the coherent port bow.

Figure 17: Exposed section of the orlop within Area 3, showing lodging knee and pad pieces © PAS.

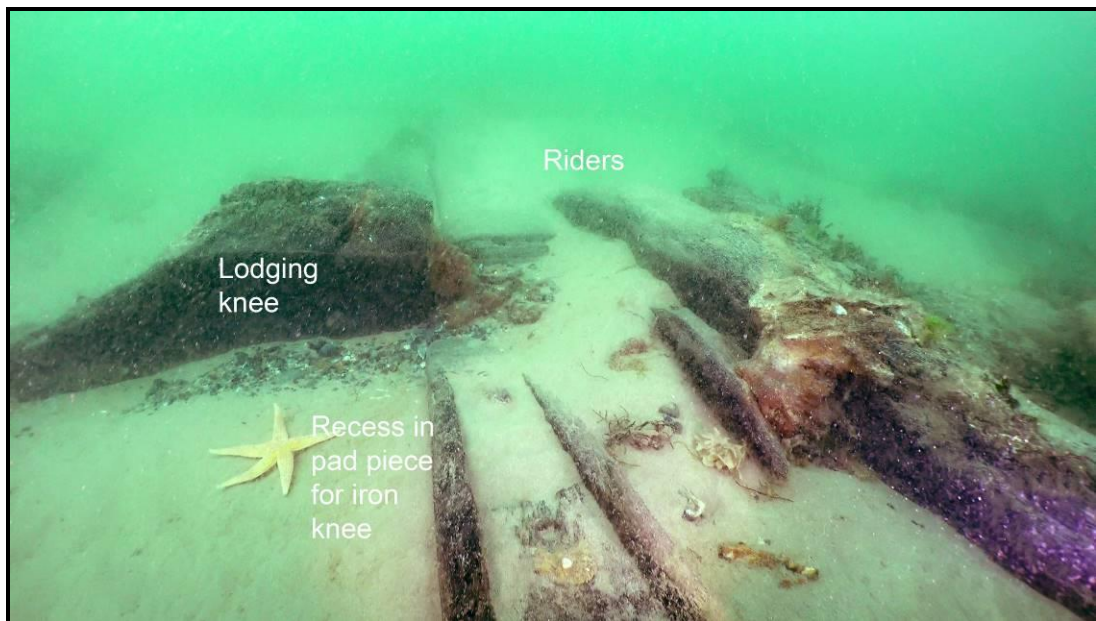
Figure 18: Close-up view of the recess in the pad piece for the iron knee © PAS.

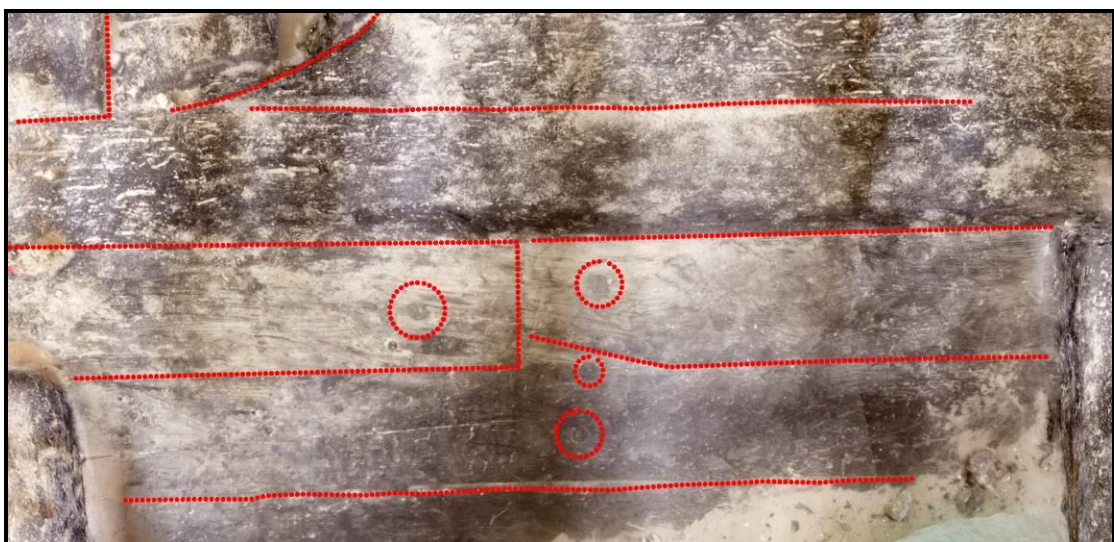
- 5.3.1. Immediately below the riders are the ceiling planks, which are exposed at the west end of the riders. The planks have been fastened to the frames below using wooden treenails. The high-resolution renders provide an immense amount of detail, allowing for the visibility of very small details like treenails, plank joints, biological damage and even wood grain (Figure 21).
- 5.3.2. In Figure 21 it is possible to identify the planks that had only recently become exposed against the planks that had been exposed for some time. The planks immediately to the west of the ends of the riders are heavily eroded by marine borers. This is clearly evident from the white calcareous tunnels left behind by the borer. The planks immediately below the riders are smooth with pristine surfaces.

Figure 21: Close-up of a section of exposed planking in Area 3 © PAS.

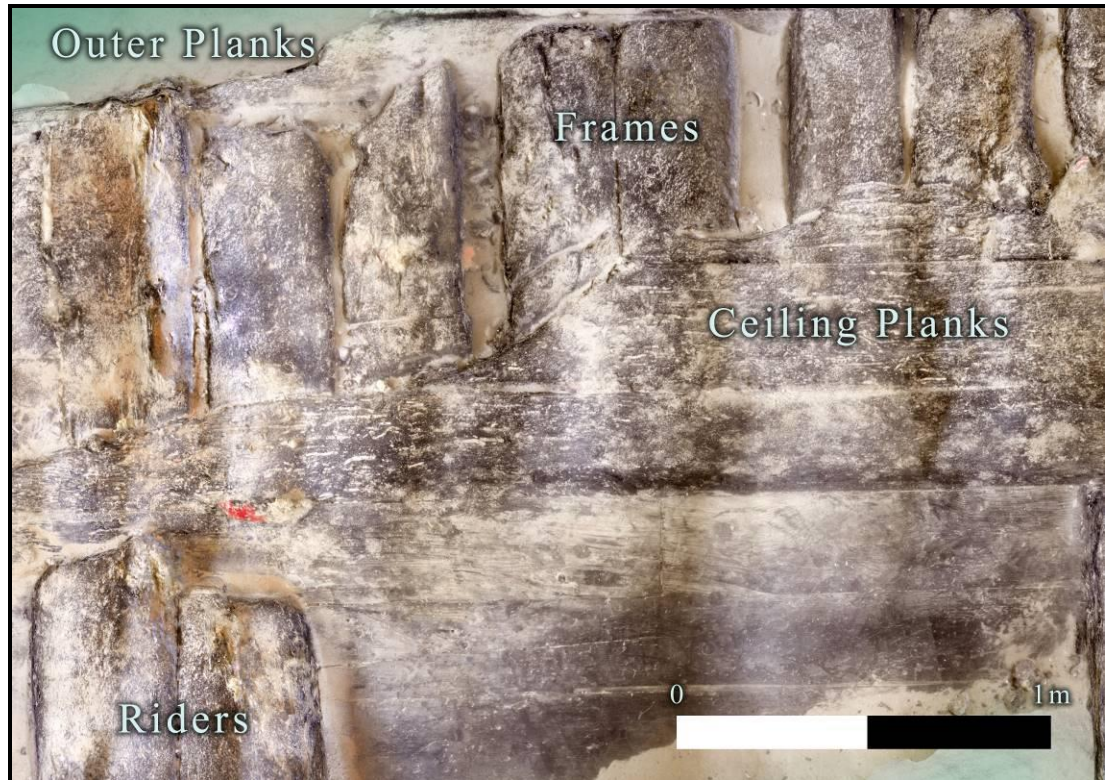
- 5.3.3. The photogrammetry survey also clearly shows the framing pattern in the construction of *Invincible*. She has been constructed with frames fastened in pairs followed by a space before the next pair. The model identifies that the space between the frames is not always uniform (Figures 19, 20 and 22).
- 5.3.4. Where the frames join is also obvious and it is clear to see from the model that this section of the starboard side broke at the joins of the framing timbers (Figure 22), which was a clear weak point.

Figure 22: Close-up showing framing pattern and joint lines where frames are joined together © PAS.

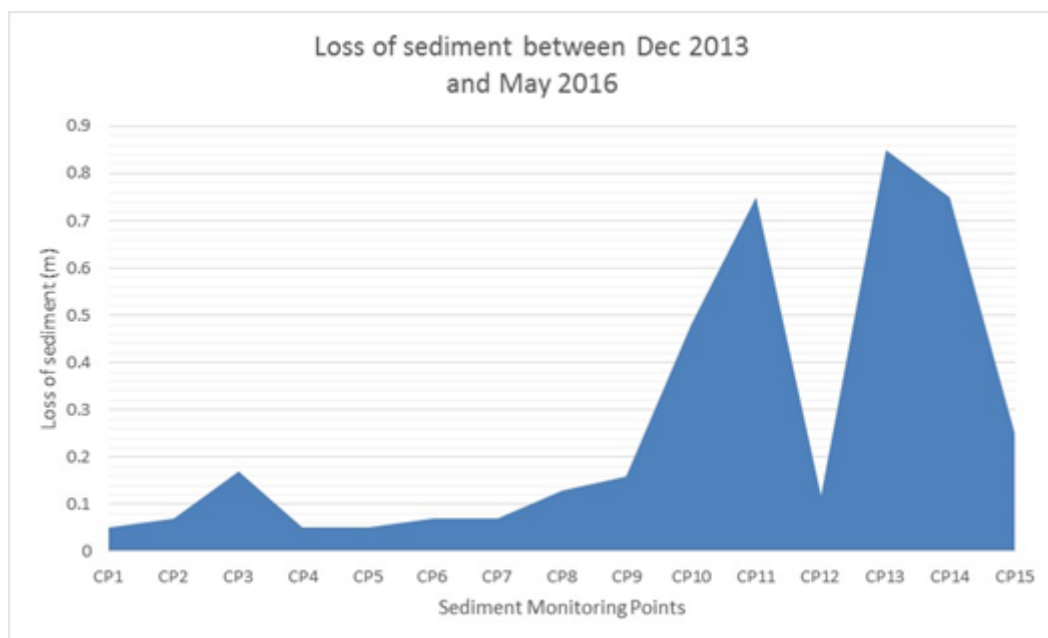
- 6.1.1. Monitoring of the sand levels has revealed that the site has not recovered from the 2014 storms and further reductions in sediments are still occurring, most noticeably in the northern areas (Figure 27). On the western edge (out-board) of the main site from CP1 to CP6 there has been an average loss of sediment of 0.08m. However, the recording of the height above the seabed and the extent of newly exposed structures and artefacts within the hull of the main site (inboard) have revealed a much greater loss. The reduction of sediments within these inboard areas is the most significant, especially towards the bow where it is revealing fragile internal structures and organic artefacts (Figures 1-13). In the northern and eastern areas of the site between CP7 and CP15 there has been an average loss of 0.4m. The loss of 0.4m has exposed large areas of starboard side structure (Figure 27).

Figure 28: Sediment monitoring results

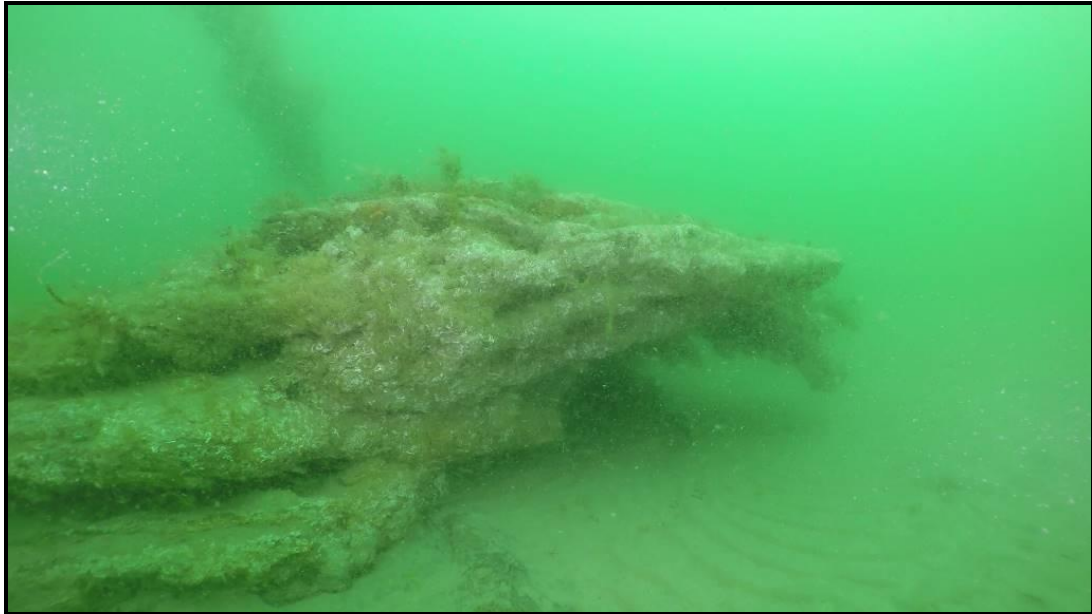
- 6.1.2. In May 2016, a large concretion consisting of strips of iron was noticed at the stern end of the main site. This feature had not been seen on the site by the current licensee and had only uncovered during the winter of 2015/2016. The concretion was upstanding by up to 1m from the seabed level (Figure 29). However, CPs 1 and 2 which lie on the outboard side of the stern only recorded slight reductions in the level of the seabed (Figure 28). This was another example of how the inboard side of the main site experiences a much greater loss of sediments than the surrounding seabed to the west of the site. This means the internal structures of the site are at a much greater risk.

Figure 29: Exposed strip iron at stern.

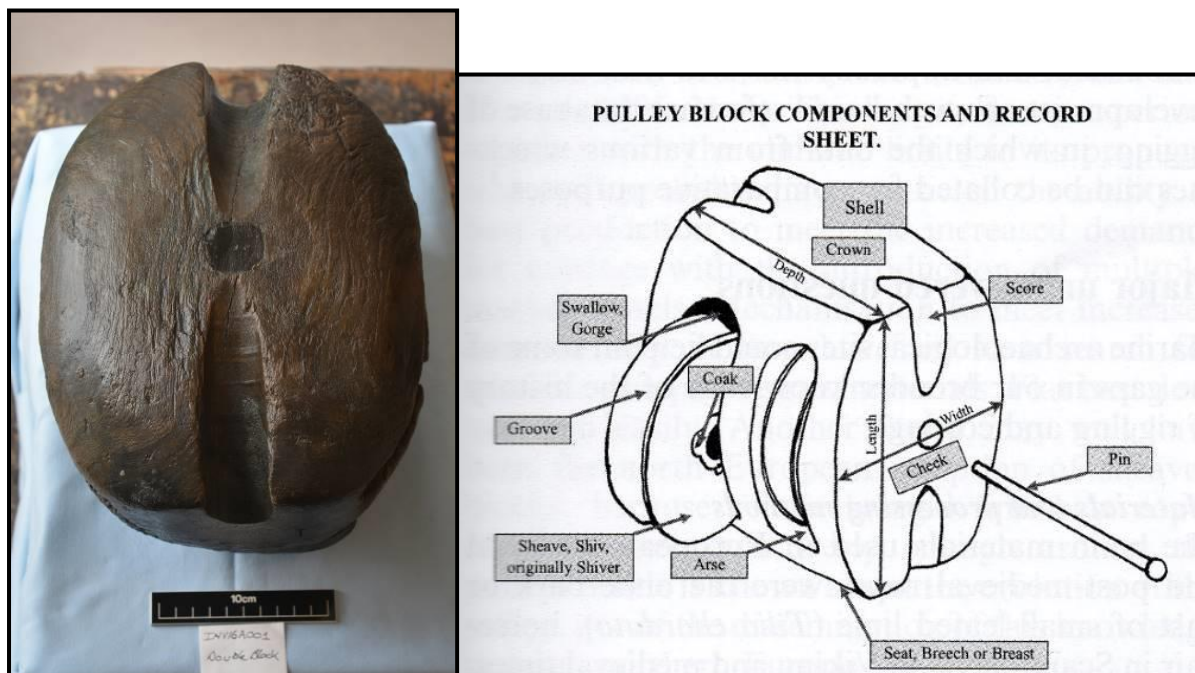
INV16A001 – Double block

- 6.2.1. The double block was recovered from outside the south end of **Area 3**. It is complete with some biological damage on one side. The block has a shell carved from a single piece of wood with two slots to house two wooden sheaves, which turn on a single wooden pin inserted through the centre of the block. There is scoring on the sides of the shell at either end to allow the rigging to fit snugly to the block. The crown end is flat and the other /breech end is eroded.

Figure 30: Photograph of the double block with diagram of pulley block components (Saunders 2010:17).

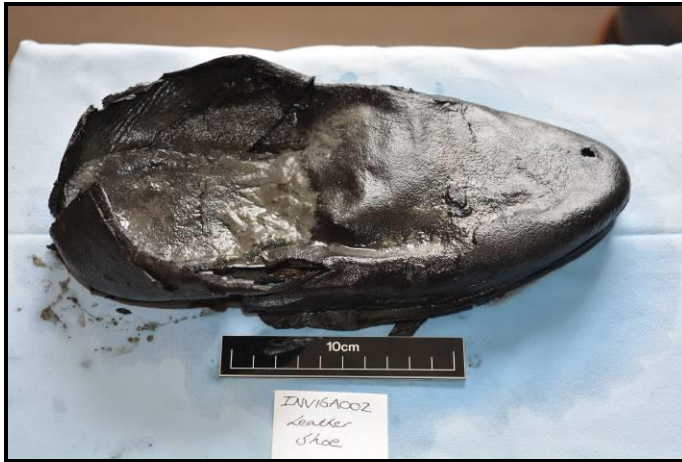
INV16A002 – Leather shoe

- 6.2.2. The leather shoe was found between a section of planking from an area of structure to the west of Area 3. It is complete but very fragile.

Figure 31: Leather shoe

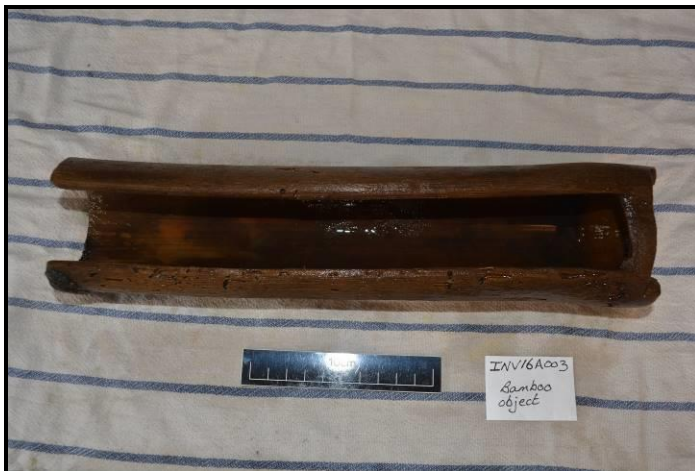
INV16A003 – Unidentified bamboo object

- 6.2.3. This object was found outside Area 1 amongst the disarticulated timbers. It is tubular with a rectangular cut down one side. It is 300mm long with a diameter of 67mm. The slot is 285mm long and 35mm wide. It was possibly used as some sort of container or scoop.

Figure 32: Bamboo object
