Historic England

# A Preliminary Study of Flood Remediation in Hebden Bridge and Appleby

March 2017

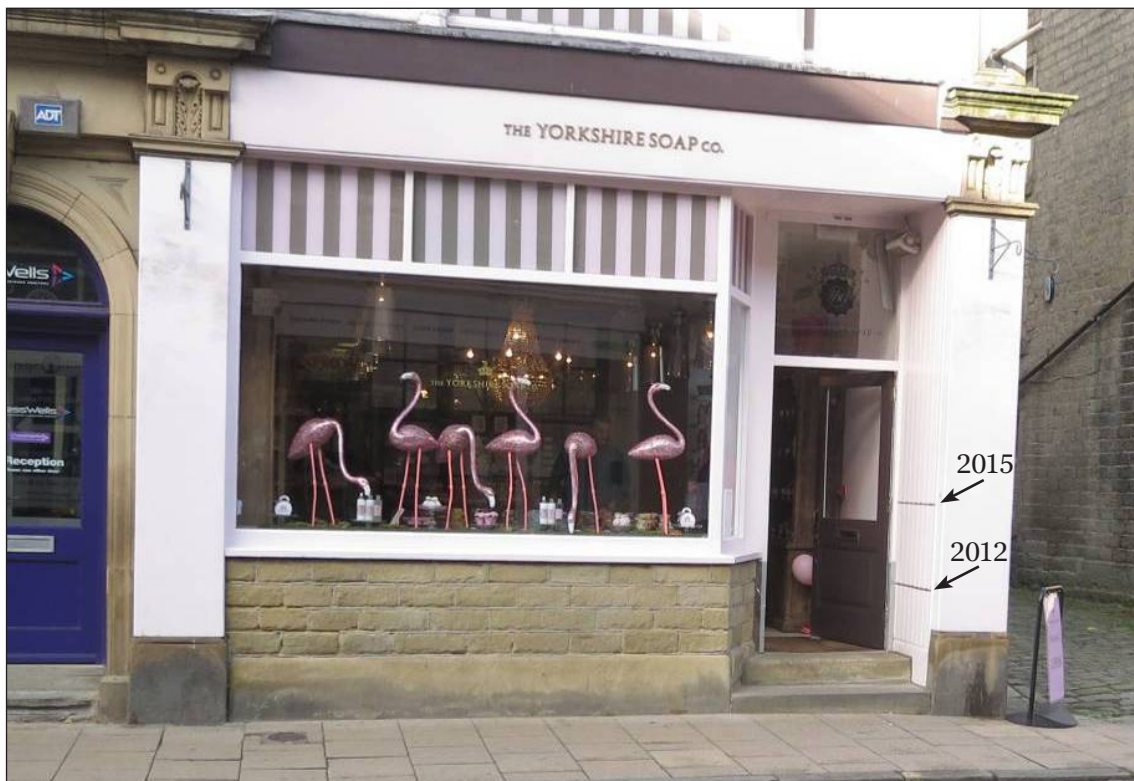
Flooding occurred on 26th December 2015. An idea of the depth of water is gained from a marker on the wall of the Yorkshire Soap Co shop (indicated by the arrows in the image below). The lower mark was the height of the previous flood water and was used to select the height of flood barriers. Unfortunately barriers that were supposed to keep water out helped to keep it in when water went over the top.

*Figure 1: Shop front in Hebden Bridge showing levels reached by flood water in 2012 and 2015.*

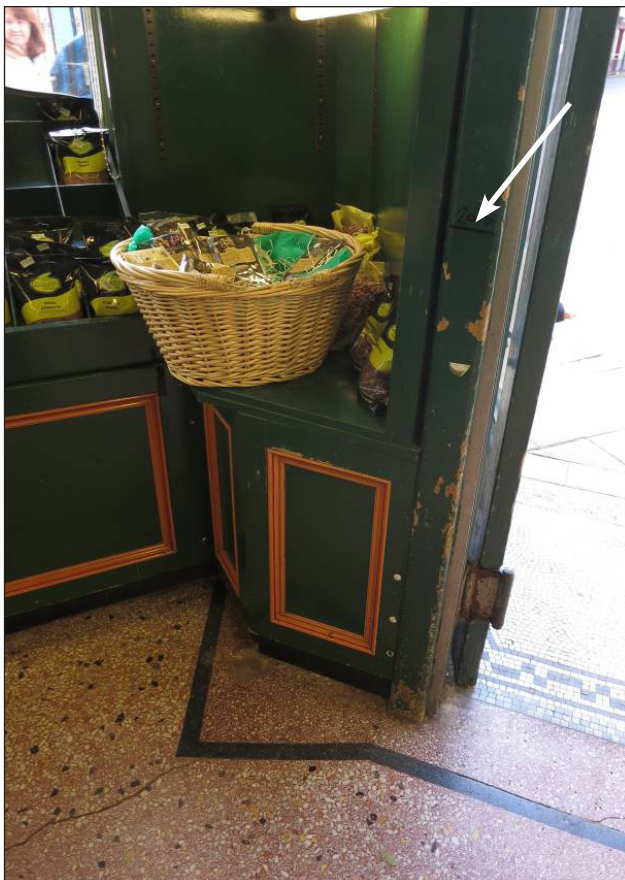
1m (indicated by arrow in Figure 3).

*Figure 3: Arrow indicates the approximate depth of water above ground floor level.*

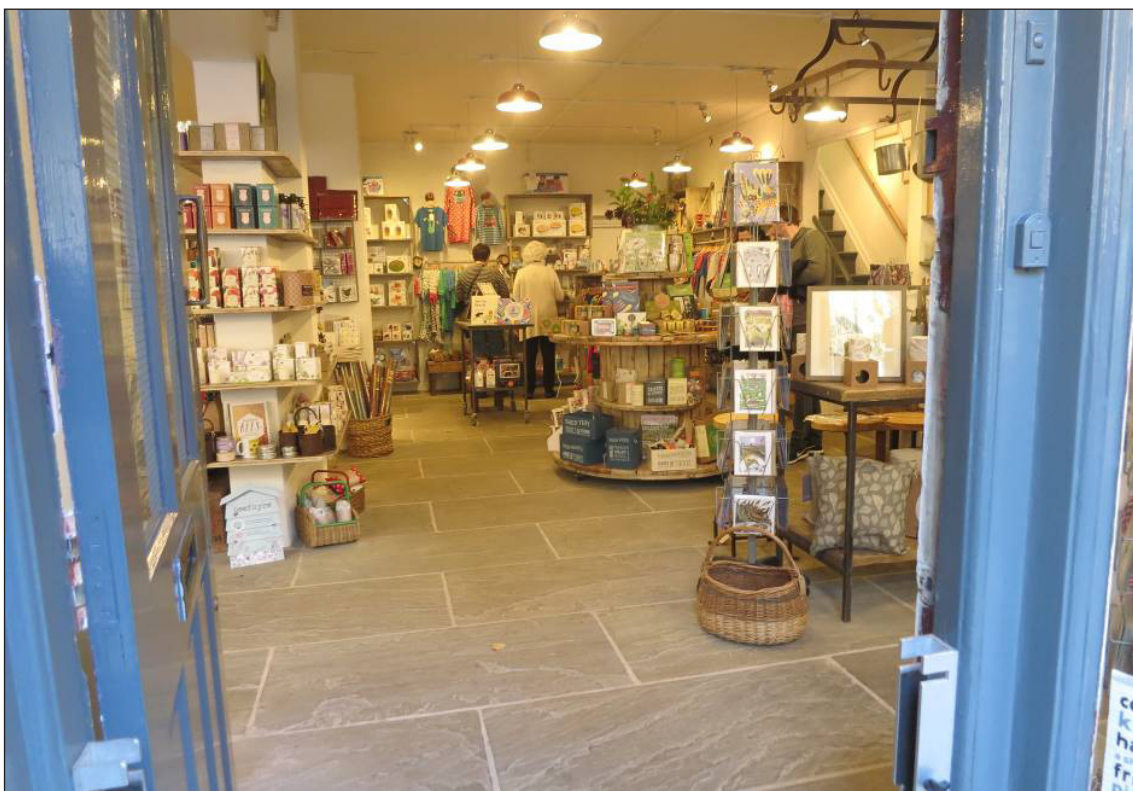
*Figure 6: The timber floor was removed and replaced with stone flags.*

Professional drying. Heaters and dehumidifiers used. The timber floor was removed and replaced with stone flags on a concrete slab (Figure 6) and plaster was hacked from the walls to a height of 1.5m.

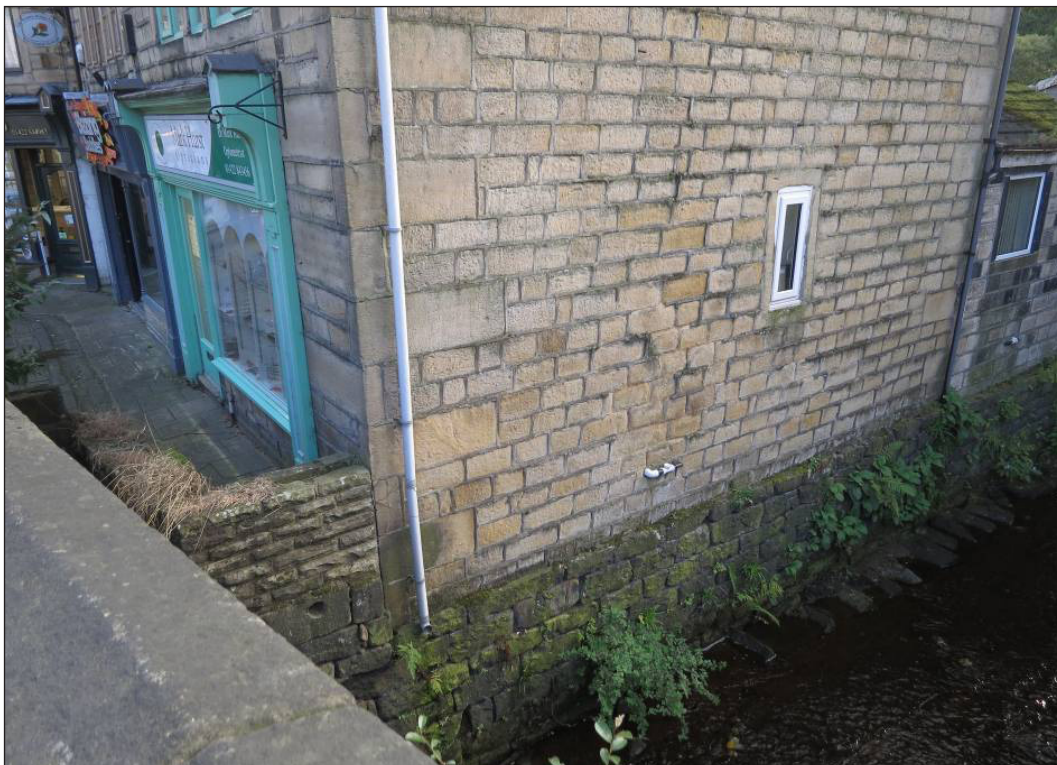
Not clear, but shop is on the banks of the river (Figure 8) so that flood water would have drained as soon as the river dropped.

*Figure 8: The shop is located on the banks of the river.*

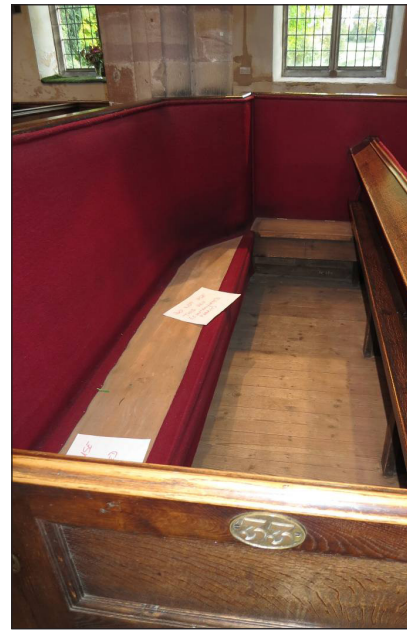
None – building considered to be dry. Moisture content in floorboards beneath pews was measured at 16% (11.10.16). The floorboards showed little sign of ever having been wet (Figure 10).

*Figure 10 (right): The floorboards within the pews showed little sign of ever having been wet.*

There is no mould growth, but the textile linings in the Corporation Pews (Figure 10) were considered to be contaminated by the flood water and are to be removed. This recommendation was made by the assessor for the insurance company although no testing has been undertaken.

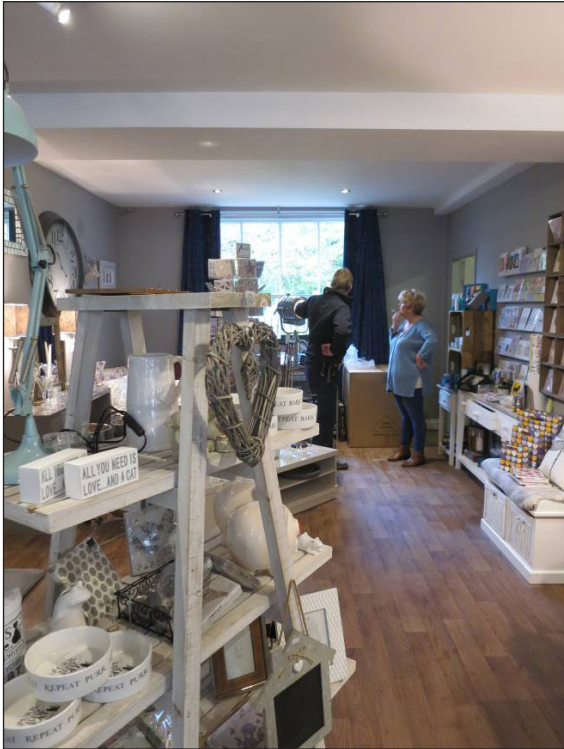
Only the nearby church flood protection, which failed causing water to come over the back window sill (Figure 12).

*Figure 12: The interior of the shop.*

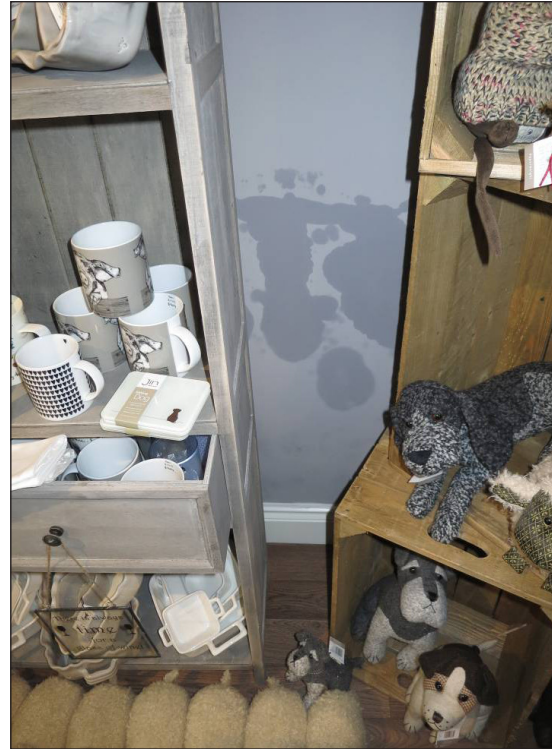
*Figure 13: The side wall is now wet.*

None but the side wall is now wet (Figure 13) and the skirting board has a moisture content of 22%. The plaster was said to have been replaced with sand and cement, but the surface is damaged.

Damp patches appearing on party wall at low level. See Figure 13.

Yes, but see Figure 13.

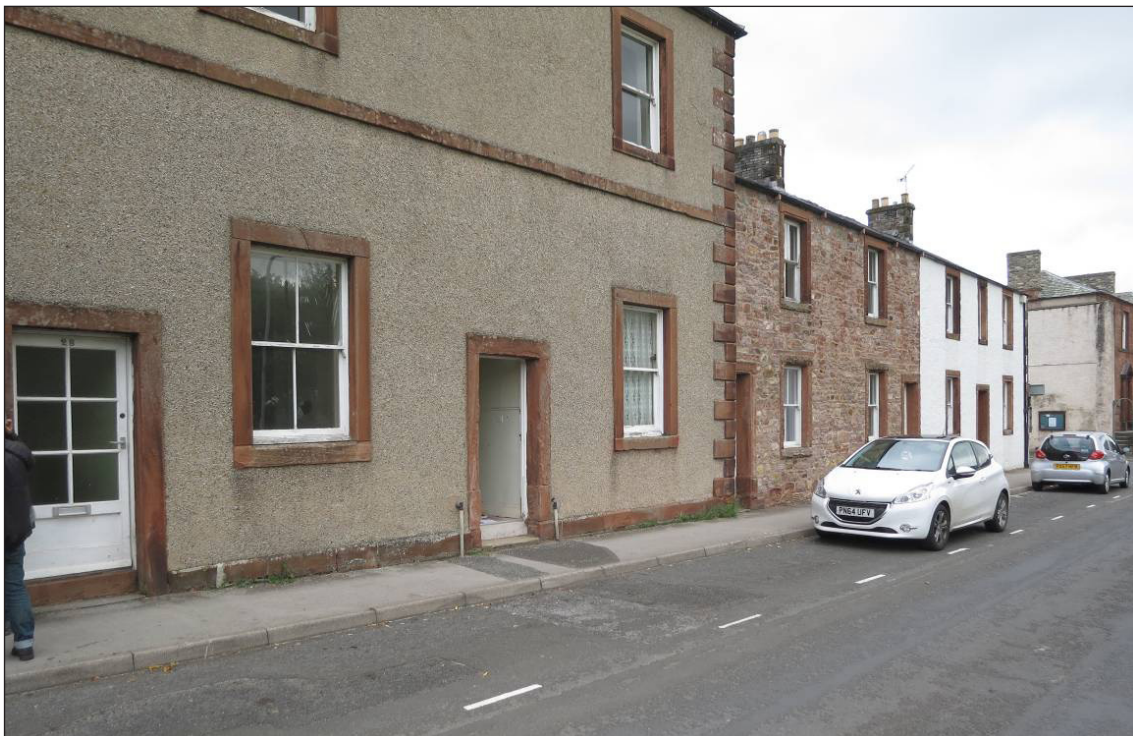
Never flooded before. Flood cause by failure of the river flood barrier. Flood barrier failed because there was no power for pumps.

Figure 15: 27-32 Church Street.

Cleaning and dehumidification. The local authority required that the tenants move out and the suspended timber floors be replaced with concrete slab floors. At the time of our visit (11.10.16) the timber floors were in good condition with moisture contents in the range 14%–16%.
