ARCHAEOLOGICAL SERVICES IN RELATION TO MARINE DESIGNATION

UB-109, off Folkestone, Kent

ARCHAEOLOGICAL REPORT

January 2015

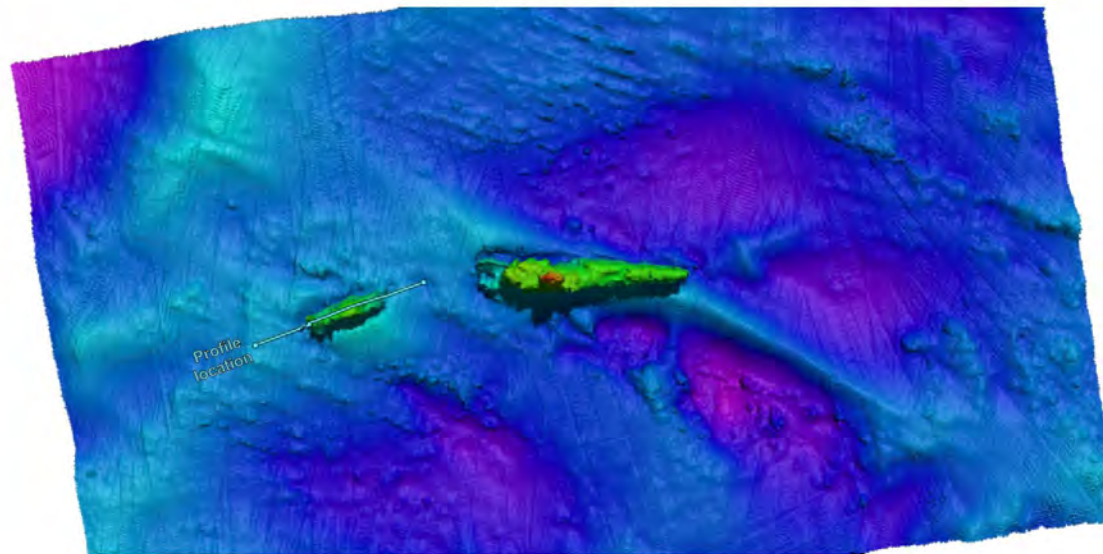
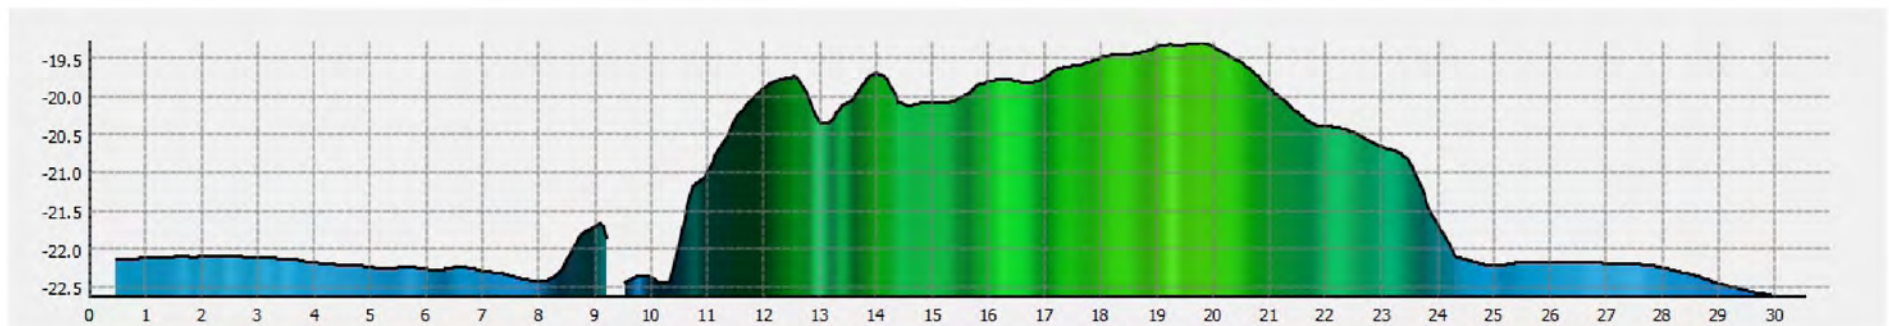
Figure 5

- 4.5.26 The full width break in the hull occurs approximately 4.75m aft of the conning tower (**Figures 3 and 5**). It is not a straight fracture and approximately a third to half of the lower pressure hull and bases of the saddle tanks extend for approximately another 5-6m. Unless there was subsequent damage, the shape of the fracture line that split the hull was therefore z-shaped. The position of the fracture suggests that it occurred at the transverse watertight bulkhead at the forward end of the engine room.

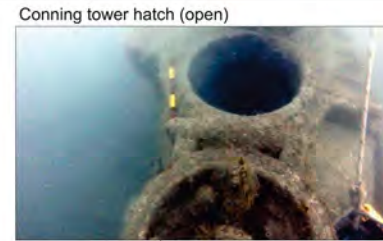
Conning tower hatch (open)

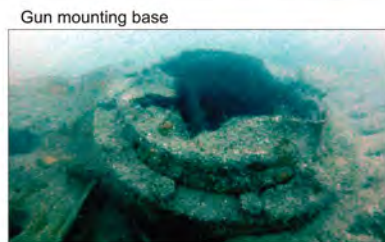
- 4.5.15 Although the deck gun is missing, part of its seating survives *in situ* forward of the conning tower. It consists of a horizontal partially webbed rectangular steel base plate at deck level. Through this is bolted the circular gun mounting base, which is attached to the pressure hull and reinforced by triangular stiffening brackets also attached to the pressure hull. The lower end of the base survives but only a fragment of the cylindrical upper section survives. The edge is ragged and deformed and either the result of a heavy impact that carried away the gun or crushing forces from the weight of the gun as the mounting collapsed due to corrosion.

Gun mounting base

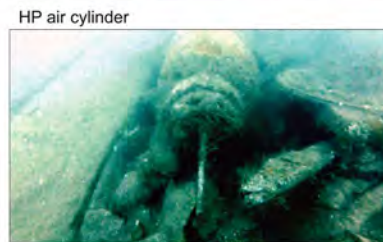
HP air cylinder

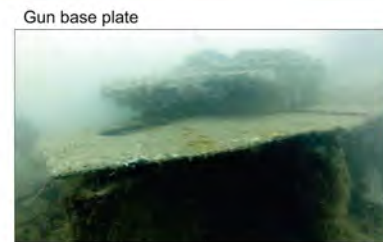
Gun base plate

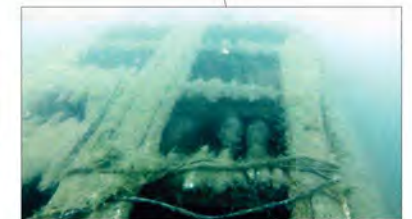
- 4.5.17 Although most of the deck casing bulge around the gun mounting is missing, some of it survives. As elsewhere on the boat the casing consists of thin wooden deck planks supported by longitudinal steel angle beams with free flooding slots on either side, with transverse angle beam supports.

Surviving deck and casing

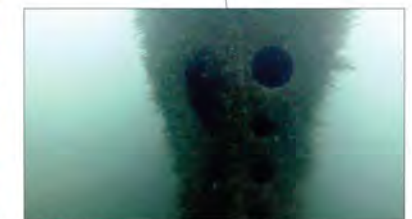
- 4.5.24 Immediately forward of this the upper bow casing is missing. This section of the hull is not part of the pressure hull. This may have become detached at the same time as the net cutter as a result of an impact. The flat that is flush with the top of the pressure hull and which protrudes forward below the missing casing has possibly survived because it is secured to the raking stem below by strong transverse web frames. Most of the exposed stem and the foremost part of the bow casing have not survived and what can be seen internally is the forward face of two webbed transverse frames that are riveted together.

Webbed transverse frames at bow

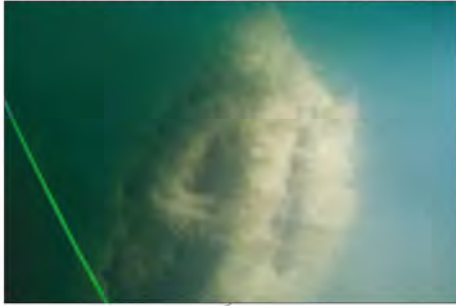
Approximate end of structure

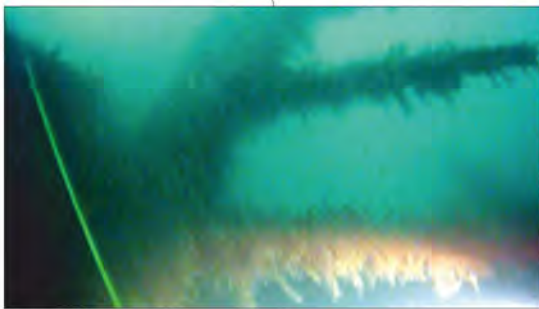
Starboard rudder
