Archaeological Services in Relation to Marine Designation

UB 78, off Folkestone, Kent

Archaeological Report

Ref: 83803.40
January 2015

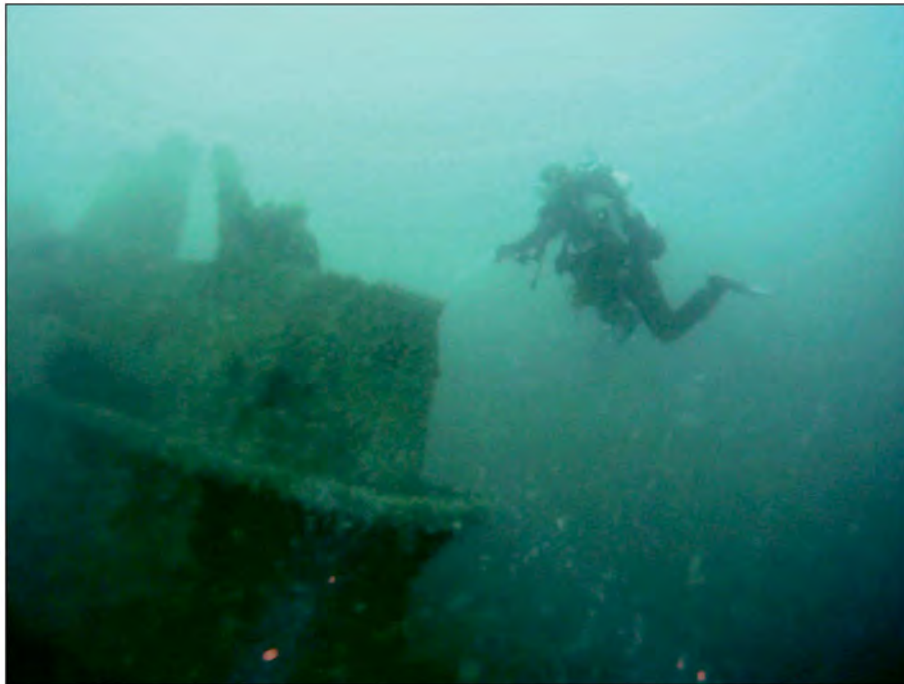
Plate 1: Video still of aft end of conning tower

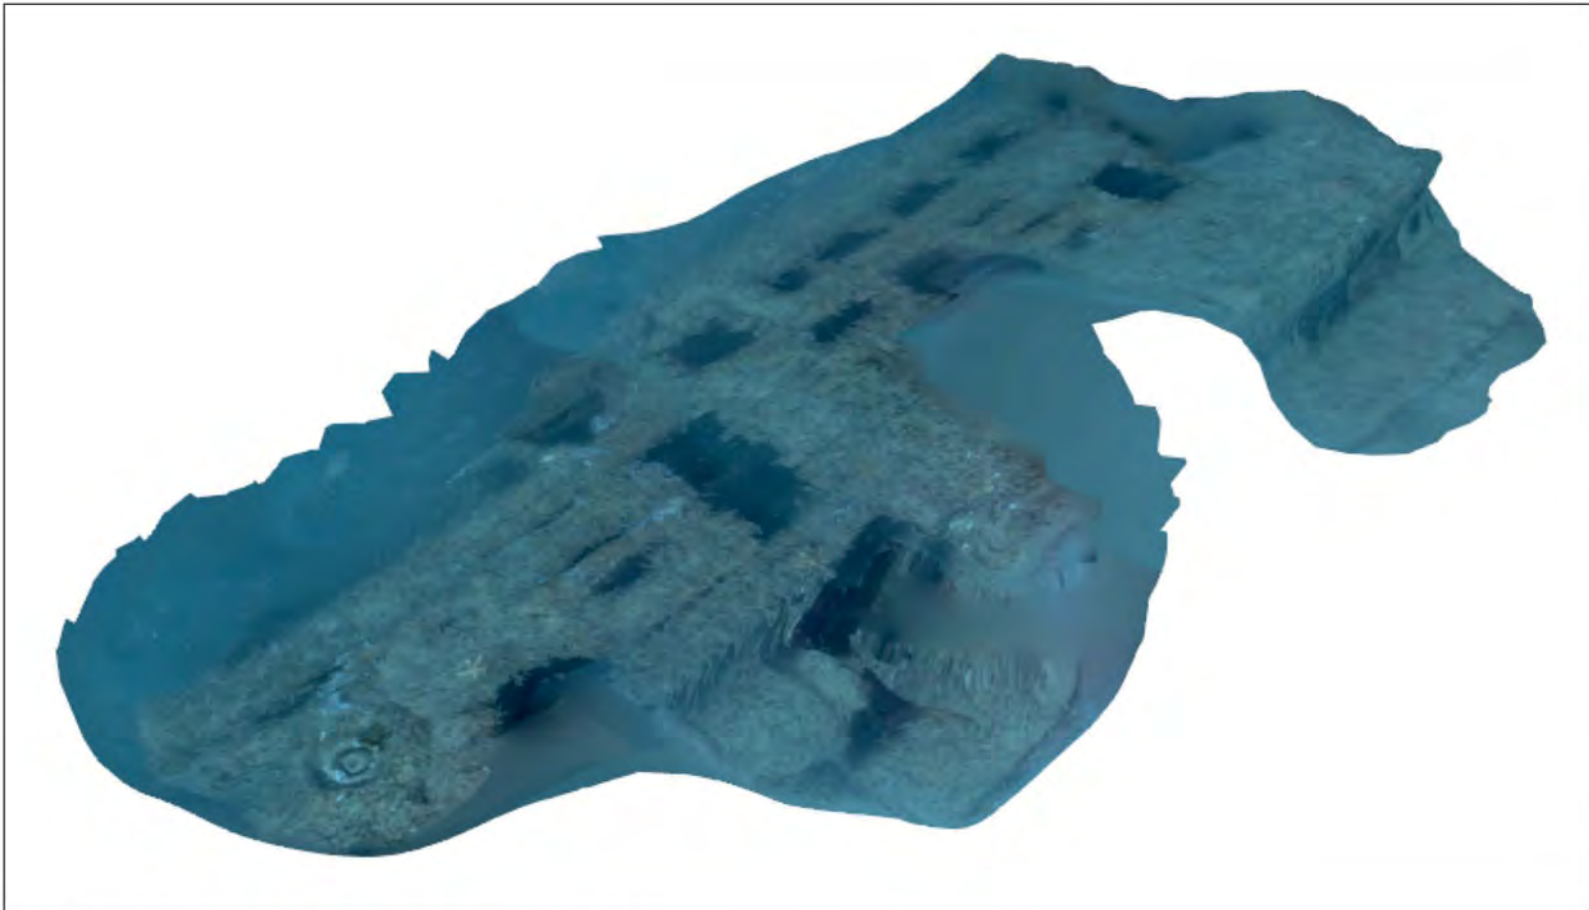
- 4.4.12 Forward of the tower the deck casing is *in situ* (**Plate 3**), with only small sections of planking missing. The casing consists of thin wooden deck planks supported by longitudinal steel angle beams with free flooding slots on either side, with transverse angle beam supports. Heavy marine turf has colonised the planking, the surfaces of which appear to be moderately eroded. There is a small amount of unidentified debris lying on the deck. The deck railings are not present and may have been dismantled at the time of loss.

- 4.4.16 Further forward there is a small base ring set into the deck with a squared central shaft that does not protrude (**Plate 3**, to the left). This appears to be the deck base plate of the capstan, together with the top of its spindle. The capstan head itself is missing. This motorised capstan is connected by a transmission arm to a windlass further forward which

Plate 3: Photogrammetry model of part of *UB 78*'s foredeck
