Goodwin Sands and the Downs: Multi-Beam Surveys of the Designated Wrecks

Multi-Beam Surveys of the Designated Wrecks on the Goodwin Sands and the Downs

July 2017

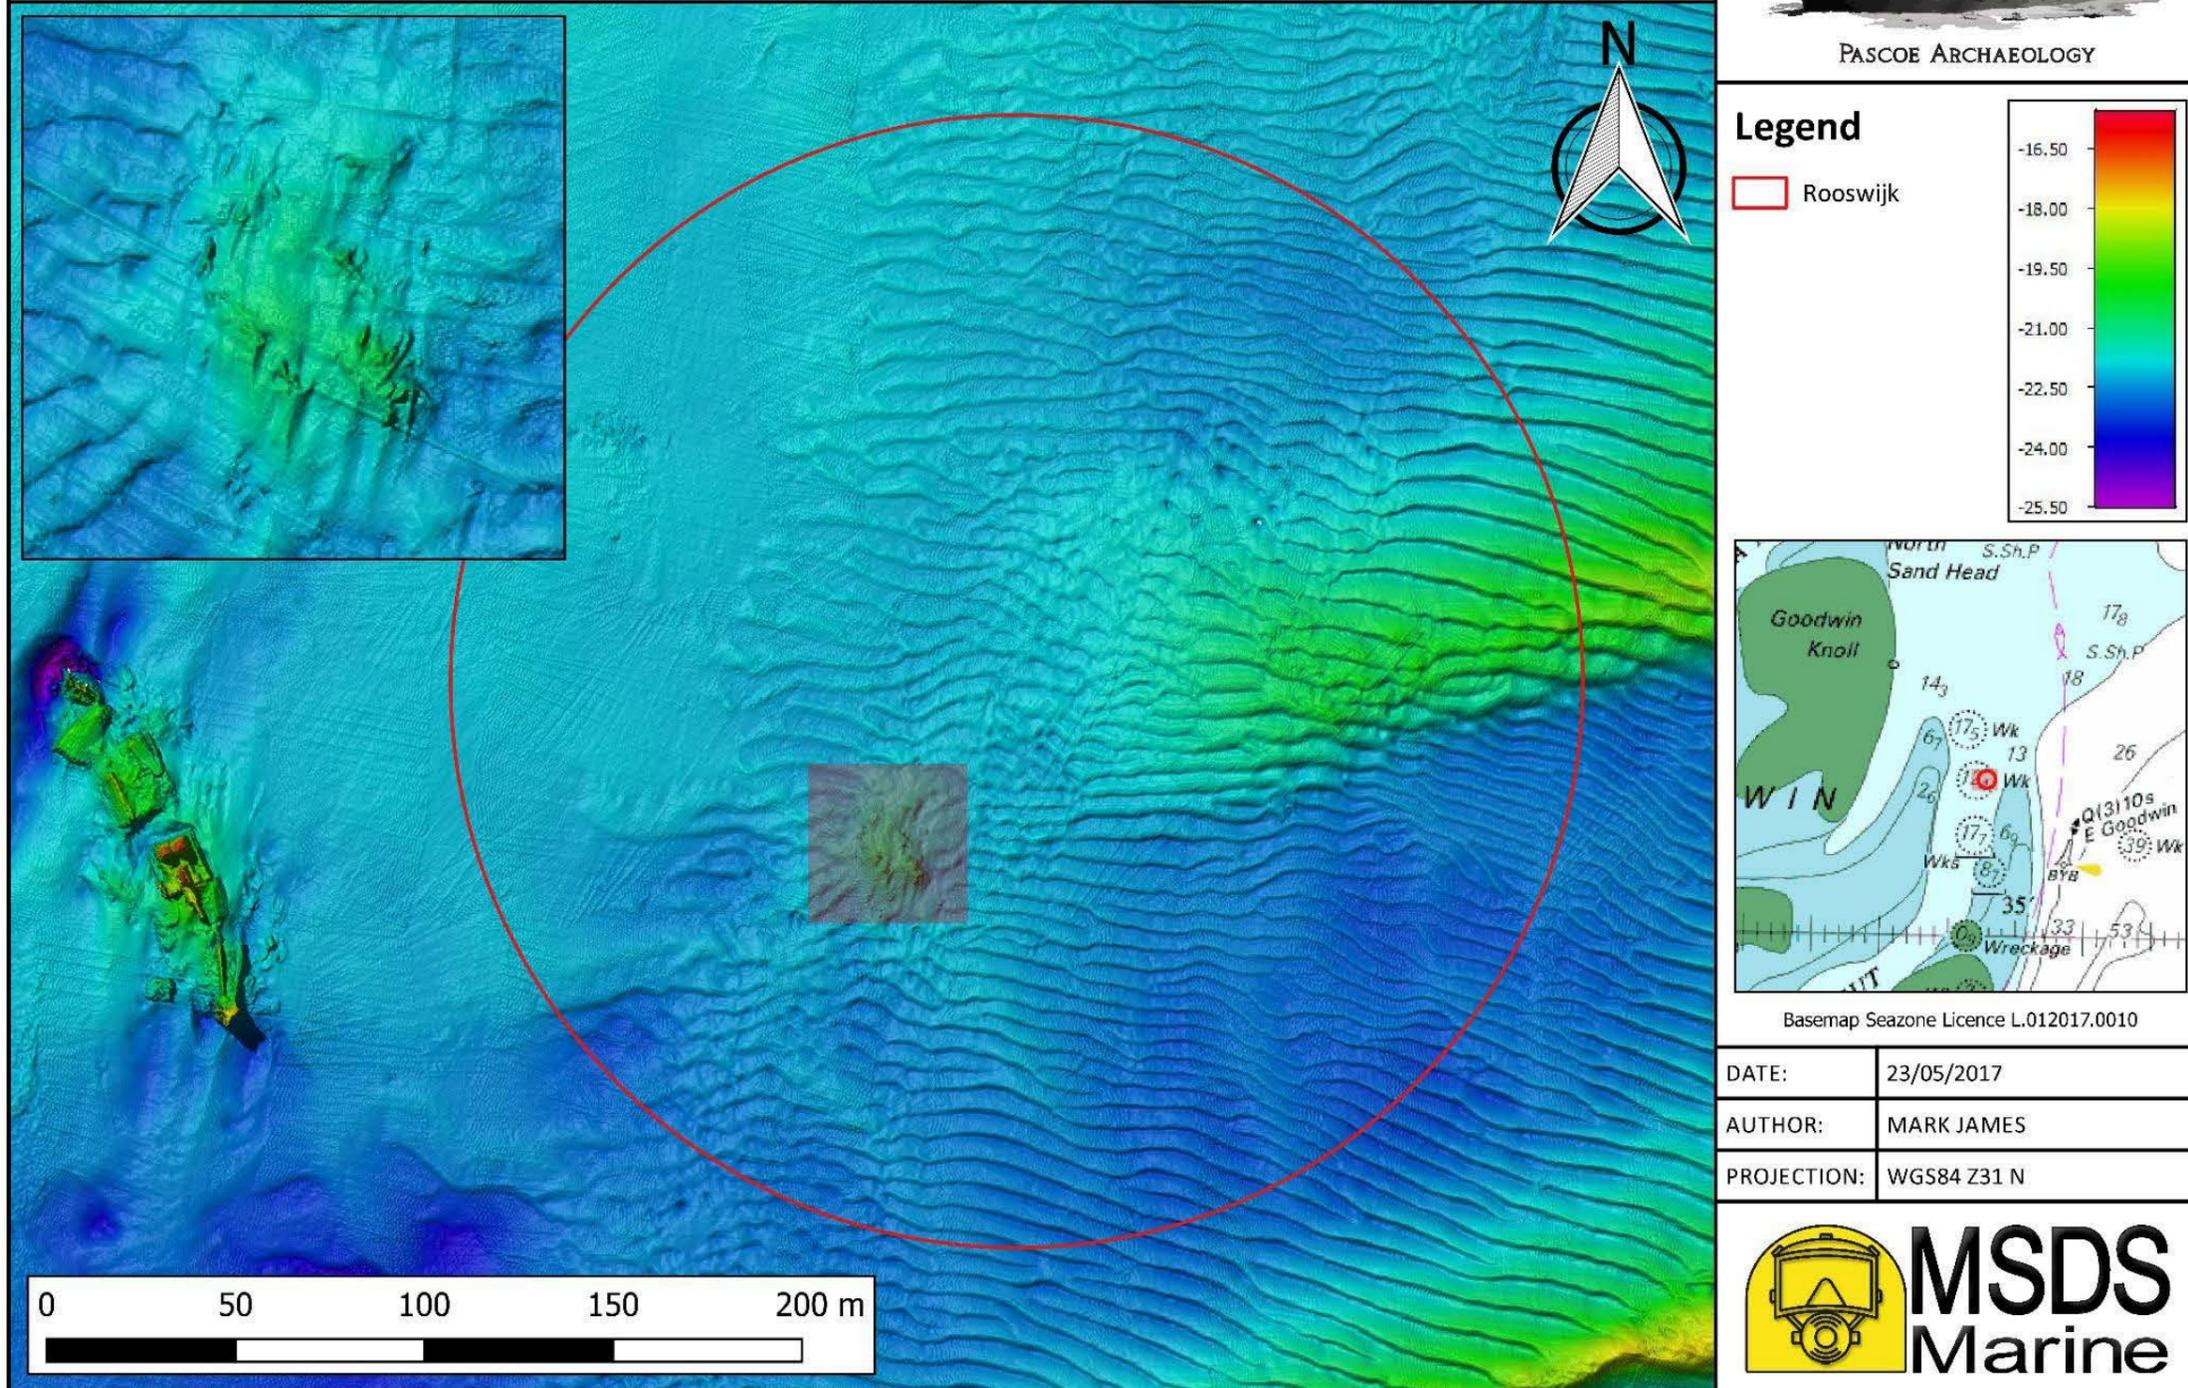
Fig. 1: Rooswijk West site (Main site) in relation to the designated area.

4.2.4 The West site consists of a wreck mound 27m long by 24m wide at its widest, 14m wide across its centre and orientated southeast–northwest (Figures 1–2). There are numerous exposed features, including anchors, guns, structure and cargo. There are also several features exposed lying outside the main mound. Knowledge gained from previous investigations and artefactual evidence recovered suggests that the remains of the bow are towards the southeast and the stern of the vessel towards the northwest.

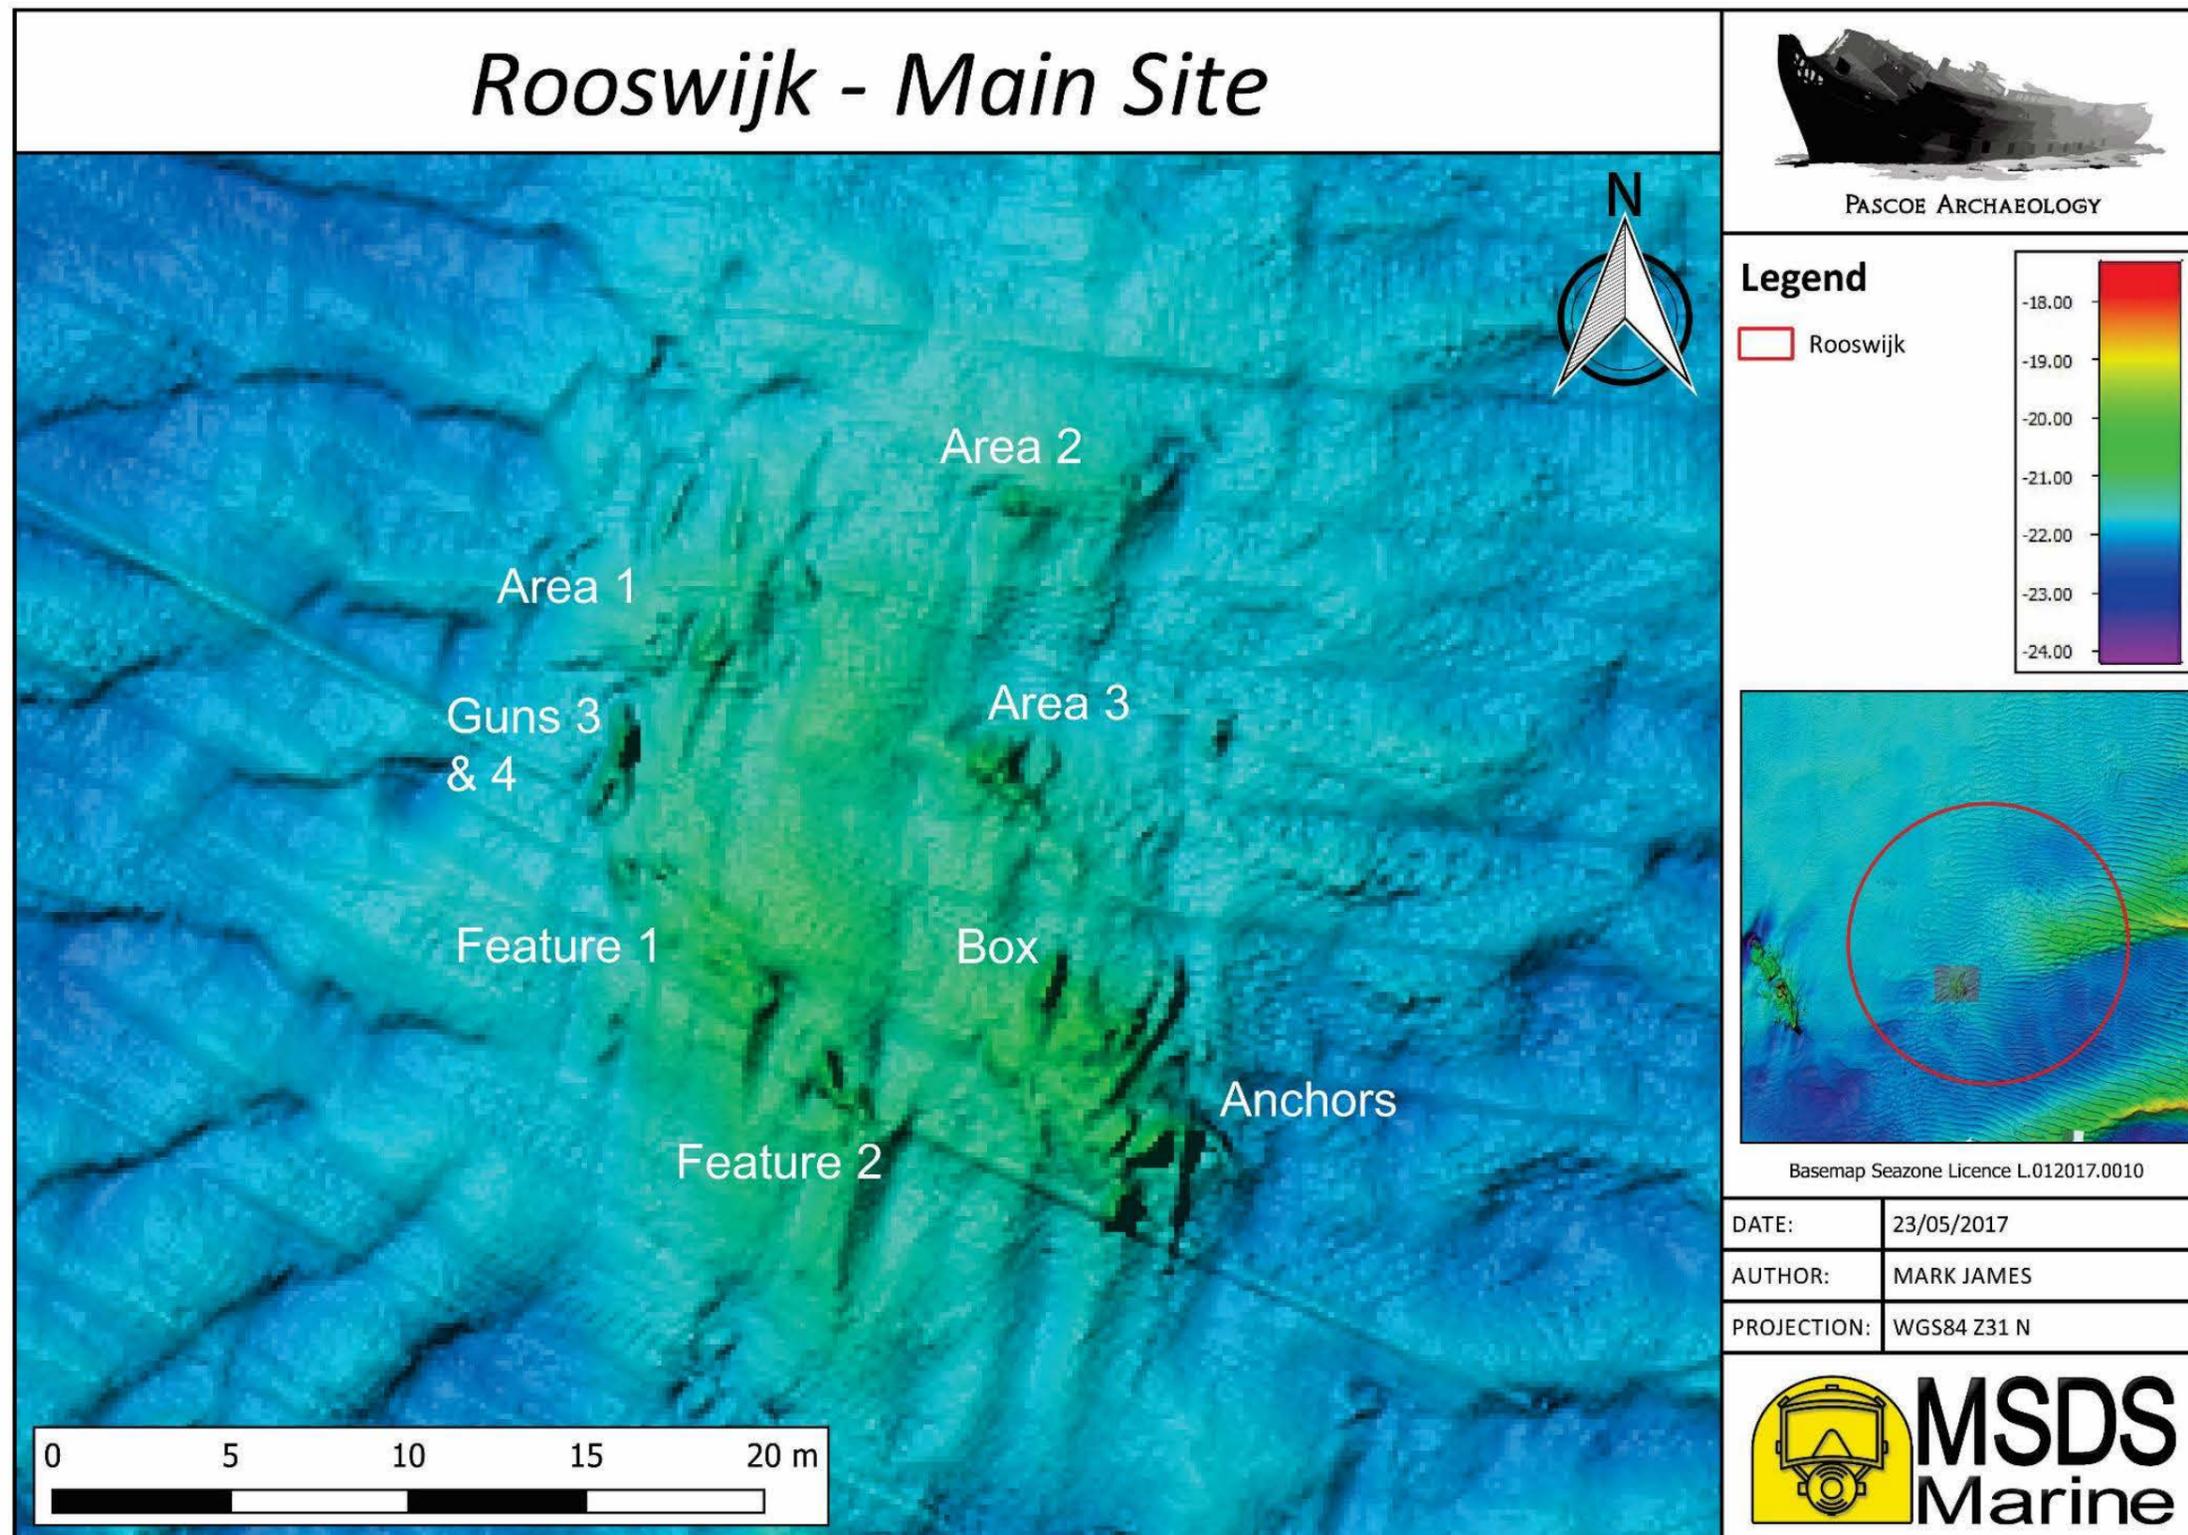
Fig. 2: Close-up of Rooswijk West site (Main site).

- 4.2.5 Analysis of the 2017 MBES survey data shows that the site is generally more exposed than it was in the 2016 survey data. There are a greater number of exposed archaeological features and features which were exposed previously are both more pronounced and extensive.

- 4.2.6 At the northwest end of the wreck-mound are two guns (labelled guns 3&4 from 2005 investigations), directly north of these is a roughly 7 x 7m area of exposed features (Area 1) consisting of a several linear features orientated in north–south and east–west directions. These could represent both exposed guns as well as timber structures and are consistent with some of the observations made in this area during the 2016 investigations. During this time two guns flush with the seabed and part of a possible shot locker, enclosed by timber structures, were found. From the 2017 MBES data it now appears that there is a far greater exposure of features compared with both the 2016 MBES data and diving observations.

- 4.2.7 Six metres east of Area 1 is a T-shaped feature (Area 2), across the top of the T it is 5.1m long by 1.5m wide and the upright of the T is 4.7m long by 1.7m wide. In the 2016 MBES data only a 1.4 x 1.2m section was exposed, therefore this area has exposed significantly since the 2016 survey. It is uncertain what the whole feature could represent but it is known from the 2016 investigations this is partly concreted cargo.

- 4.2.8 Four metres south of Area 2 is an exposed section of structure (Area 3). The identification of this structure is known from Wessex Archaeology diving inspections in 2011 (WA 2012) and was confirmed during the 2016 diving investigations. It consists of a section of the hull including a gunport, frames, knee, inner and outer planking (WA 2012). The 2017 MBES data shows this feature is now 2.8m long by 2.3m wide. Exposure has increased on the northeast side by 1.3m and the overall appearance is much more pronounced than recorded on the 2016 MBES data.

- 4.2.9 Five metres south of Area 3 is a rectangular feature which is approximately 1.4m long and 0.7m wide and this is also the highest point of the wreck mound. This feature was observed during the 2016 diving investigations and is the concreted remains of a large box.

- 4.2.10 At the very southeast end of the wreck mound there is the clear shape of an anchor, including flukes and shank. There are in fact two anchors one on top of the other. Besides the western fluke is a rectangular feature, this is a cut stone block.

- 4.2.11 Between the anchors and the rectangular feature is a long linear feature 4.6m in length. This feature is barely visible in the 2016 MBES data, so exposure has increased significantly in this area. It is possible this feature is structural as timber frames were observed in this area during the 2016 diving investigations.

4.2.12 On the western side of the wreck mound there are two main features. Feature 1 is roughly 6m long by 2m wide. This was identified during the 2016 diving investigations as strips of concreted iron. Feature 2 is 3.7m long by 1.2m wide and this was a combination of strips of iron and timber structure.

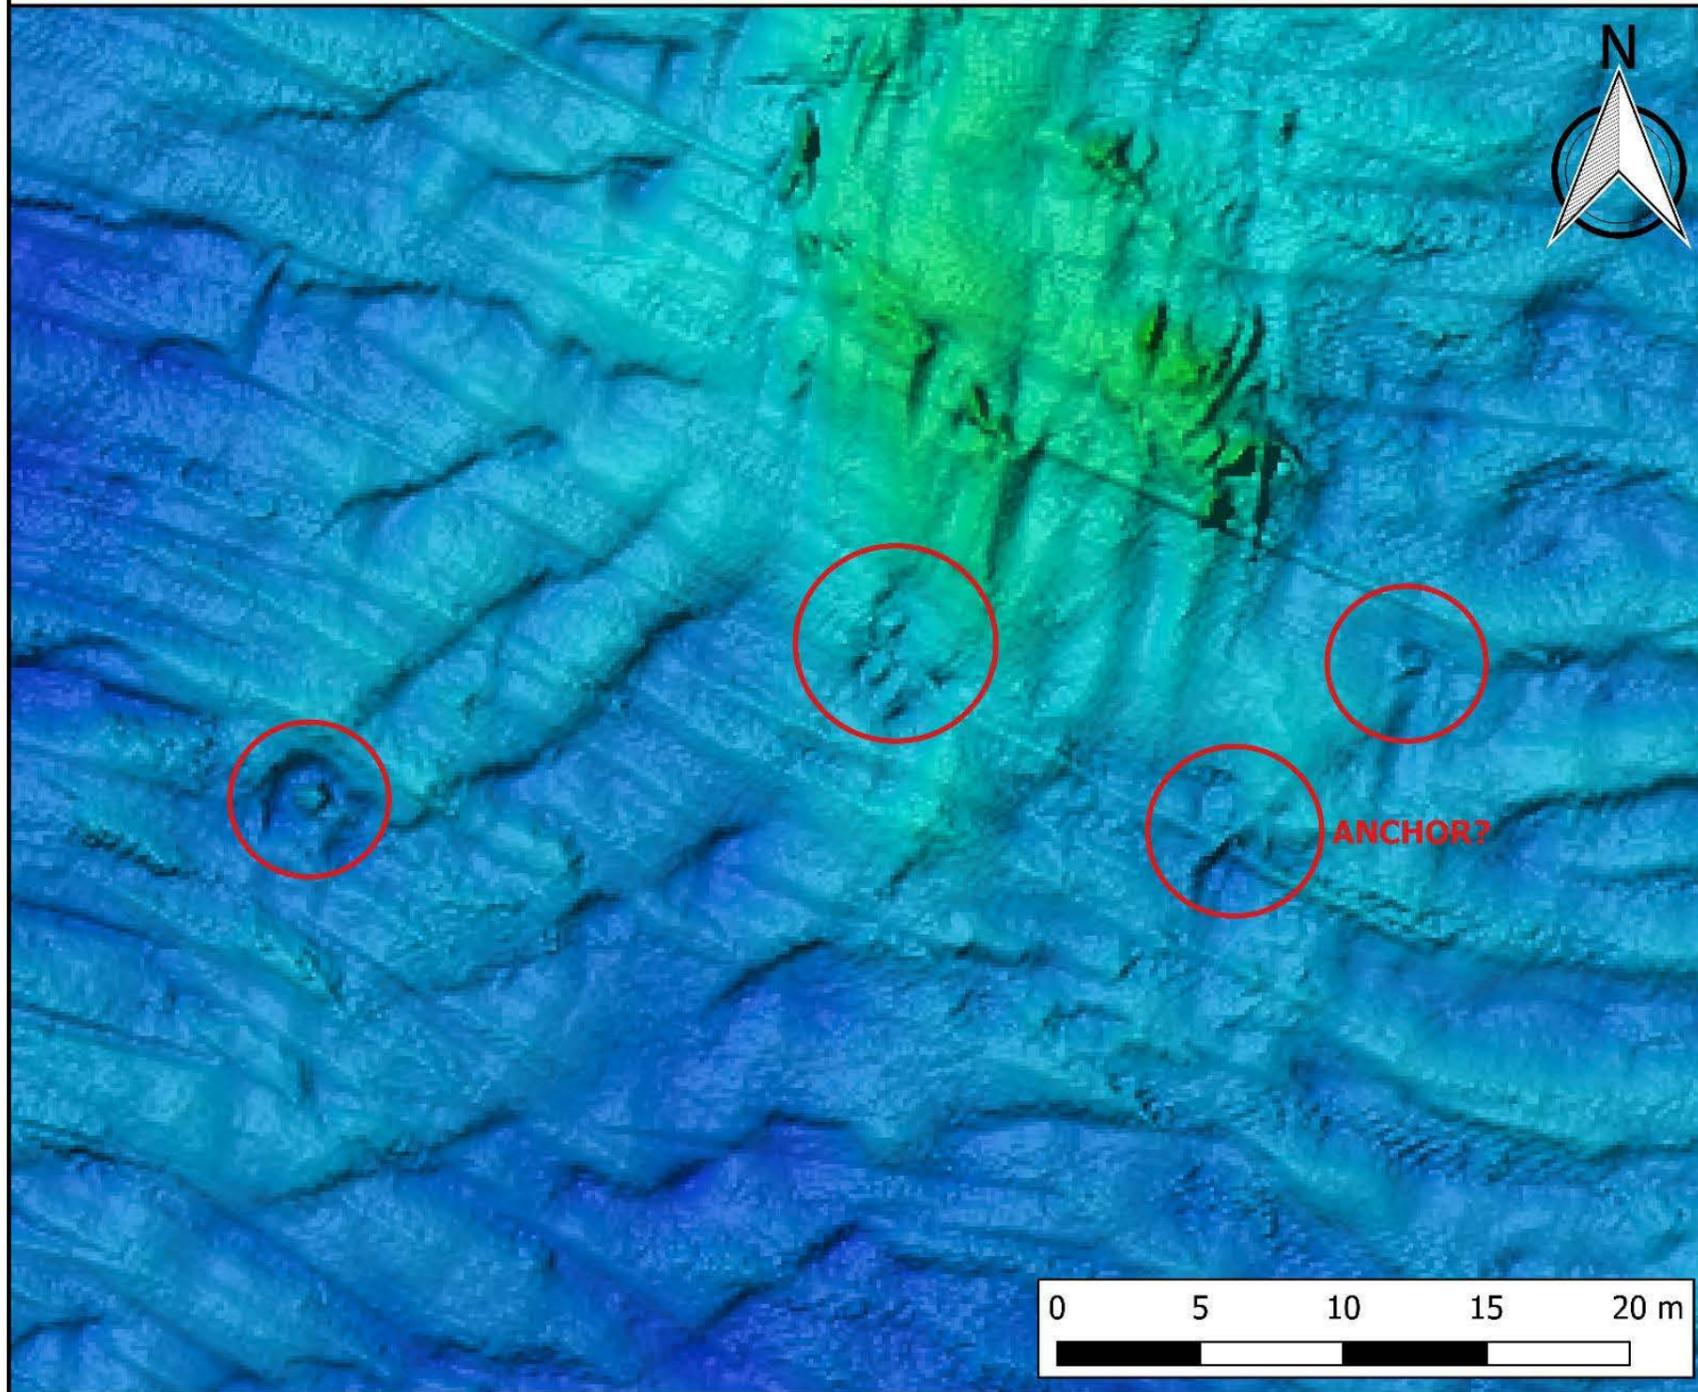
Fig. 3: Features off the main wreck mound

4.2.13 Nine metres south of the anchors is an anomaly that has the appearance of a partly exposed anchor (Figure 3). The shape is consistent with one exposed fluke and the shaft. The shaft is 3.4m long and the length of the fluke from the crown is 1.6m. If it is an anchor it is a smaller type than the ones on the main wreck mound.

4.2.14 Six and half metres southeast of the anchors on the main wreck mound is a circular anomaly (Figure 3). It has a diameter of 1.5m.

4.2.15 7.5 metres SSW of the top of Feature 2 is an area 3.8 x 3m of exposed material but it is not possible to identify what it may be.

4.2.16 27 metres southwest of the top of Feature 2 is an isolated anomaly with a distinct scour around it. The anomaly is 1.5x 1.2m and the scour is approximately 1m wide.

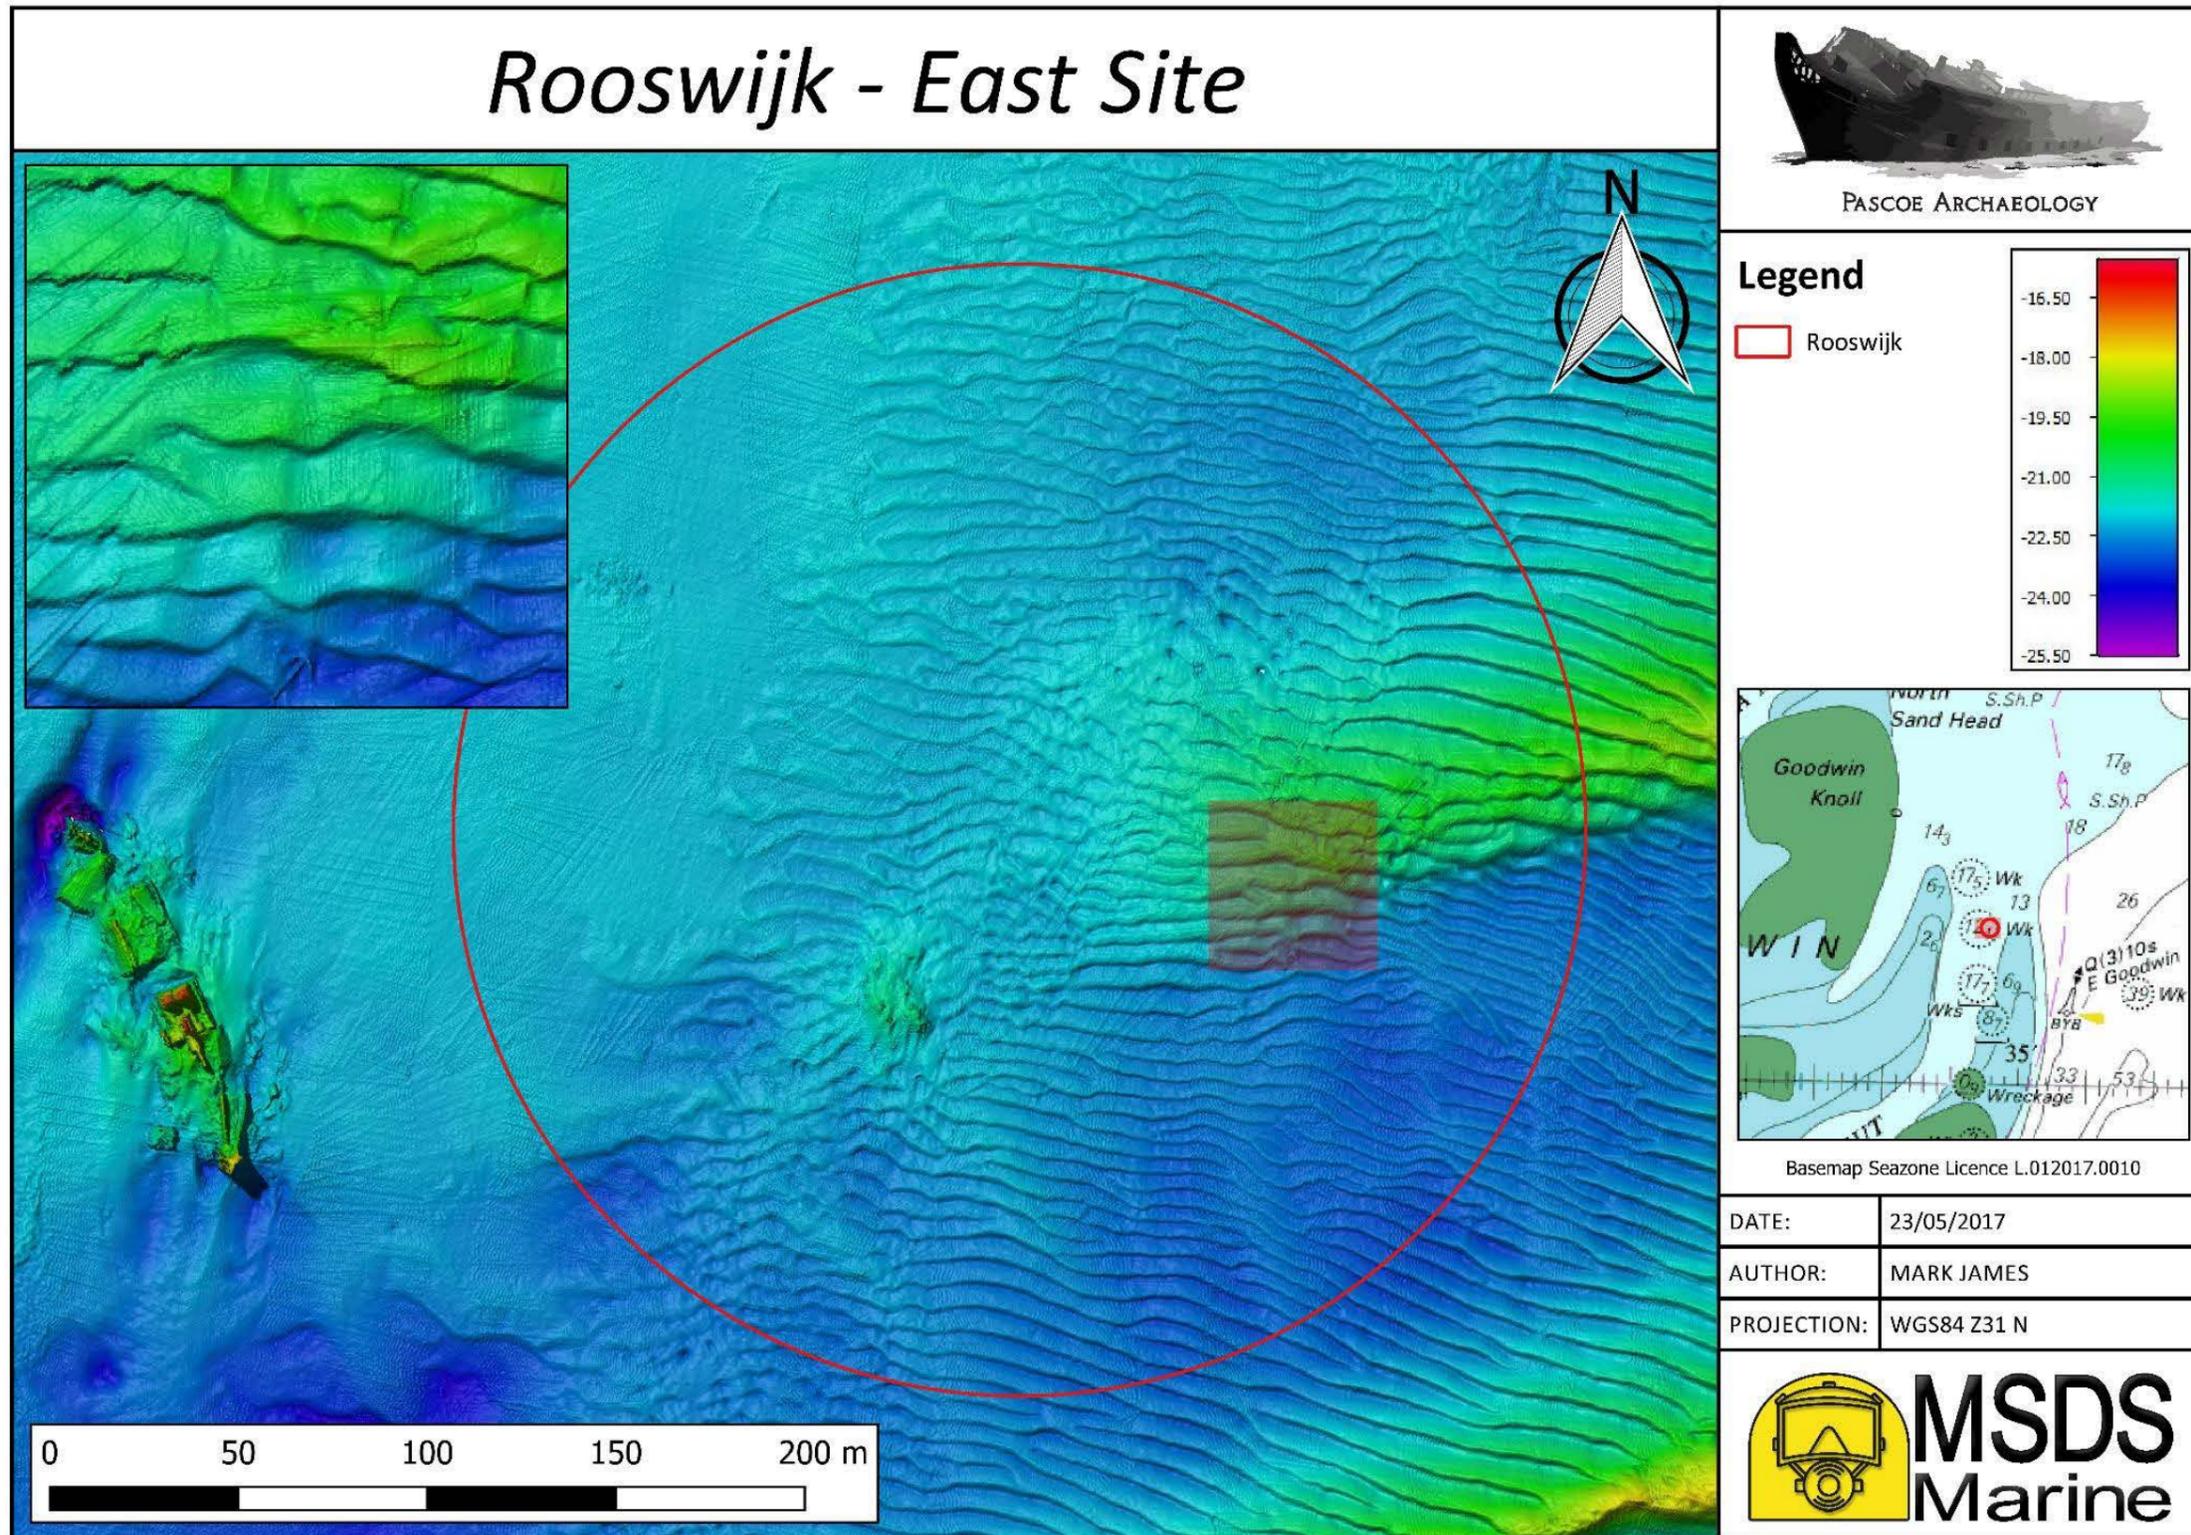
Fig. 4: Rooswijk East site in relation to the designated area.

4.2.17 The East site has changed dramatically since the 2016 MB survey. In the 2016 survey it was possible to identify a scatter of small rectangular anomalies. These were known to be the cut stone blocks the *Rooswijk* was carrying as part of the cargo. In addition, an area of concretion consisting of strips of iron and a single anchor was visible at the southern limit of the site. A large bank of sand was encroaching from the north which, in 2016, was 29m north of the anchor.

4.2.18 The 2017 MBES survey has identified that the large bank of sand has migrated southwards covering the entire site with the exception of the anchor. The edge of the bank of sand is now only 4.5m away from the crown end of the anchor. It has therefore advanced approximately 24.5m since the last survey in 2016 (Figures 4–5).

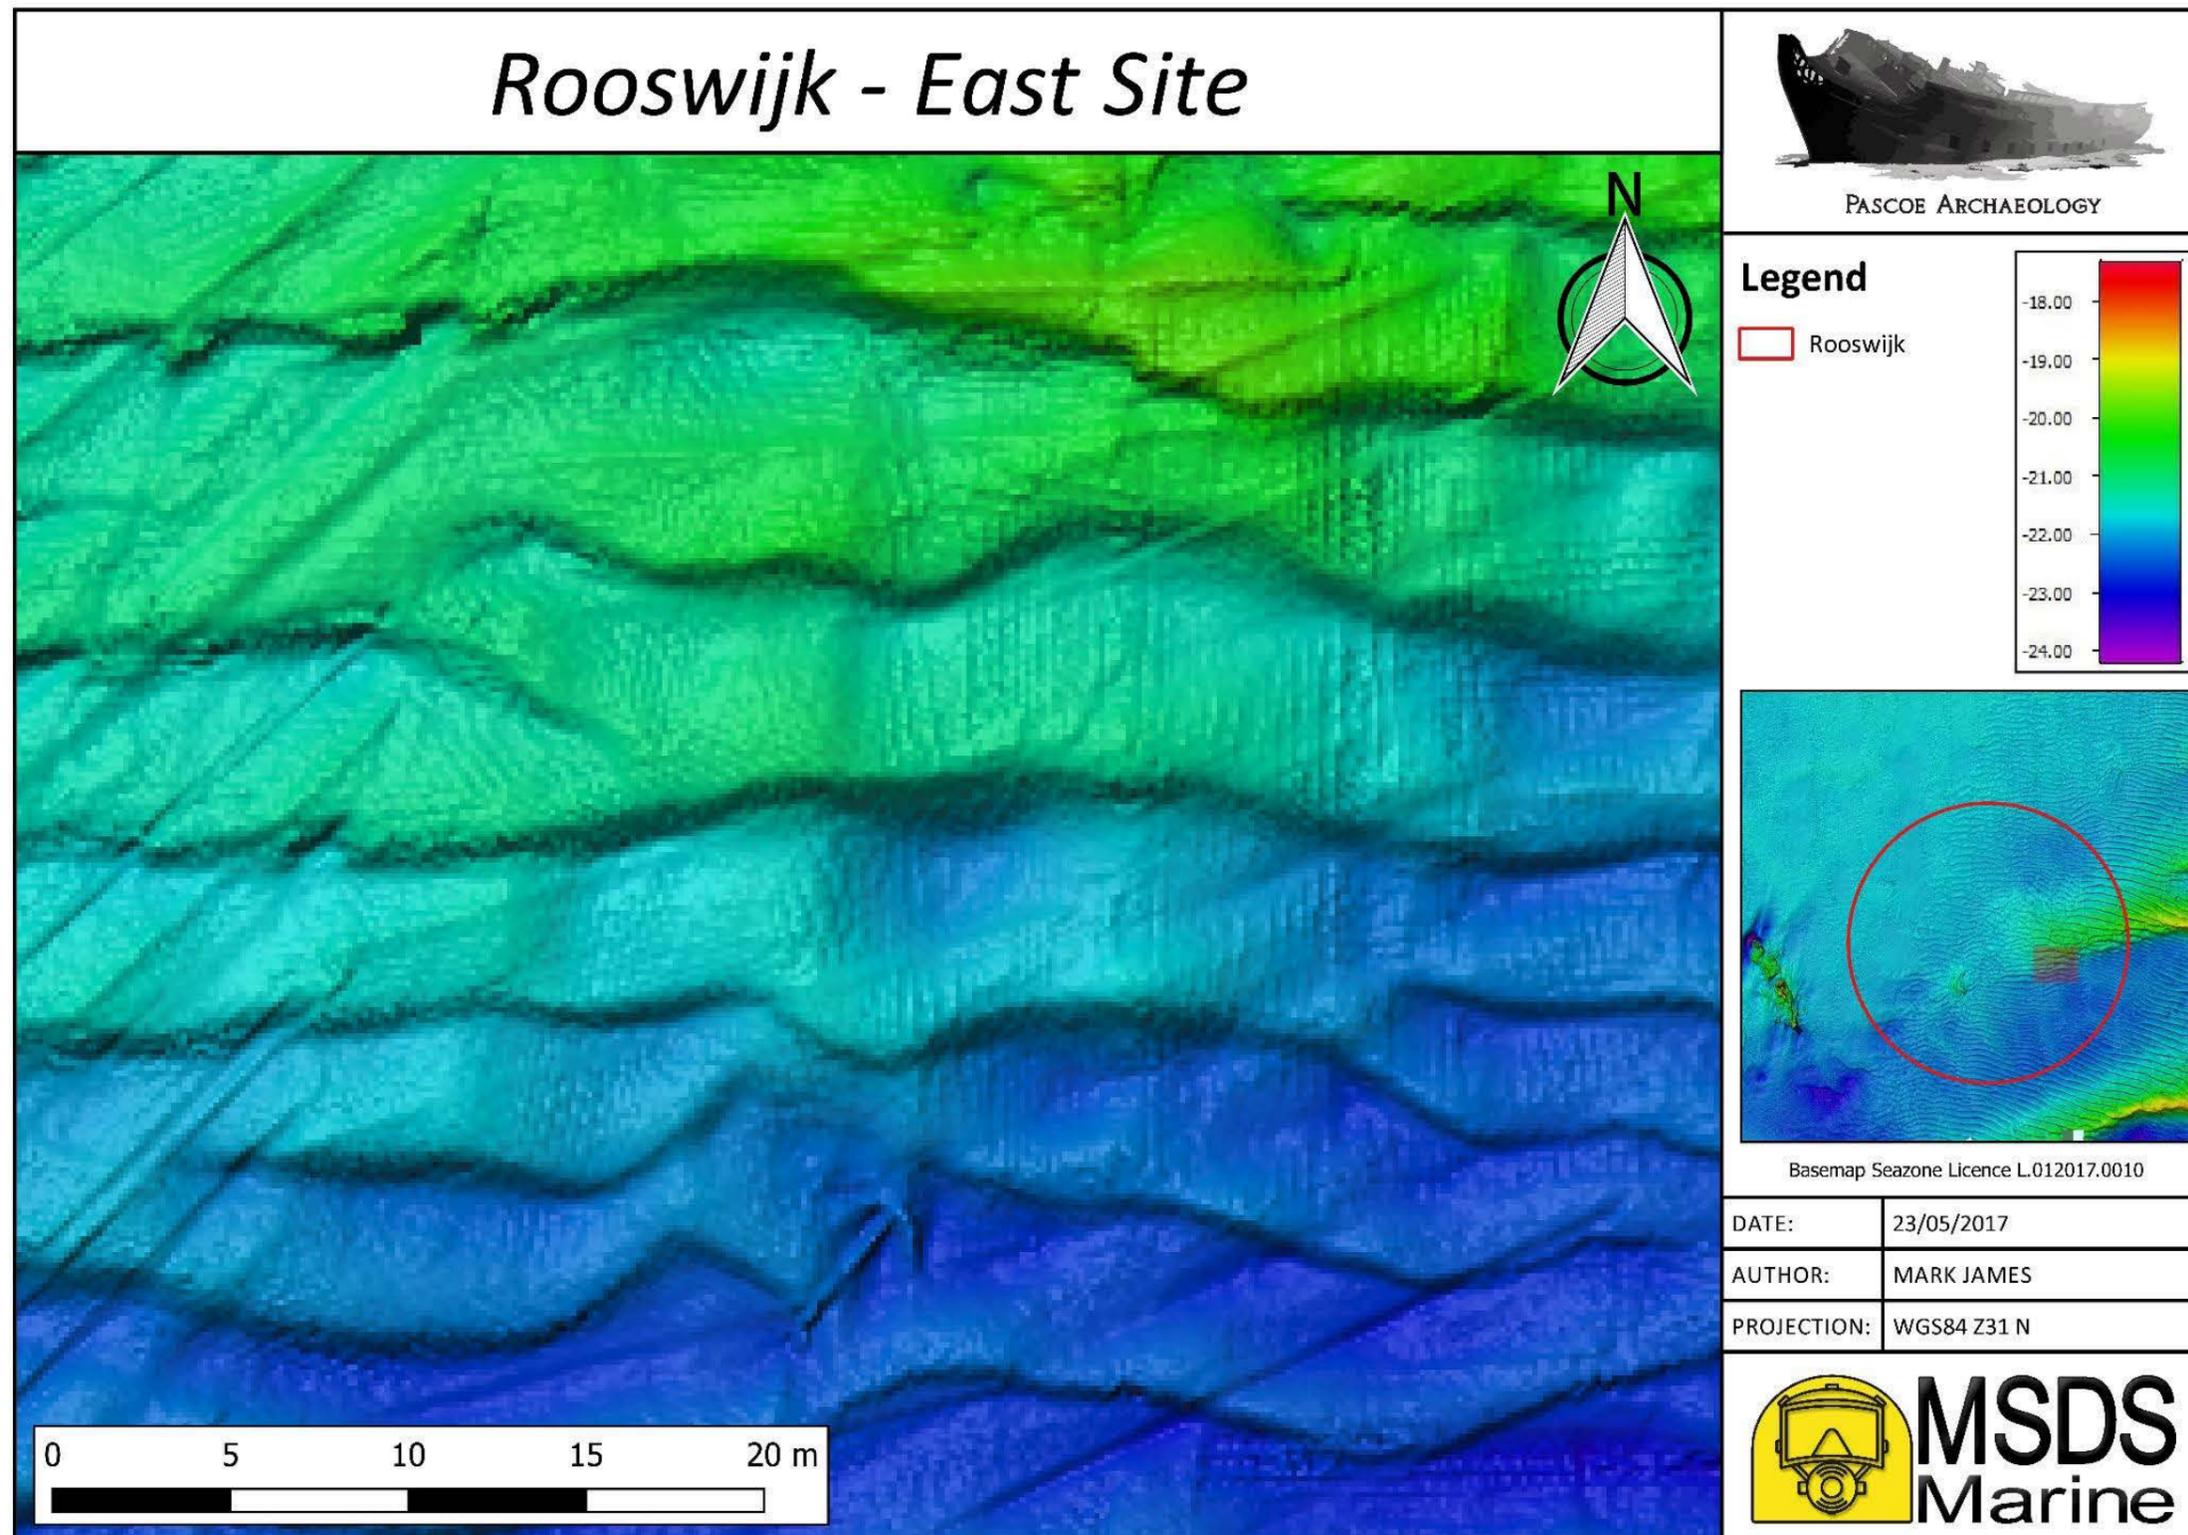
Fig. 5: The only exposed feature on the East site is an anchor.

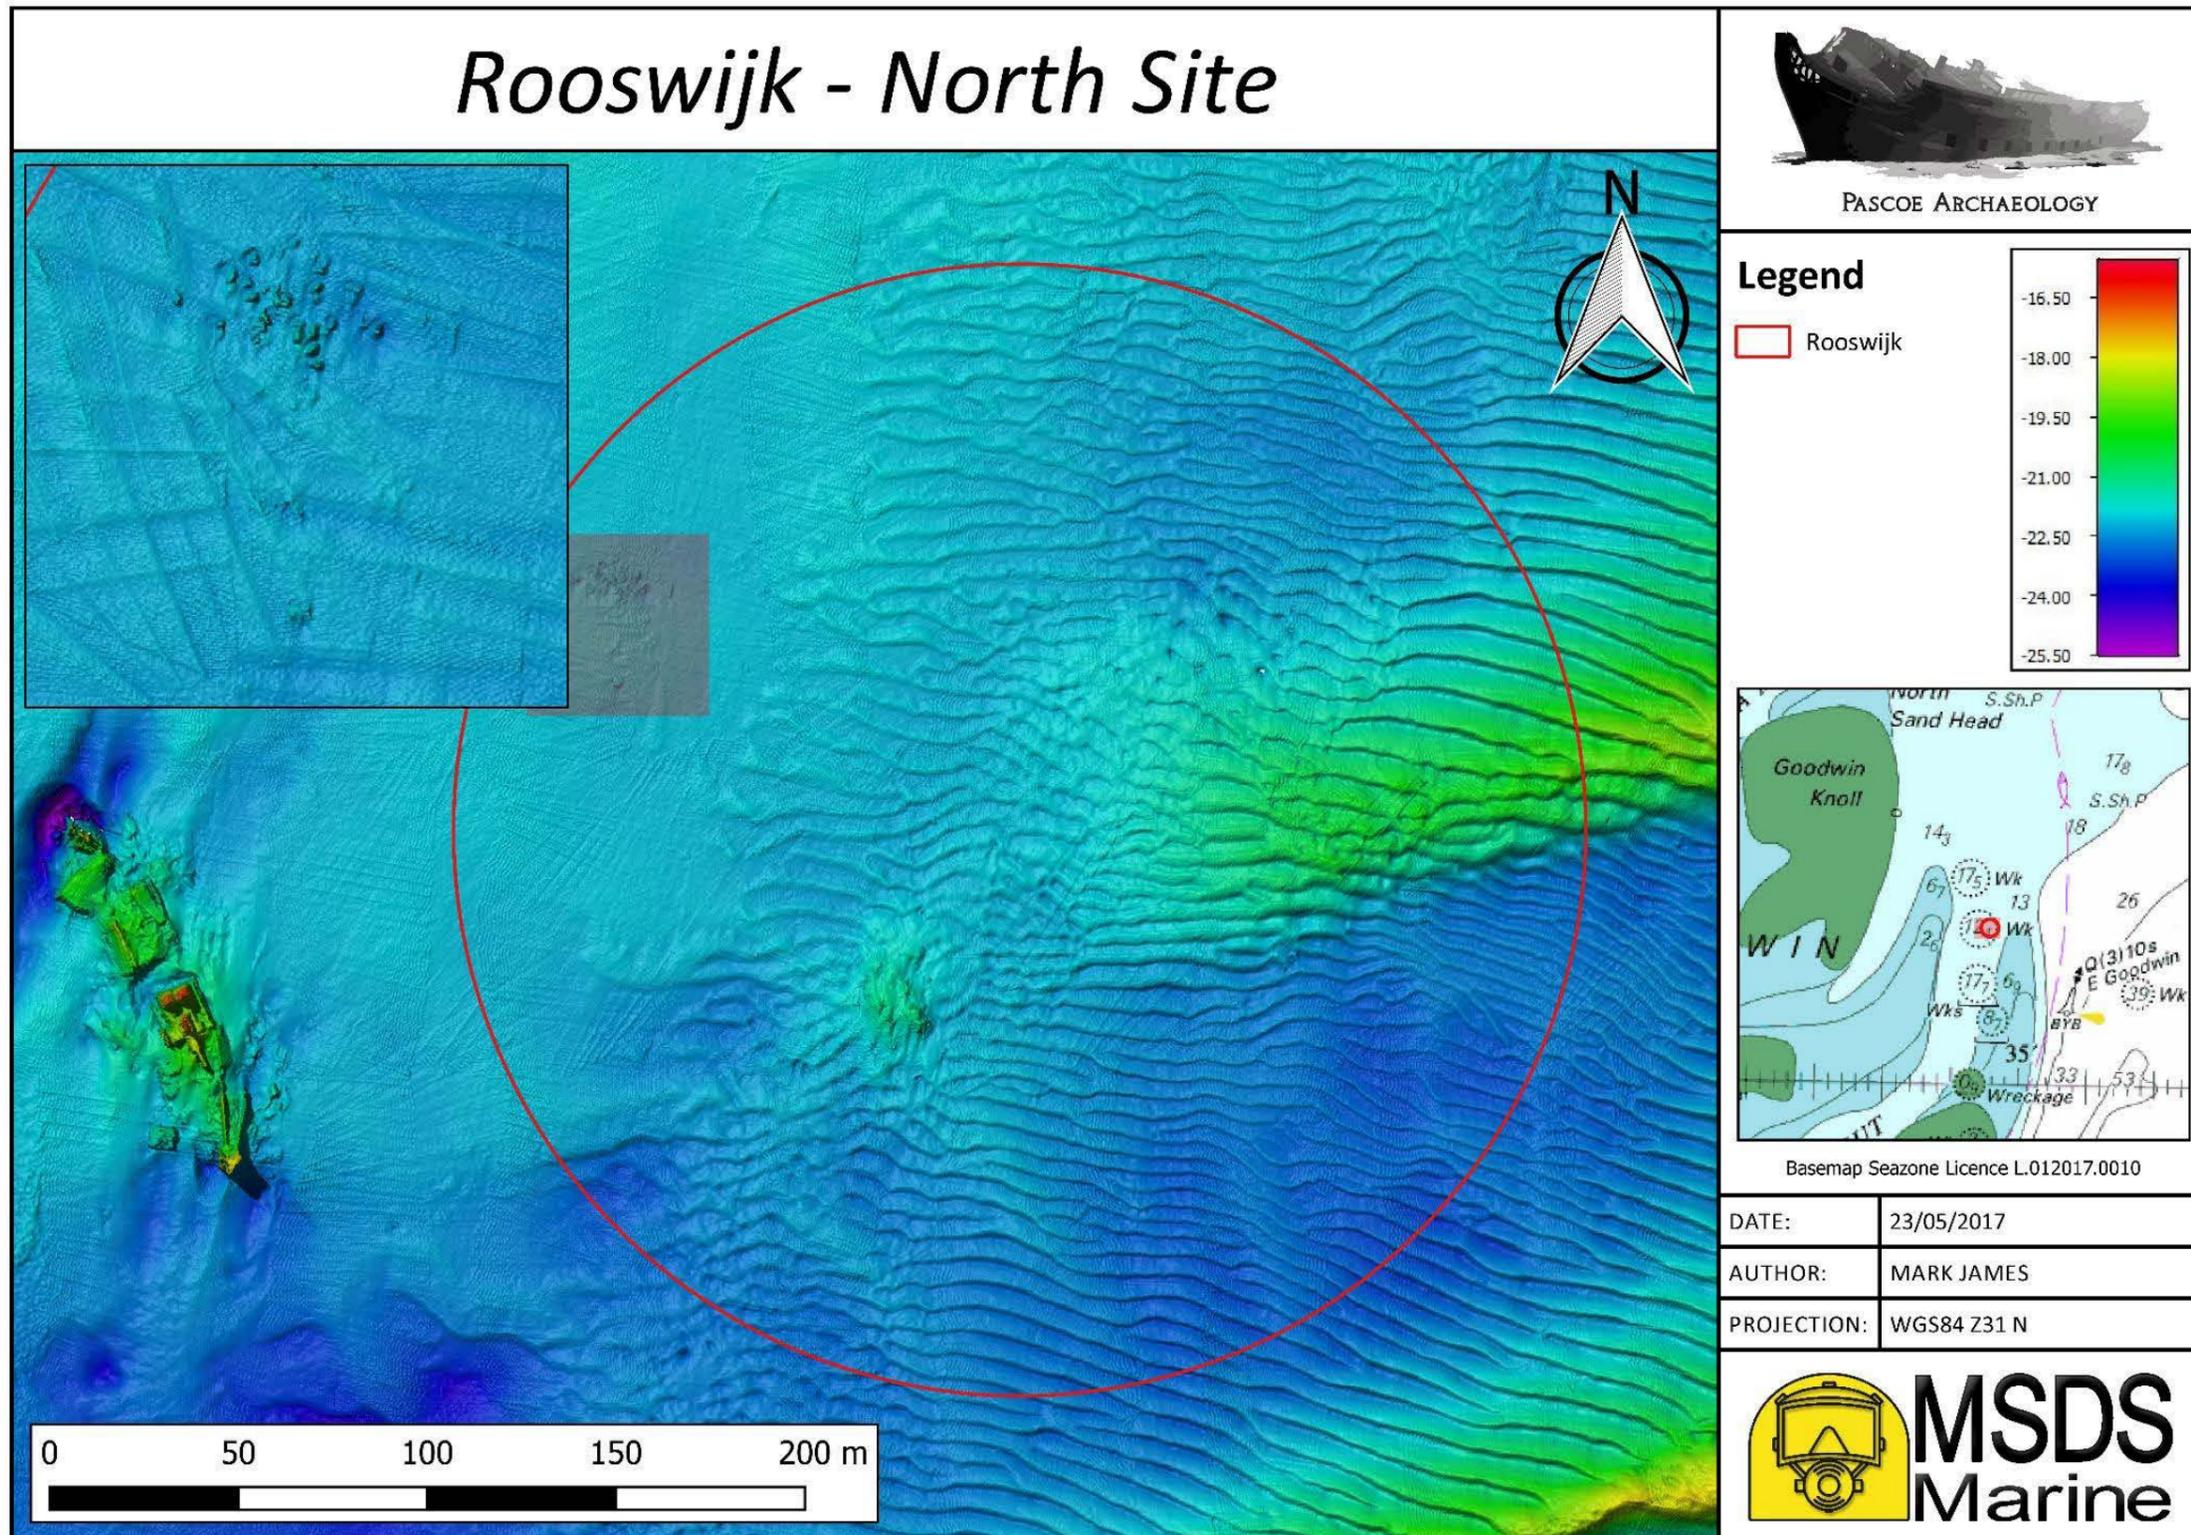
Fig. 6: Rooswijk North site in relation to designated area.

4.2.19 The North site consists of a scatter of small anomalies, many of which have been identified as concreted barrels. They cover an area roughly 19 x 15m. In addition, there appears to be a debris trail extending a further 20m south (Figures 6–7).

4.2.20 Compared with the previous survey there appears to be a slight reduction in sand over the site as the seabed is flatter and anomalies more pronounced.
