Goodwin Sands and the Downs: Multi-Beam Surveys of the Designated Wrecks

Multi-Beam Surveys of the Designated Wrecks on the Goodwin Sands and the Downs

July 2017

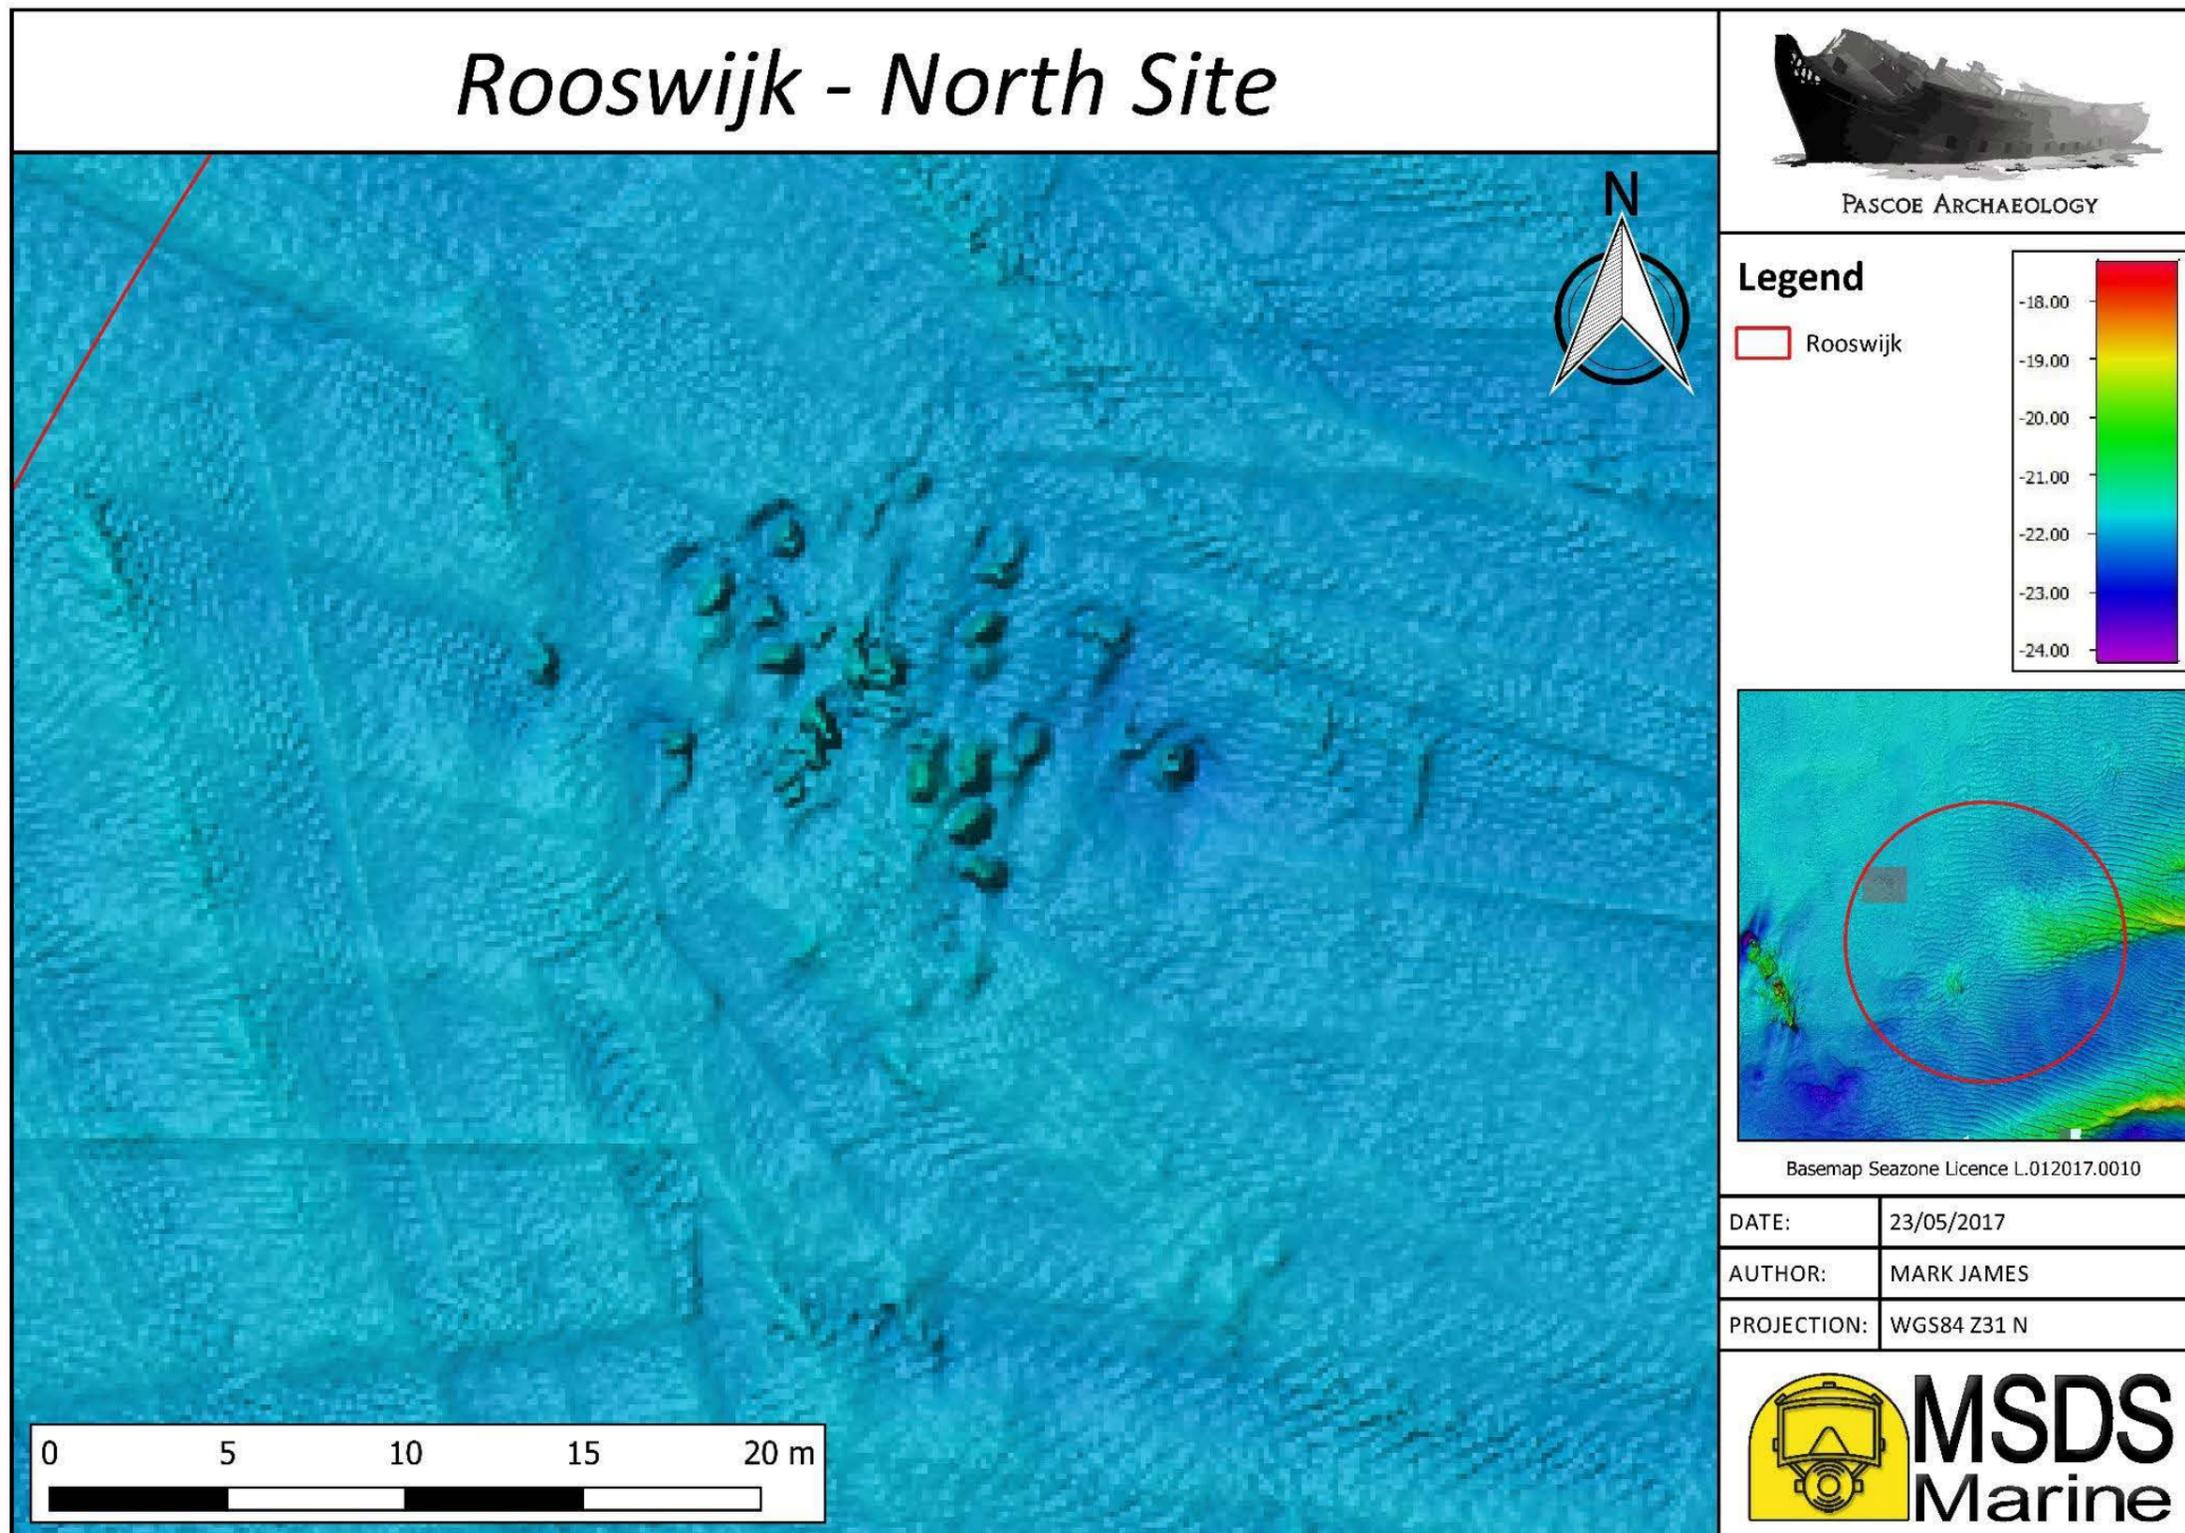
Fig. 7: Close-up North site.

4.2.19 The North site consists of a scatter of small anomalies, many of which have been identified as concreted barrels. They cover an area roughly 19 x 15m. In addition, there appears to be a debris trail extending a further 20m south (Figures 6–7).

4.2.20 Compared with the previous survey there appears to be a slight reduction in sand over the site as the seabed is flatter and anomalies more pronounced.

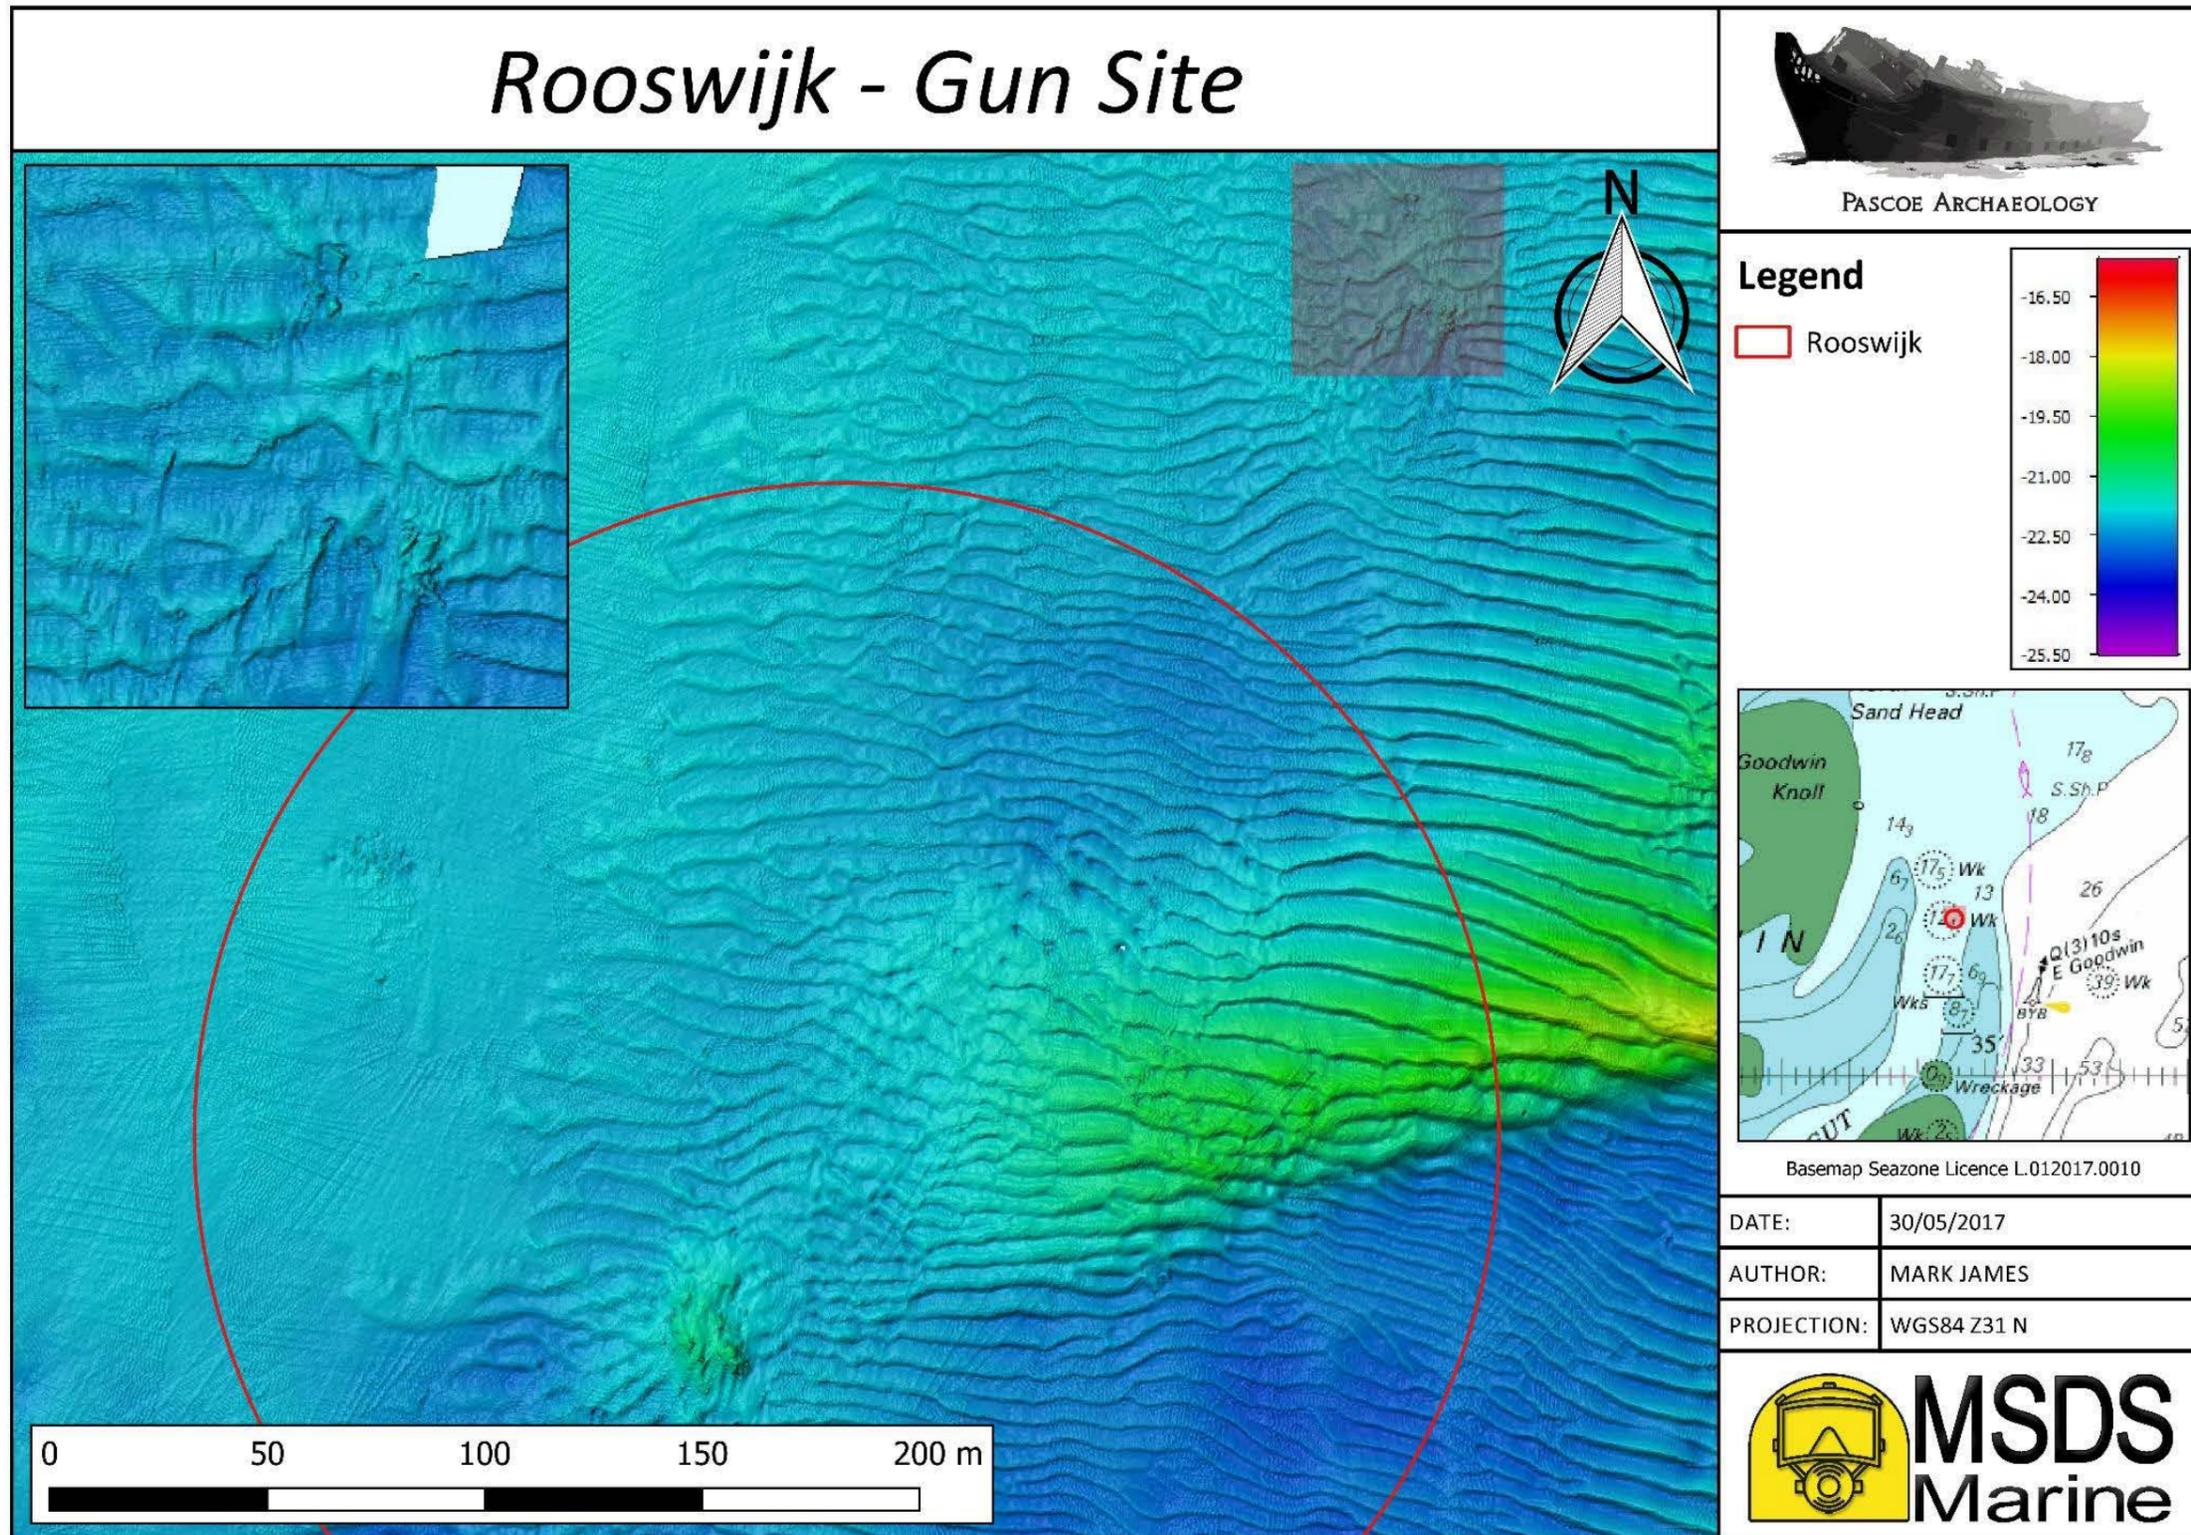
Fig. 8: Gun site in relation to the designated area.

- 4.2.21 Northeast of the edge of the designated area is a scatter of nine linear anomalies. The closest of the anomalies is 55m from the edge of the designated area and the furthest is 101m (Figures 8–9). These linear anomalies range in length from 2–2.6m and are roughly 0.4–0.5m wide. There is no obvious evidence of any ship's structure in or around these linear anomalies. There are, however, a small number of other rough shaped anomalies but nothing to suggest significant sections of ship structure exposed or potentially lying just beneath the surface. For example, there are no mounds that may suggest buried material.

- 4.2.22 Due to the sizes and shape of the anomalies it is highly possible that they are guns. The lack of any exposed evidence of ship's structure or mounds to suggest potential buried material would indicate this is a potential site of jettisoned material rather than a final wrecking position.

- 4.2.23 This area was less exposed during the 2016 survey as it is only possible to clearly make out one of the possible guns and a very slight impression of two others. This demonstrates how the seabed has changed between surveys and how a relatively small reduction in sediments can expose a significant number of archaeological features.

- 4.9.4 Of great interest is the identification of a potential gun site northeast of the edge of the designated area. Considering the *Rooswijk* was armed with 30 guns and so few have been seen on the West site, there is a potential that this new site could be related to the *Rooswijk*. Should these guns originate from the *Rooswijk* then it would change the current understanding of the wrecking event. It is therefore important to investigate this site more closely and this will be conducted as part of a sub project of the main 2017 excavation of the *Rooswijk*. If this site is found to be related to the *Rooswijk* then increasing the designated area to protect it should be considered.

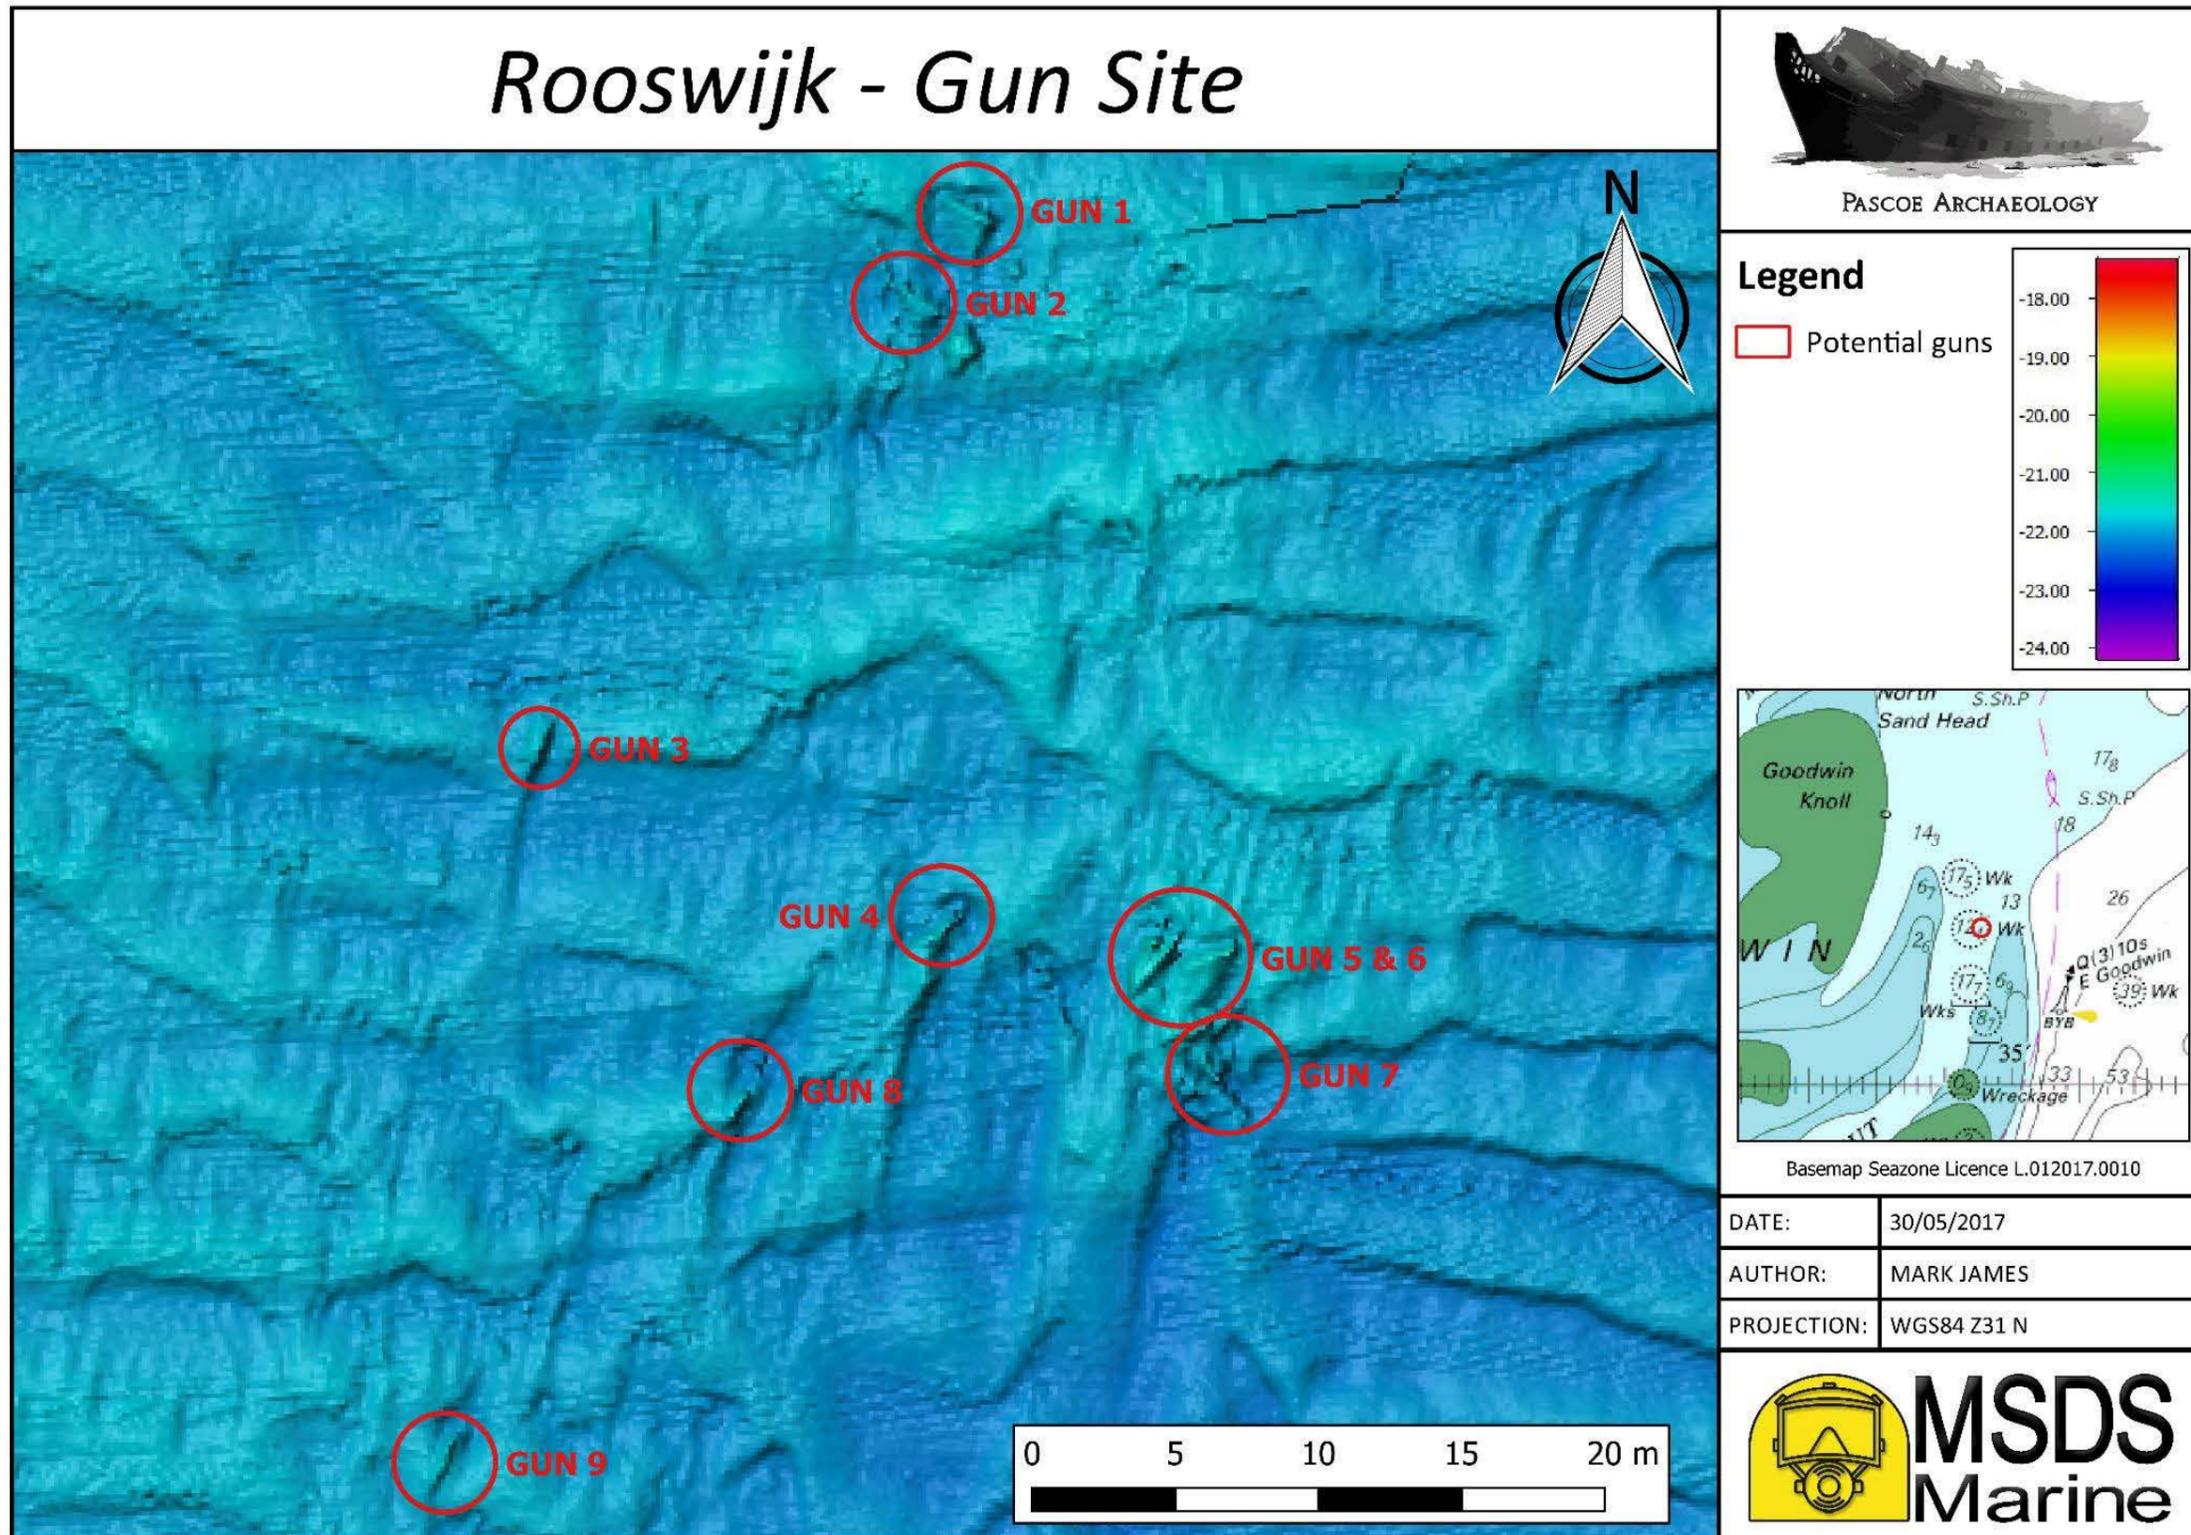
Fig. 9: Close-up of Gun site showing 9 potential guns.

- 4.2.24 As mentioned above, nine potential guns have been identified in the 2017 data and three of these can be seen in the 2016 data. Figure 9 has the potential guns circled and their exposed dimensions and orientations are listed below.

Gun	Survey Year	Length (m)	Width (m)	Orientation
1	2016 and 2017	2.3	0.5	NW/SE
2	2017	2.4	0.5	NW/SE
3	2017	2.5	0.5	NNE/SSW
4	2017	2.0	0.4	NE/SW
5	2017	2.4	0.5	NE/SW
6	2017	2.4	0.4	ENE/WSW
7	2017	2.6	0.5	NW/SE
8	2016 and 2017	2.6 (from 2016 data)	0.4	NNE/SSW
9	2016 and 2017	2.5	0.4	NNE/SSW

material present is consistent with the material found on the other sites within the designated area. For example, if the exposed objects are guns do they match the guns found on the west site? If the material from this new site is consistent with the *Rooswijk* then increasing the size of the designated circle to encompass the new site should be considered.

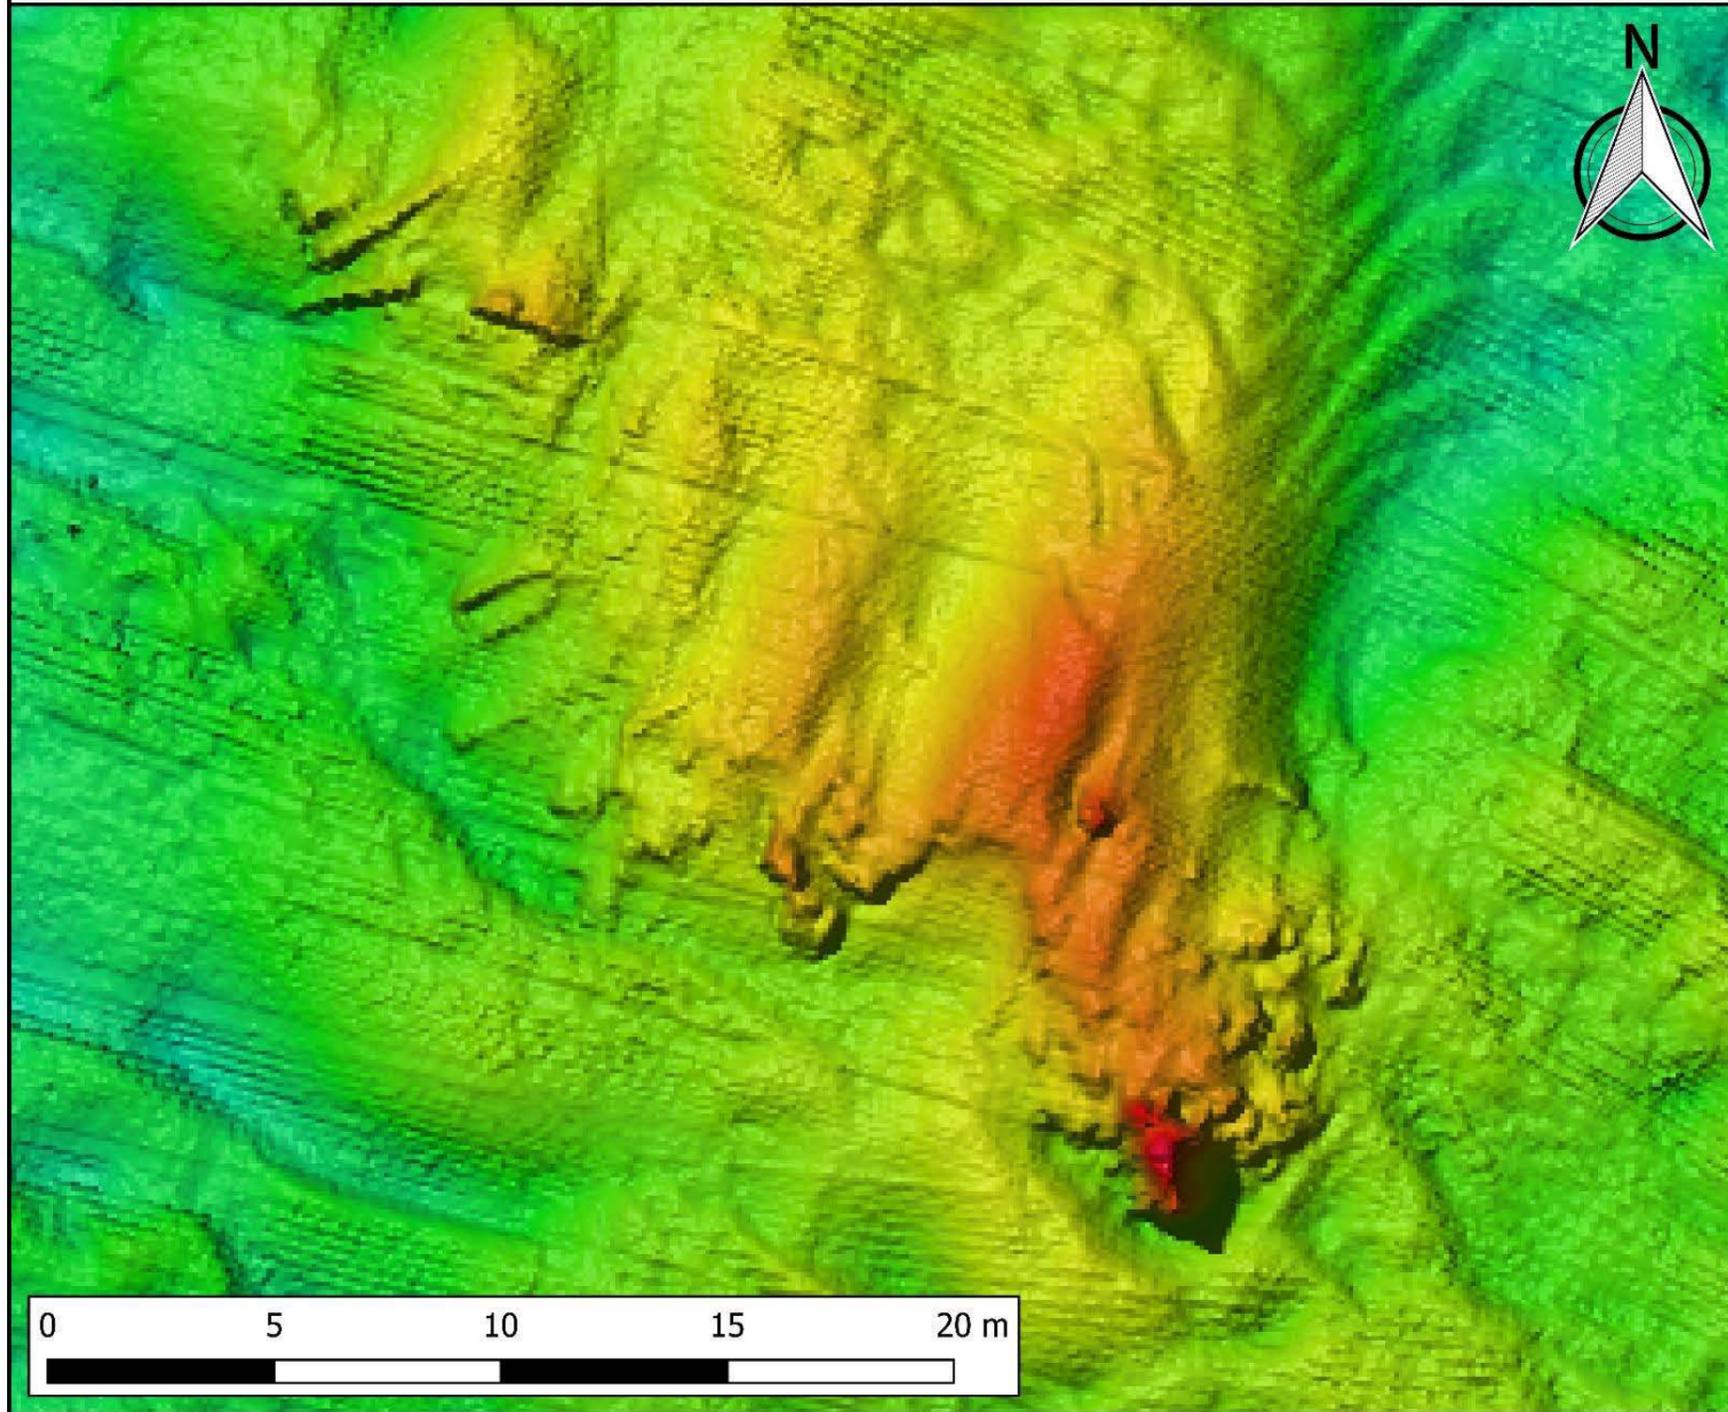
Fig. 11: Close-up of the Northumberland wreck mound.

- 4.3.4 The 2017 MBES data shows there is a greater slope to the mound on the west side which extends from the northern limits to the southern limits of the site. There is also a distinct scour on the east side of the mound that extends 30m to the north. The mound flattens out to the north (Figures 10–12). There is also a potential for buried archaeological material around the north as many of the guns previously observed on the site were found along the northern parts of the site (Pascoe *et al* 2015, 134).

Due to the fact the *Northumberland* is experiencing a period of seabed erosion via the migration of a sand bank away from the site and as a result archaeological material is vulnerable to biological and physical decay risk is assessed as: **High**

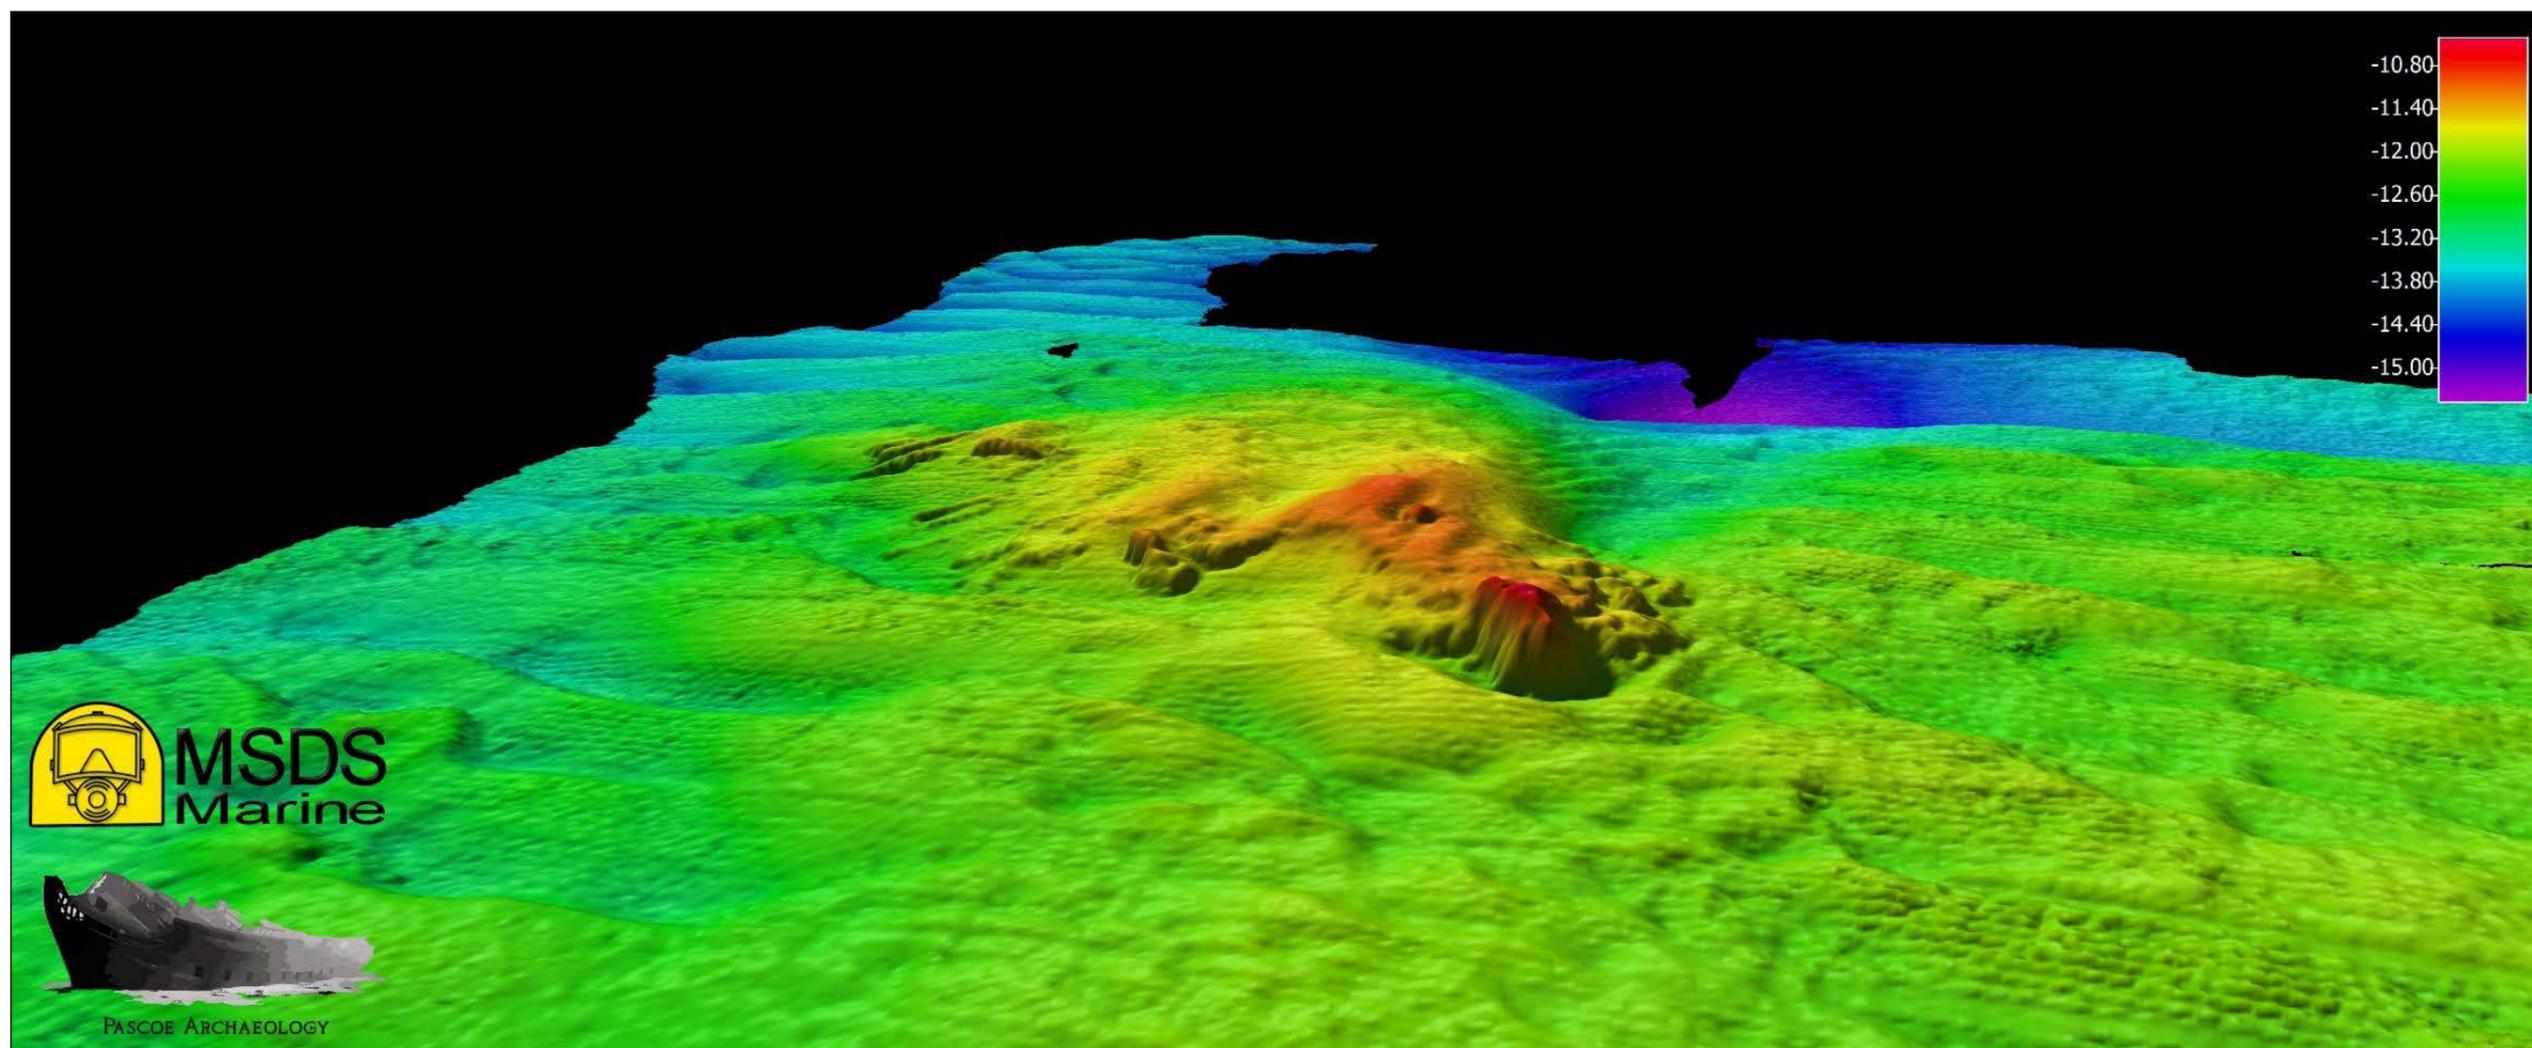
Fig. 12: Side elevation of the Northumberland site looking north. Large upstanding feature in the foreground and possible guns in the middle and north of the site.

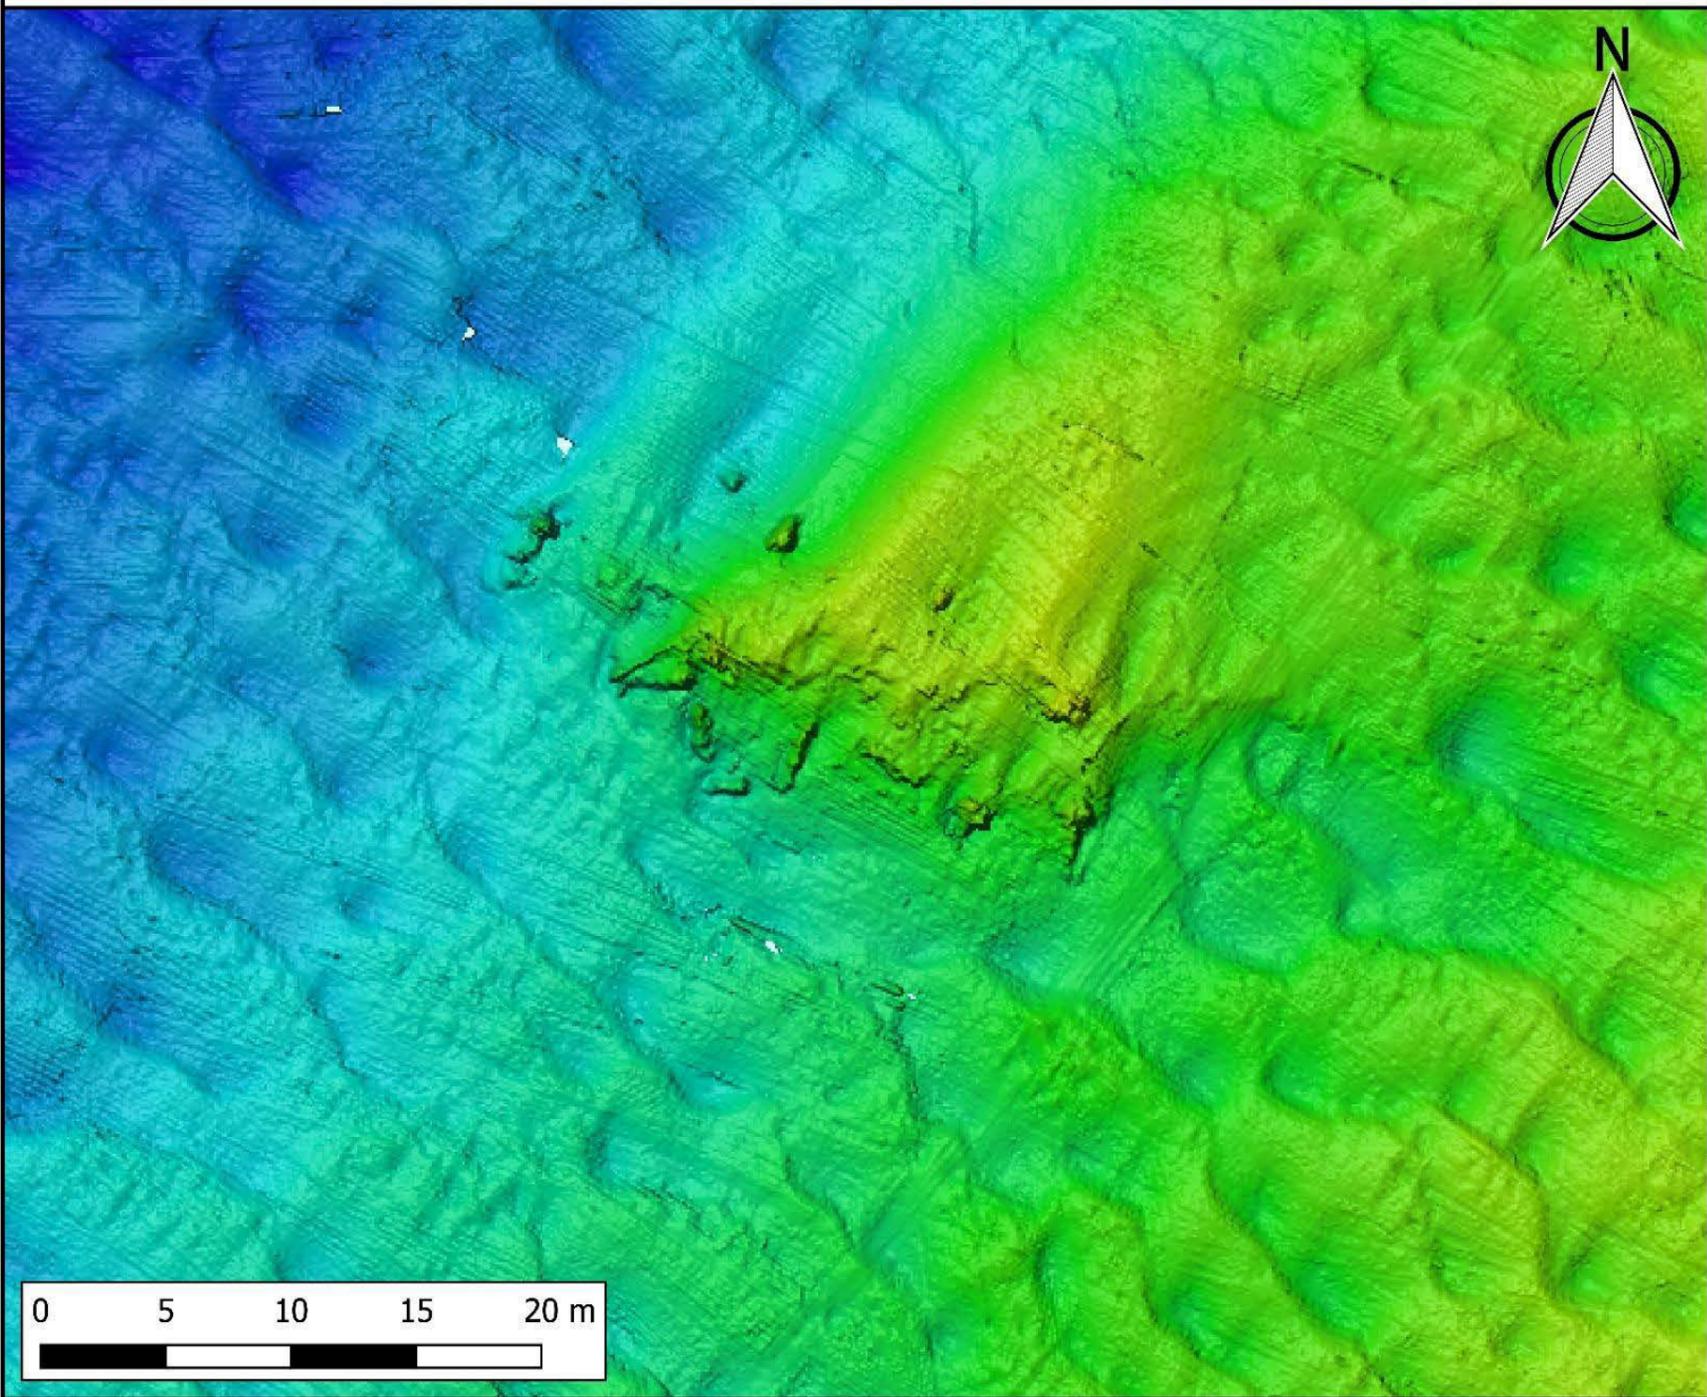
Fig. 14: The main wreck mound of the *Stirling Castle*.

westwards towards the site is the cause of the increased sedimentation on the wreck. Should the migration of this sand bank continue in a westward direction then the site of the *Stirling Castle* will continue to cover up.

As the site is experiencing a period of deposition of sediments rather than erosion but there are still notable archaeological features visible and vulnerable to physical and biological decay. Risk is assessed as **Medium**.

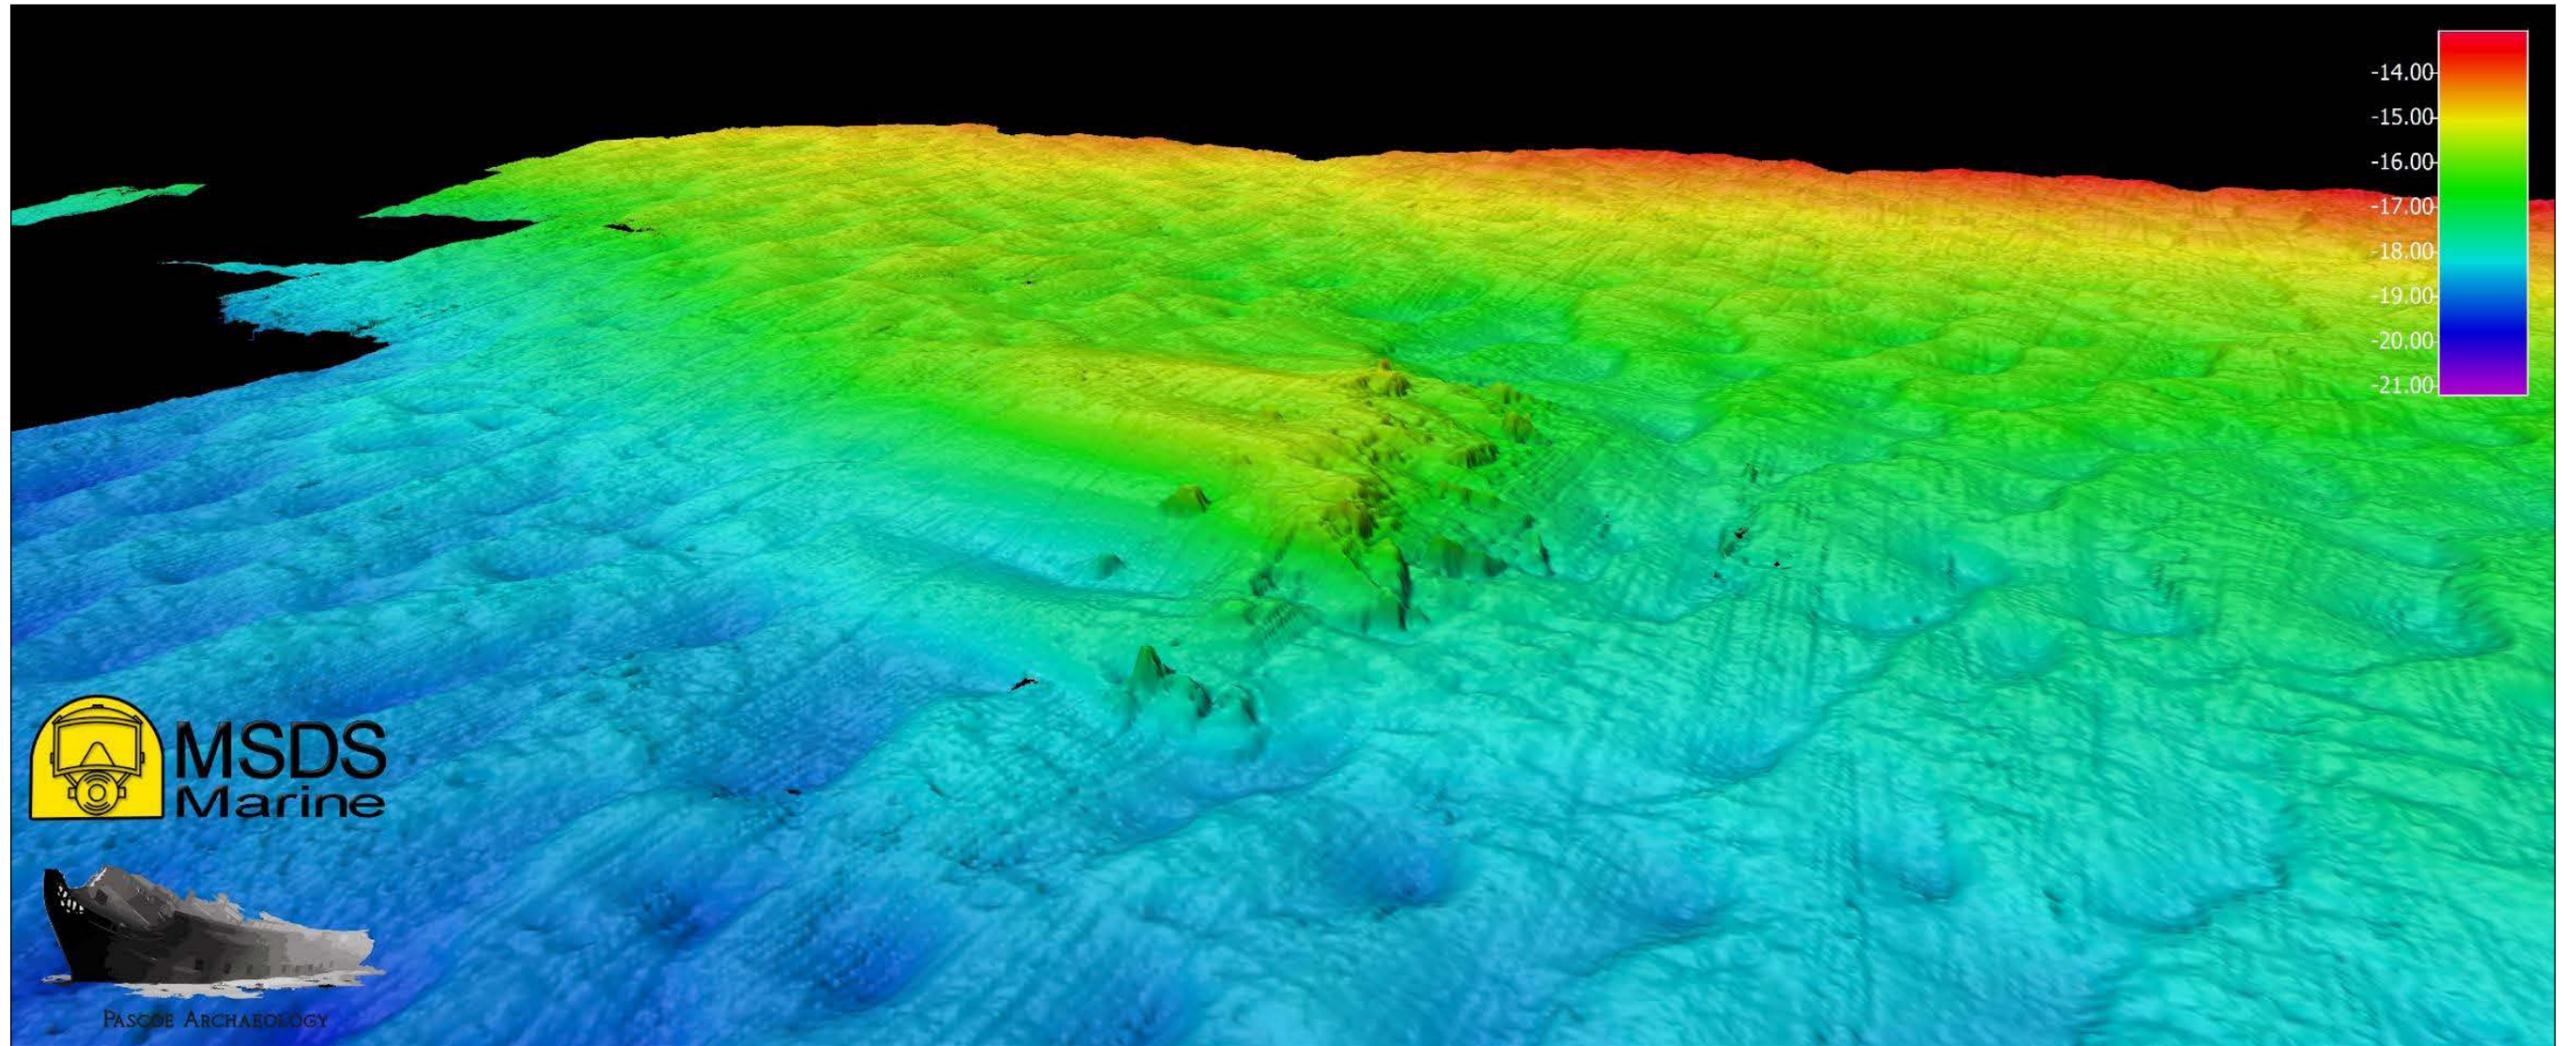
Fig. 15: Side elevation of the *Stirling Castle* site looking east towards the advancing sand bank.
