Goodwin Sands and the Downs: Multi-Beam Surveys of the Designated Wrecks

Multi-Beam Surveys of the Designated Wrecks on the Goodwin Sands and the Downs

July 2017

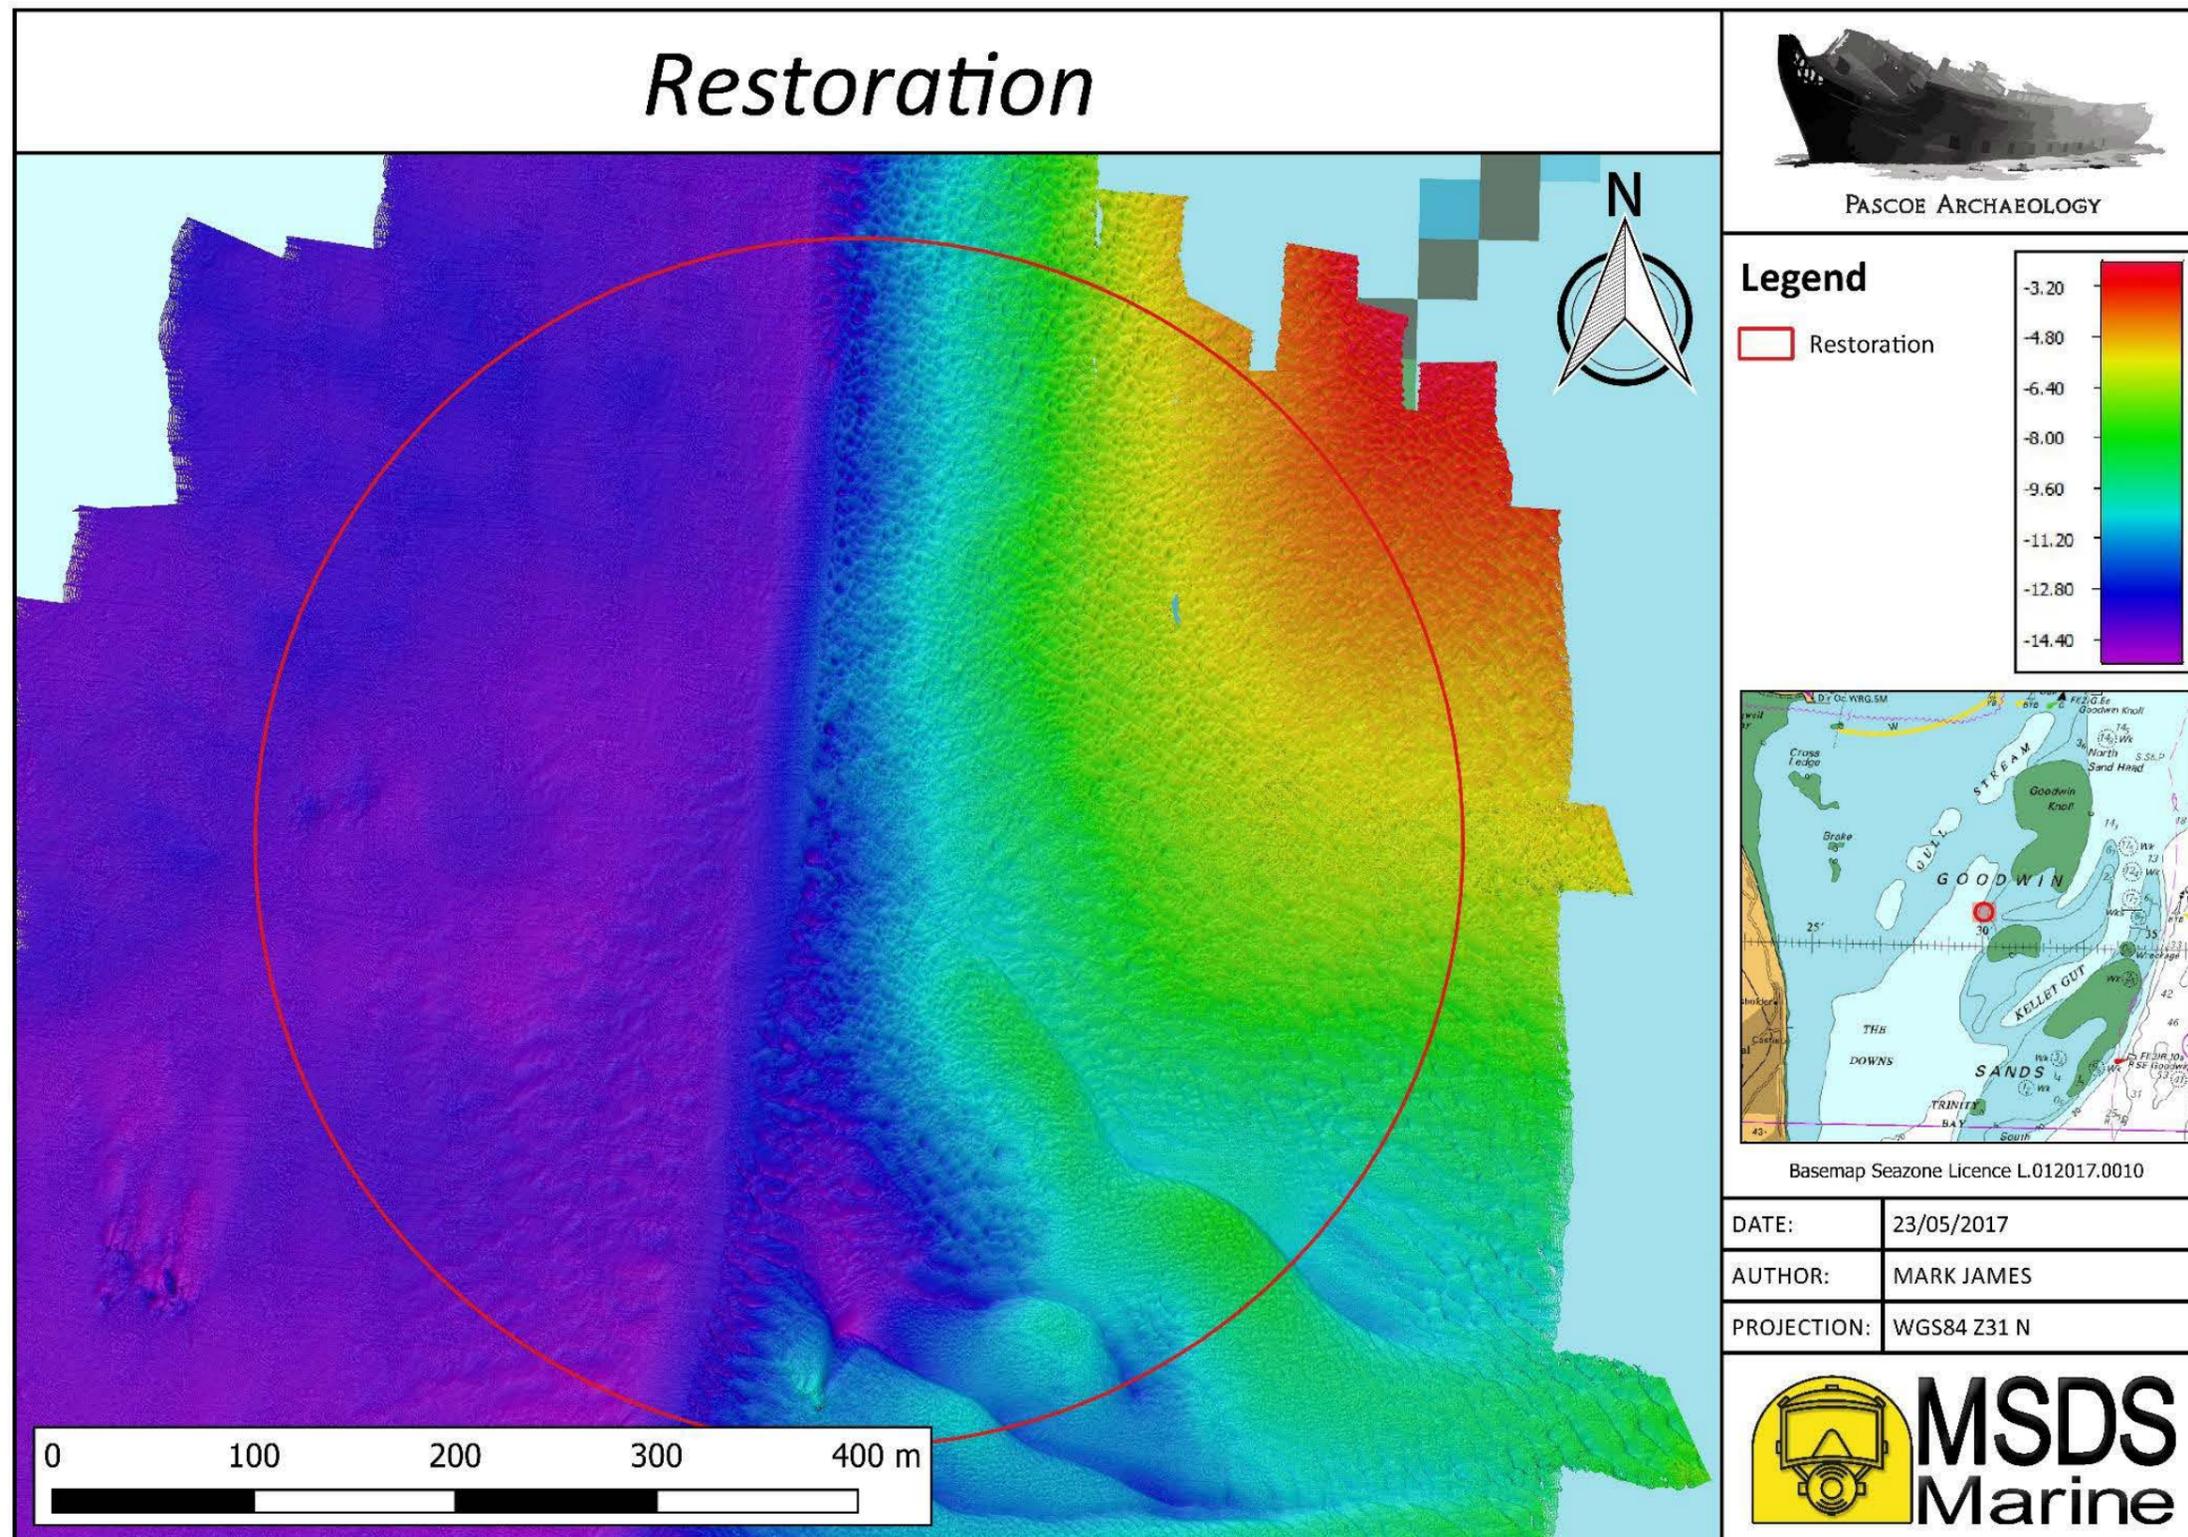
Fig. 16: No exposed wreck at the location of the *Restoration*. The *Northumberland* can be seen 280m to the south.

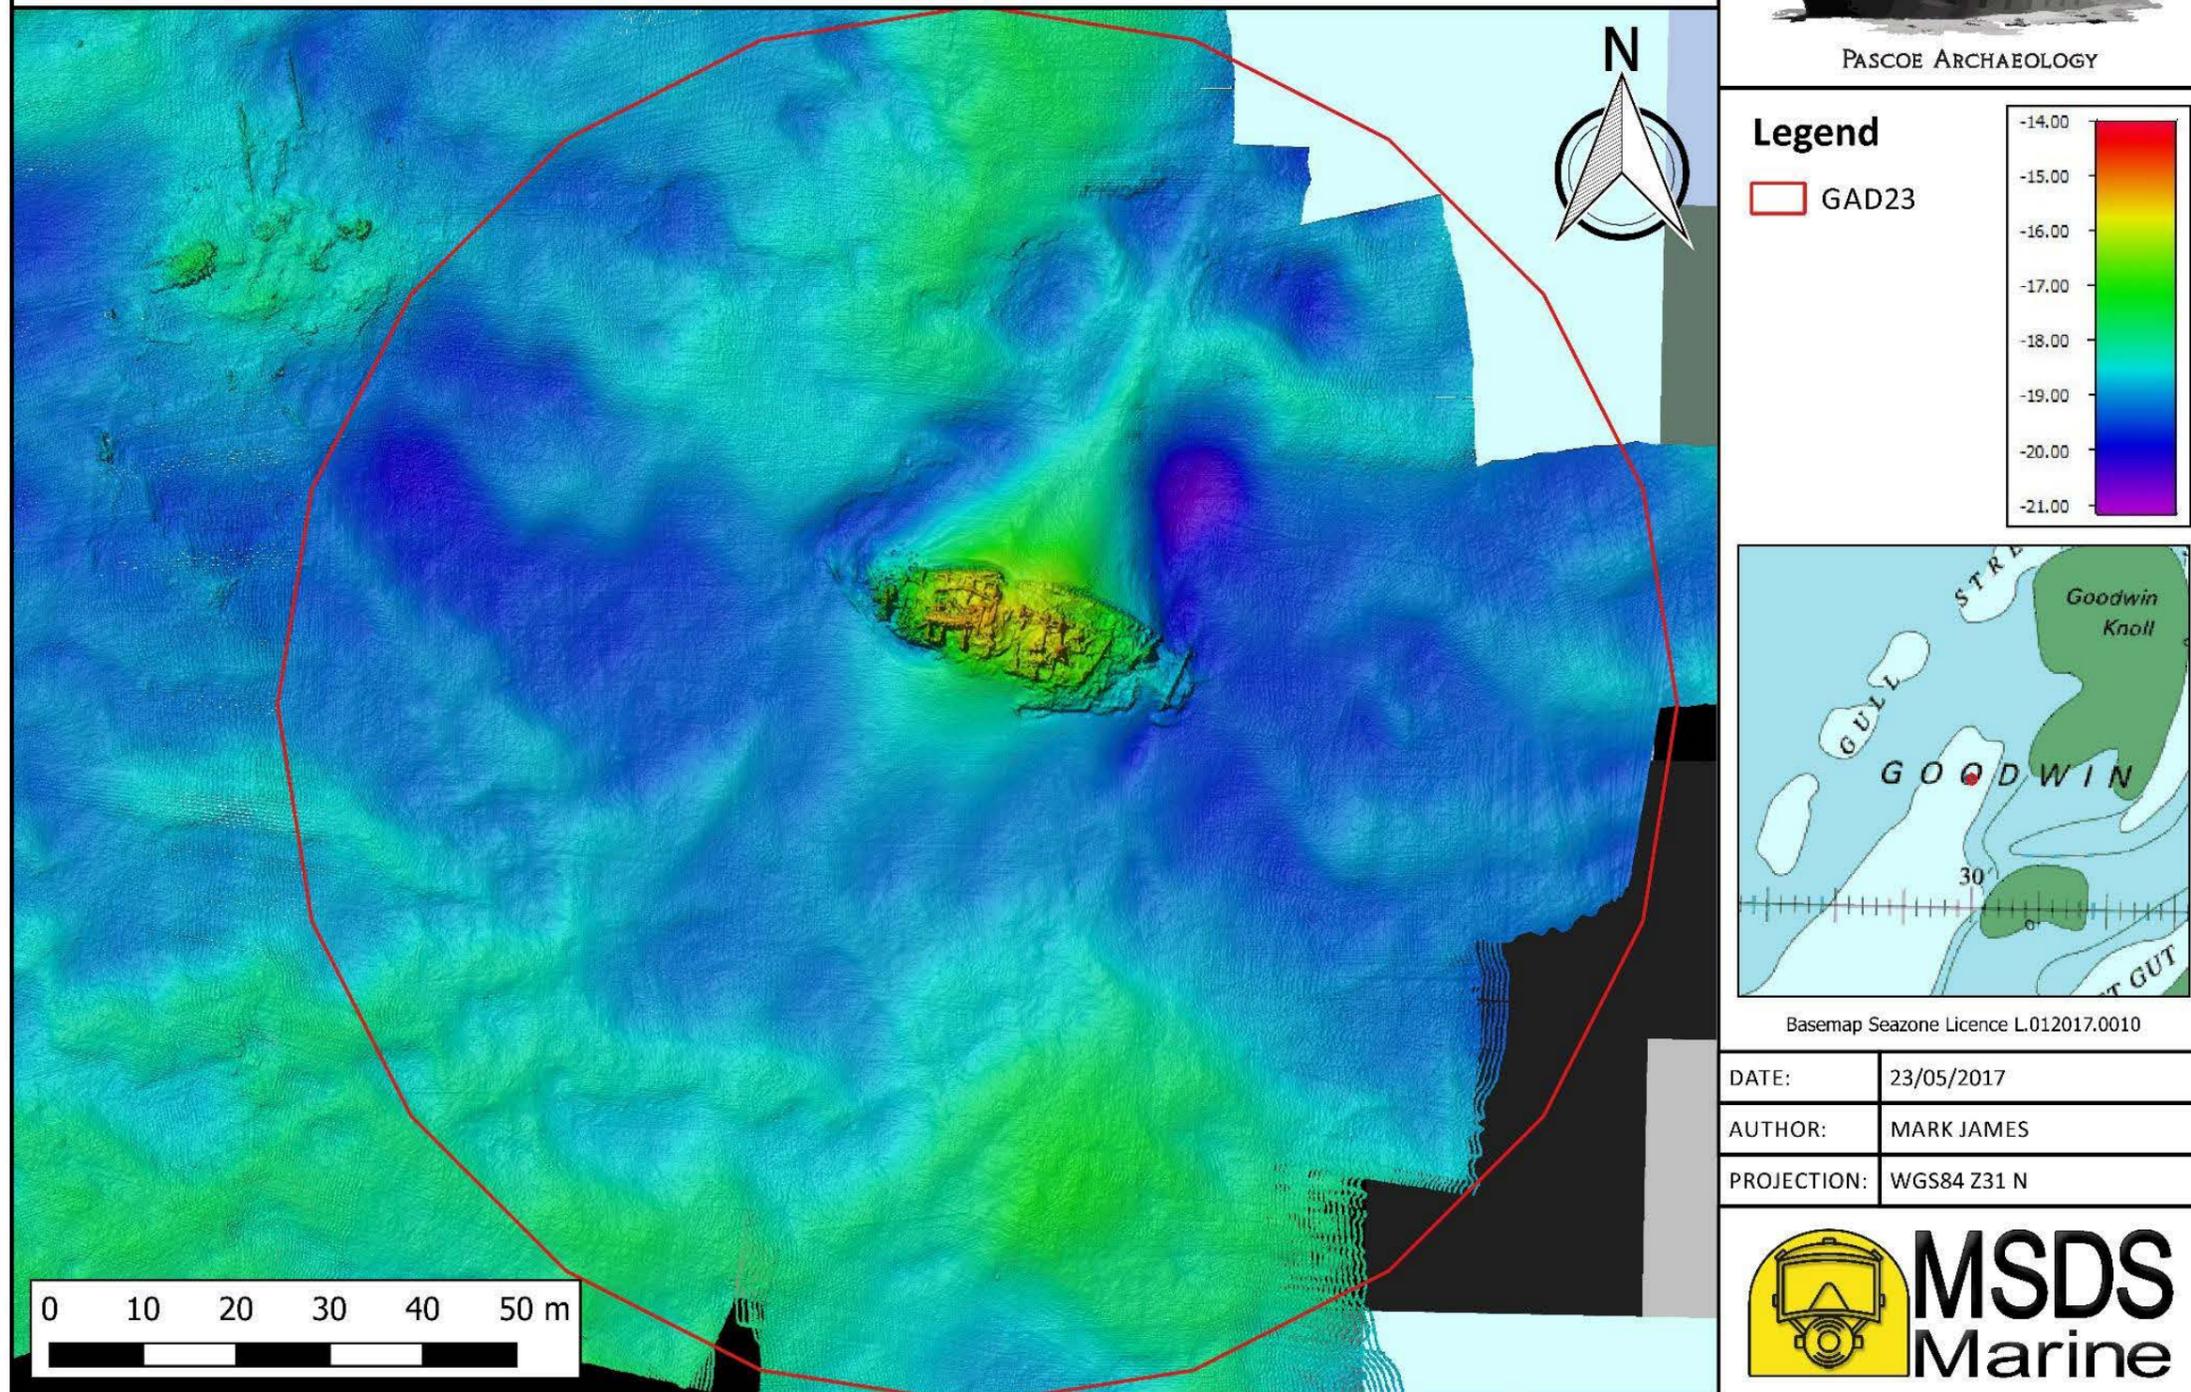
Fig. 19: GAD 23 and surrounding area.

4.8.3 The 2017 MBES survey shows the site is 43m long by 14m wide approximately east–west. The highest point of the wreck is at 15m and the deepest along a scour at the east end of the site is at 19m (Figures 19–22). Comparing the condition of the site with the 2006 ADUS MBES data, and diving experience on the site from 2011, indicate that it has experienced significant changes.

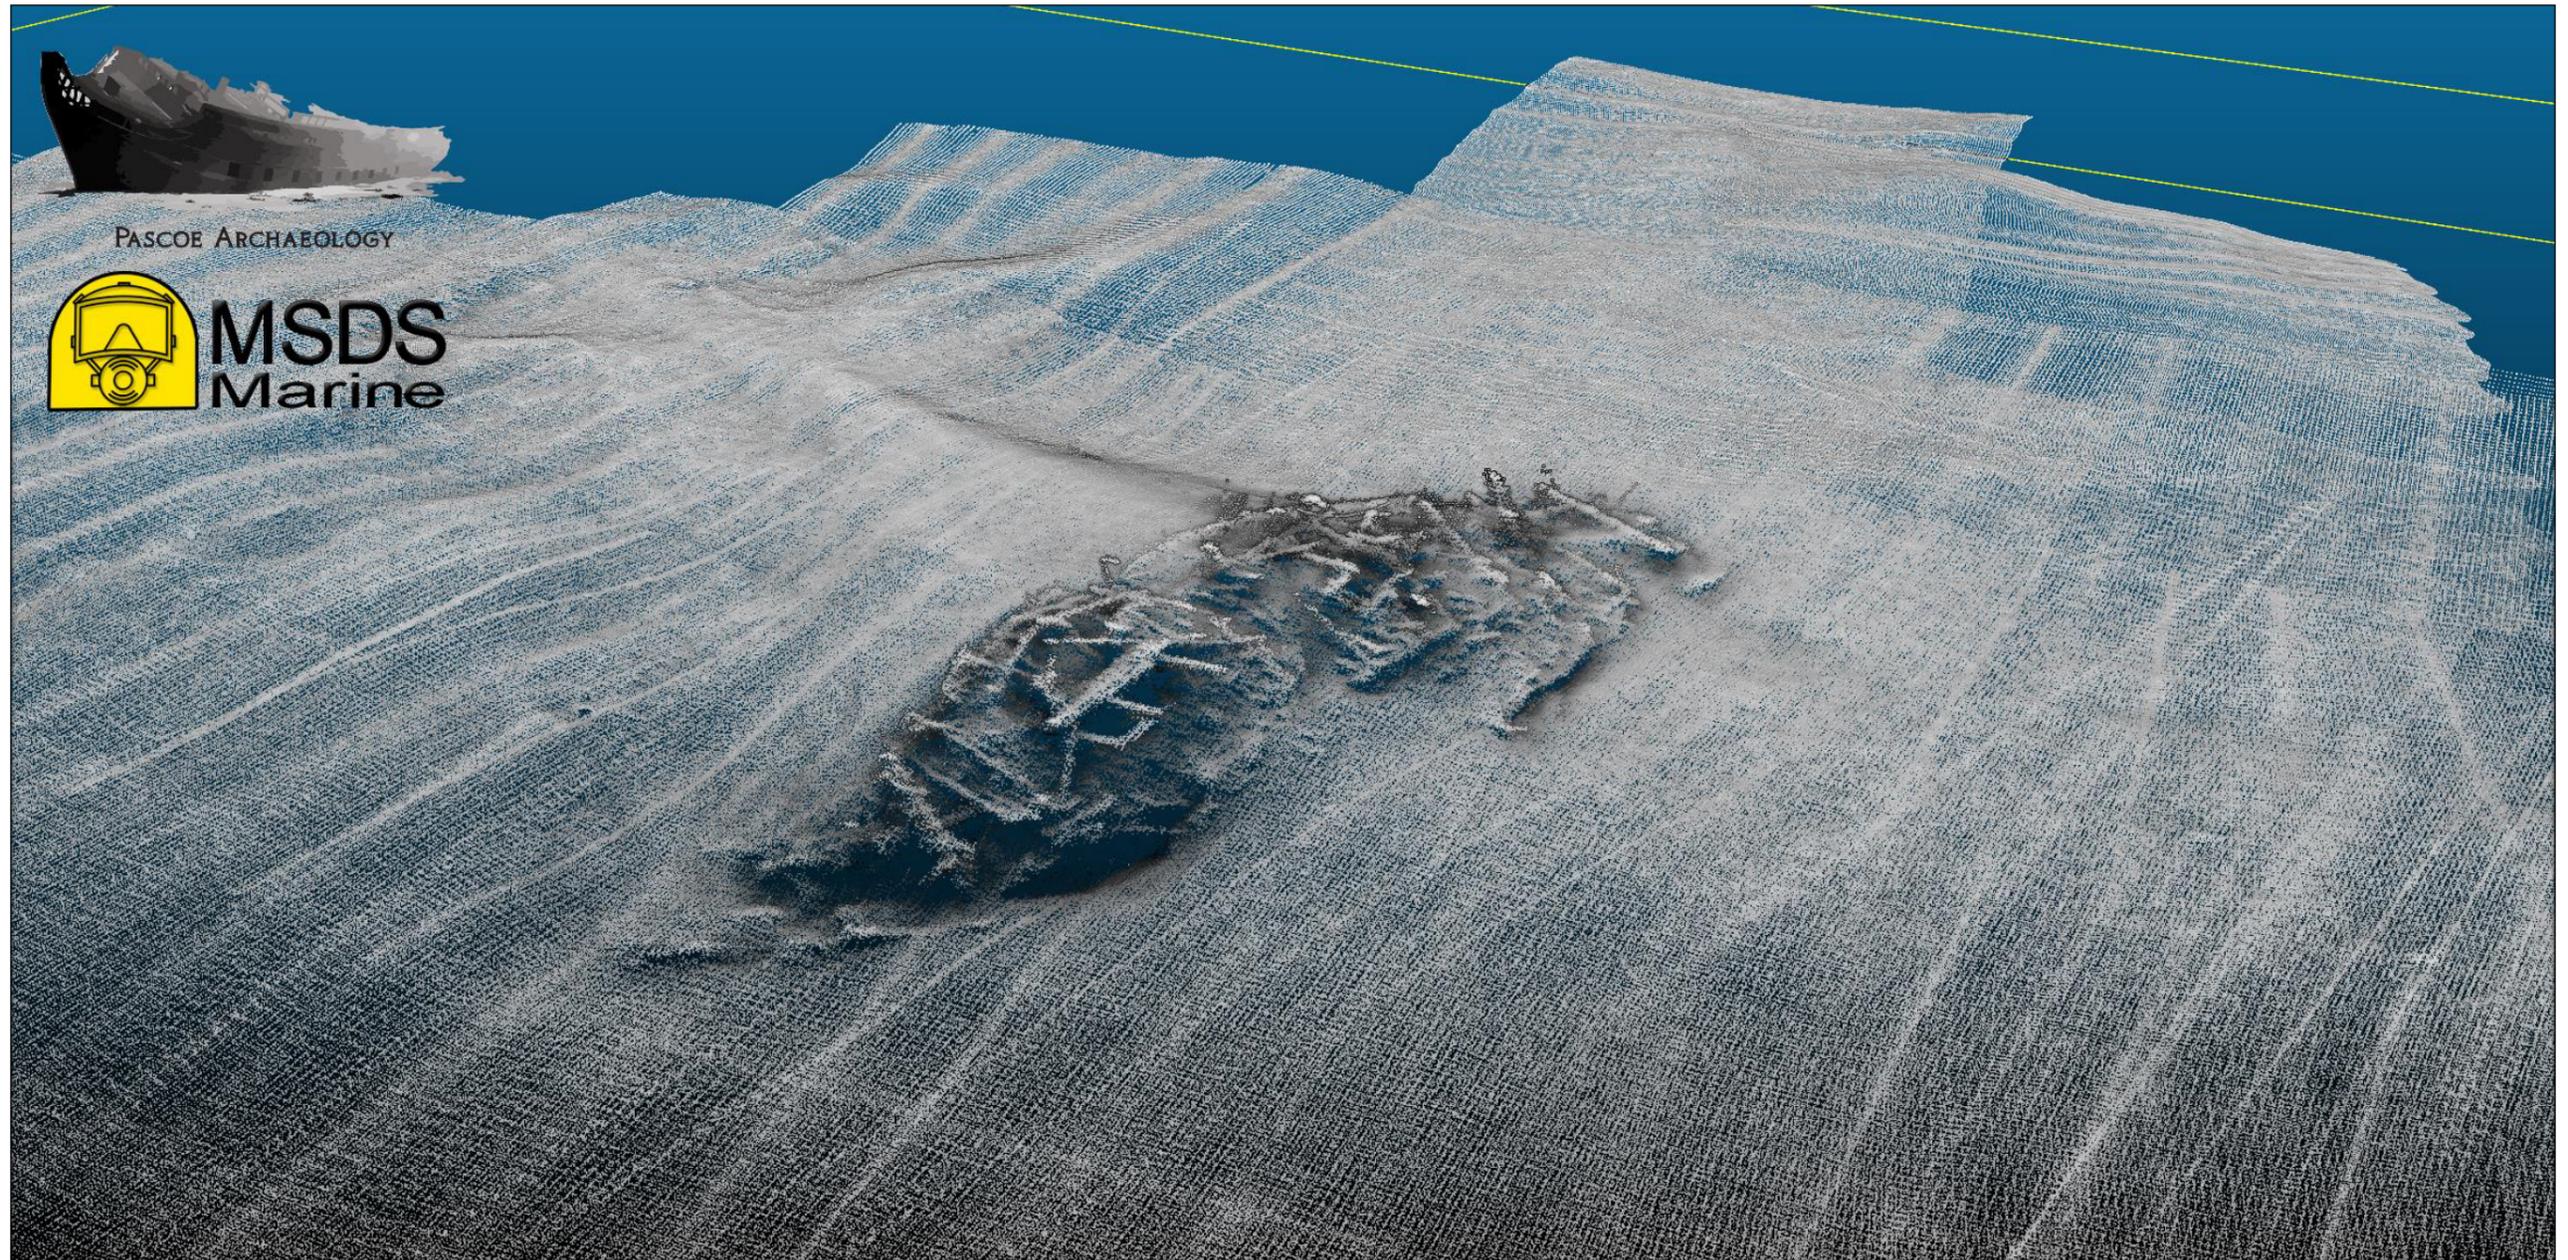
- 4.8.6 The 2017 MBES survey has revealed that the bow has broken and collapsed outwards and now lies on the seabed. At least a 10m section of the port side and a 5m section of the starboard bow has collapsed. As the height of the wreck has reduced greatly this is allowing the scour pit below the bow to fill in. The windlass has also collapsed and has slumped down to the port side. A 4m section of the deck immediately behind the windlass has dropped. This has left a 5m section of deck, including deck beams, hanging unsupported extending back towards amidships. The MB data shows extremely clearly the remains of deck beams extending out across the wreck with the cargo of coal spilling out through the port side (Figures 20–22). A combination of the weight of coal and sand within the wreck and the loss of surrounding sediments has caused the port side to bulge and eventually collapse.

- 4.8.8 Overall the site has deteriorated greatly with the collapse of the bow and port side. Exposure has increased all over the site due to the general drop in sediment. This can clearly be seen with the appearance of more structures across the whole site such as the deck beams extending across the wreck and the exposure of stern structures.

collapsed and broken away. This has caused areas of the deck either to collapse or to be left hanging unsupported. A general reduction in seabed sediments over the whole site has exposed greater areas of the starboard side and the stern structures as well deck structures over the whole wreck.

When the wreck was surveyed in 2006 by the ADUS it was relatively intact and much of the starboard side and stern area were buried. Continued exposure and further loss of seabed sediments on and around the wreck have left it extremely vulnerable to physical and biological degradation. This has been the cause of the wreck sites' deterioration.

Fig. 21: Side elevation of GAD 23 site looking at the collapsed bow in the foreground and unsupported deck beams, aft towards amidships.

- 4.9.13 Further reductions in surrounding seabed sediments have uncovered previously buried sections of the wreck on the starboard side and at the stern. The site would benefit from diver investigations to record those newly exposed areas of the wreck before they deteriorate any further and are eventually lost.

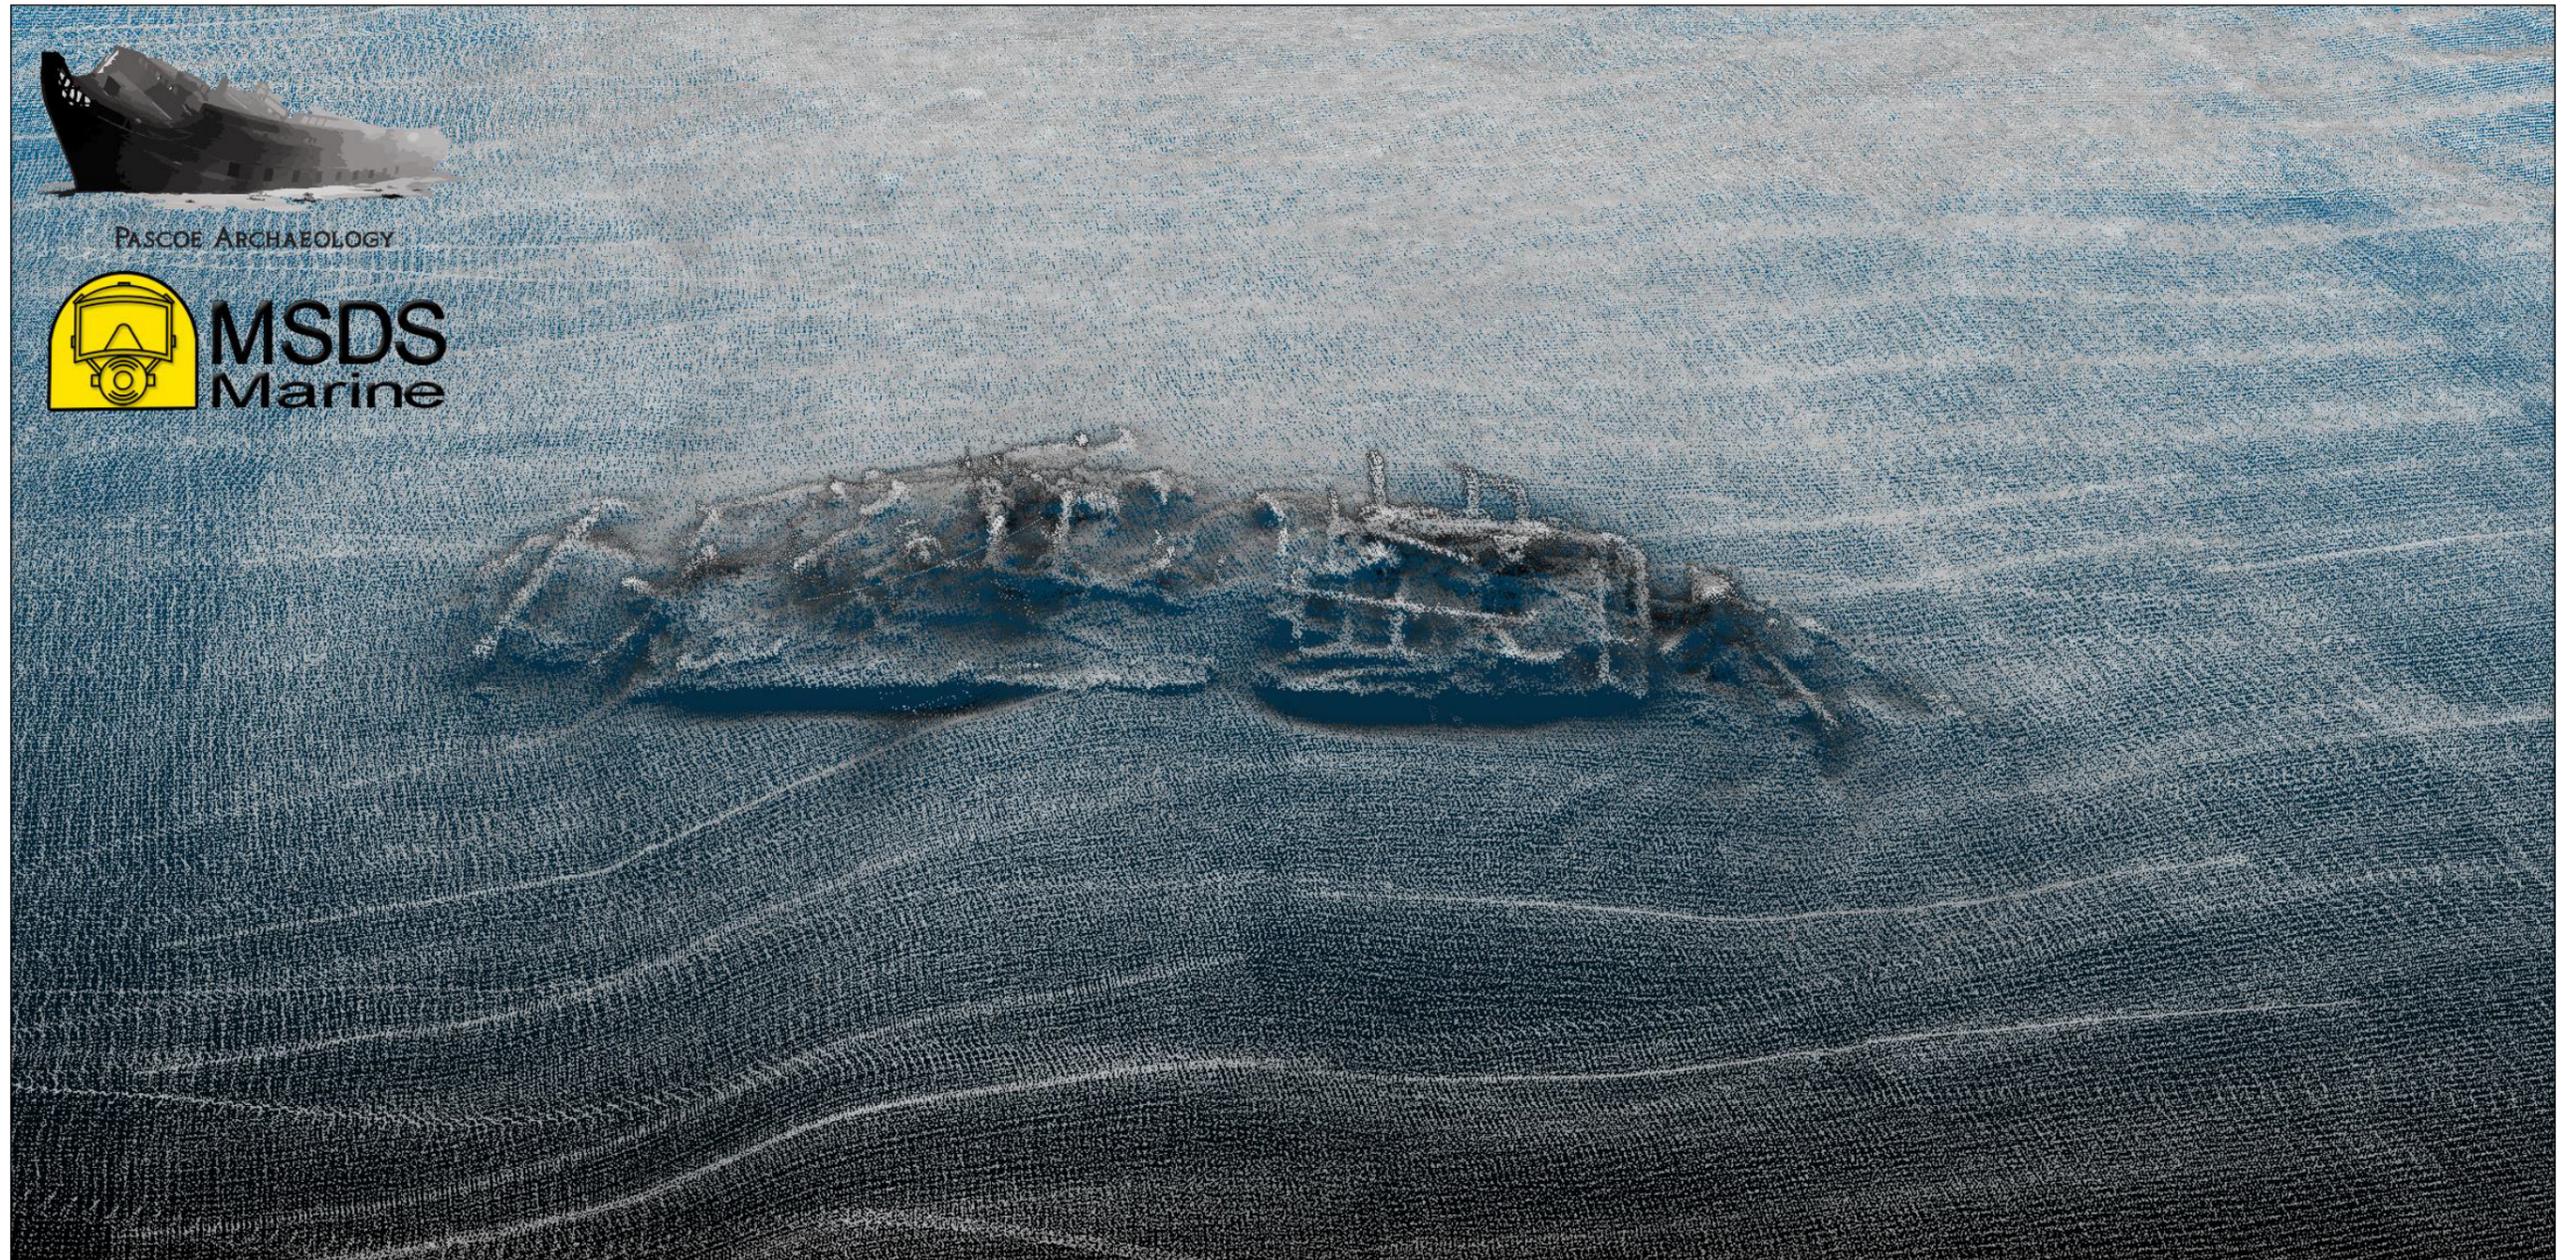
4.8.4 The layout of the wreck site is still clearly discernible. The remains of the bow are at the west end and the stern at the east. The remains of the starboard side can be seen protruding from the sand from the bow to the stern and the port side is more fractured with the cargo of coal spilling out from amidships. The stern area appears more exposed with a long horizontal timber, possibly a transom extending across the aft end of the wreck (Figures 20–22). This was not visible in the 2006 ADUS MBES data.

- 4.9.12 The undesignated site of GAD 23 has experienced dramatic change. The continued exposure of the site and reductions in seabed sediments since 2006 has resulted in the collapse and degradation of substantial sections of the wreck. Considering it is a wooden wreck it is still in remarkable condition but that condition is most definitely on the decline.

Fig. 22: Side elevation of GAD 23 site looking at the starboard side, the bow is to the right and stern to the left.
