# An Assessment of a Second World War Hangar Structure at Tollerton Airfield, Rushcliffe, Nottinghamshire

AN ASSESSMENT OF A SECOND WORLD WAR HANGAR  
STRUCTURE AT TOLLERTON AIRFIELD,  
NOTTINGHAMSHIRE

NGR: SK 61544 36017

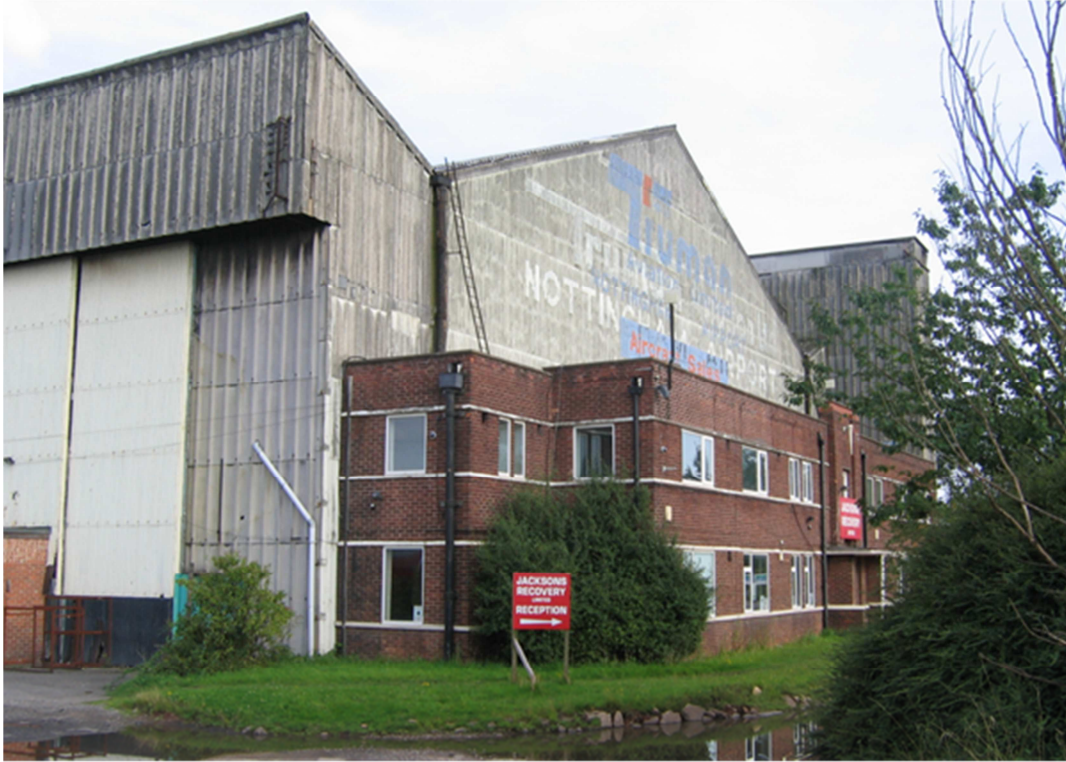
Figure 5: To the left of the rainwater pipe a slightly raised portion of cladding indicates the position of the door that was used by the fire watchers to gain access to the roof. [Milan Petrovic 07-08-2009]

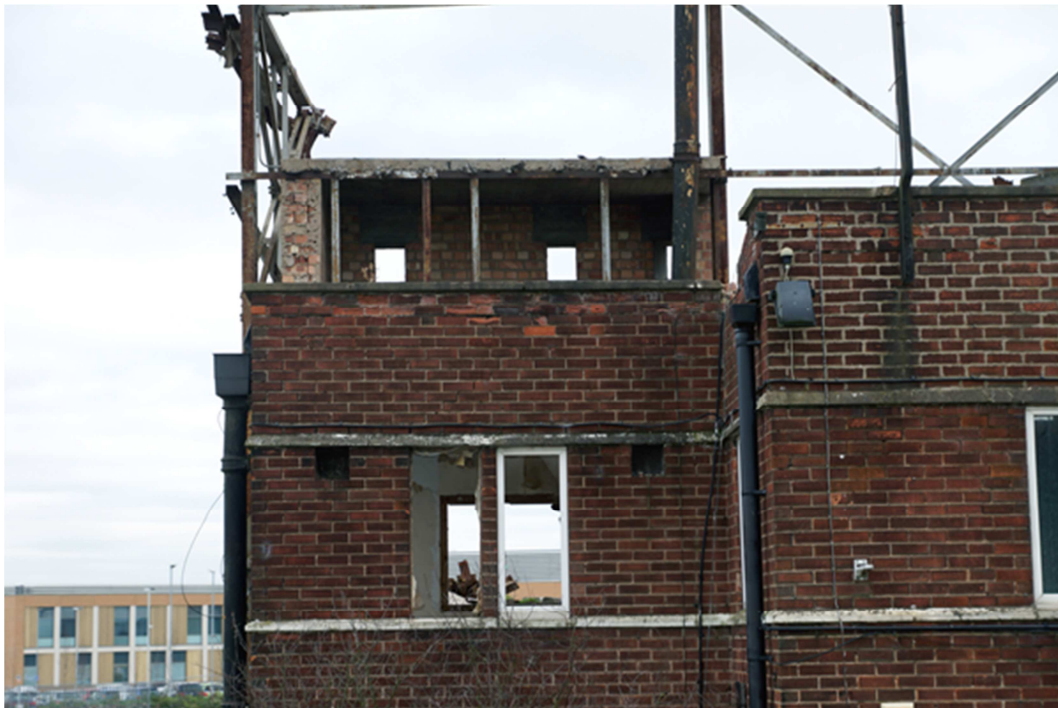
*Figure 9: Exterior view looking east, it is partially hidden by the parapet wall of the flat roof. [Paul Francis 05-12-2017]*

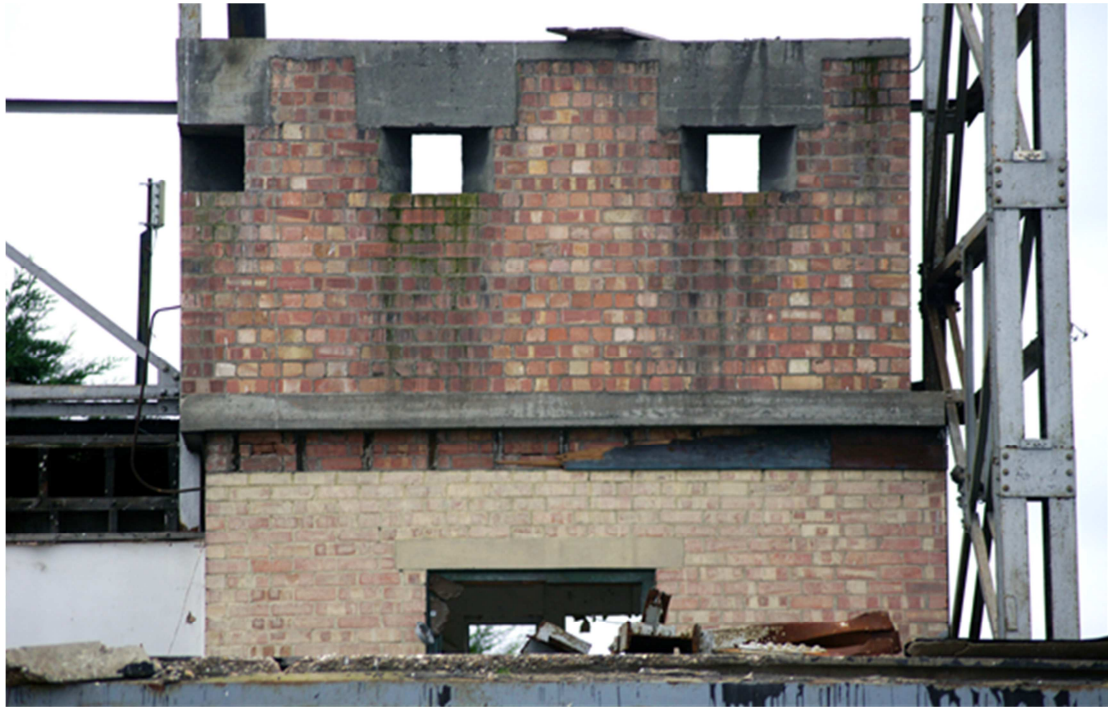
The structure appears to have all the hallmarks of being hurriedly built with little thought to fire safety, being reliant on standard off-the-shelf unprotected floor joists. If these had caught fire then it would have come crashing down, despite this, three walls were constructed heavy brick and included a roof that was proof against incendiary bombs and a concrete slab floor (this may be a screeded patent hollow fire-proof floor such as Smith's flooring).

*Figure 10: View from the hangar's interior showing the front (east) elevation. Note the row of joists below the floor slab. [Paul Francis 05-12-2017]*

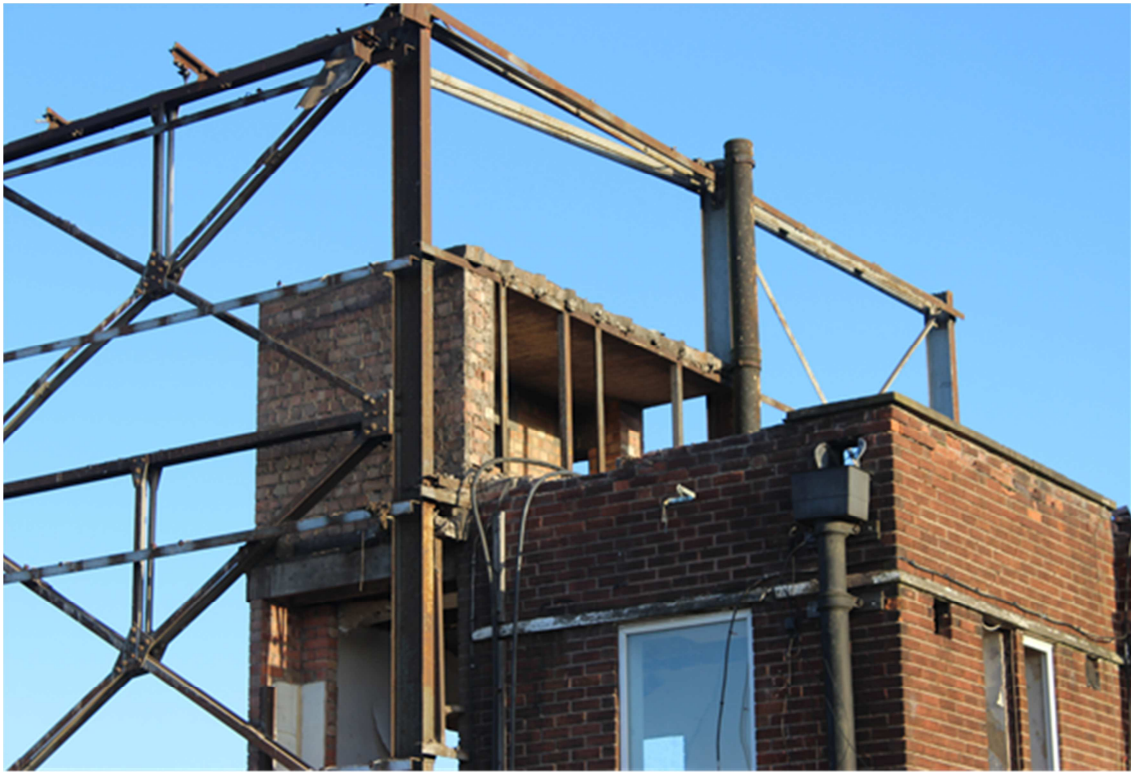
*Figure 14: Views showing the metal brackets from the hangar wind girder framework preventing movement of the brick work and roof slab. [Milan Petrovic 15-03-2017]*

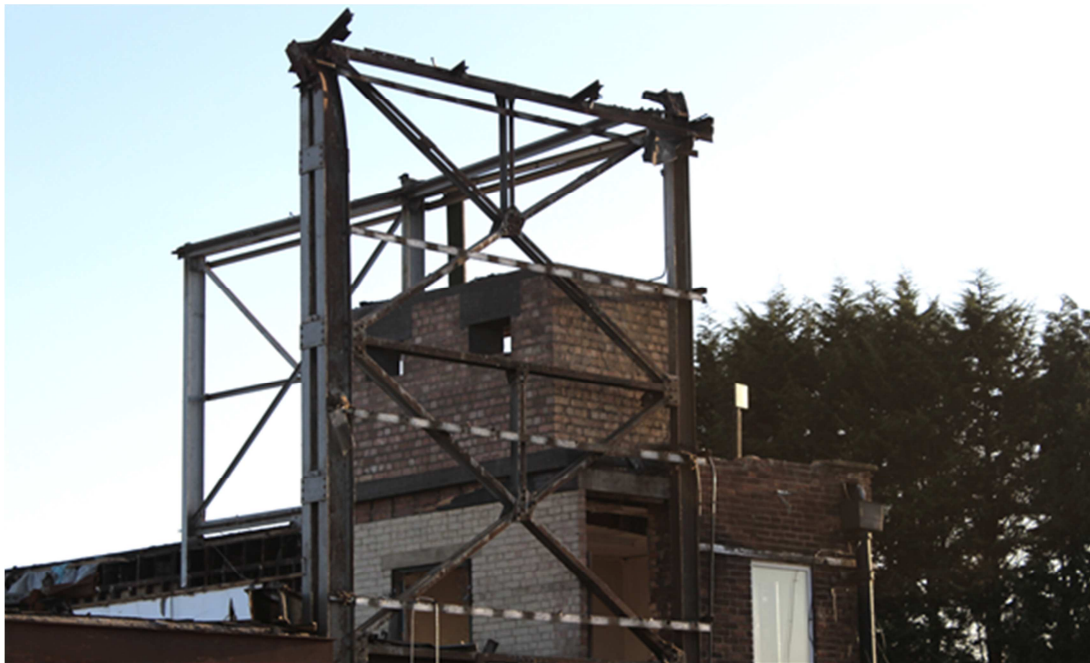
*Figure 15: Views showing the metal brackets from the hangar wind girder framework preventing movement of the brick work and roof slab. [Milan Petrovic 15-03-2017]*

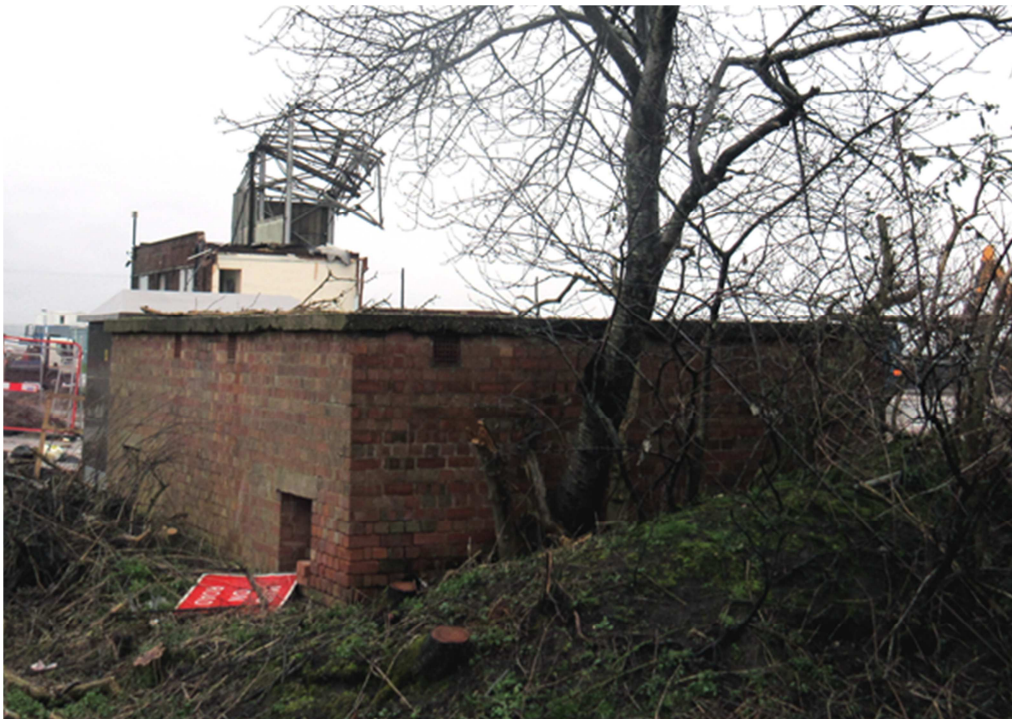
It had two emergency escape apertures with 4.5 inch brick panels at the rear, for kicking out in an emergency (see Figure 19). In contrast, the aerodrome had many locally made Stanton arched precast concrete shelters, at least two were extant in 2009 at NGR: SK 61790 36007 and SK 61747 36006.

*Figure 19: Air-raid shelter (Bldg.47) rear elevation showing two emergency escape apertures. [Milan Petrovic February 2017]*

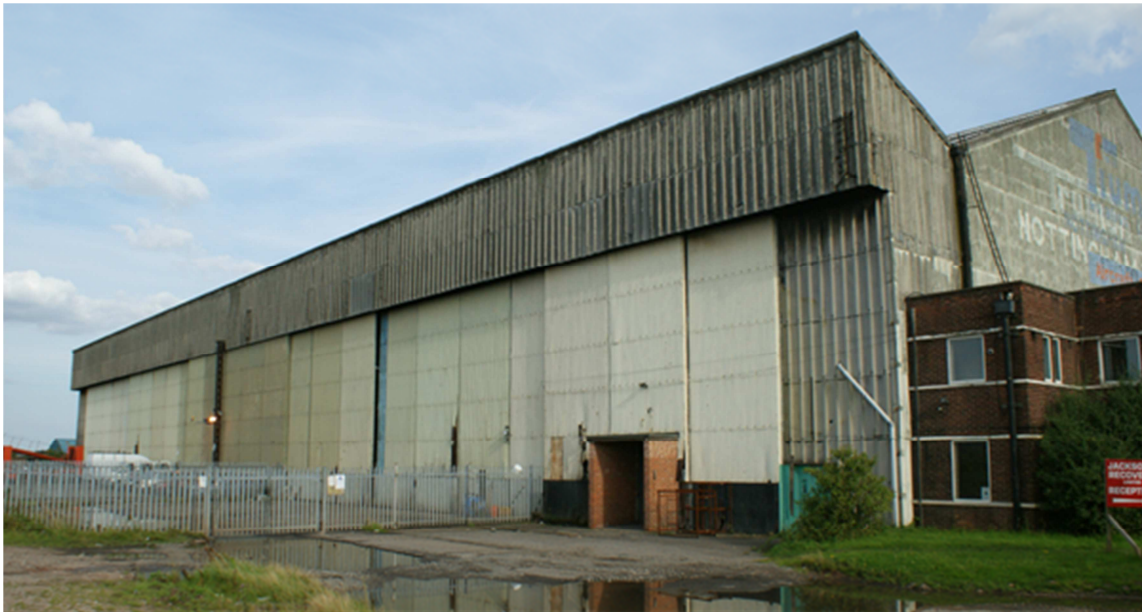
*Figure 26: Main hangar, airfield elevation (Bldg.43). Note the roof access ladder positioned close to the fire watcher's shelter (which is hidden behind the wall cladding). [Paul Francis 07-08- 2009]*
