SPAB Building Performance Survey 2013

Interim Report
October 2013

Dr Caroline Rye, Cameron Scott and Diane Hubbard
Society for the Protection of Ancient Buildings
Supported by Historic England

THE SPAB RESEARCH REPORT 2

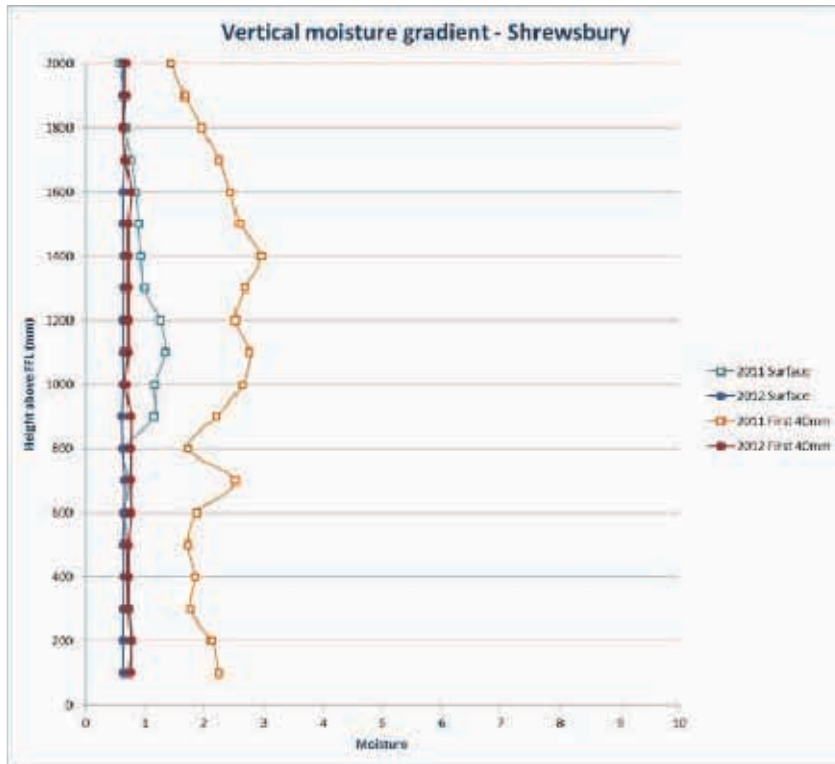
The following observations concern moisture readings taken at the interior surface and sub-surface of the walls at Shrewsbury, Drewsteignton, Riddlecombe and Skipton (Figures 2 - 5). In general all four walls, post-refurbishment, have seen a decline in moisture readings at both surface and sub-surface levels. The two walls, Shrewsbury and Drewsteignton (Figures 2 and 3) that have been subject to internal wall insulation in the form of sheet materials, PIR and Woodfibre board, show similar patterns of behaviour. Previously, in 2011, the surfaces of these two walls appeared to be fairly stable and dry (there is a brief deflection mid-way up the plot for the wall in Shrewsbury which has been accounted for as the effect of water moving into the interior surface along a lintel). The 2011 plots for the sub-surfaces of these walls, about 40mm back, were a little more dynamic and indicated the influence of ground water at the base of the walls. The measurements taken in 2012 show both the plots of surface and sub-surface moisture

occupying the 'dry' end of the nominal moisture scale. This indicates something about the limitation of these methods of measurement as a means by which to assess moisture risk in internally insulated solid walls. The internal surface and sub-surface of the walls at Shrewsbury and Drewsteignton are drier as this is where a new insulating layer of dry sheet material has been applied. The affect of this build-up to the internal face of the wall is to move the zone of moisture measurement away from the original masonry part of the wall. It is in the solid masonry part of these walls that we have previously seen fluctuating moisture readings indicating a dynamic environment influenced by external forces such as ground water and/or rain, therefore, whilst it is true to say that the internal leaves of these walls appear to be slightly drier this is not necessarily the case for the walls as a whole.

Figure 2. Pre and post refurbishment measurements of surface & sub-surface moisture at Abbeyforegate, Shrewsbury, 2011 & 2012.

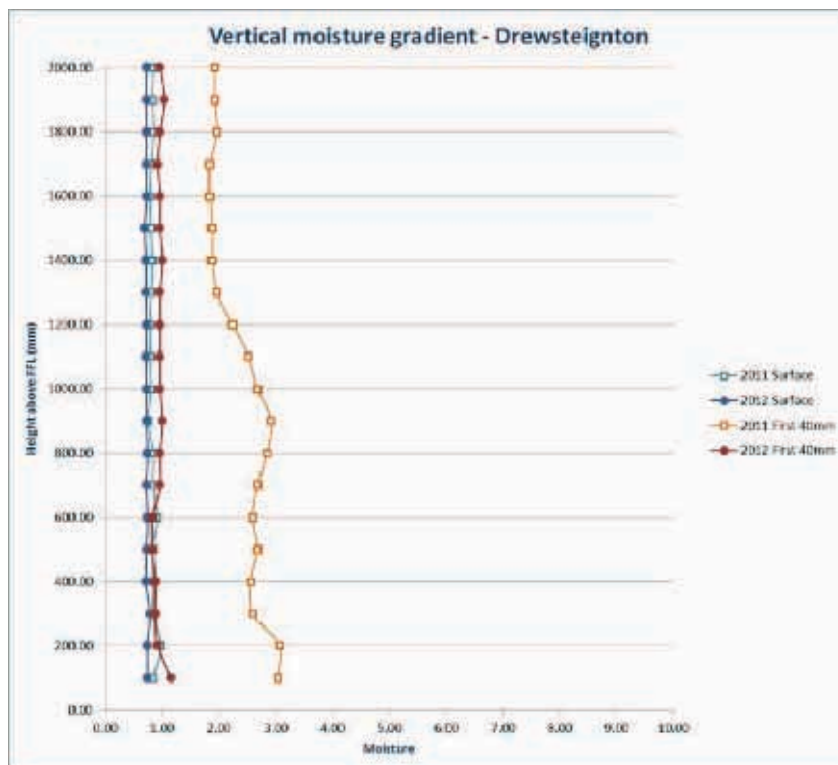
Figure 3. Pre and post refurbishment measurements of surface & sub-surface moisture at Mill House Test Wall, Drewsteignton, 2011 & 2012

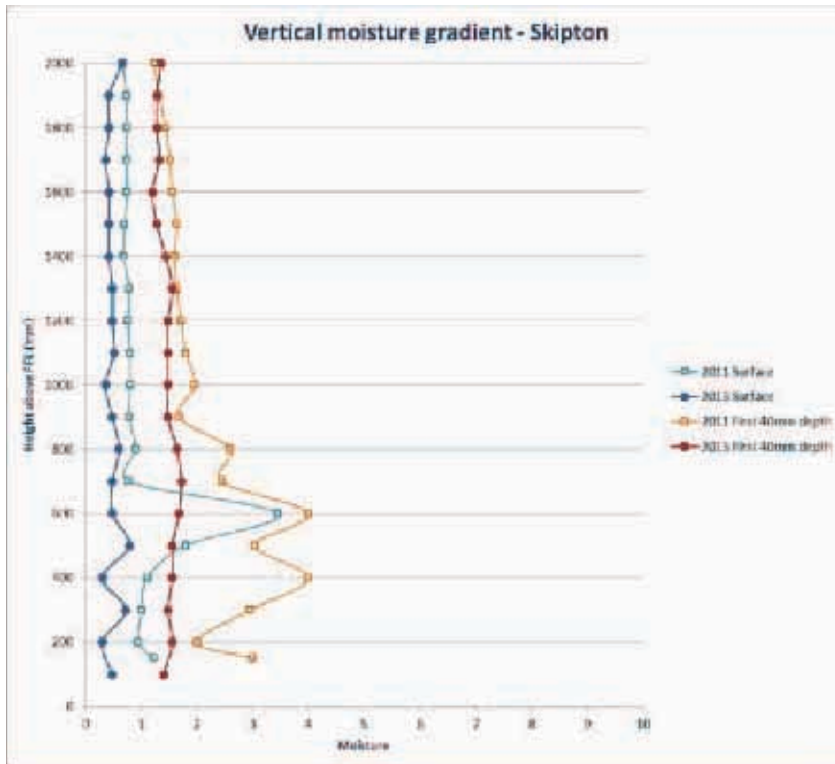
The other wall in the study that has been internally insulated using a hemp/lime plaster is the wall at Skipton. In comparison with the other IWI walls which have been insulated with sheet material the surface and sub-surface measurements of moisture at Skipton show some differentiation (Figure 4). The differentiation may reflect the fact that the sub-surface material is still in the process of drying but also, as the plaster is directly coupled to the masonry in this instance, rather than measuring the dry sheet material, there is some influence of the masonry component in the measurements gathered 40mm back from the wall surface at the sub-surface level. However, the 2013 post refurbishment measurements do indicate that in comparison with the measurements taken pre-refurbishment in 2011 the surface and sub-surface of the wall at Skipton has, at least nominally, become 'drier'. And in addition the influence of ground water at the base of the wall and possibly water tracking in to the internal wall face under the window cill is less significant at the surface and sub-surface level than it was prior to refurbishment.

Figure 4. Pre and post refurbishment measurements of surface & sub-surface moisture at White House Farm, Skipton 2011 & 2013.

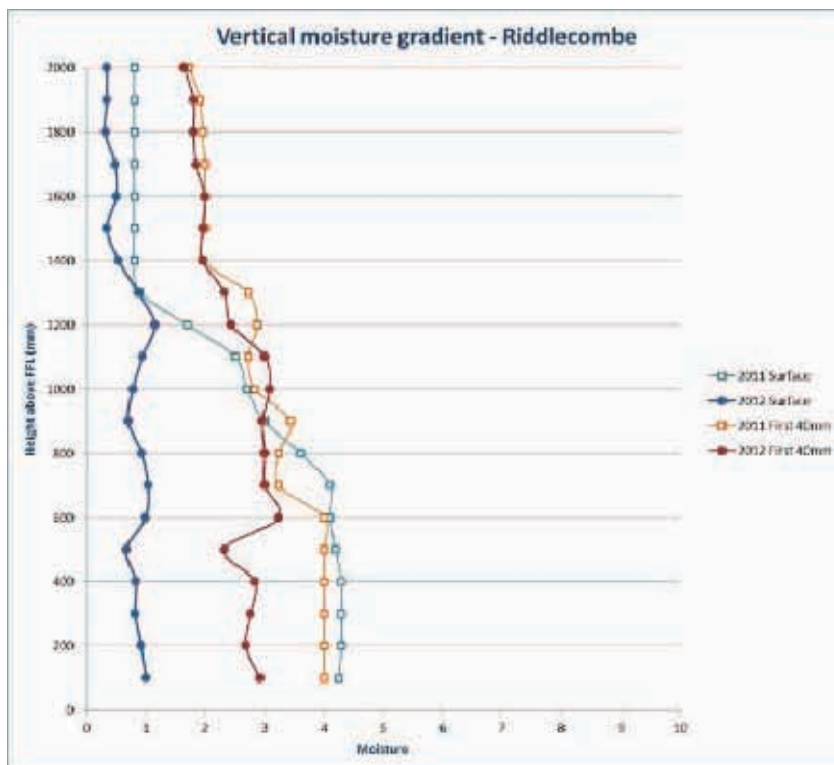
The graph for Riddlecombe, an externally insulated wall, is somewhat different but also shows the general declining trend for surface and sub-surface moisture (Figure 5). At this property the vapour permeability of both the internal and external finishes of the walls has, in theory, been increased by the application of lime-based finishes and both the moisture buffering and evaporation potential of these materials could account for the improvement in moisture readings taken here in 2012. This improvement is particularly pronounced for the lower part of the wall and it should be noted that the stone plinth (300mm) upon which the cob wall sits has received an additional coat of stabilising mortar to both its interior and exterior face which could alter moisture readings for this part of the wall. Also of note, however, is that above 1400mm readings for sub-surface moisture at Riddlecombe return to those previously recorded, pre-refurbishment, in 2011. This suggests that beyond the internal wall surface moisture conditions deeper within the wall have not really altered as a result of the refurbishment work. This may be a reflection of the fact that high %RH and possibly high moisture levels within this wall continue to be a feature of the wall at Riddlecombe.

Figure 5. Pre and post refurbishment measurements of surface & sub-surface moisture at The Firs, Riddlecombe, 2011 & 2012.

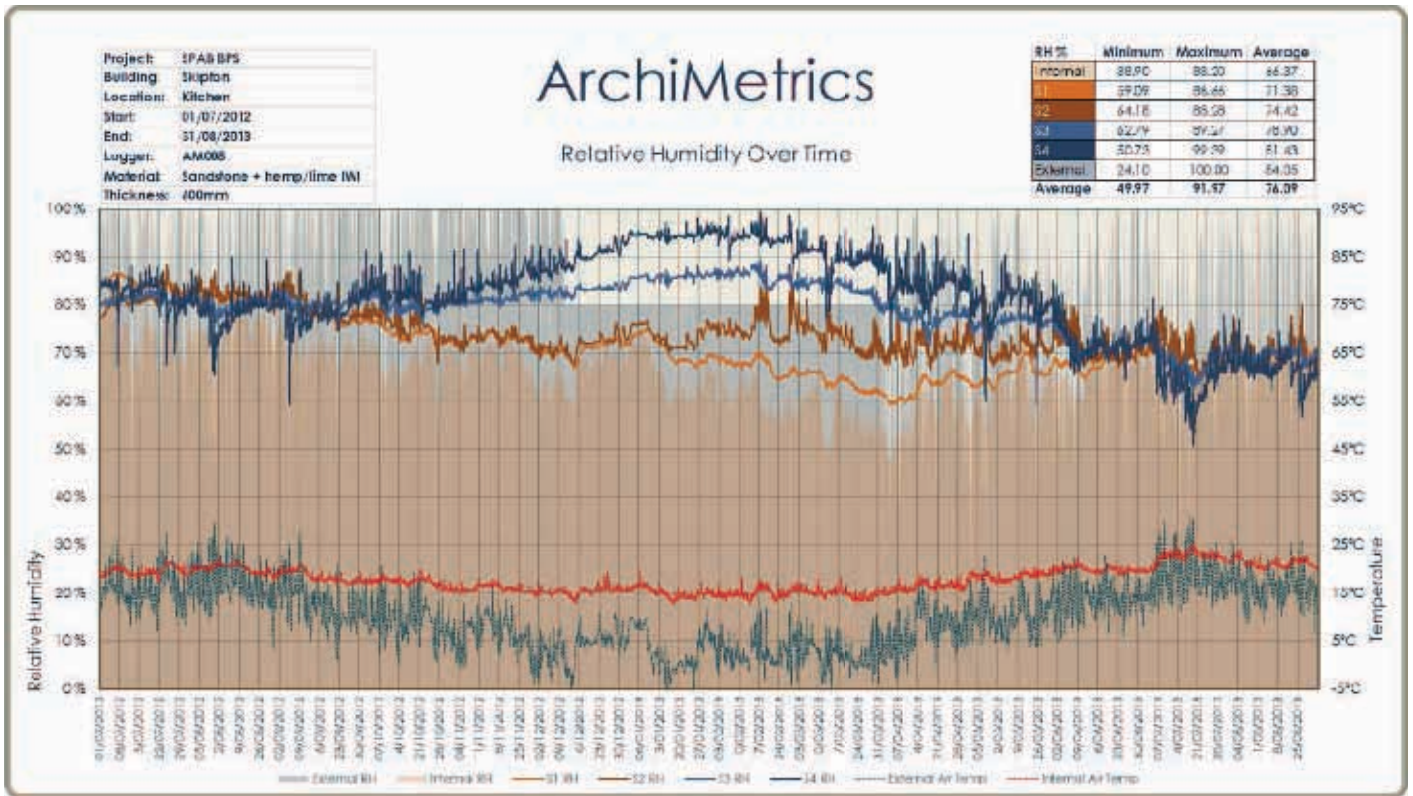
The graph for Skipton, Figure 7, shows a contrasting trend of downward %RH over the reported monitoring period. This could be a reflection of the generally warmer conditions experienced in the summer of 2013 where external as well as interstitial %RH (sensors 4-2) is shown to be lower than that of

the previous summer, combined with the drying that is occurring to the internal wall finishes measured by sensor 1. The wall at Skipton also shows moments of vaporisation behaviour, similar, if less pronounced to that seen at Riddlecombe as well as the affect of its fissured construction in that responses to external conditions mapped at sensor 2 are sometime more pronounced than those plotted for sensor 3, the sensor that is physically closer to the outside possibly as a result of erratic air-pathways through the wall. At Shrewsbury the extended period of peak 100% RH measured at sensor 4 seems at first glance to be alarming, however this peak should be read within the context of responses over an annual cycle which show that %RH reduces at the onset of warmer spring weather and averages 83.49%. It is also worth noting that unlike the other walls in this sensor 4 at this location is placed in much closer proximity to external conditions, 30mm back from the external wall face and this, combined with the generally open and porous nature of this wall, as previously observed results in extreme responses. Given the potentially volatile nature of the wall, including its south-facing aspect, %RH measurements made at this location are, with the exception of sensor 4, remarkably stable.

Figure 7. Relative Humidity over time, White House Farm, Skipton, 2012 -13.

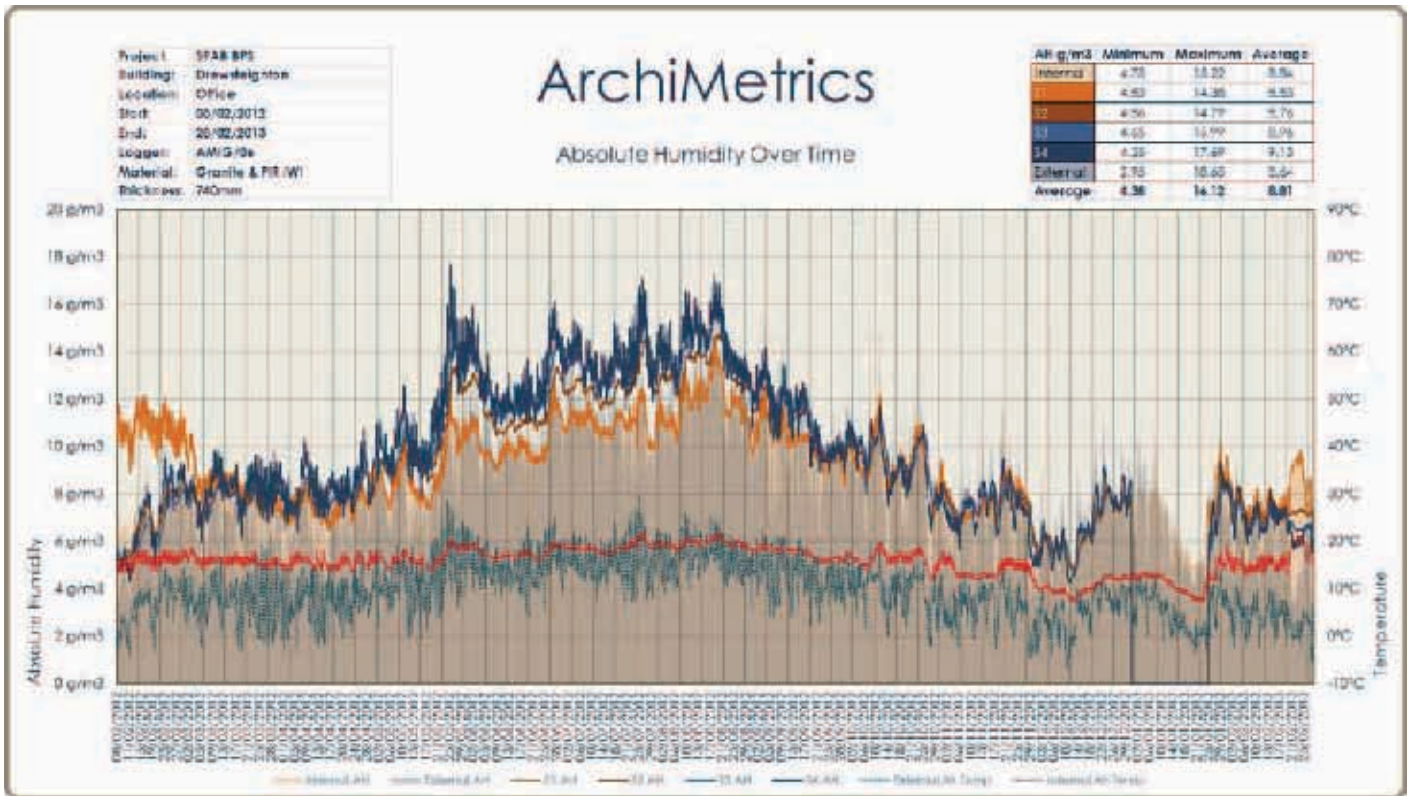
where it is only from January 2013 onwards that this arrangement is seen. (The peak absolute humidity at sensor 1 seen early on in Figure 12 is as a result of the drying of the gypsum skim on the plasterboard drylining). Drewsteignton also differs from the walls at Shrewsbury and Skipton in another way in that it seems to reverse a dispersal pattern. At Shrewsbury and Skipton measurements of the weight of vapour through the wall are more dispersed and differentiated during the winter, presumably, as with %RH, as a result of a greater temperature gradient through the wall section. However, at Drewsteignton a greater differentiation between g/m^3 of vapour is found in the summer and measurements of the weight of vapour through the wall section become more aligned in wintertime.

Figure 12: Absolute Humidity over time, Sensors 1 - 4, Mill House, Drewsteignton 2012 - 2013.

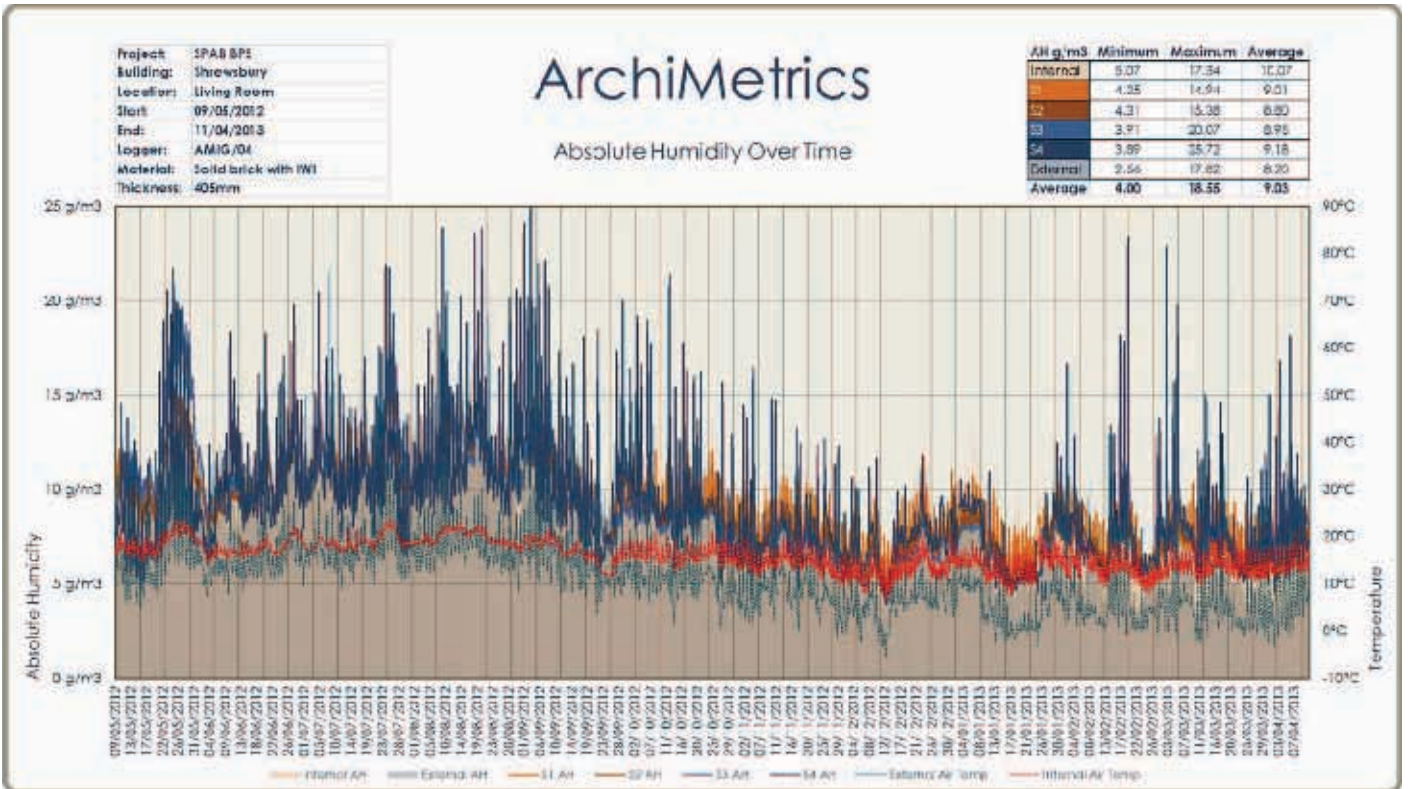
static and shows the exterior wall face to be the driest point of all four sensing positions. This period also coincides with high %RH, 100%, measurements at this location (Figure 6). This is during a period of snow fall in the area, when the vapour carried in the atmosphere is very low but despite this, due to the extremely low temperatures, dewpoint is frequently reached. Therefore whilst this part of the wall is 'dry' from a vapour point of view it is also at dewpoint and therefore likely to be 'at risk' from a small amount of liquid condensation.

Figure 39: Absolute Humidity over time, Sensors 1 - 4, Abbeyforegate, Shrewsbury 2012 - 2013

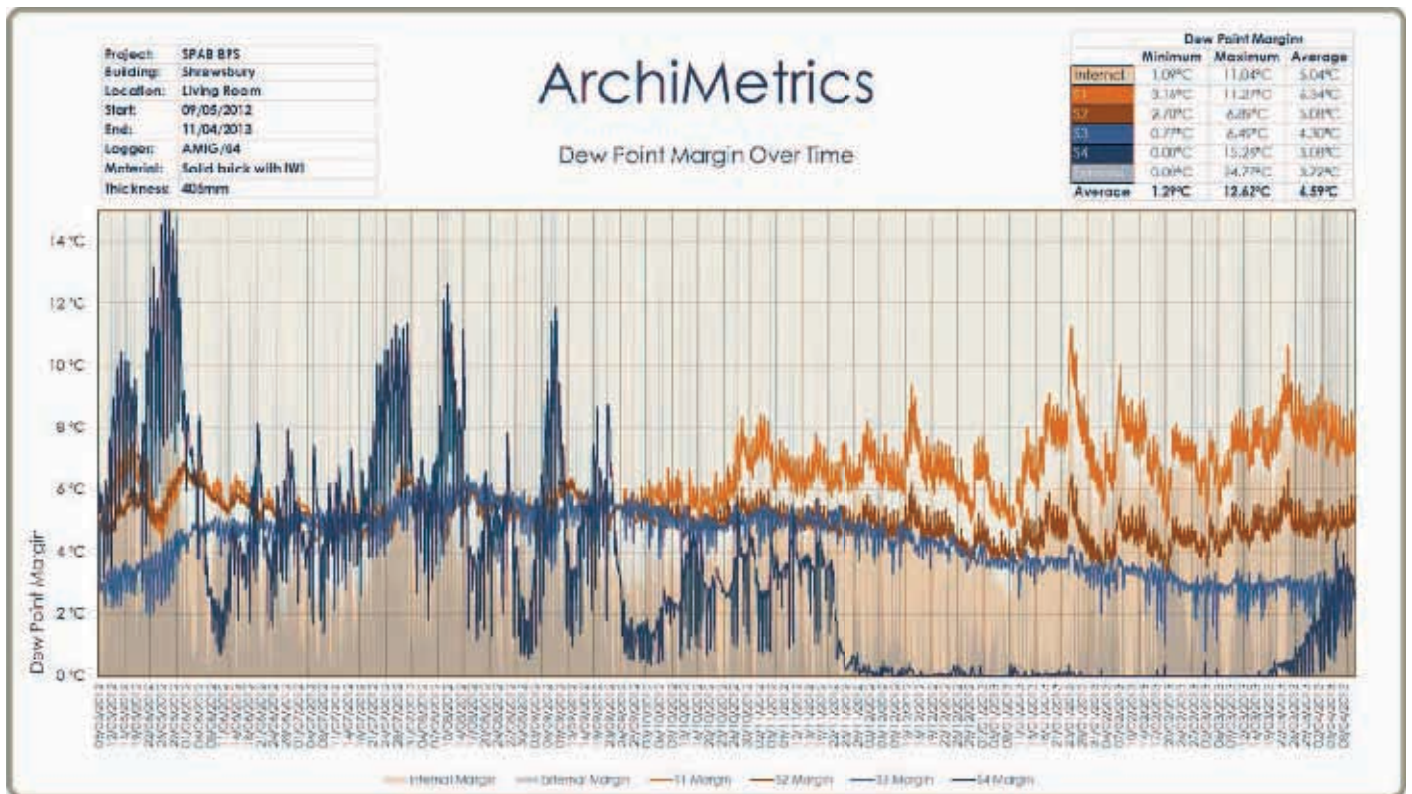
extremes of heat resulting in a dewpoint margin overall that suggests the wall is at little risk from prolonged condensation. With regard to the risk of prolonged condensation, the behaviour deeper within the interstices of the wall is of more interest as here, away from the direct influence of internal or external conditions, the opportunities for the dispersal of vapour may be decreased. In this respect, and has been previously noted in the discussion concerning %RH over time, the wall at Shrewsbury appears to be functioning well with levels %RH below risk thresholds and this is reflected in Figure 22 in the 'healthy' dewpoint margins recorded for sensors 1 - 3; 6.34°C, 5.08°C and 4.30°C respectively.

Figure 22: Dewpoint Margin over time, Abbeyforegate, Shrewsbury 2012 - 2013.

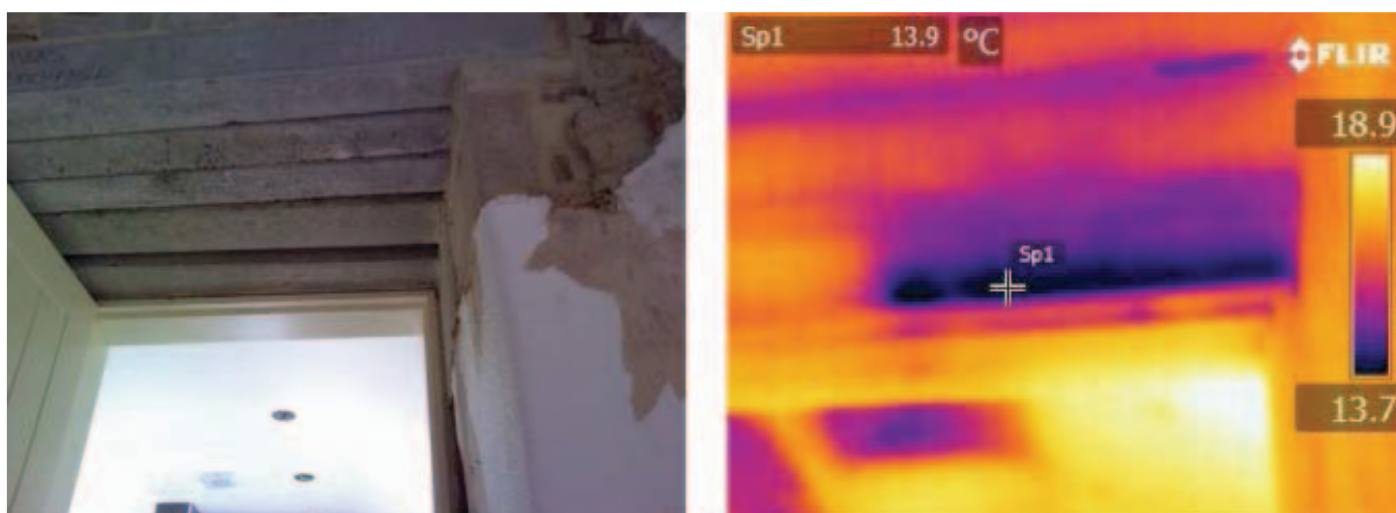
Figure 45. White House Farm, Stirton, Skipton - doorway into bathroom from main bedroom.

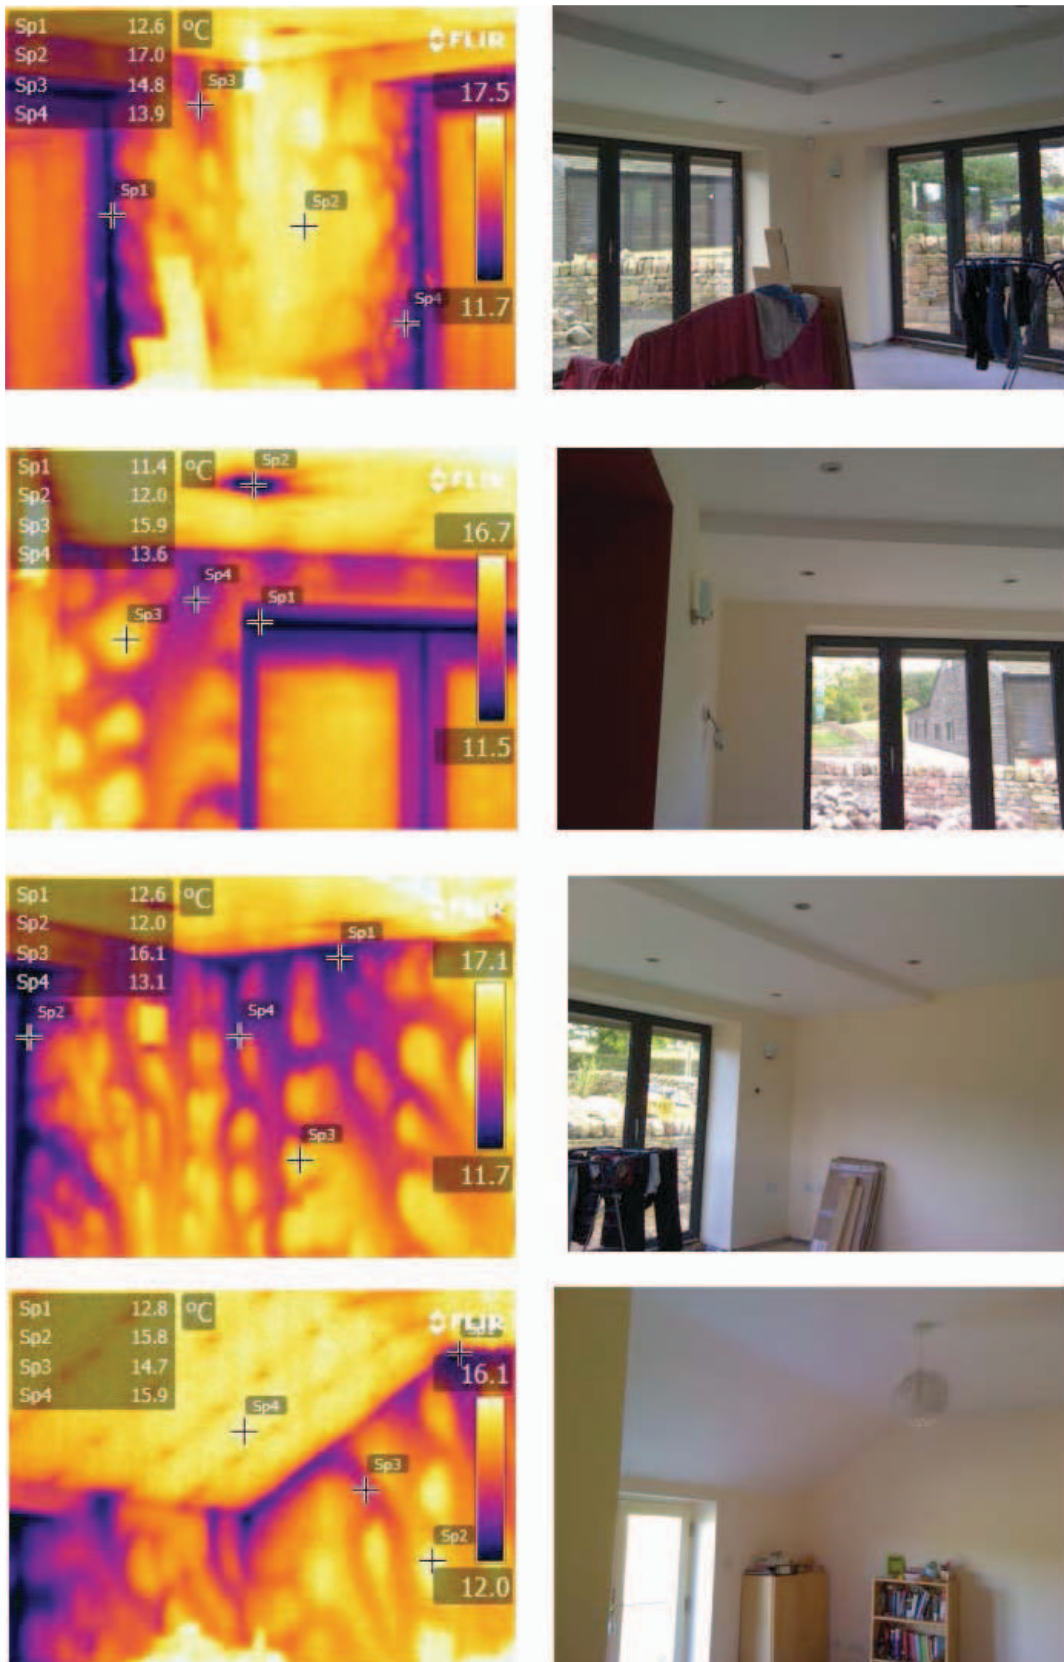
Unlike the older part of the building, the new addition displays a great range of temperatures under the air permeability test conditions (Figure 50). The pattern displayed is likely to relate to the location of plaster dabs. The images also show some ingress around the door frames and light fittings.

Figure 50. White House Farm, Stirton, Skipton - Addition to dwelling. Top □ North east corner of addition, middle □ north wall and east wall, including section which protrudes, bottom □ north east corner on bedroom on first floor of addition.

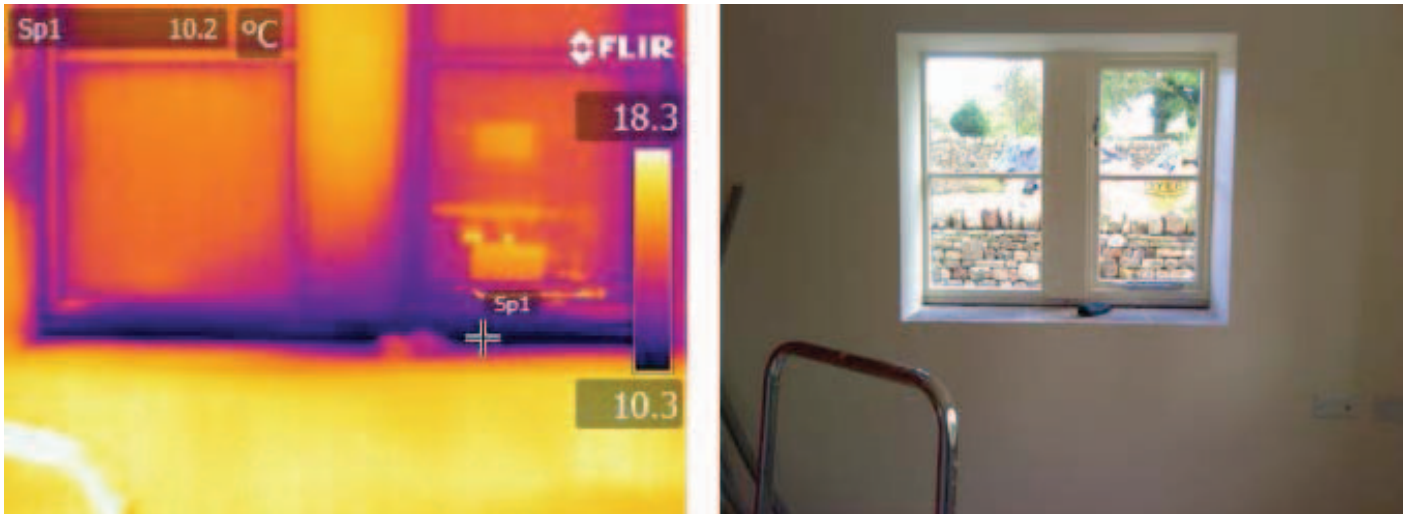
The sills in the extension are yet to be fitted and so ingress is displayed in this area (Figure 53).

Figure 53. White House Farm, Stirton, Skipton □ ingress at base of window on east wall (no sill fitted).

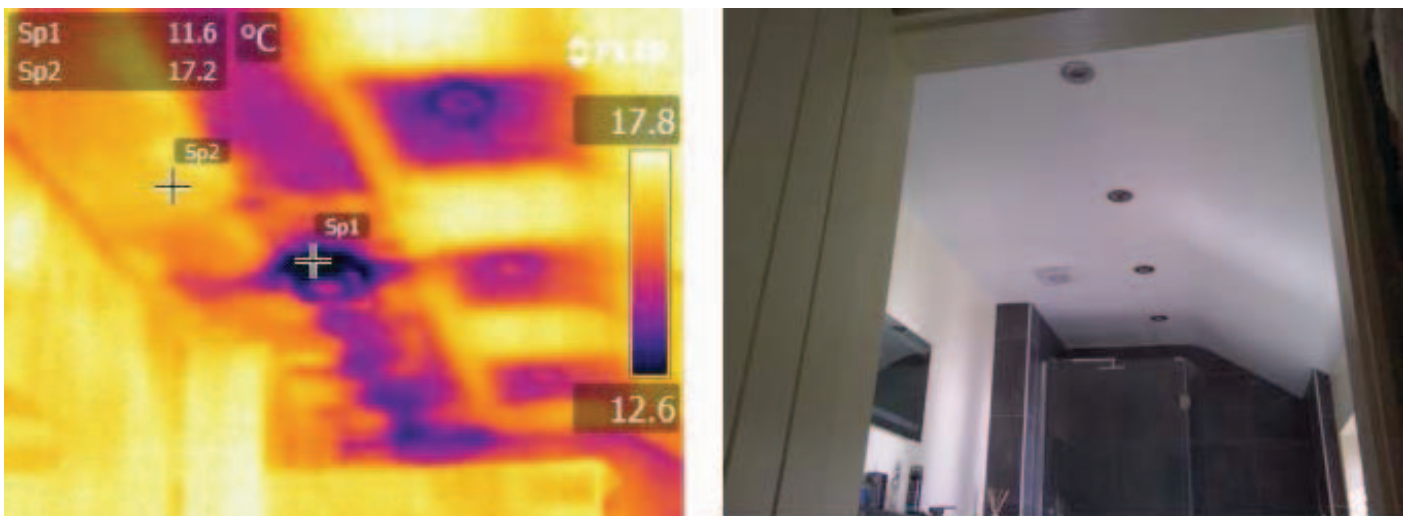
There is also evidence of missing or reduced insulation in the first floor en-suite shower room (Figure 54).

Figure 54. White House Farm, Stirton, Skipton. Reduced insulation in the ceiling of the first floor en-suite shower room.

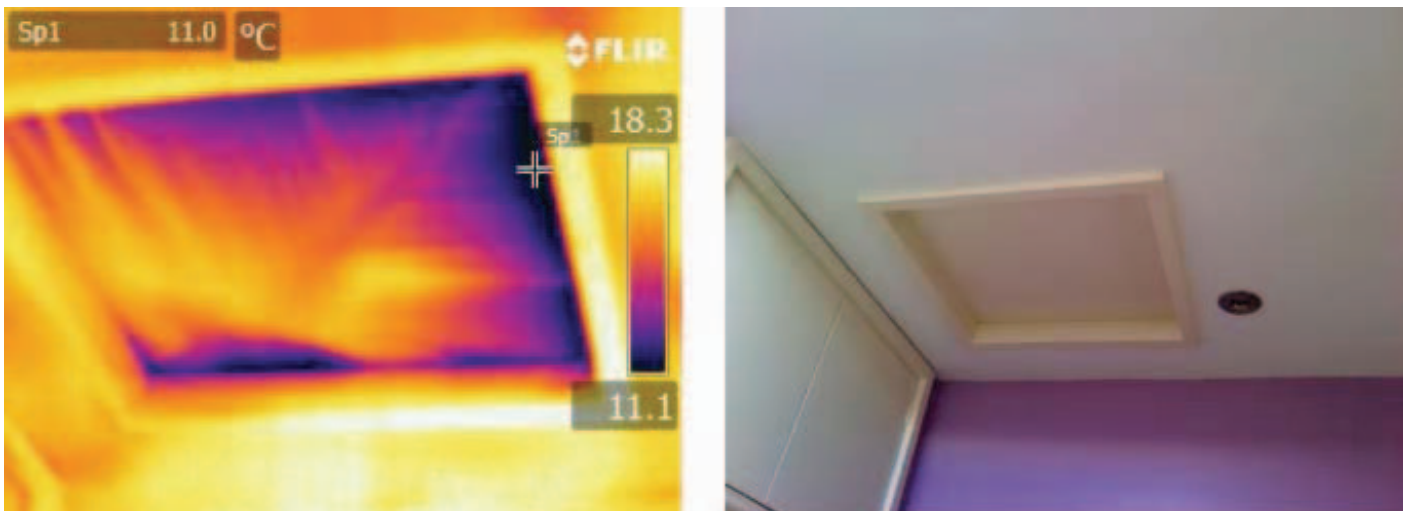
Figure 56. White House Farm, Stirton, Skipton. Ingress around loft hatch in main bathroom.
