Ancient Monuments Laboratory  
Report 38/97

WALL PAINTING CONDITION AUDIT,  
RICHMOND CASTLE, NORTH  
YORKSHIRE

J Davies  
T Manning

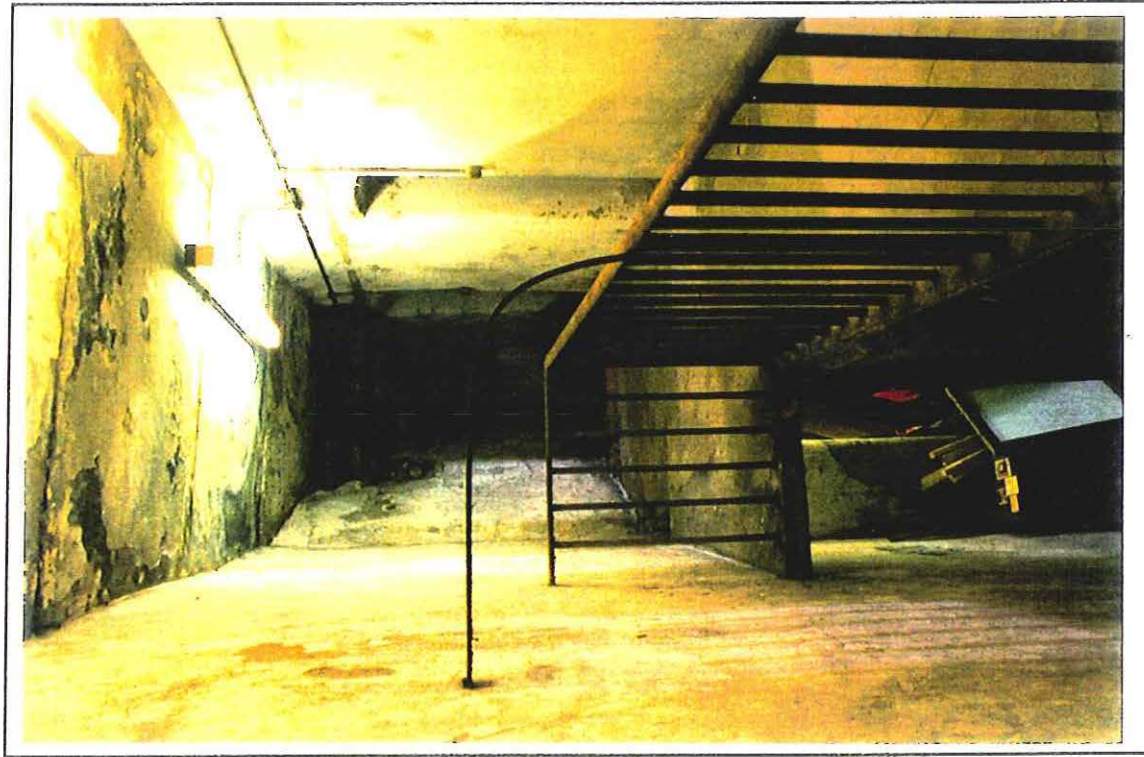
First floor, general view of interior

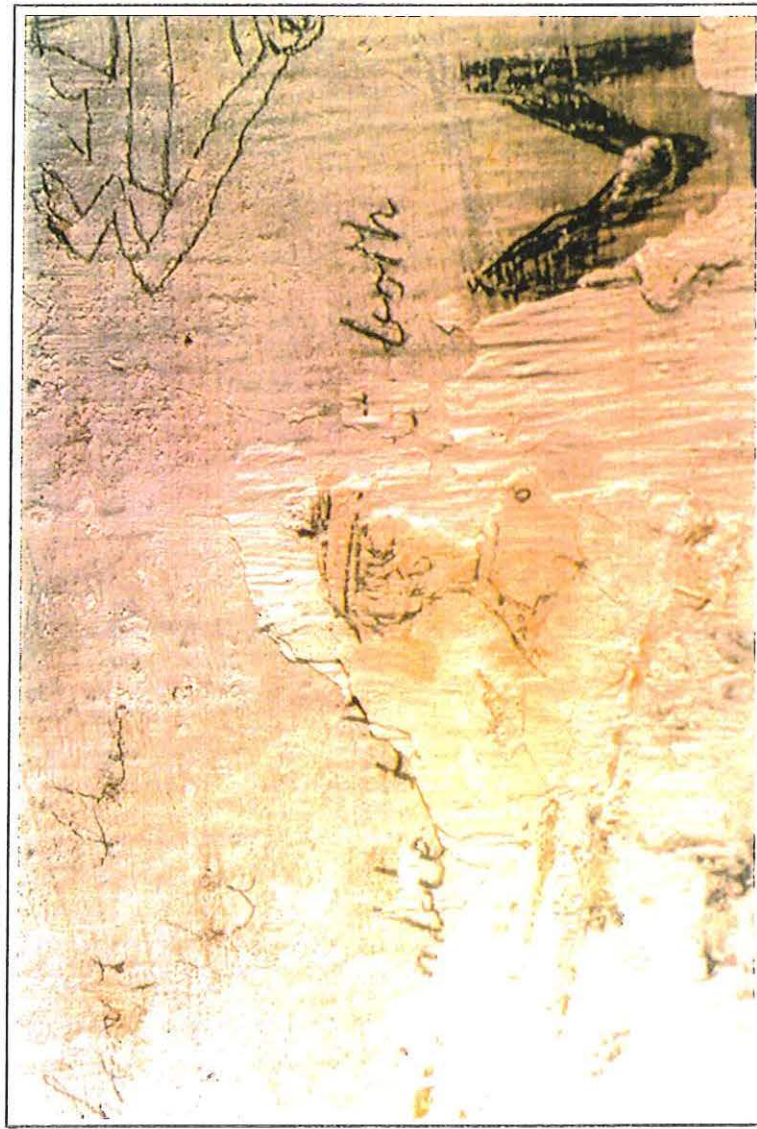
Detail, Cell 8, showing multiple layers of graffiti
