Ancient Monuments Laboratory  
Report 40/97

WALL PAINTING CONDITION AUDIT,  
ST MARY'S, STUDLEY ROYAL,  
NORTH YORKSHIRE

J Davies  
T Manning

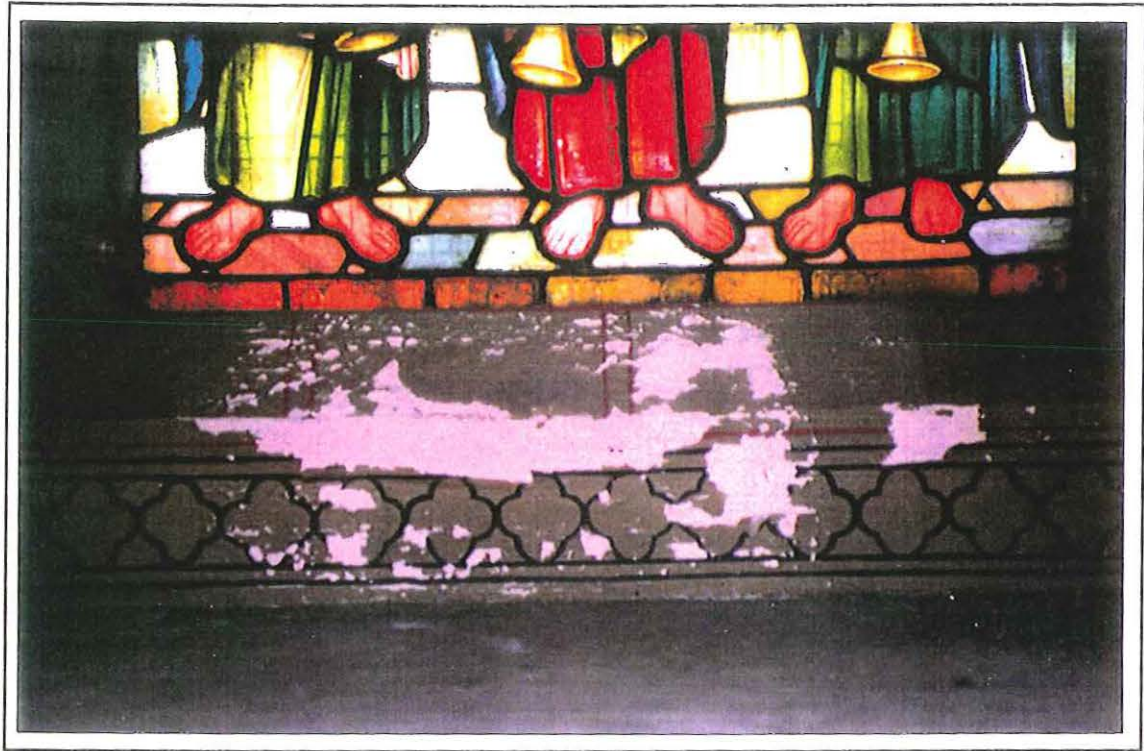
**Comments** 'On the interior there is clear evidence of water infiltration due to faults in the exterior stonework. There is a loss to the stone mullion on the exterior, north wall, east window (Sanctuary) which has allowed water to penetrate and has led to exfoliation and loss of paint to the interior surface. It is a possibility that the loss and delamination of the interior surface may also be related to the movement, and subsequent crystallisation, of soluble salts.'

Detail of damage to base of windows in the sanctuary

- Repair to damaged stone mullion, Sanctuary, north wall, east window: Infiltration has caused severe damage to the interior of the painted stone window mullion in this area, including exfoliation and loss of the paint layer. It appears that a programme of stone replacement is planned for the exterior of the church, and presumably the source of this damage (a badly weathered piece of stone on the exterior, which has allowed for infiltration of liquid water) is to be rectified shortly. Once this work is complete, it is highly recommended that the interior stone, ground, and paint layers are repaired and reintegrated as necessary.

**Type** FILLS/REPAIRS INSERTION **Date** 08/06/95  
**Person** TM/JD  
**Comments** Minor repairs are required to the stonework where penetrating damp and salt activity have caused paint loss. In particular, infiltration has caused severe damage to the interior of the painted stone window mullion in the east window, north wall, Sanctuary, including exfoliation and loss of the paint layer.

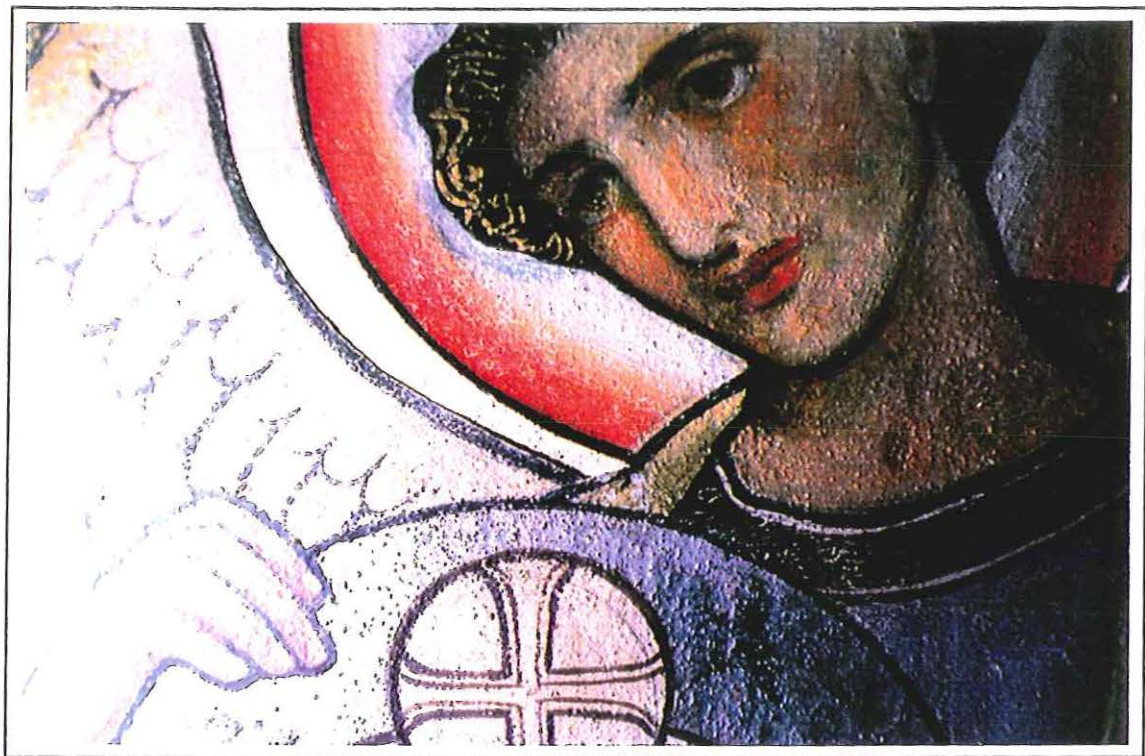
Detail, angel holding emblem of the Crucifixion, sanctuary arch. Note the lifting of the canvas support.

- Repairs to delaminating areas of canvas: several corners of the applied canvases are lifting slightly from their support (either timber or stone). Although at the moment this does not appear to pose any great threat to the paintings it is recommended that these edges are fully re-adhered to their supports before dusting.
